# Structure and Crack Response to Coal Blasting in Brazil

Rosenhaim, V.L., Aimone-Martin, C.T. Munaretti, E., Koppe, J.C.

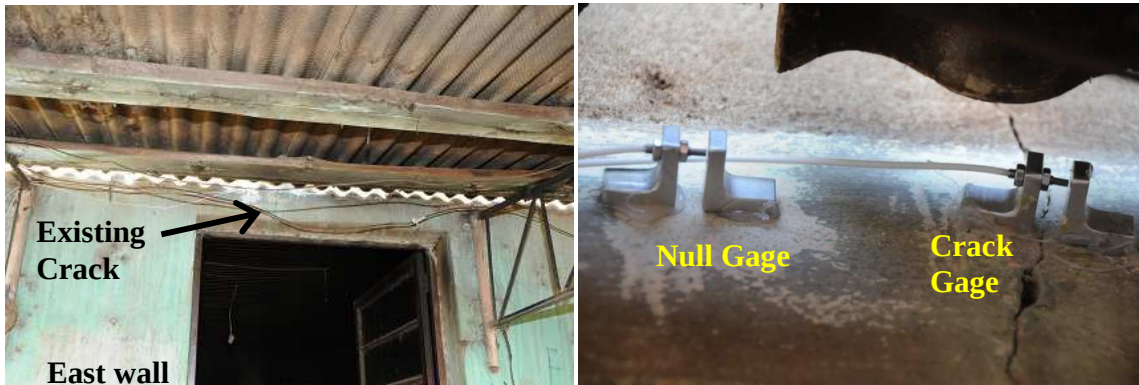
A displacement gage was mounted over an existing exterior wall crack located on the door lintel, shown in Figure 2. This gage was used to measure variations in crack aperture due to blast-induced structure motions. Crack width was correlated with ground vibrations and air overpressure amplitudes and variations resulting from climate changes. Aperture variations were measured on an hourly basis over six months and correlated with daily variations of temperature and humidity (weather-induced crack response). A gage was installed on a portion of undamaged wall (null gage), also shown in Figure 2, to measure the natural expansion and contraction of the material with weather changes and this value was subtracted from the measurements of the crack aperture to isolate crack movement.

Figure 2: Location of displacement gages above a doorway, mounted over the existing wall crack and in the undamaged wall
