# Xcelodose 600S- ME-5 Microbalance Failure Investigation

Mechanical failure pathway, observed handling practices, and corrective-action direction

RCA

AUG–SEP 2026

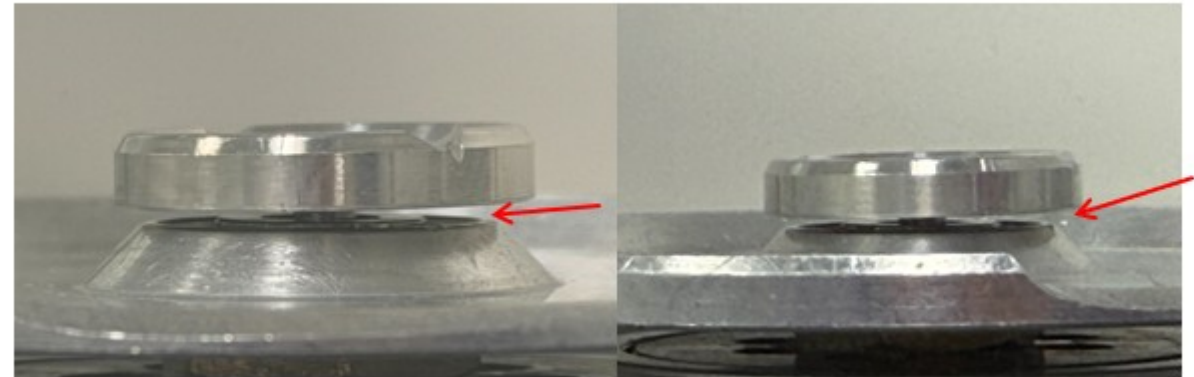
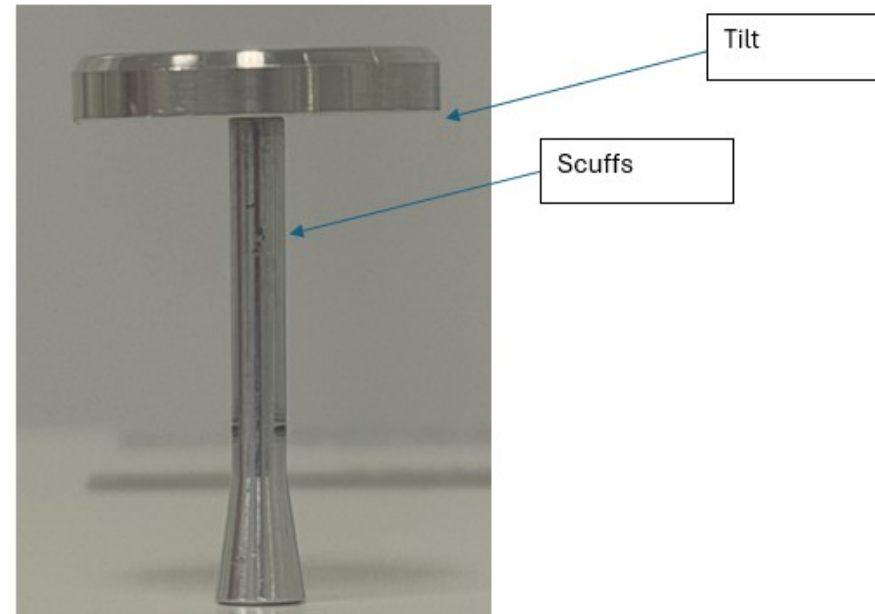
Pan tilted towards left on #0 [REDACTED]

## Tilted weigh pan + scuff marks

Failed manufacturer specification; corner load and linearity could not be adjusted.

- Visible geometry is consistent with deformation / misalignment.
- The exact time and loading event that produced the deformation is not directly observed.

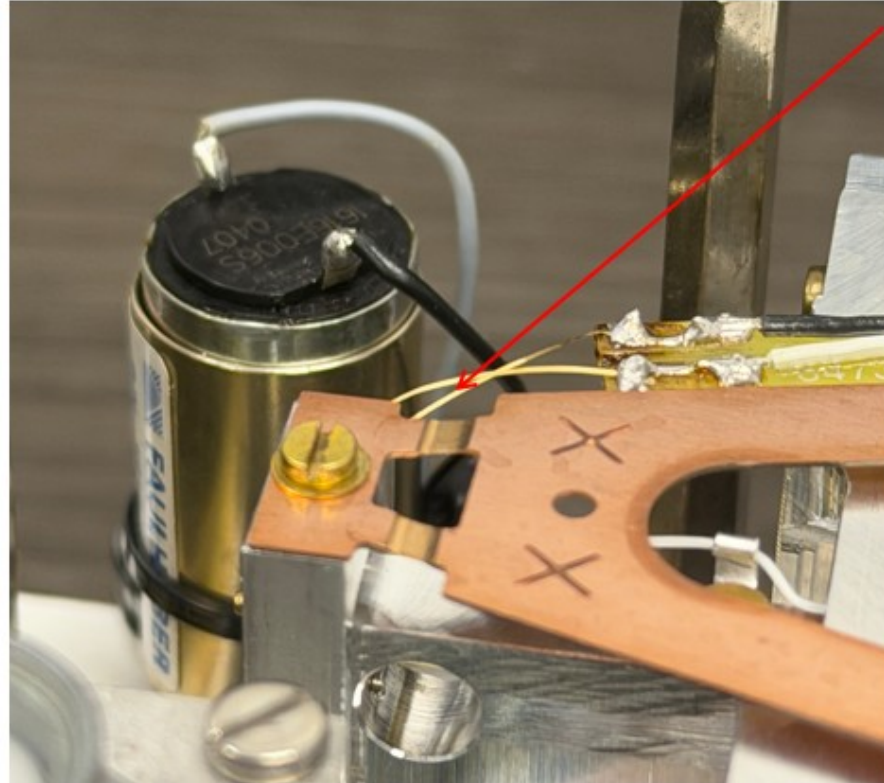
## Asymmetric front springs

Failed corner-load test; unit could not be repaired.

- Visible asymmetry is consistent with spring deformation / mechanical misalignment.
- This unit provides historical evidence of the same corner-load failure family.
- This unit was investigated in TW#151494, direct loading was observed and determined as deformations cause; Pan bend observed similarly to # [REDACTED]

Top front springs are aligned differently, left slopes downward and right side slopes upward.

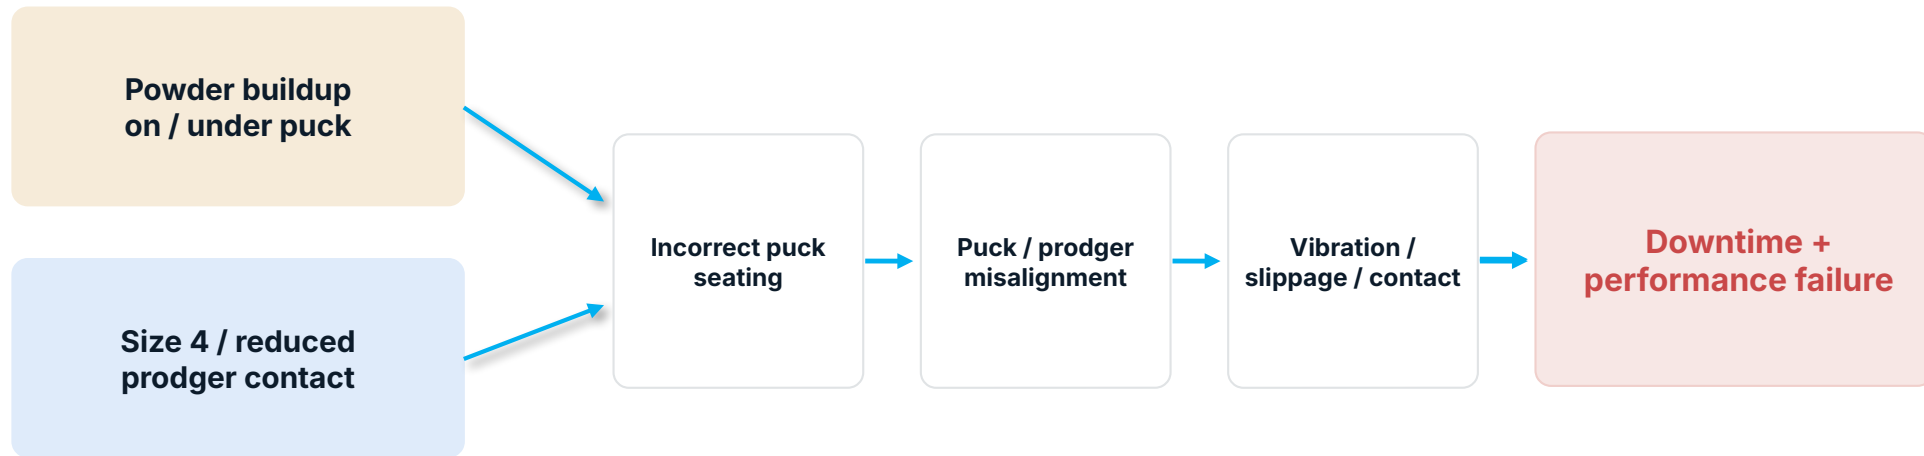
# Powder and alignment conditions may amplify vibration and cause **Downtime**

This pathway is supported by observed buildup and operator / SME input, but it is not as direct as the pan-loading evidence.

Observed: powder stuck on pucks (17 / 20 AUG) • Reported: Size 4 slippage + incomplete prodger contact  
Observed: pre-alignment performed by 2nd shift • 23-AUG downtime reported as alignment-related

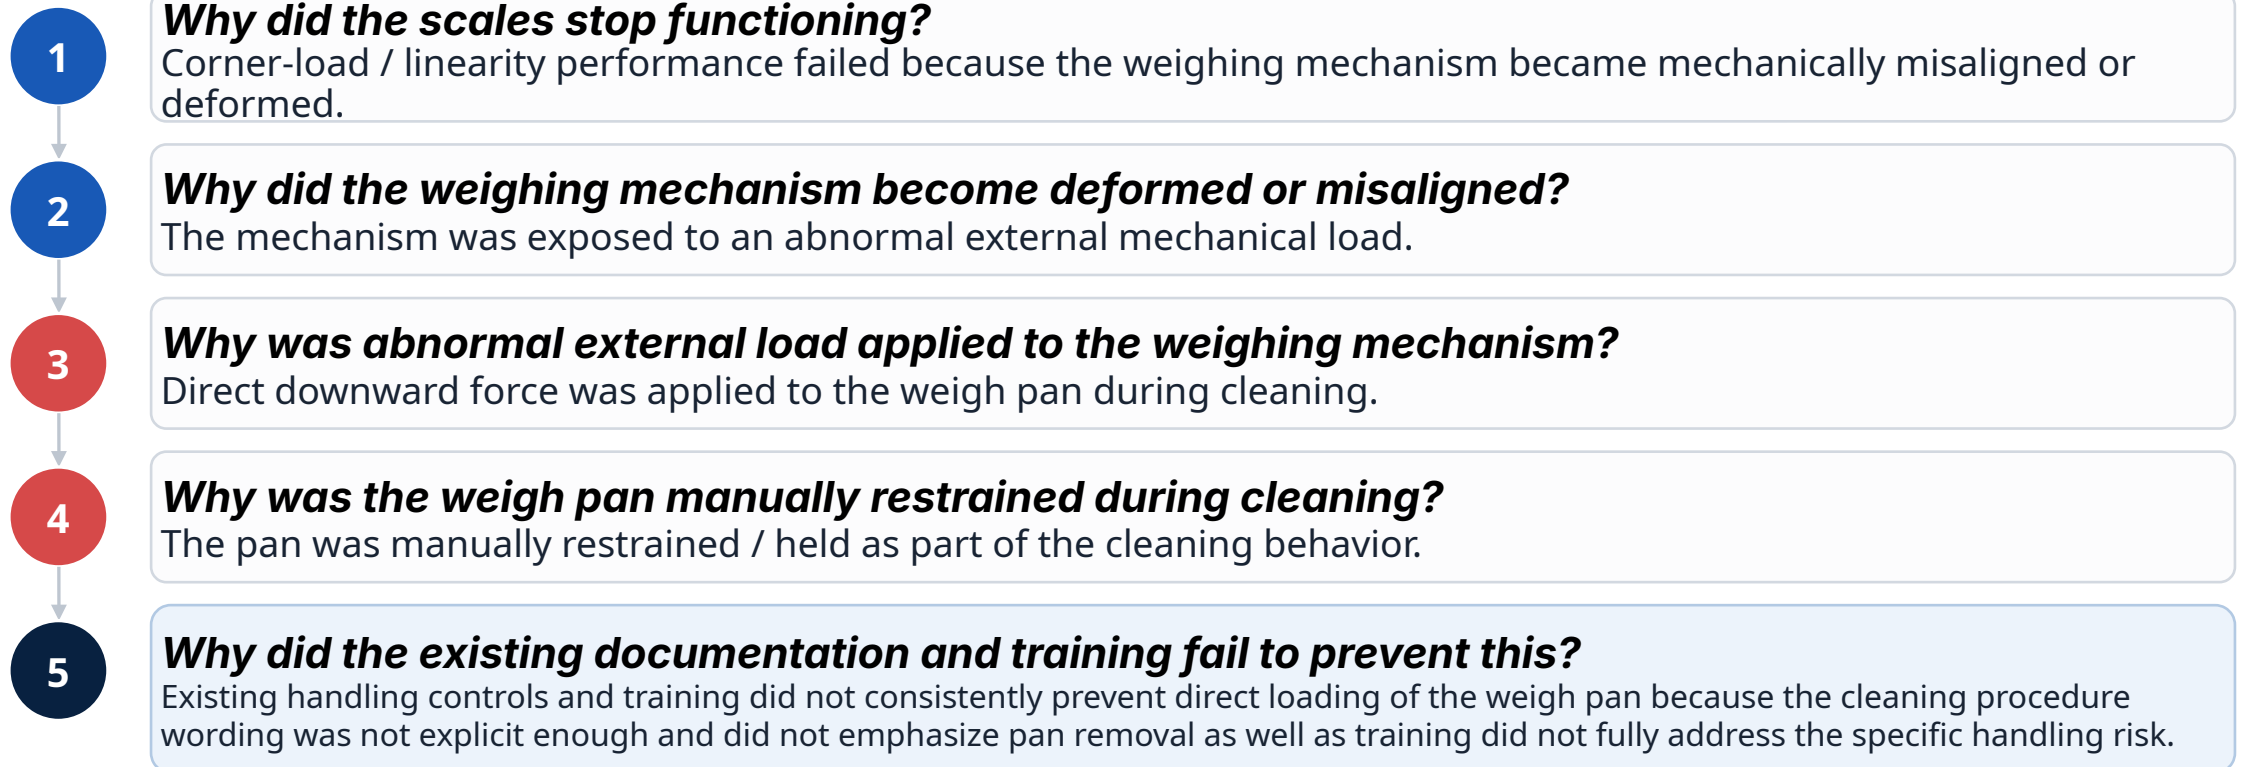
# The 5-Why moves from the failed balance to the control that allowed repeat loading

The system-level failure is not “an operator mistake”; it is an ineffective control that allowed the same fragile-component loading behavior to recur.
