Vehicle Damage Assessment Report

Report No. E6D00A98  
Date: 14.05.2026

| Type | A6 |
| Subtype | A6 3.0 TDI quattro |

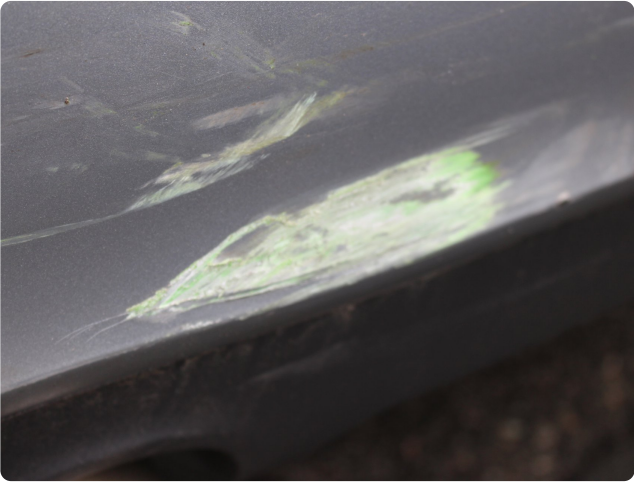
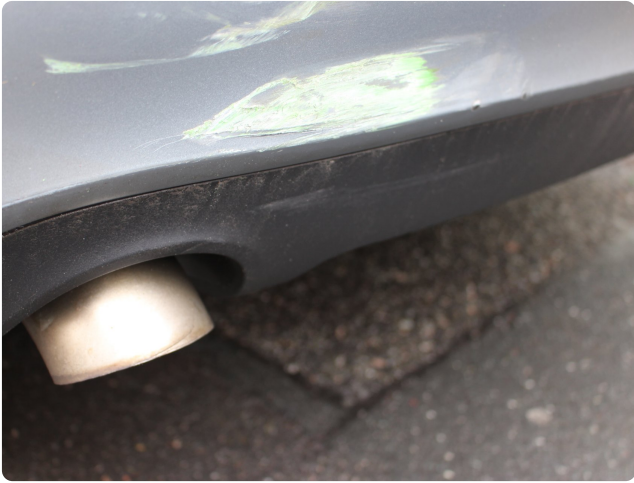
#1: Right side panel scratches | Severity: moderate | Repair: Clean and assess the scratch depth. If scratches have not penetrated to bare metal, perform paint correction and polishing. If deeper, sand affected area, apply primer, base coat, and clear coat. Treat any corrosion spots before repainting.

| Risks | Paint may have penetrated into scratches requiring deeper surface preparation;<br>possible minor dent underneath paint damage |

Visible paint damage and scratches on the right side panel surface. The affected area shows multiple scratch marks with a greenish-yellow discol-

| Body Paint | Spot repair |
| Repair Method | Conventional body repair with paint correction |
