Vehicle Damage Assessment Report

Report No. BD011329

| Type | Corsa |
| Subtype | Corsa D 1.2 16V |

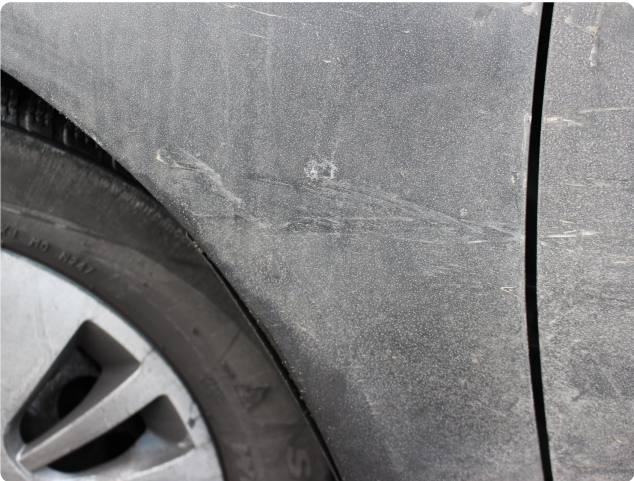
The left side panel exhibits multiple surface scratches and paint abrasions visible in the central area of the panel above the wheel arch. The scratches

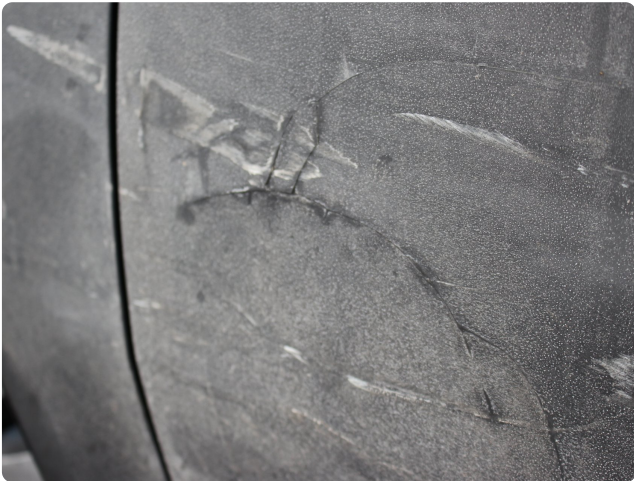
- #1: Right door panel scratches | Severity: moderate | Repair: The damaged area requires paint repair involving sanding, priming, base coat application, and clear coat refinishing. Depending on scratch depth, minor filler application may be necessary. Complete door panel repainting recommended to ensure proper color match and finish quality.
- #2: Left side panel scratches | Severity: minor | Repair: Paint surface repair through wet sanding, polishing, and buffing of the affected area. If scratches penetrate through clear coat to base coat, localized spot repair with paint blending may be necessary.

Visible damage to the right side door panel consisting of multiple deep scratches and paint damage. The scratches appear to have penetrated
