# PW Exhaustive OT

Oldtimer Valuation Report

Report No. B52B994B

| Subtype | DB11 V12 Coupe |

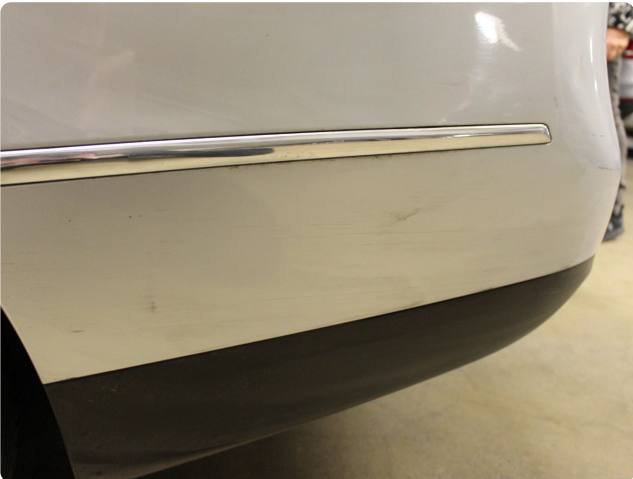
Visible damage to the right side lower door area of a white vehicle. The chrome trim molding shows signs of impact or contact damage with visible scuffing

- #1: Right front door lower area | Severity: moderate | Repair: Replace or refinish chrome trim molding. Repair and repaint lower door panel section. Clean and assess if door edge requires additional paintwork or minor body filler application.
- #2: Front hood/bumper scratches | Severity: minor | Repair: The affected area requires paint touch-up and blending. Surface preparation including sanding, primer application, and refinishing with matching metallic paint followed by clear coat. Buffing and polishing to blend with surrounding panels.

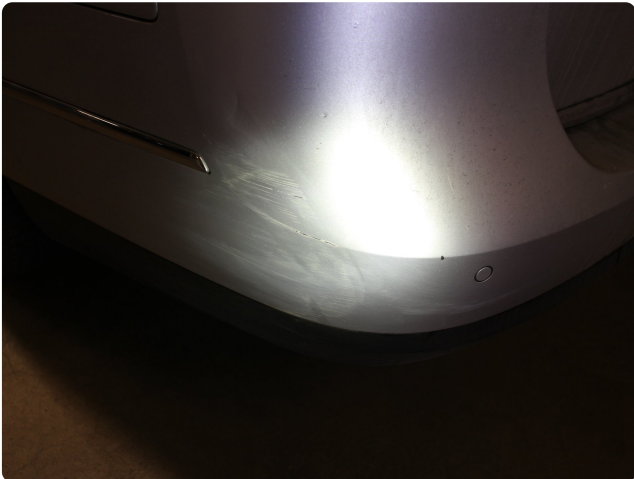
Visible scratches and scuff marks are present on the front curved surface of what appears to be a silver/metallic painted panel, likely the hood or front
