## Test Report

No.: NBHL26070075701CW

Sample Description : DISPOSABLE FOOD CONTAINER WITH 20% PCR

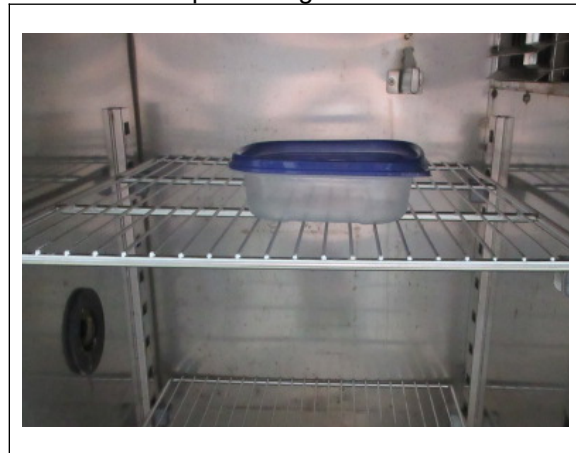
Test Sample During the Freezer Test

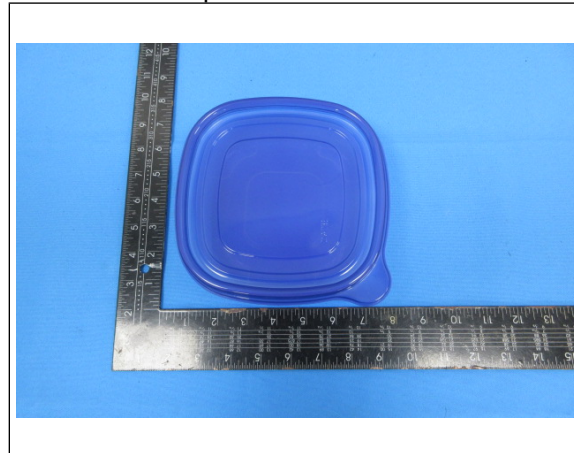
### Test Sample After the Freezer Test
