Battery contacts

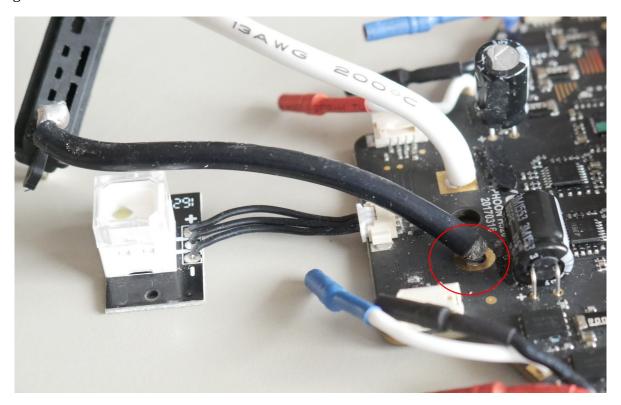
The other day I got a motherboard from a crashed H520. What I noticed immediately was a burned ground cable, which was only connected to the mainboard with a few wires from the strand of the ground cable.

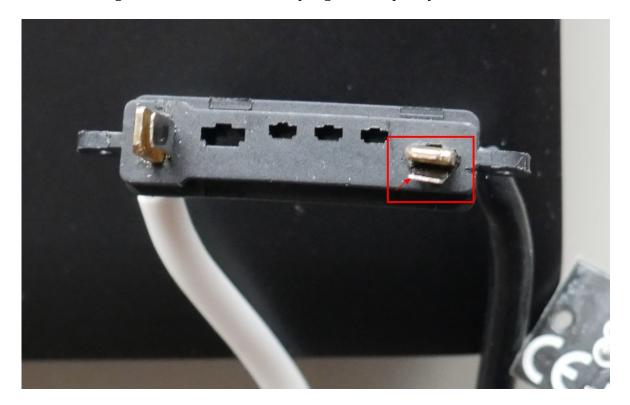
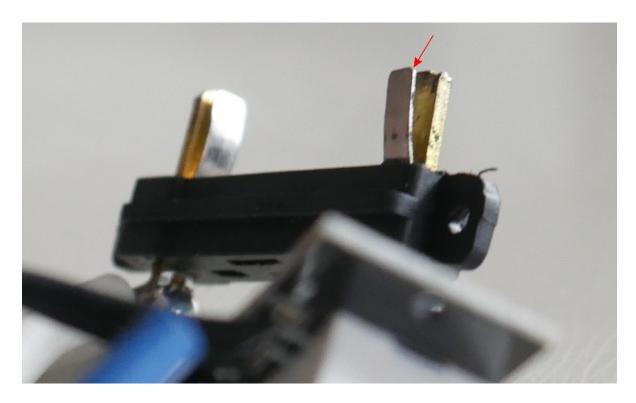
The battery contacts were also no longer usable. The contact springs had lost their spring force. In the case of the ground contact, the contact spring was completely bent.

This can be seen clearly at the ground connection. At high currents, the contact pair becomes very hot and the contact resistance increases dramatically. The voltage breaks down and the drone loses power, which can be end up in a crash.

- Well, in any case, when pushing the battery in, make sure that it snaps in properly and can be pushed tightly onto the contacts. If this is too easy, you should think about it.
- Every now and then, you should look inside the battery well and check the contact springs. They should be curved and rest against the top of the contact.
- Also the battery contacts should always be subjected to a critical inspection.
- Check to see if there are any severe voltage drops in the flight logs when the drone is taking off. This indicates either an old, weak battery or such problems of the battery contacts.

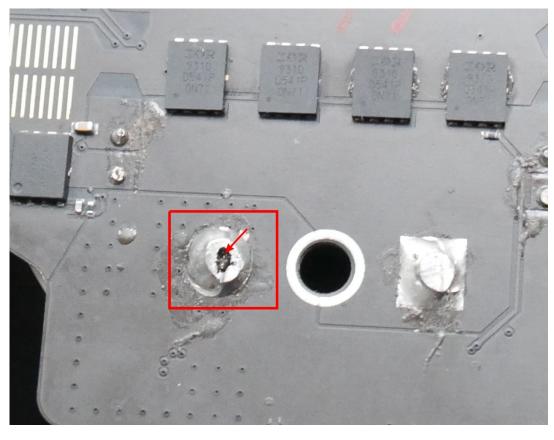
The same result has a cold solder joint on the battery cable. Here we see both. What is cause and what is effect is impossible to say. In any case the copter crashed.

→ All in all unfortunately a typically example of such contact problems.

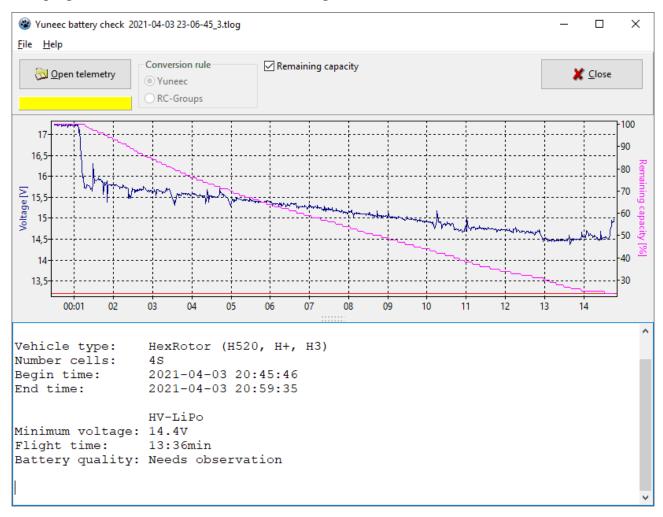
Battery check tool

The check requires an entire flight with a fully charged battery. The assessment is (and can be) only very superficial and is dependent on or influenced by many factors. Nevertheless, it can be seen intuitively, at least on the diagram, how the discharge behavior of the battery is.

The advantage over pure voltage measurement is that you can see the voltage curve under load. If the voltage drops sharply under load, this indicates a high internal resistance of the battery. This happens gradually with aging or relatively quickly with defects.

- Segment 1 shows the typical course of a good battery with long flight time and low voltage drop.
- Segment 2 shows an aged battery, which should be inspected continuously.
- Segment 3 shows a defective or at least very old battery that belongs in the scrap. This battery actually caused a crash.

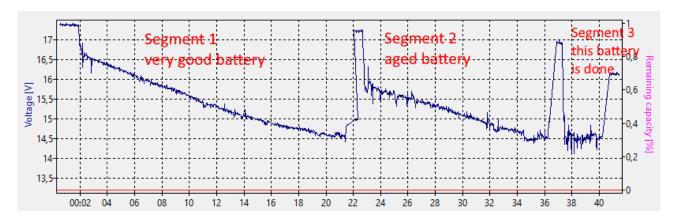
In the attached screenshot we see the evaluation of a TLOG file from the H520, which contains three flights with three different batteries, here called segments of the file.

Regular checking of the voltage chart in the flight logs is highly recommended anyway, in order to detect power supply problems before it comes to a crash.
