# M7.7 28 March 2025 Sagaing Earthquake, Satellite-Based Comprehensive Damage Assessment Report

Sagaing, Mandalay, Shan (North), Magway, Nay Pyi Taw, Shan (South) and  
Bago (East) Regions  
Myanmar

13 June 2025

**Prepared By**  
United Nations Satellite Centre  
(UNOSAT)

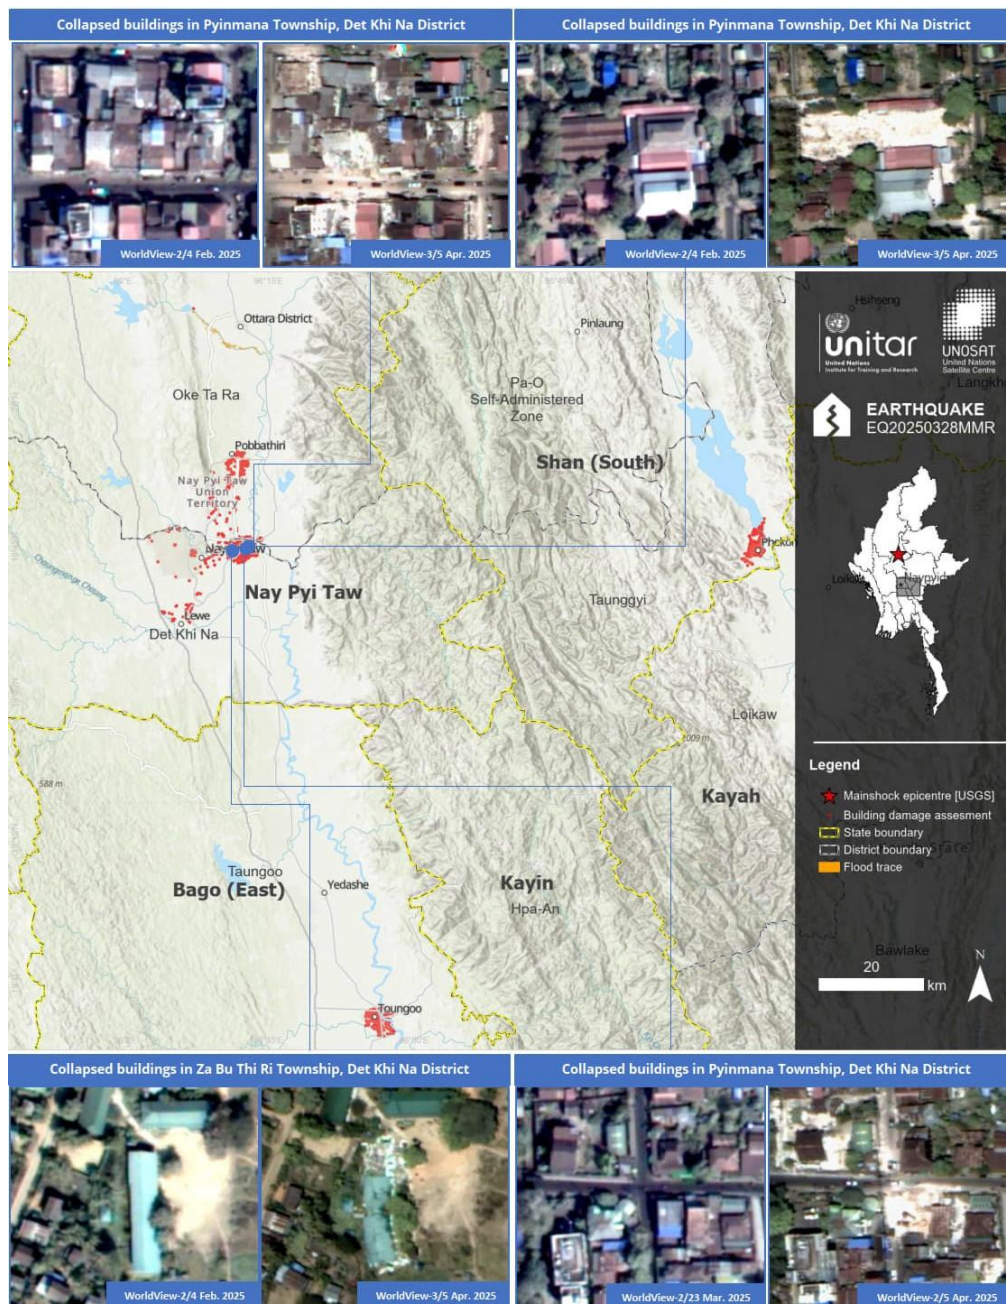
The preliminary assessment of damage to buildings and structures in the Nay Pyi Taw, Shan (South) and Bago (East) Regions was conducted by UNOSAT, Copernicus EMS using a photo-interpretation approach with very high-resolution satellite images from before and after the seismic event. These images were made available through the International Charter Space and Major Disasters. Post-event satellite images were acquired on 31 March and 1, 3, 14 and 16 April 2025, along with pre-disaster images. In the analysed areas, 7,645 buildings with significant visible damage were identified. The district of Taunggyi recorded the highest number of earthquake-affected buildings, with 5,059 damaged or potentially damaged structures.

Figure 7 - This map depicts the extent of damaged buildings in the Nay Pyi Taw, Shan (South) and Bago (East) Regions of Myanmar, with a specific focus on the Nay Pyi Taw Regions. Inset images from the WorldView-3 satellite, acquired on 5 April 2024, highlight and visualize the damage to buildings in Za Bu Thi Ri Township and Pinyinmana Township in Det Khi Na District.

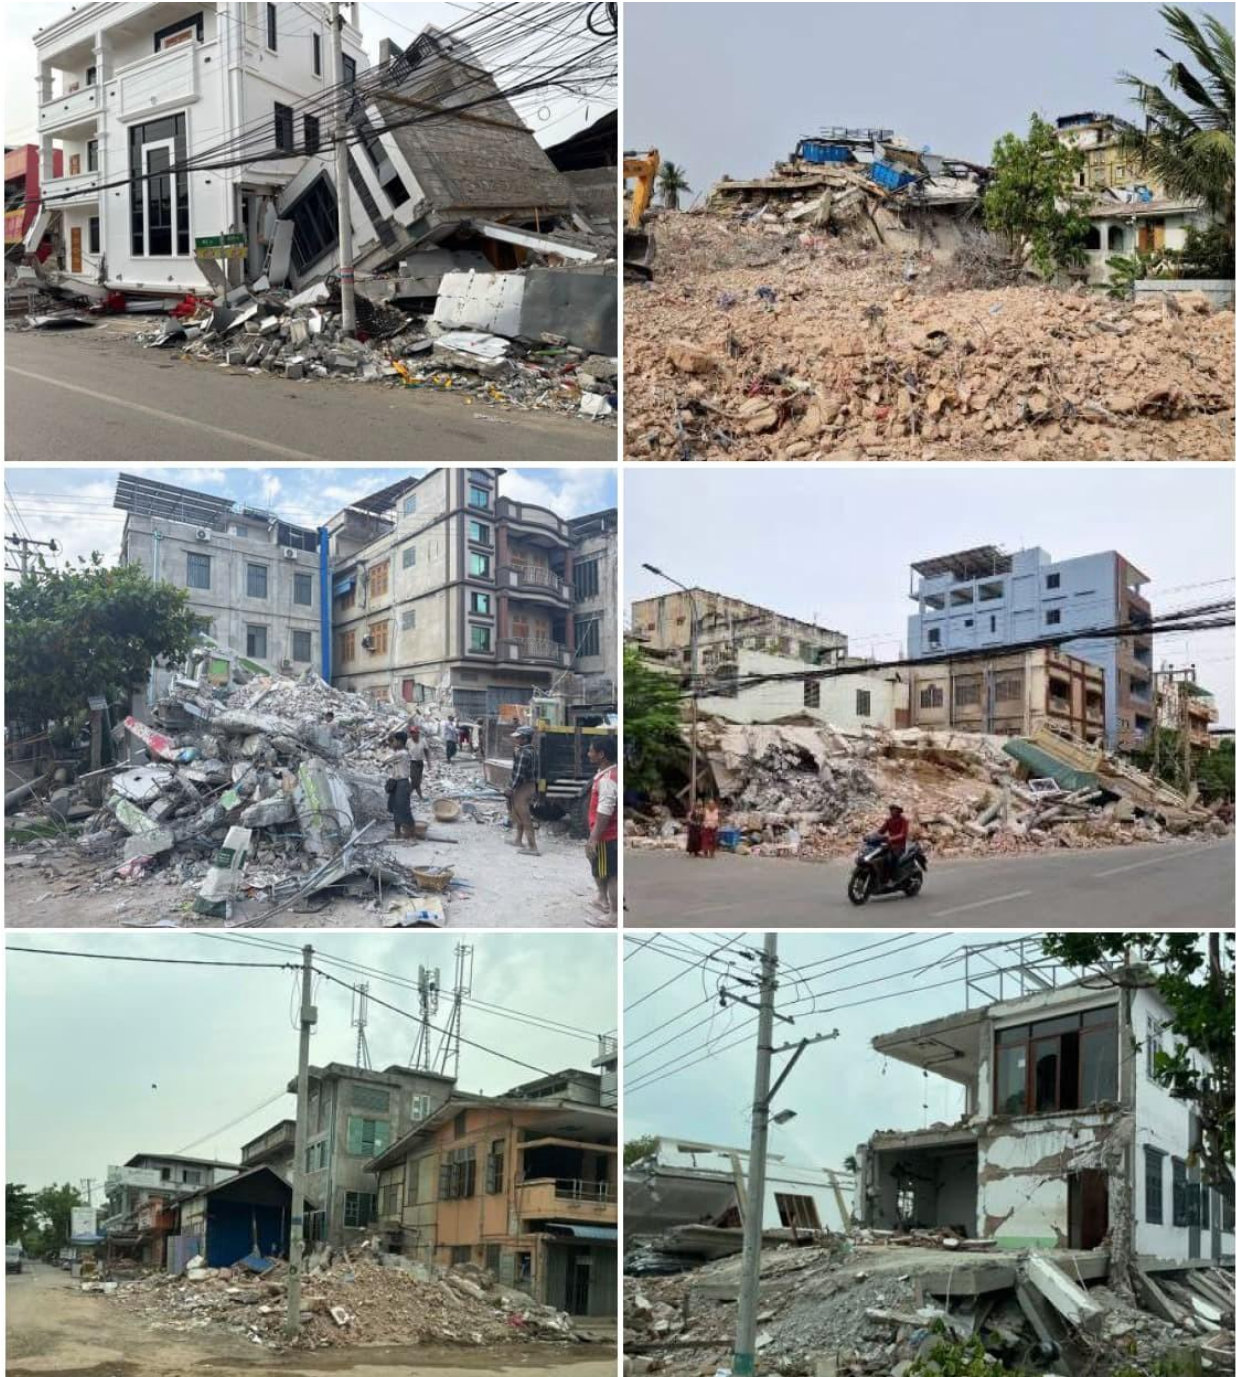
Figure 14 – These are ground photos collected through the UN-assigned system, which allows local people to submit photos from the ground. This is very important and useful, as it supports validation by enabling comparisons with satellite-based damage assessments. As shown, the earthquake caused severe damage, including completely collapsed buildings in many areas—particularly in the Mandalay and Sagaing Regions, which are close to the epicentre
