Property: 110 N CHESTNUT ST

Claim Number: PR02105351 Policy Number: Type of Loss: Water Damage

Estimate: 110-N-CHESTNUT-ST

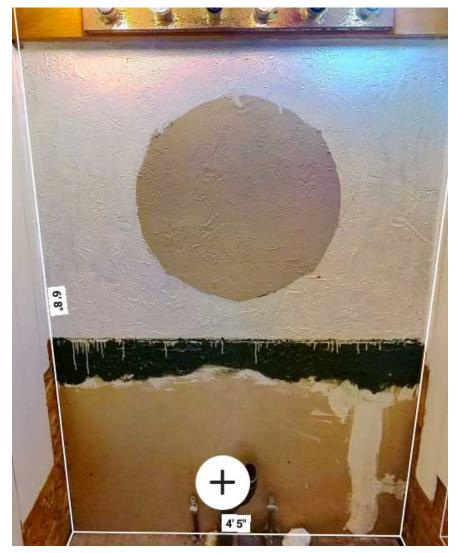
1 1-Vanity wall
Vanity wall where drywall is all damaged, need to replace.

DESCRIPTION	QUANTITY	UNIT PRICE	TAX	O&P	RCV	DEPREC.	ACV
Walls							
1. Tear out wet drywall, cleanup, bag for disposal	37.33 SF	1.12	0.35	8.44	50.60	(0.00)	50.60
Tear out wet drywall on the wall where	vanity was in b	athroom, see pics to	confirm dama	ge.

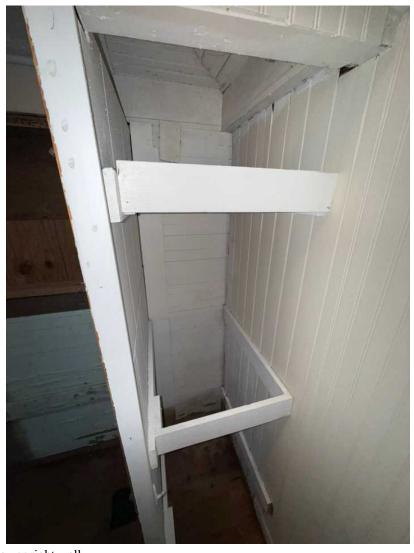
2 2-Closet behind shower right wallCloset behind shower area wall (which is to displace from its current position)

31. R&R Stud wall - 2" x 4" x 8' - 16" oc	$4.00\mathrm{LF}$	24.37	2.03	19.88	119.39	(0.00)	119.39
Right wall of shower to be pushed back	to wider the show	er area, need to re	move it from i	ts current posi	tion and repla	ace at a little back	k

32. Carpenter - General Framer - per hour	4.00 HR	81.27	0.00	65.02	390.10	(0.00)	390.10
In moving that above stud wall, closet is		lease refer to pics	to confirm, th	is line item acc	ounts for lab	or to remove and	demolish
that small closet so that the stud wall can	be pushed back.						
Flooring

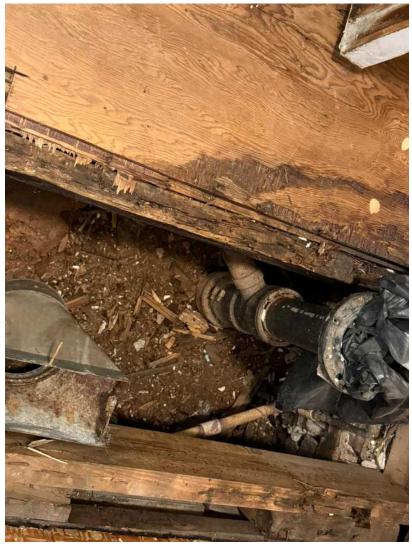
3 3-Floor joist damage Floor joist damaged/missing in shower area.

33. R&R Joist - floor or ceiling - 2x10 -	18.16 SF	5.10	1.80	18.88	113.30	(0.00)	113.30
w/blocking - 16" oc A part of floor joist is missing and is a l	ittle damaged, nee	ed to replace for th	at, please refe	er to pics at lass	t to confirm		
P and of from the first of an an an an		The second of the second	, <sub>F</sub>				
				1	io conjirm.

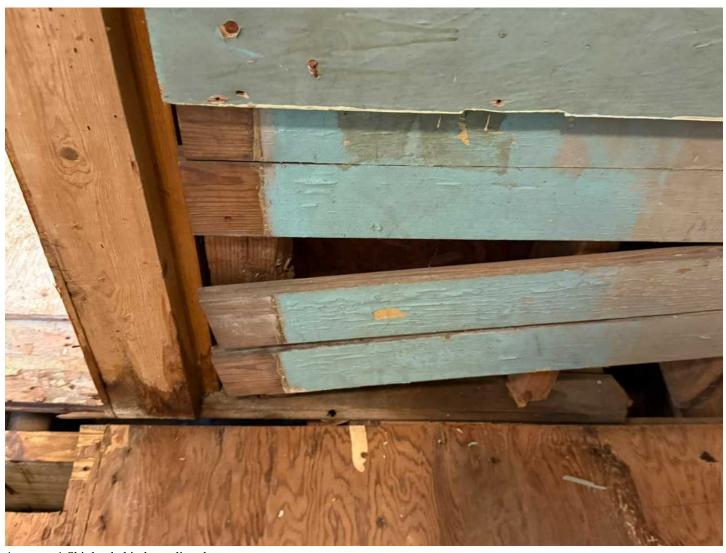
4 4-Shiplap behind paneling damage shower

Wood behind paneling in shower area is all damaged and rotten, need to replace

27. R&R Sheathing - shiplap - cedar*	0.00 SF	11.17	0.00	0.00	0.00	(0.00)	0.00
Shiplap wood sheathing behind panelin	g in shower area i	s all damaged and	rotten, need t	o replace.
