**Meso Scale (1:10000) Landslide susceptibility corridor mapping along NH-244, Doda-Lawa, Doda and Kishtwar Districts, UT: Jammu and Kashmir.**

(Item Code: M4LSSM/NC/NR/SU-JK/2024/50064)

Arun Dev, Director  
Mohd. Ibrahim, Senior Geologist

August, 2025

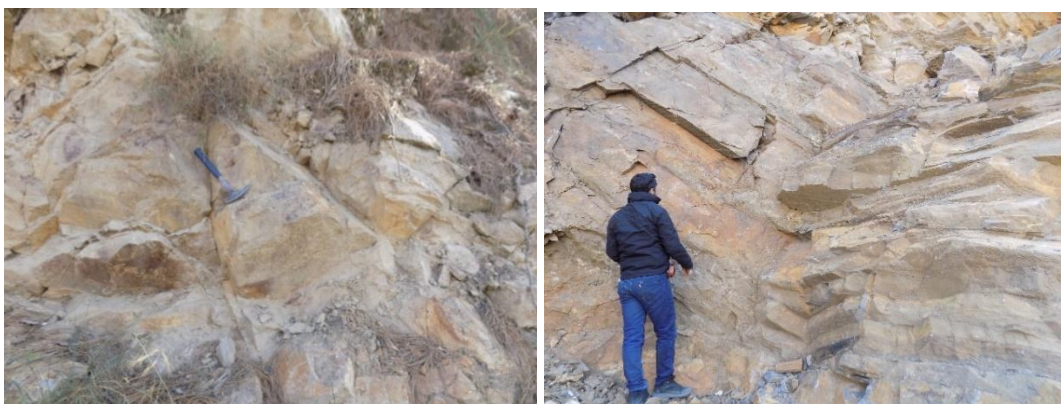
Figure 2.1 Field photographs showing a.Quartzite exposure near Prem Nagar b. Near Thattri along NH-244..

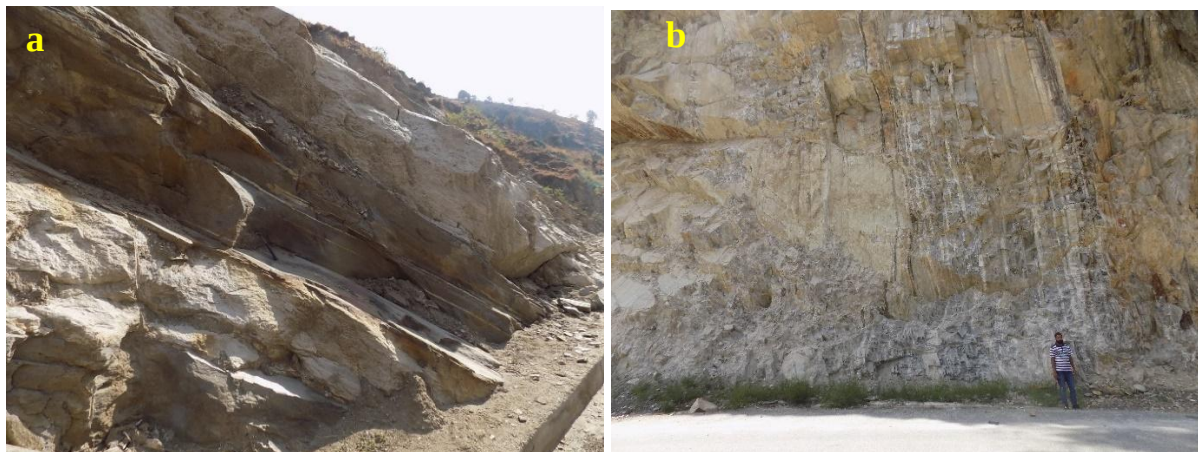
Fig.2.4 Field Photograph showing a.Exposure of marble band near Darabshalla.b.exposure of marble band at Thatri

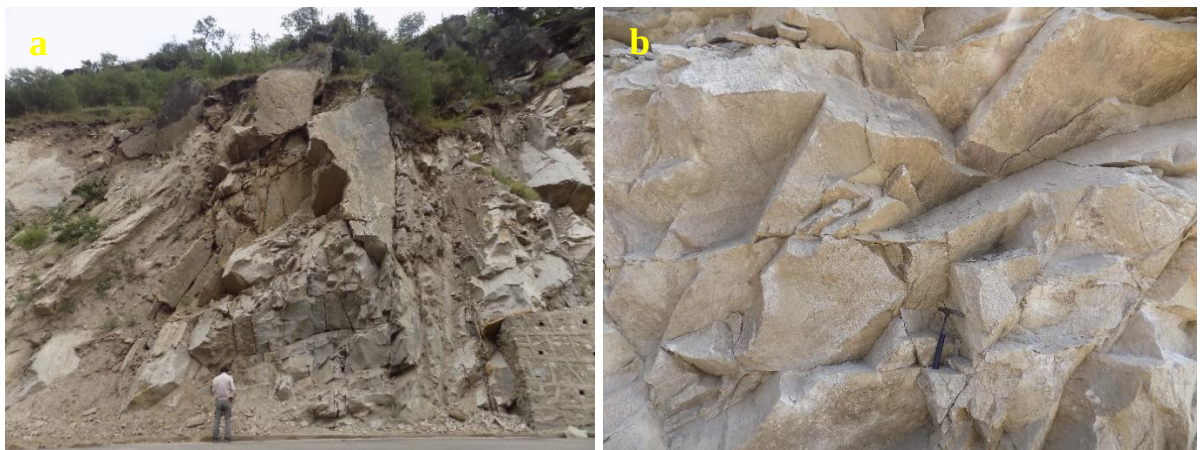
Fig.2.6. Field Photograph showing Kaplas Granite intrusive exposure near Doda bridge along NH-244

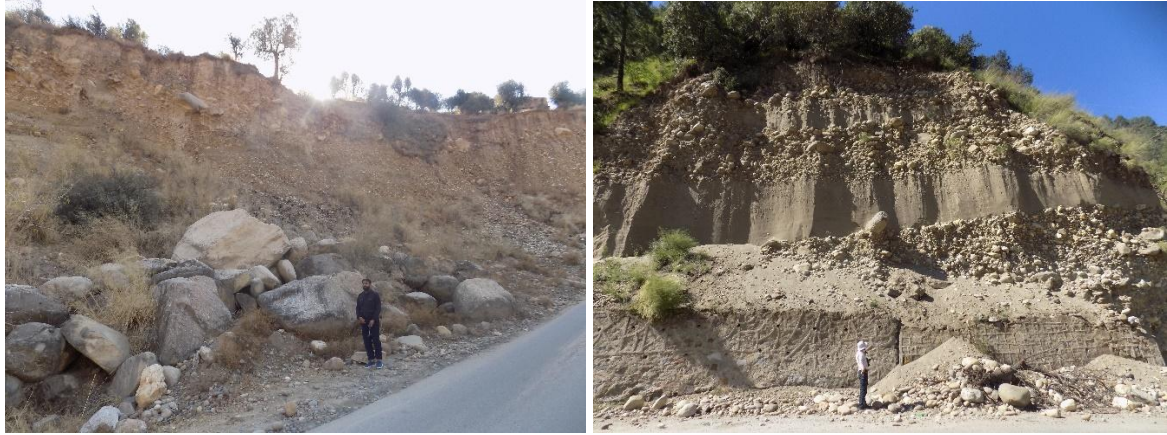
Fig.2.7. Field Photograph showing Quaternary exposure a. near Thattri, b. near Prem Nagar along NH-244

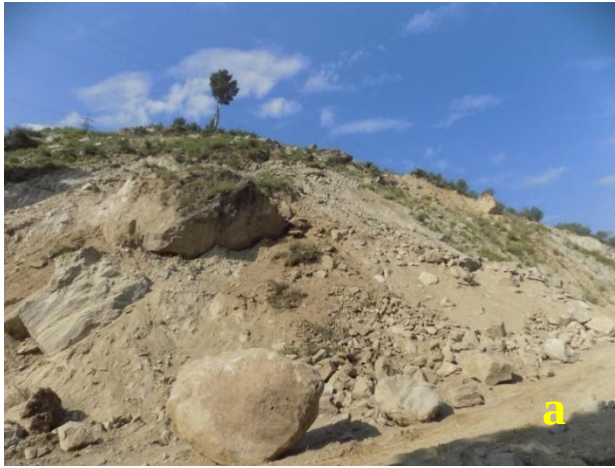
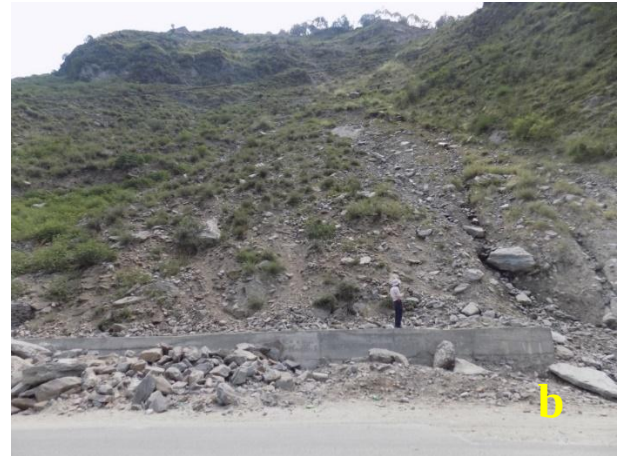
Fig.3.3 Field photographs showing landslides (a) Debris slide near Ganpath bridge (b) Debris slide near Premnagar.

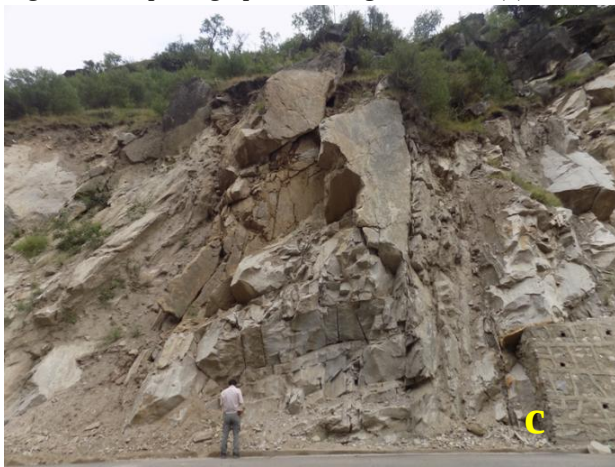
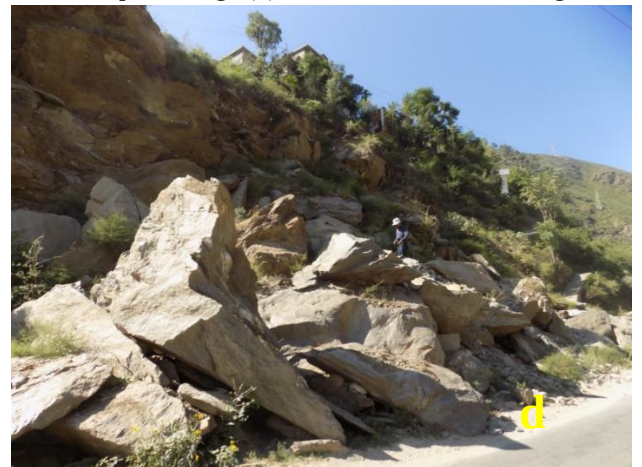
Fig 3.4 Field photographs showing landslides (c) Toppling failure near Kandni (d)Toppling failure in quartzite and interbedded schist near Thatri.

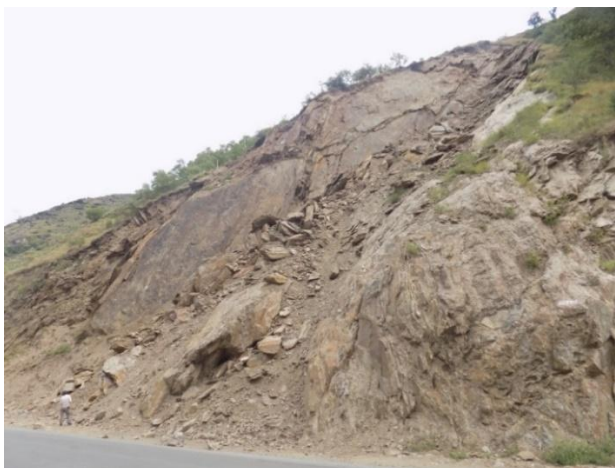
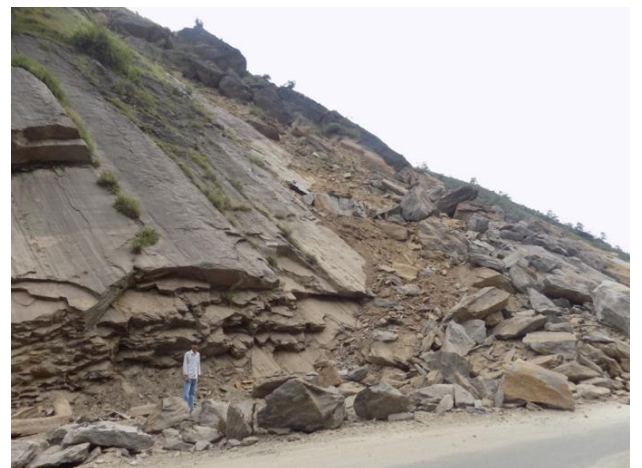
Fig 3.5 Field photographs showing landslides (e) Wedge failure near Lawa (f) Planar in mica schist

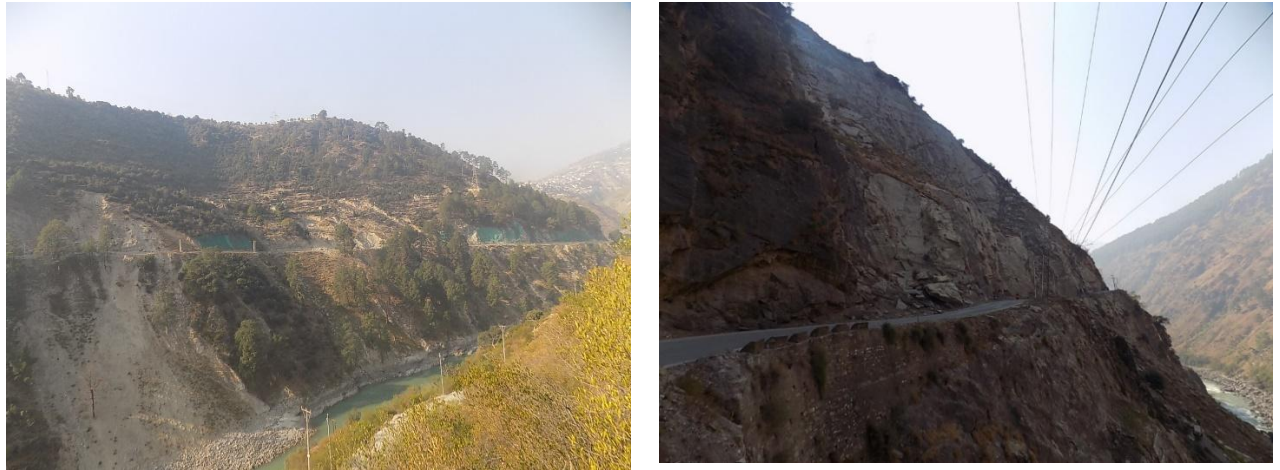
Fig 3.6 Field photographs showing landslides (g) Major landslide at Gadsu (h) Rock slide near Darabshalla.

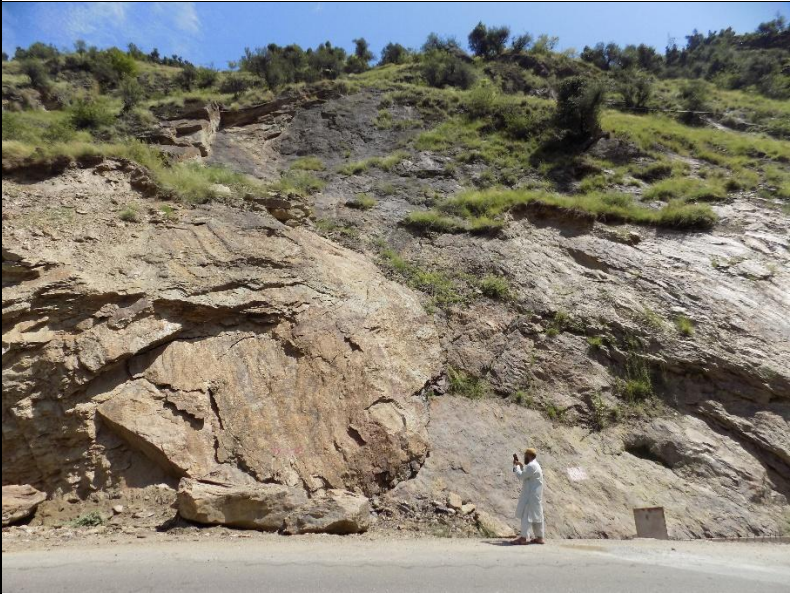
| 39 | Photos. Sketch of Plan & section of the slide | |

| 40 | Summary/Abstract | The slide has happened due to planar failure along J1 plane and due to cut slope. |

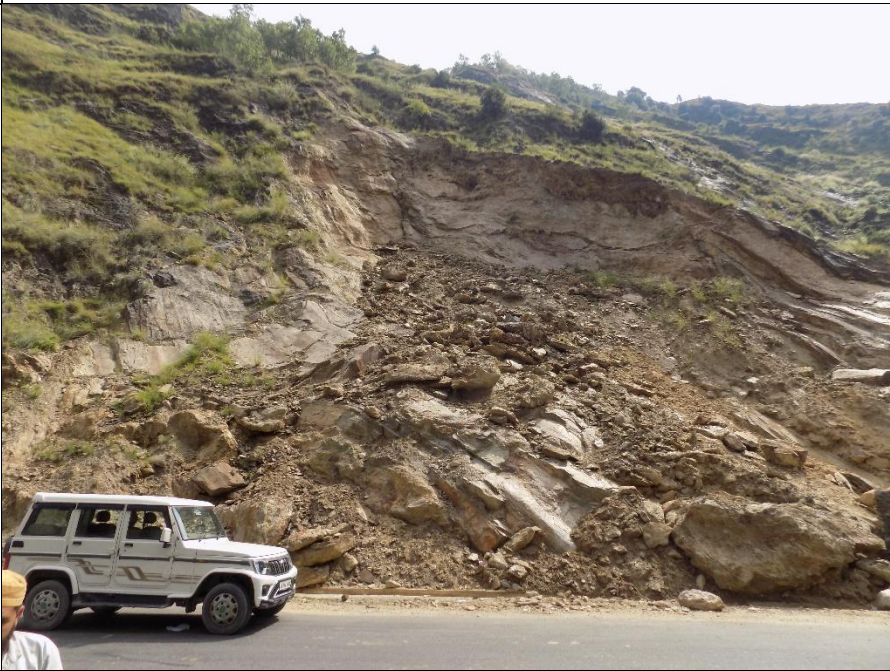
| 39 | Photos. Sketch of Plan & section of the slide | |

| 38 | Remarks, if any | Road is vulnerable |

| 37 | Remedial measures | Rock bolting with wire mesh along with shotcrete for closing the joints so that water cannot percolate |

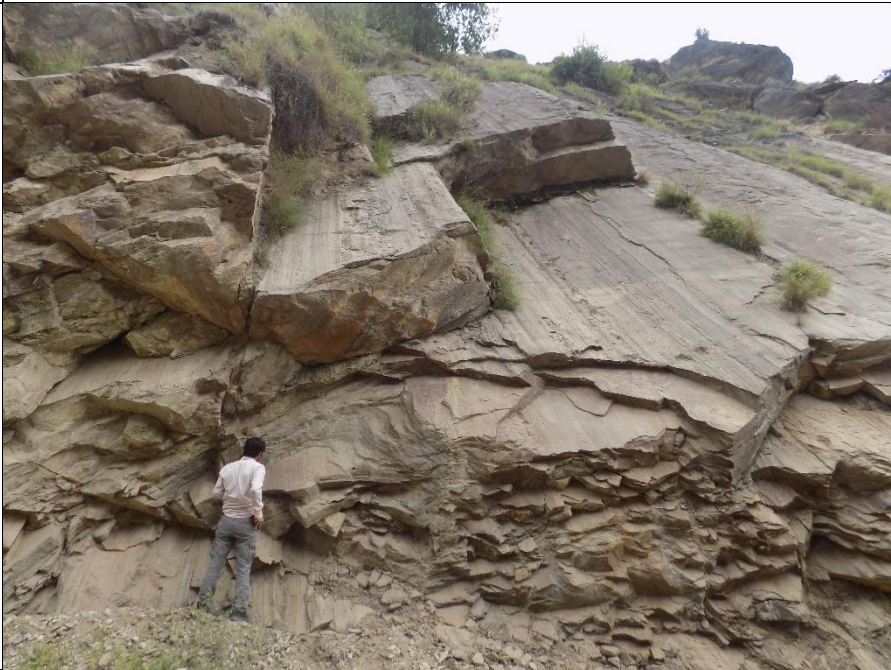
| 39 | Photos. Sketch of Plan & section of the slide | |

| 40 | Summary/Abstract | The slide is happened due to cutting of toe for road widening |

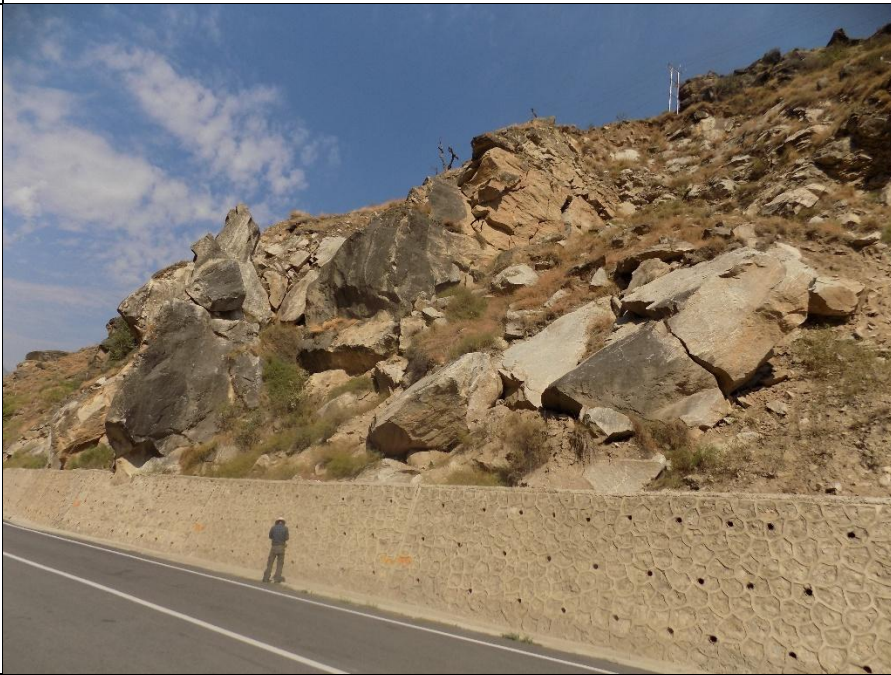
| 39 | Photos. Sketch of Plan & section of the slide | |

| 40 | Summary/Abstract | The slide is happened due to toppling failure along the water percolation from drainage |

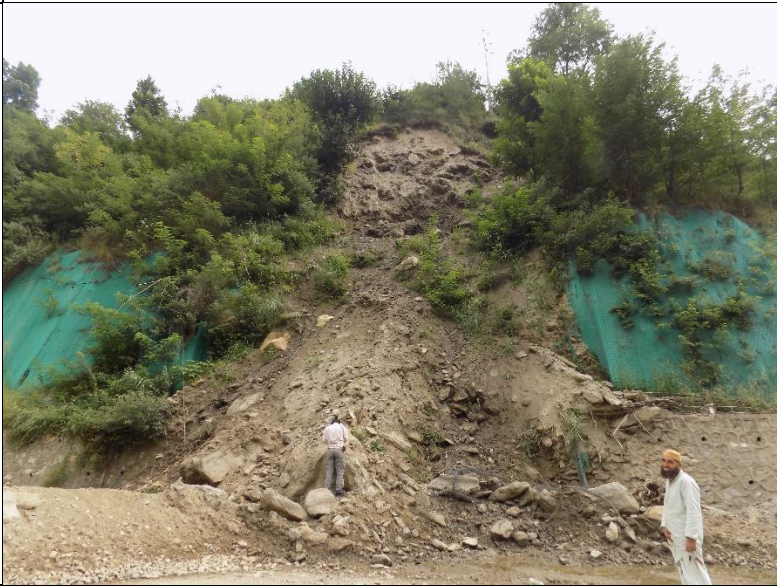
| 39 | Photos. Sketch of Plan & section of the slide | |

| 40 | Summary/Abstract | . Access water seepage into the slide zone has contributed for sliding. |

| 37 | Remedial measures | Channelization of the drainage, wiremesh with geojute along with erosion resistant plantation |

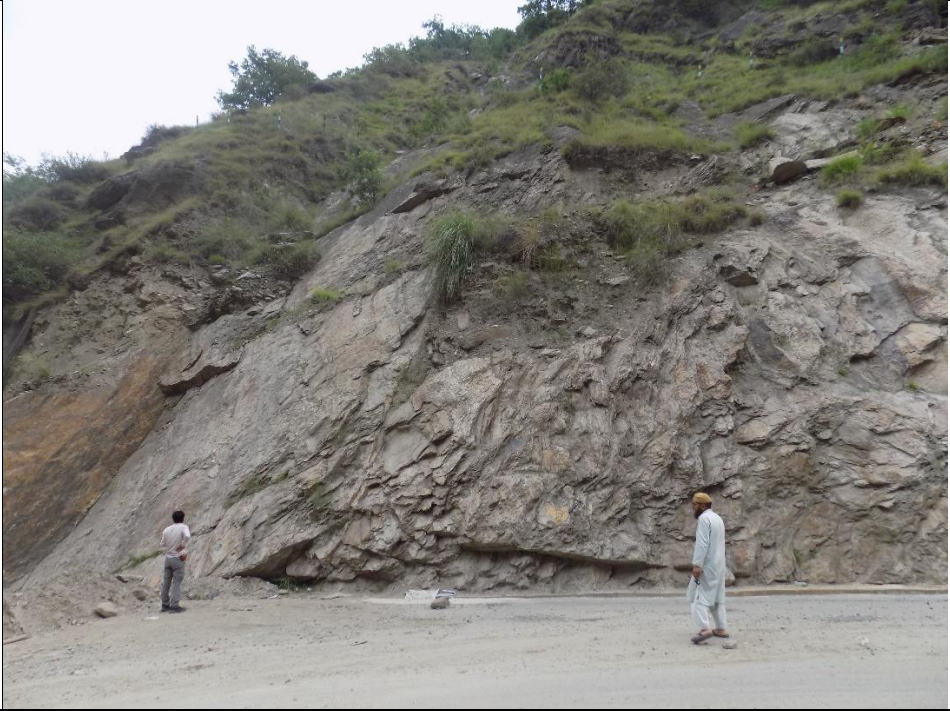
| 39 | Photos. Sketch of Plan & section of the slide | |

| 40 | Summary/Abstract | . Planar failure along J1 plane due to toe cut. |

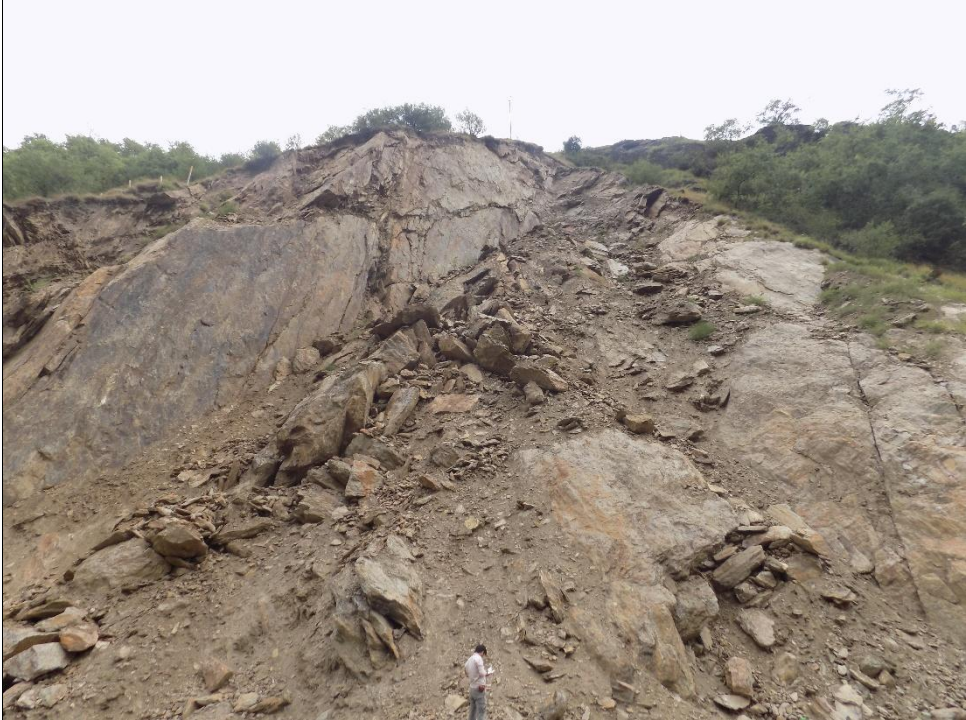
| 39 | Photos. Sketch of Plan & section of the slide | |

| 40 | Summary/Abstract | The slide is happened due to unscientific steep cut slope |

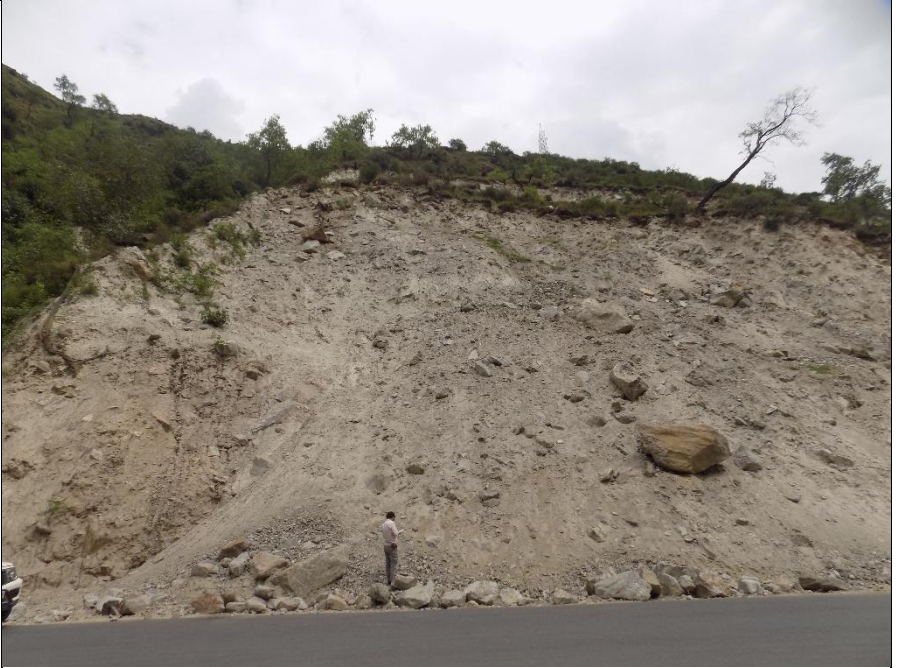
| 39 | Photos. Sketch of Plan & section of the slide | |

| 40 | Summary/Abstract | .The slide is happened due to unscientific steep cut slope for road widening |

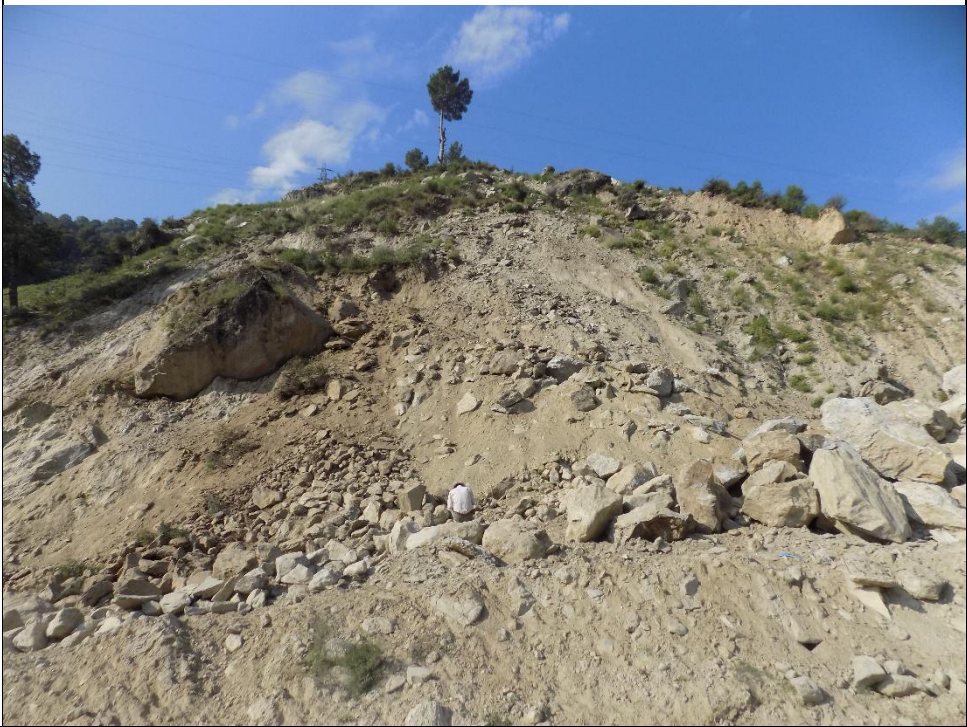
| 39 | Photos. Sketch of Plan & section of the slide | |

| 40 | Summary/Abstract | . Slide has occurred due to cut slope failure |

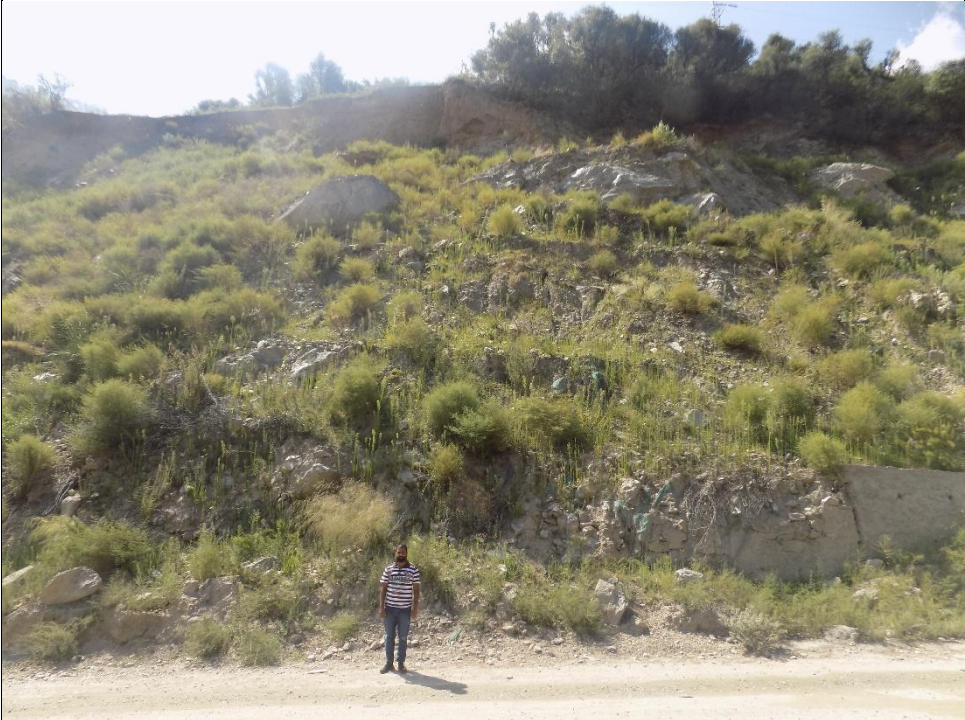
| 39 | Photos. Sketch of Plan & section of the slide | |

| 40 | Summary/Abstract | The slide is happened due to cutting of slope and toe cut |

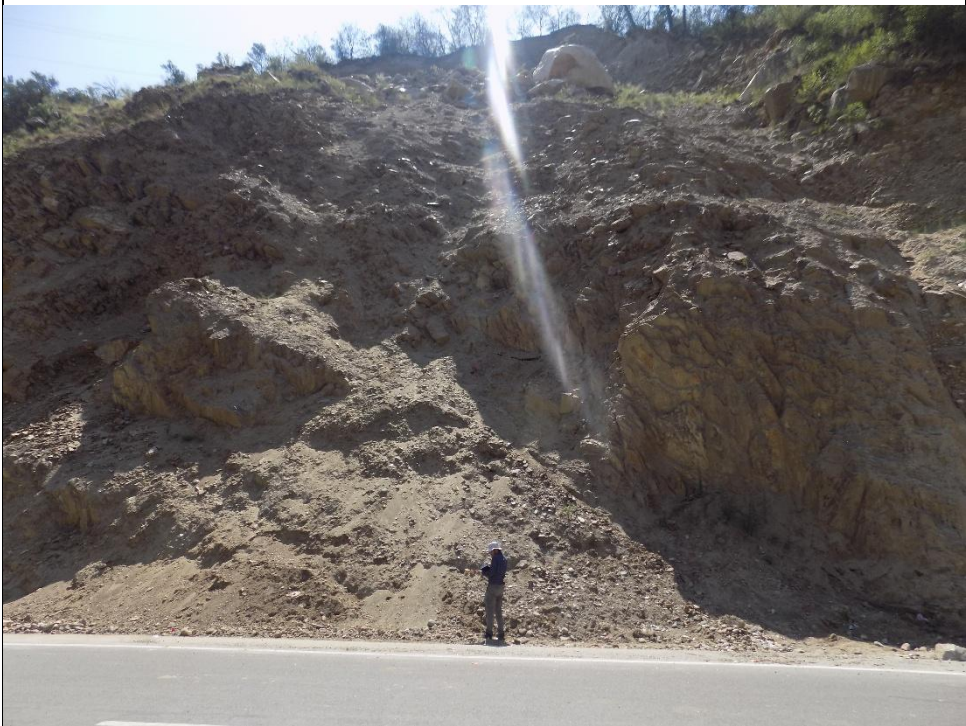
| 39 | Photos. Sketch of Plan & section of the slide | |

| 40 | Summary/Abstract | The slide is happened due toe cut |

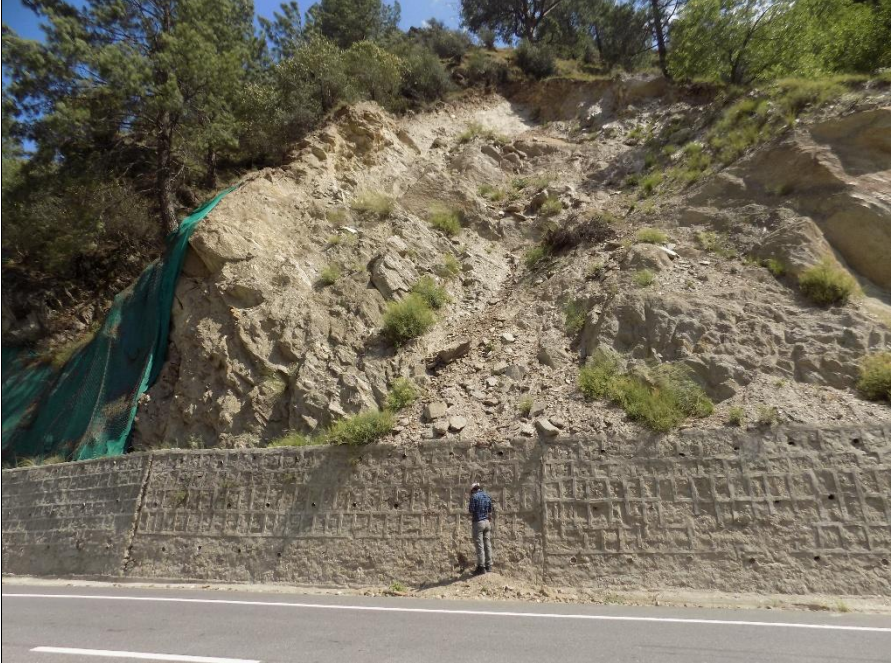
| 39 | Photos. Sketch of Plan & section of the slide | |

| 40 | Summary/Abstract | The slide occurred due to toe cutting by steep cut slope. |

| 37 | Remedial measures | Rock bolt, wire mesh with shotcrete |

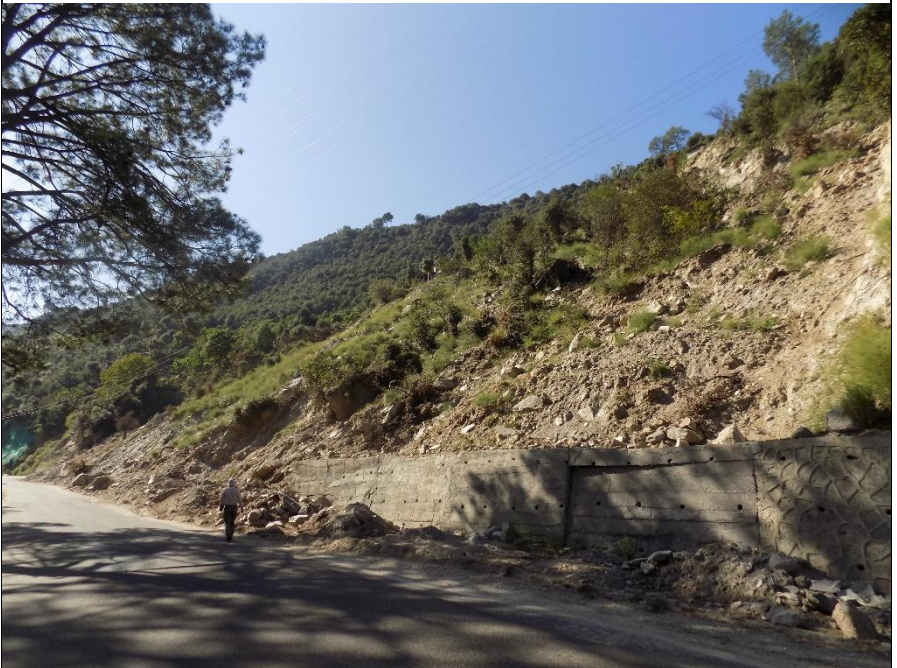
| 39 | Photos. Sketch of Plan & section of the slide | |

| 40 | Summary/Abstract | steep cut slope. Wedge failure making rotational planar failure |

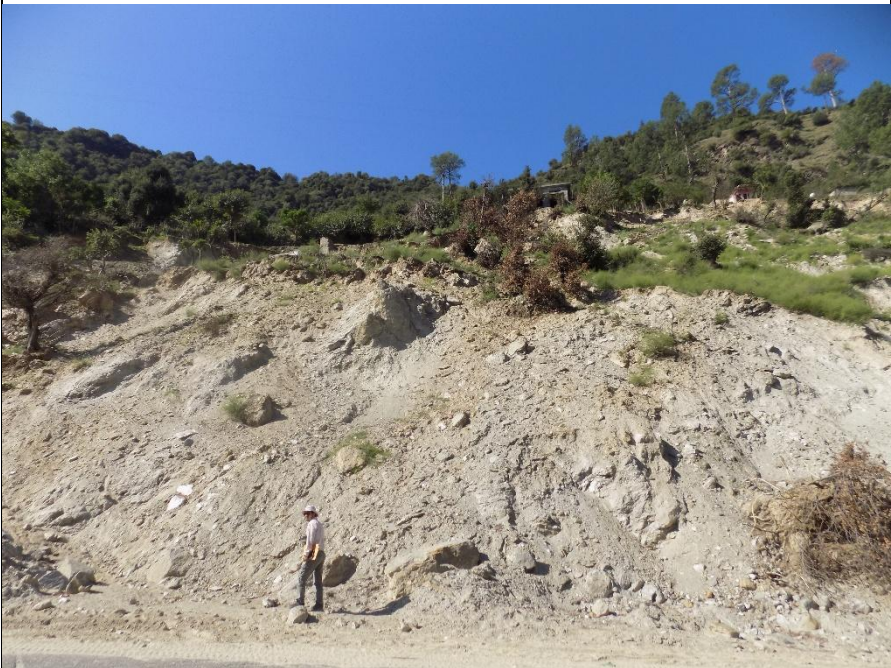
| 39 | Photos. Sketch of Plan & section of the slide | |

| 40 | Summary/Abstract | The slide is happened due to cut slope failure |

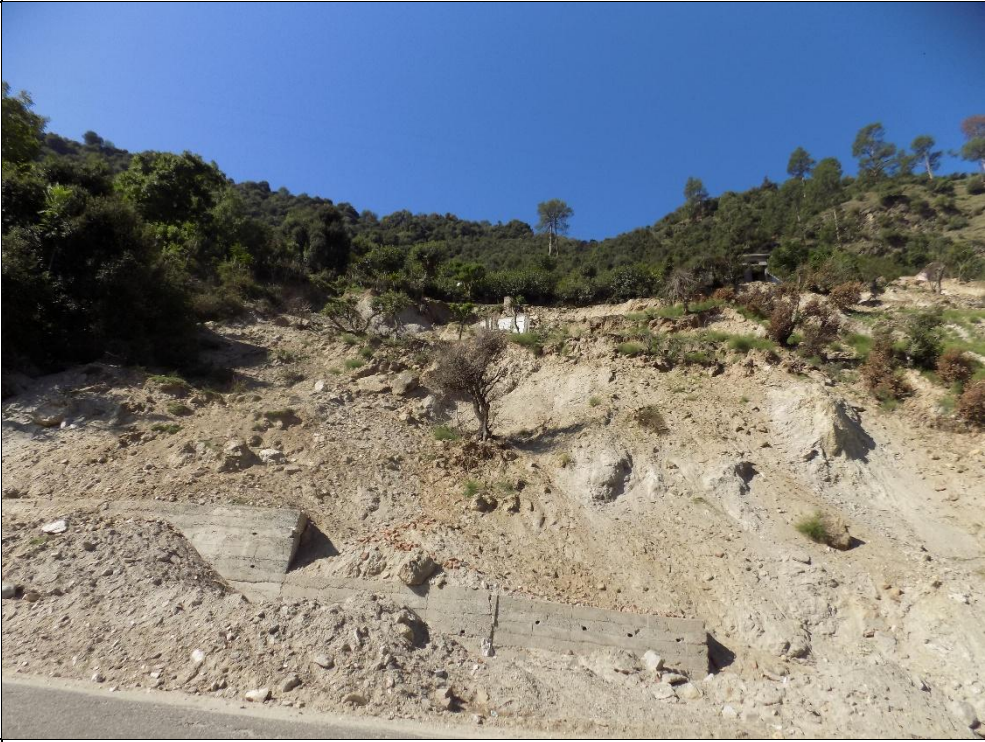
| 39 | Photos. Sketch of Plan & section of the slide | |

| 40 | Summary/Abstract | Un scientific cut slope in the loose material. |

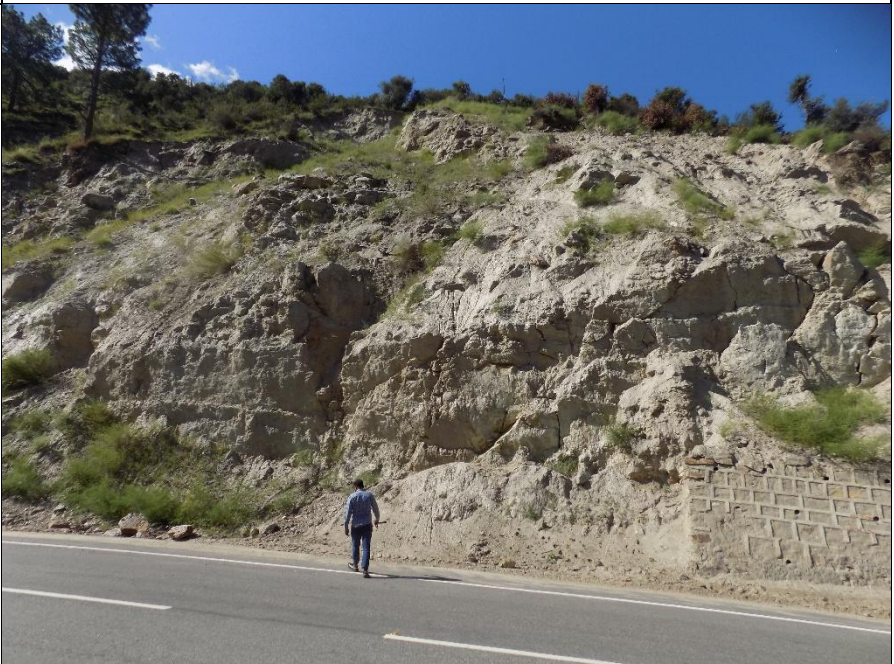
| 39 | Photos. Sketch of Plan & section of the slide | |

| 40 | Summary/Abstract | Cut slope failure due to road cutting |

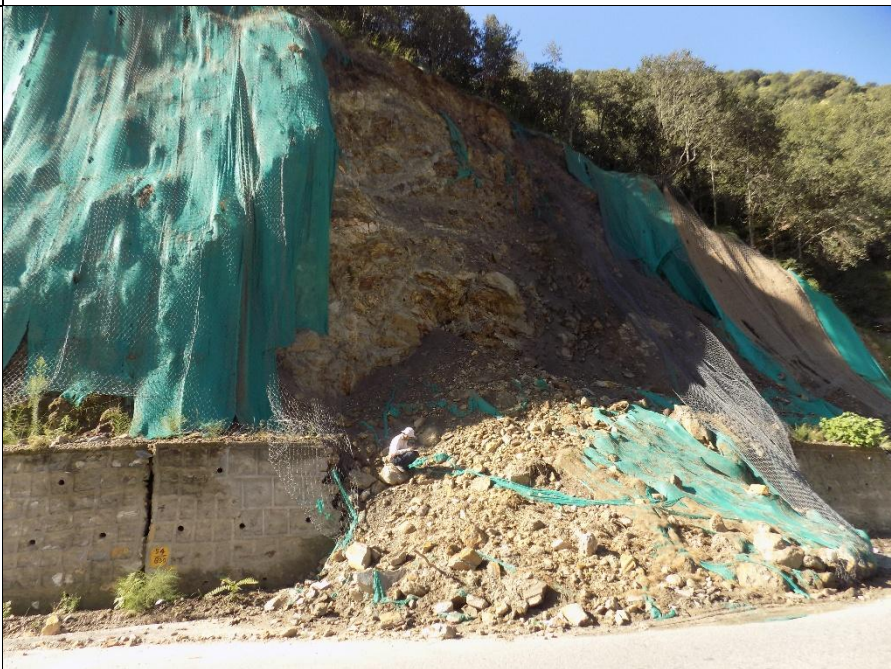
| 39 | Photos. Sketch of Plan & section of the slide | |

| 40 | Summary/Abstract | Cut slope failure due to unscientific slope cutting |

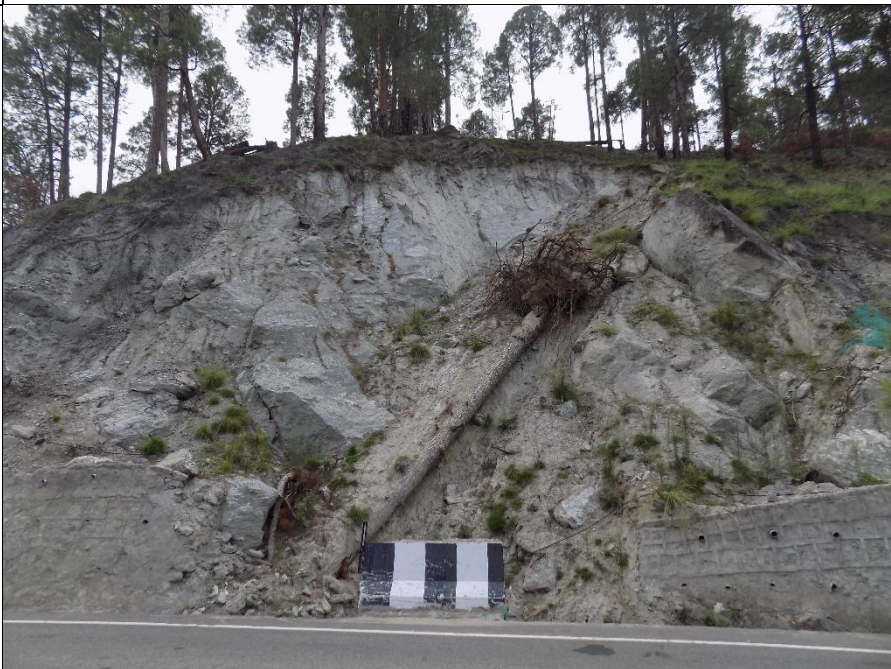
| 39 | Photos. Sketch of Plan & section of the slide | |

| 40 | Summary/Abstract | Cut slope failure occurred due to steep cut for road widening |

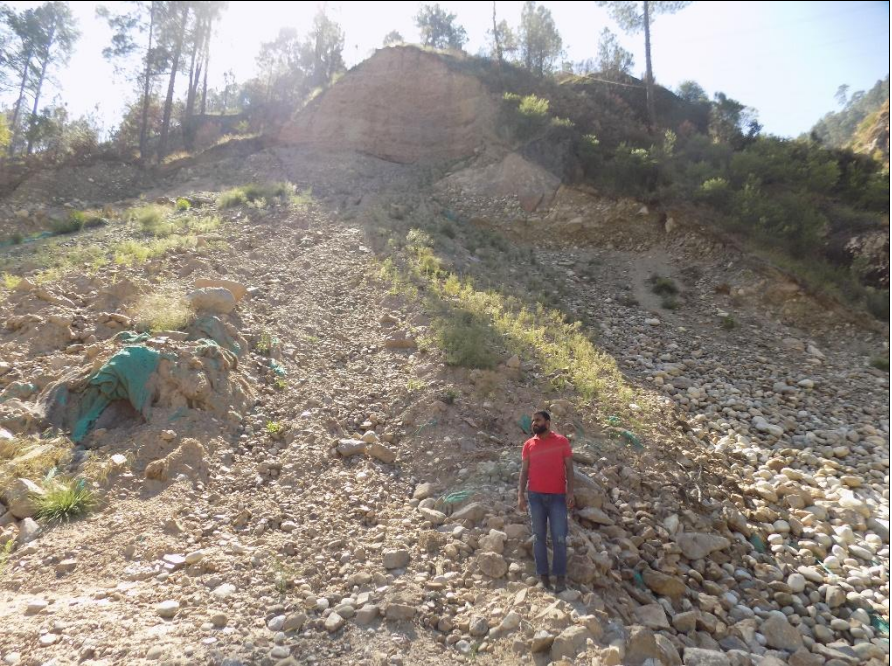
| 39 | Photos. Sketch of Plan & section of the slide | |

| 40 | Summary/Abstract | The slide is happened due to cut slope failure by road cutting and erosion by drainage |

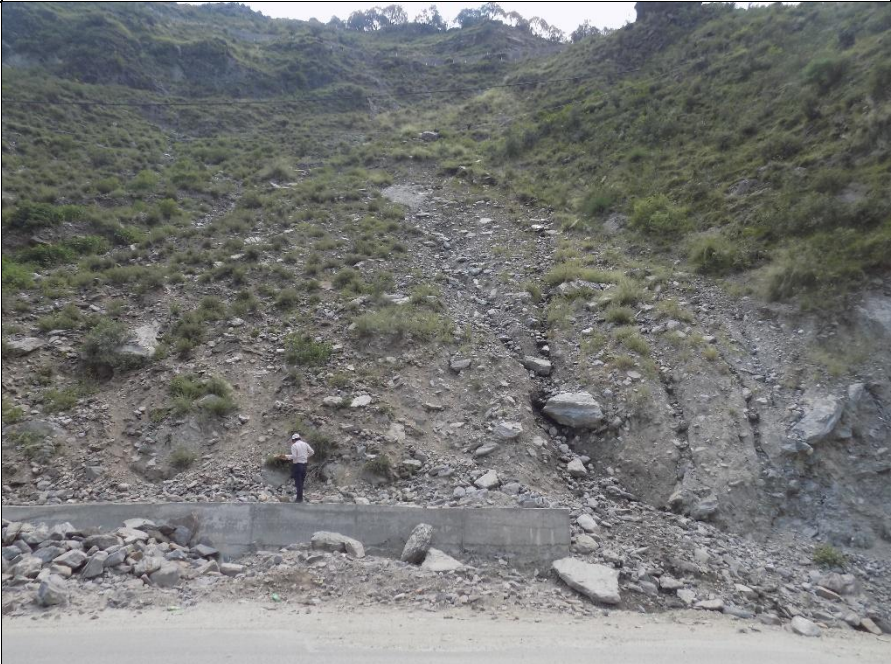
| 39 | Photos. Sketch of Plan & section of the slide | |

| 40 | Summary/Abstract | The slide is happened due to cutting of road and failed due to wedge failure |

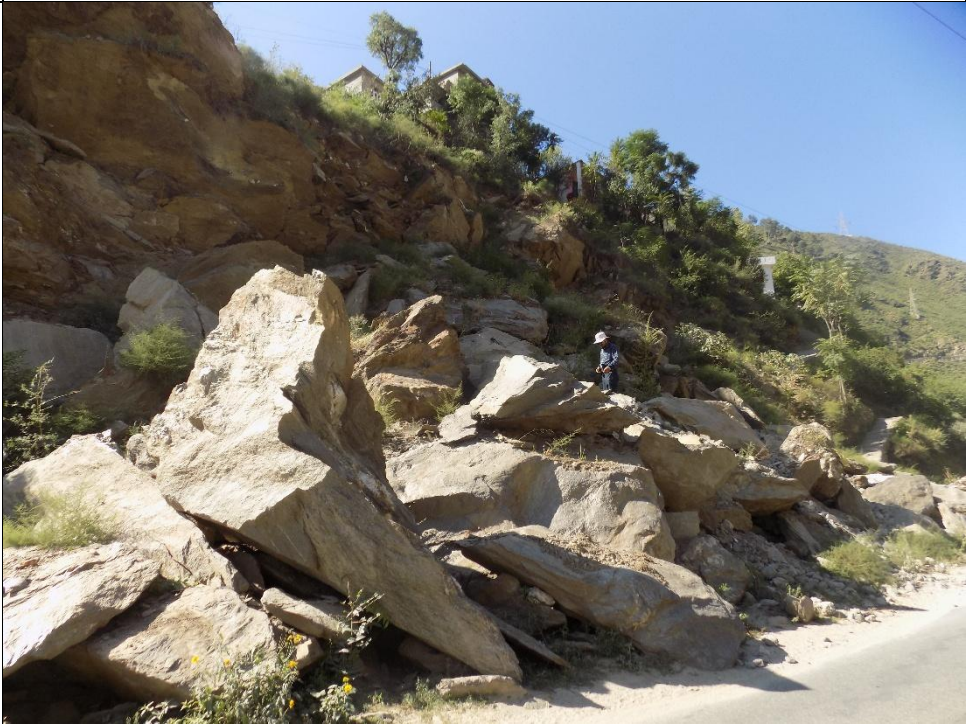
| 39 | Photos. Sketch of Plan & section of the slide | |

| 40 | Summary/Abstract | cutting of road and failed |

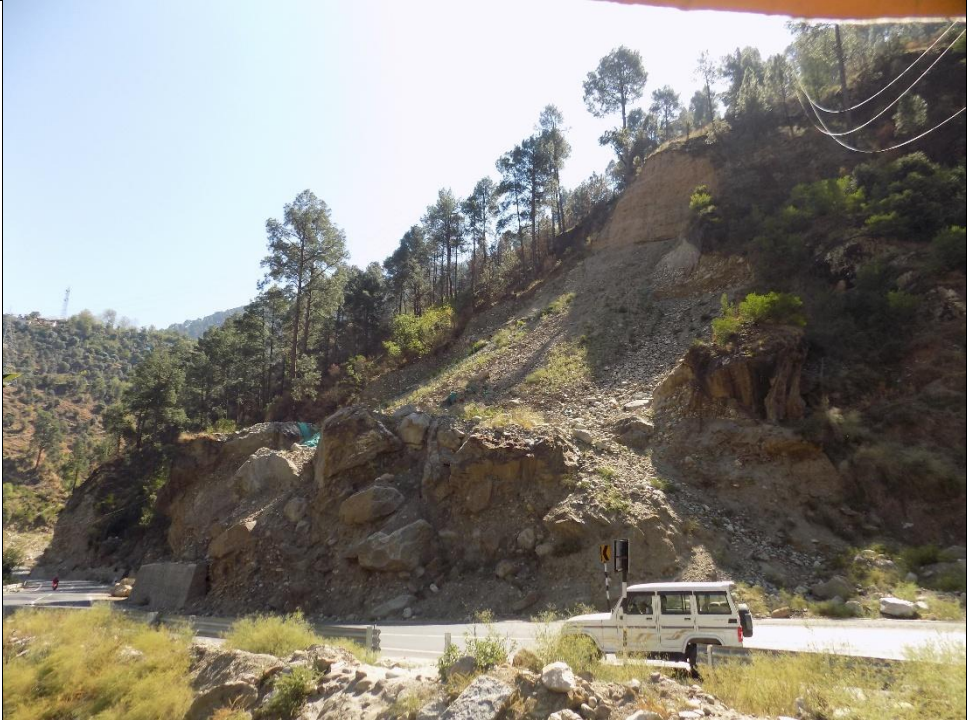
| 39 | Photos. Sketch of Plan & section of the slide | |

| 40 | Summary/Abstract | The slide is happened due to Low cohesion due to the presence of boulder with limited matrix |

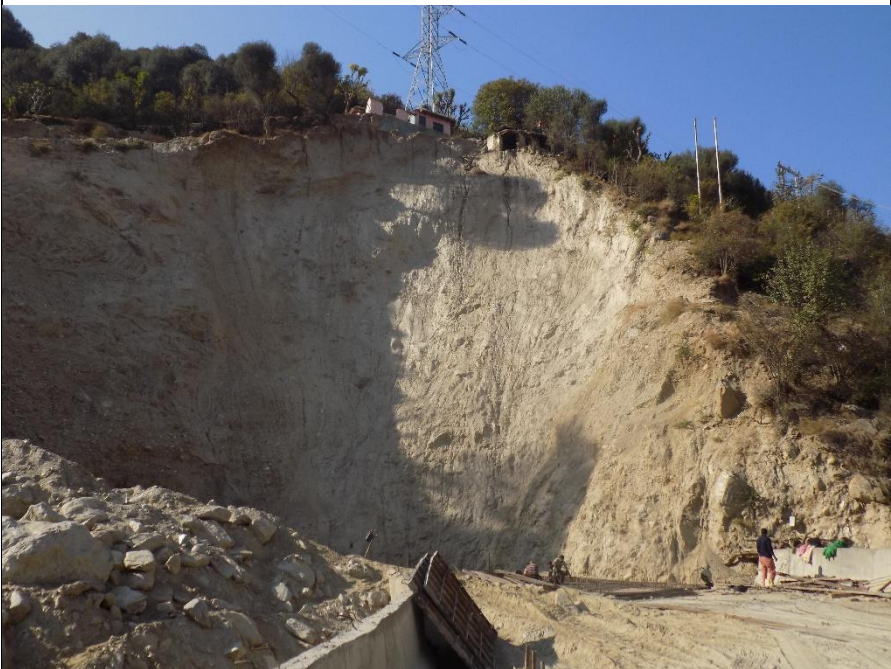
| 39 | Photos. Sketch of Plan & section of the slide | |

| 40 | Summary/Abstract | The slide is happened due to Unscientific steep cut slope in the unconsolidated overburdenwith, saturation due to rainfall. |

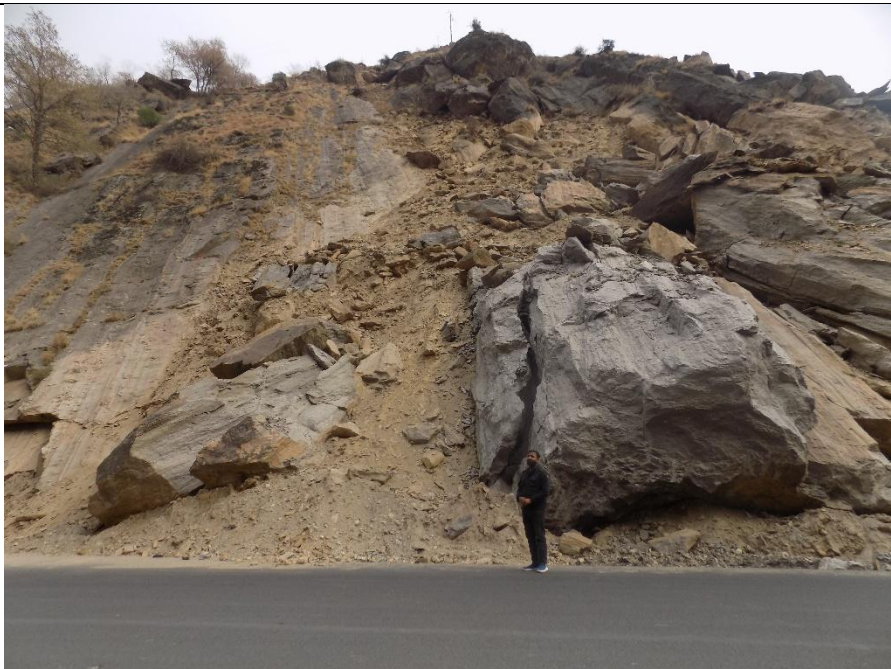
| 39 | Photos. Sketch of Plan & section of the slide | |

| 40 | Summary/Abstract | The slide is happened due to Wedge failure and planar failure |

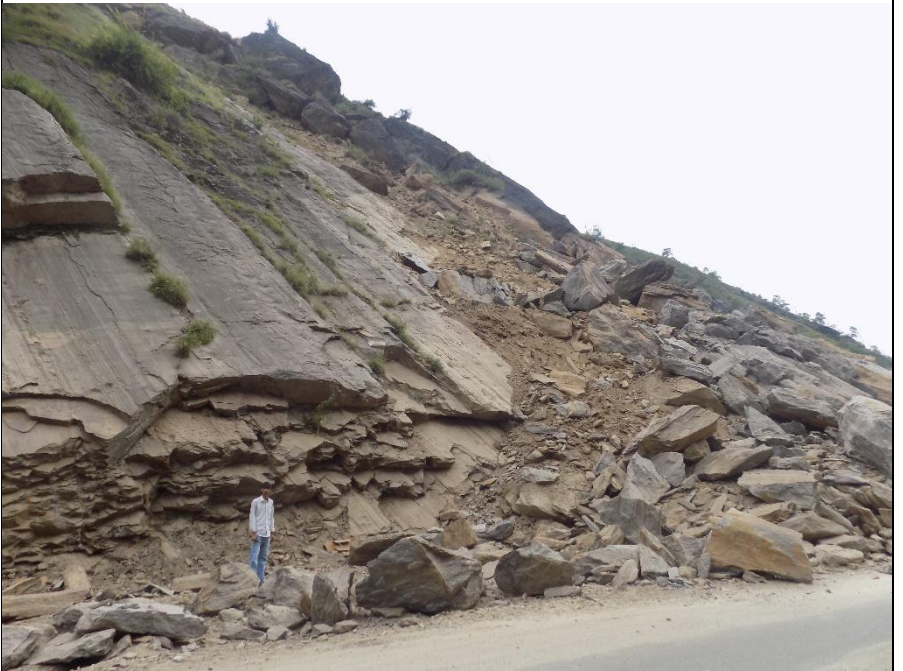
| 39 | Photos. Sketch of Plan & section of the slide | |

| 40 | Summary/Abstract | The slide is happened due to planar failure along J1 plane |

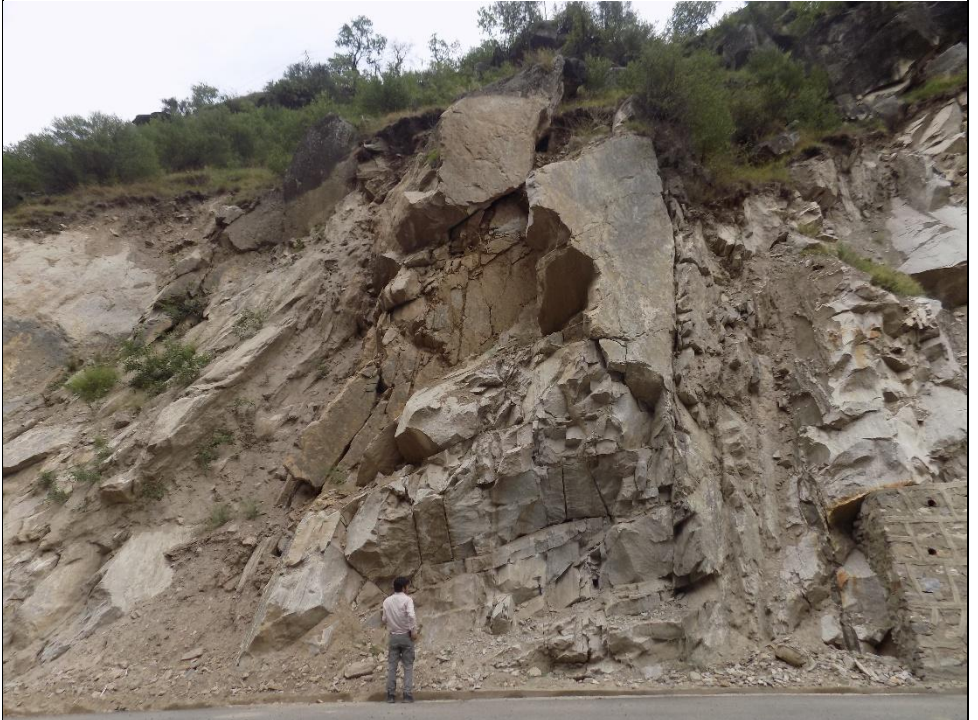
| 39 | Photos. Sketch of Plan & section of the slide | |

| 40 | Summary/Abstract | The slide is happened due to planar failure along J1 plane |

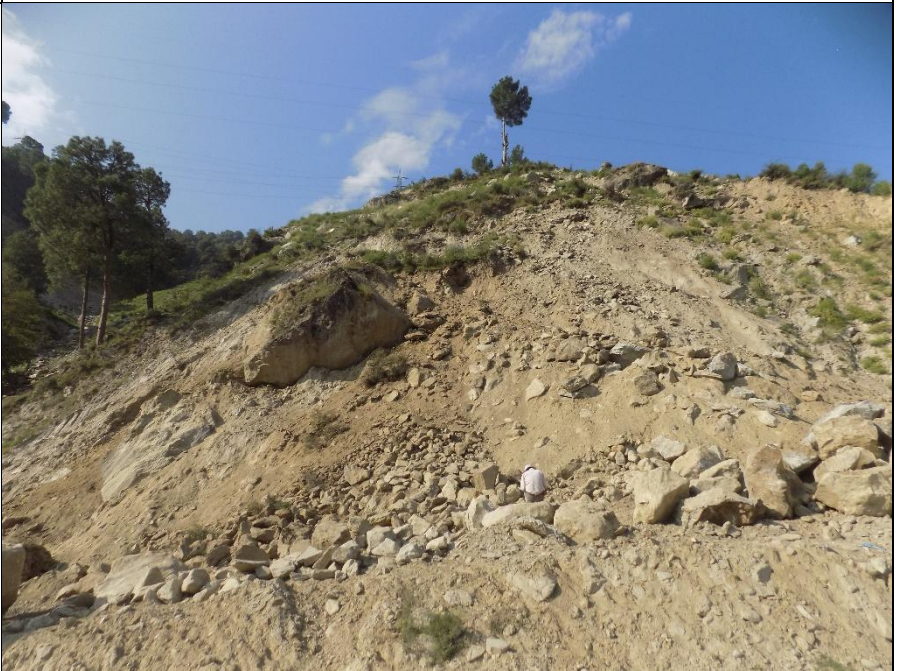
| 40 | Summary/Abstract | Low cohesion due to the presence of boulder with limited matrix |
