### REPORT ON THE LANDSLIDE AND SLOPE STABILITY ASSESSMENT OF SHRI MATA VAISHNO DEVI HIMKOTI TRACK, REASI DISTRICT, JAMMU AND KASHMIR.

(Item Code: M4-LS/NC/NR/SU-JK/2017/12224)

(Field Season: 2017-18)

अभियांत्रिकी भूविज्ञान एवं भूस्खलन प्रभाग  
Engineering Geology and Landslide Division  
मिशन IV, उत्तरी क्षेत्र / Mission- IV, Northern Region  
राज्य इकाई जम्मू एवं कश्मीर  
State Unit: Jammu & Kashmir  
जम्मू/Jammu

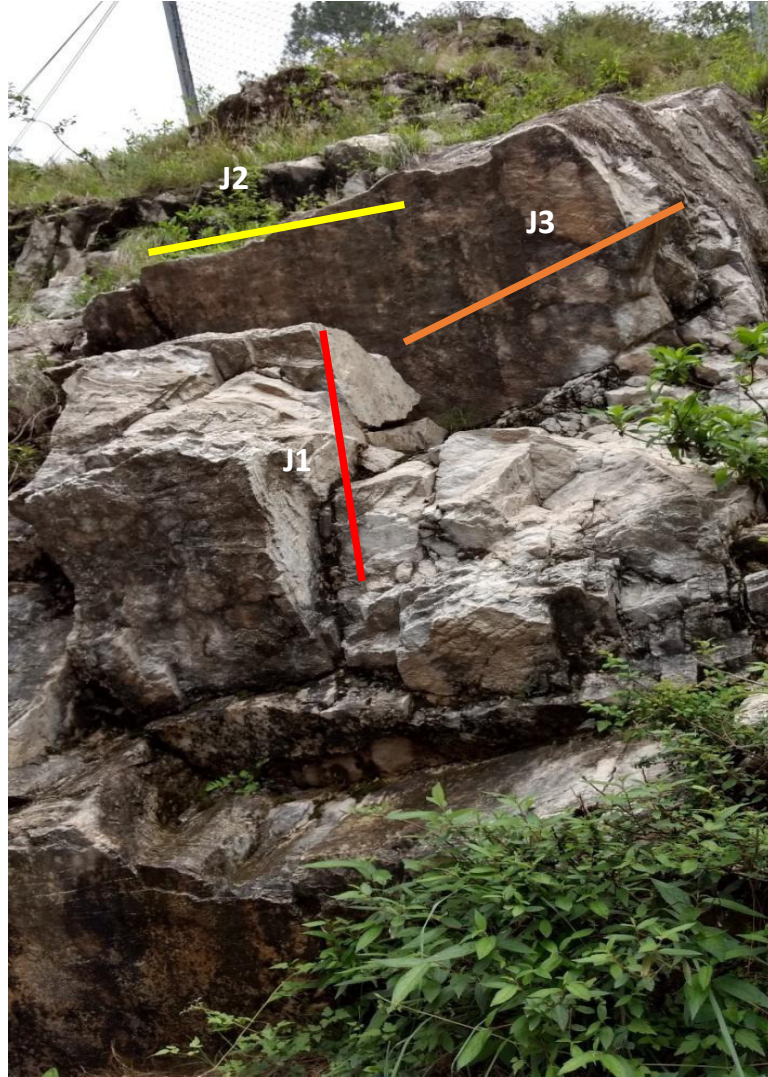
The hill slope at the affected site is steep, however, locally found to be sub-vertical. It presents a mean slope inclination of the order of 67°. At places, negative slopes have also been recorded (Fig.1). The slope forming material comprises dolomitic limestone and cherty dolomite. The rock mass at RD 0/850 km of Himkoti Track is found to be traversed by 3 plus random sets of joints which are variably-spaced, dry and tight in nature and (Fig. 4; Table 2).

Fig.4: Cross cutting tight joints in dry Condition.

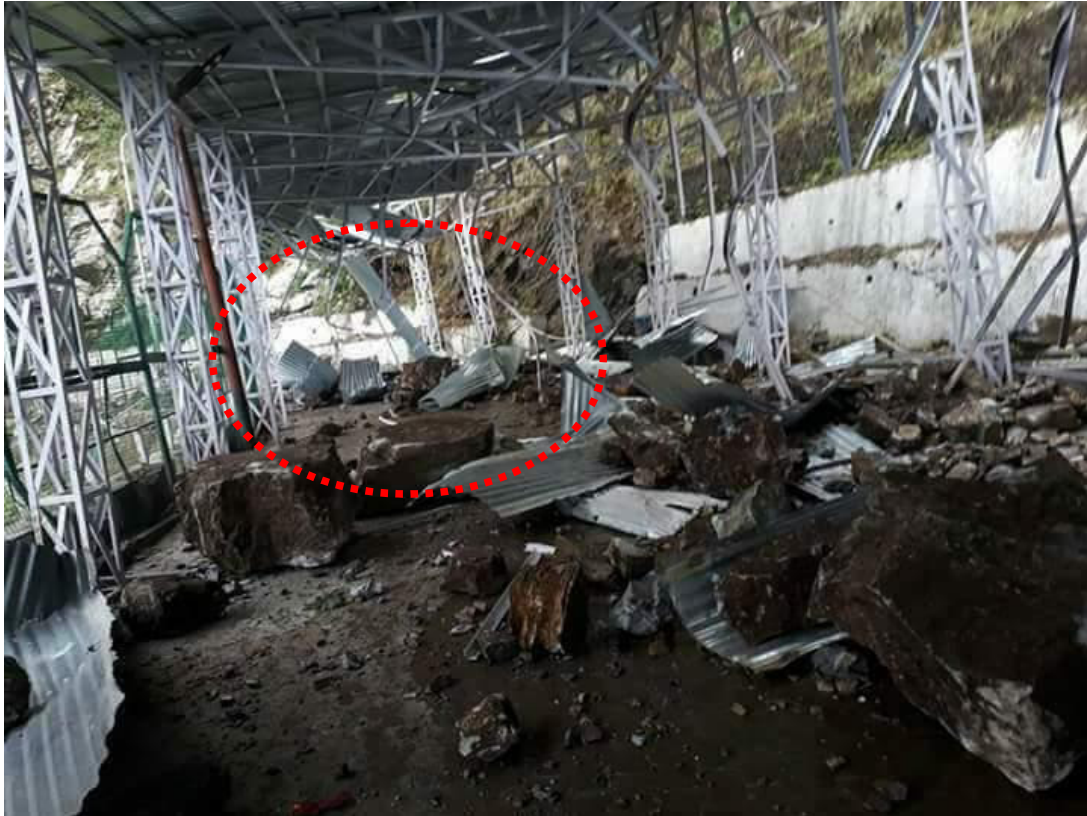
Fig.5: The view of the damage caused by slide to shed and track.

The height difference between these unstable blocks and the Track is about 100 m. The overall slope angle  $67^{\circ}$  southerly. This is high rainfall area and seismically very active zone with zone factor of 0.36. The chronic instability of the hill is around 55 %.( VE). The damage corridor width is 50m (Fig.5). Loose rock/potential unstable materials, which have moved out of place on the slope, are noticed. Hence it is recommended to manually remove the loose and detached rock mass upslope.

3. The high tensile strength of the cables/rock fall netting to be designed considering the site conditions, maximum size of boulders are 5meter. (Fig.5,9) and height according to trajectory.
