## Fwd: Incorrect Thermal broken Aluminum Joinery: 2 Rapare St. Job No.27363 - JSR Construction.

Subject: Incorrect Thermal broken Aluminum Joinery: 2 Rapare St. Job No.27363 - JSR Construction.

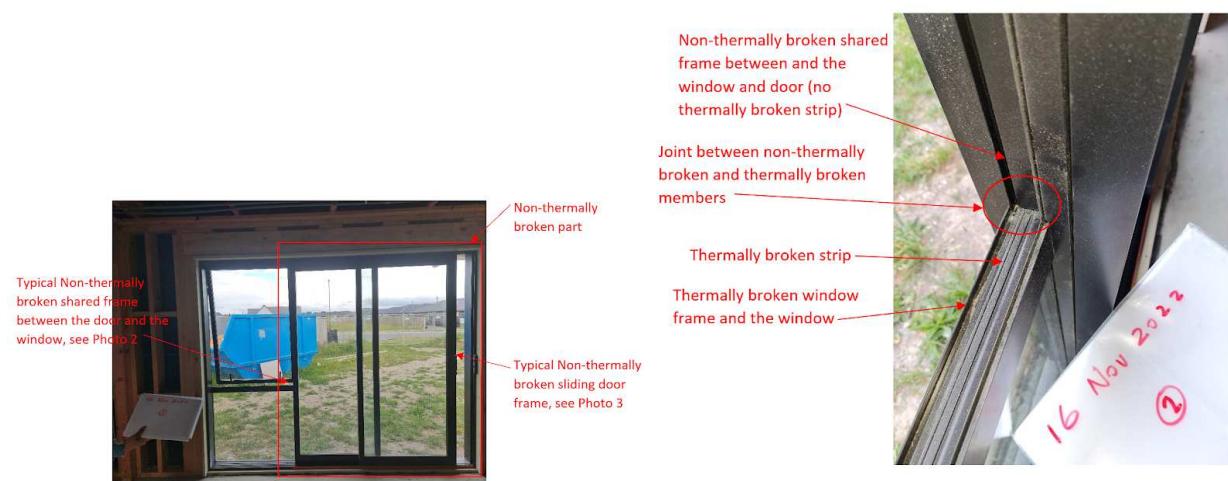
- a) Photo 1 – Indicating the non-thermally broken parts of the Sliding Door “Lounge D6” (Door number referred to the attached quote no. 27363) (Trim Size: 2130 x 2700; Area: 5.751 m sq.)

Photo 1 – Indicating the non-thermally broken parts of the Sliding Door “Lounge D6” (Door number referred to the attached quote no. 27363) (Trim Size: 2130 x 2700; Area: 5.751 m sq.)

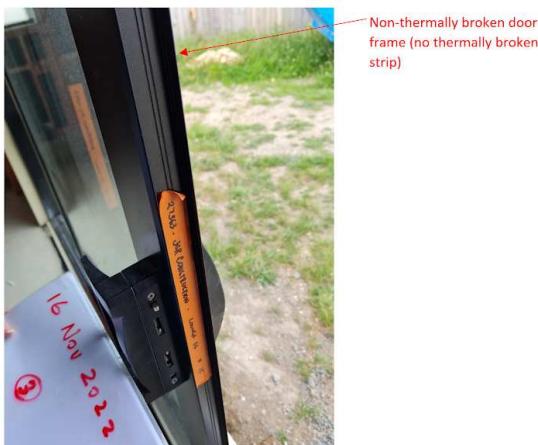
- b) Photo 2 – Typical joint between the vertical frame of the sliding door and the horizontal frame of the window shows that the shared frame between the door and the window do not have the thermally broken strip.

- c) Photo 3 – Typical slide door frame shows that the slide door does not have thermally broken strip
  - d) Photo 4 – Indicating the non-thermally broken parts of the Sliding Door “Living D6” (Door number referred to the attached quote no. 27363) (Trim Size: 2130 x 2700; Area: 5.751 m sq.)

Photo 3 – Typical slide door frame shows that the slide door does not have thermally broken

Photo 2 – Typical joint between the vertical frame of the sliding door and the horizontal frame of the window shows that the shared frame between the door and the window do not have the thermally broken strip.

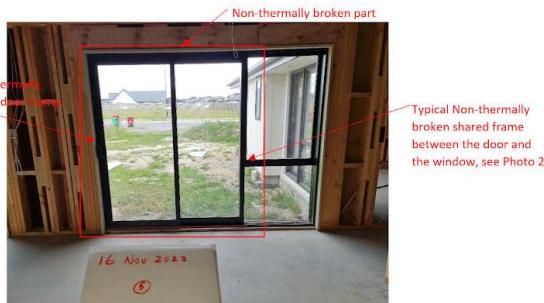
- e) Photo 5 – Indicating the non-thermally broken parts of the Sliding Door “Dining D6” (Door number referred to the attached quote no. 27363) (Trim Size: 2130 x 2700; Area: 5.751 m sq.)

Photo 5 – Indicating the non-thermally broken parts of the Sliding Door “Dining D6” (Door number referred to the attached quote no. 27363) (Trim Size: 2130 x 2700; Area: 5.751 m sq.)

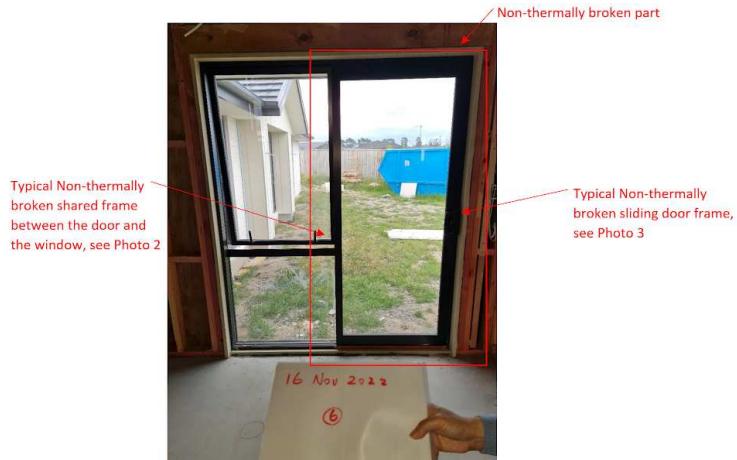
- f) Photo 6 – Indicating the non-thermally broken parts of the Sliding Door “Bedroom 3 D5” (Door number referred to the attached quote no. 27363) (Trim Size: 2130 x 1800; Area: 3.834 m sq.)

Photo 6 – Indicating the non-thermally broken parts of the Sliding Door "Bedroom 3 D5" (Door

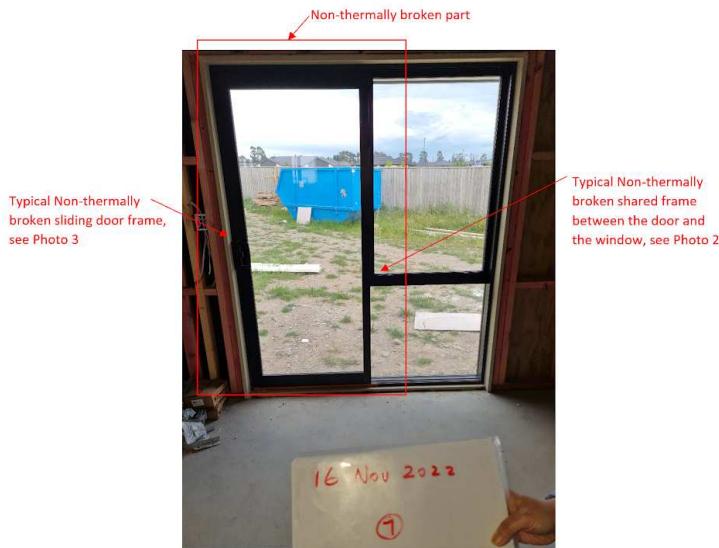
- g) Photo 7 – Indicating the non-thermally broken parts of the Sliding Door “Bedroom 2 D4” (Door number referred to the attached quote no. 27363) (Trim Size: 2130 x 1800; Area: 3.834 m sq.)

Photo 7 – Indicating the non-thermally broken parts of the Sliding Door "Bedroom 2 D4" (Door number referred to the attached quote no. 27363) (Trim Size: 2130 x 1800; Area: 3.834 m sq.)

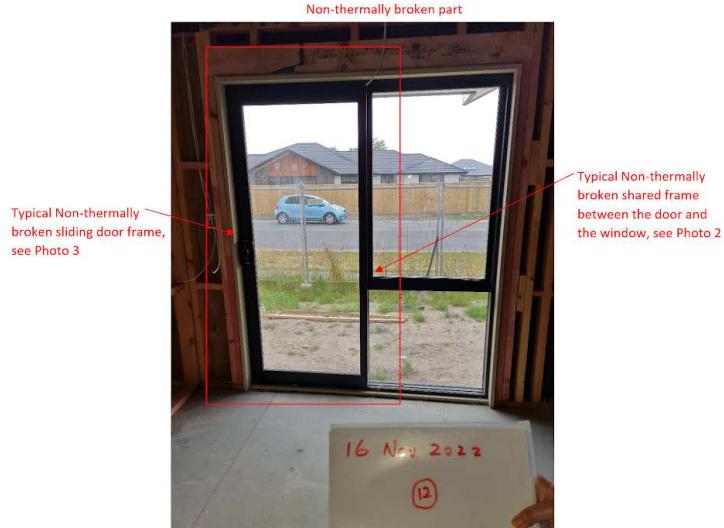
- i) Photo 12 – Indicating the non-thermally broken parts of the Sliding Door “Bedroom 4 D4” (Door number referred to the attached quote no. 27363) (Trim Size: 2130 x 1800; Area: 3.834 m sq.)

Photo 12 – Indicating the non-thermally broken parts of the Sliding Door "Bedroom 4 D4" (Door number referred to the attached quote no. 27363) (Trim Size: 2130 x 1800; Area: 3.834 m sq.)

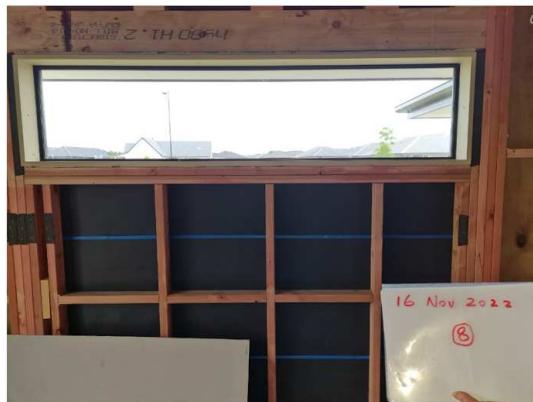
- Photo 8 – Indicating uncertain thermally broken window “Bedroom 2 W5” (Door number referred to the attached quote no. 27363) (Trim Size: 600 x 2400; Area: 1.37 m sq)

Photo 8 – Indicating uncertain thermally broken window "Bedroom 2 W5" (Door number referred to the attached quote no. 27363) (Trim Size: 600 x 2400; Area: 1.37 m sq.)

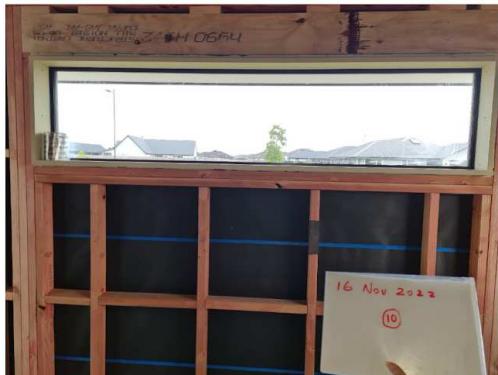
- Photo 10 – Indicating uncertain thermally broken window “Master Bedroom W4” (Door number referred to the attached quote no. 27363) (Trim Size: 600 x 2400; Area: 1.37 m sq)

Photo 10 – Indicating uncertain thermally broken window "Master Bedroom W4" (Door number referred to the attached quote no. 27363) (Trim Size: 600 x 2400; Area: 1.37 m sq.)

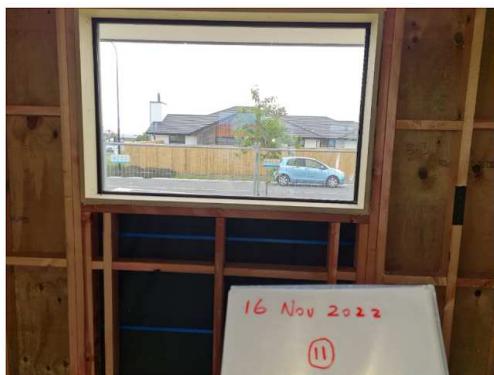
- Photo 11 – Indicating uncertain thermally broken window “Master Bedroom W3” (Door number referred to the attached quote no. 27363) (Trim Size: 1000 x 1500; Area: 1.5 m sq)

Photo 11 – Indicating uncertain thermally broken window “Master Bedroom W3” (Door number referred to the attached quote no. 27363) (Trim Size: 1000 x 1500; Area: 1.5 m sq.)

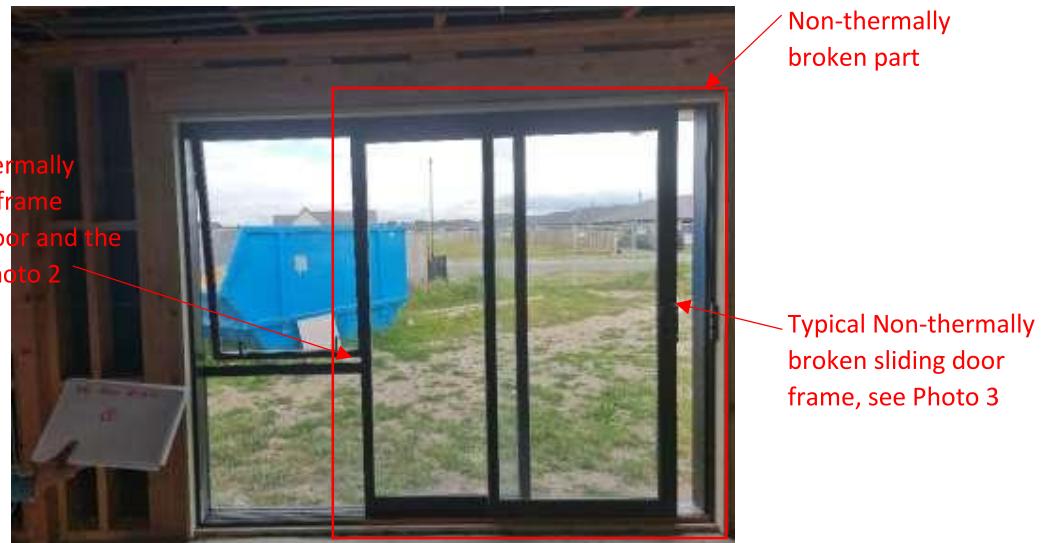
Photo 1 – Indicating the non-thermally broken parts of the Sliding Door “Lounge D6” (Door number referred to the attached quote no. 27363) (Trim Size: 2130 x 2700; Area: 5.751 m sq.)

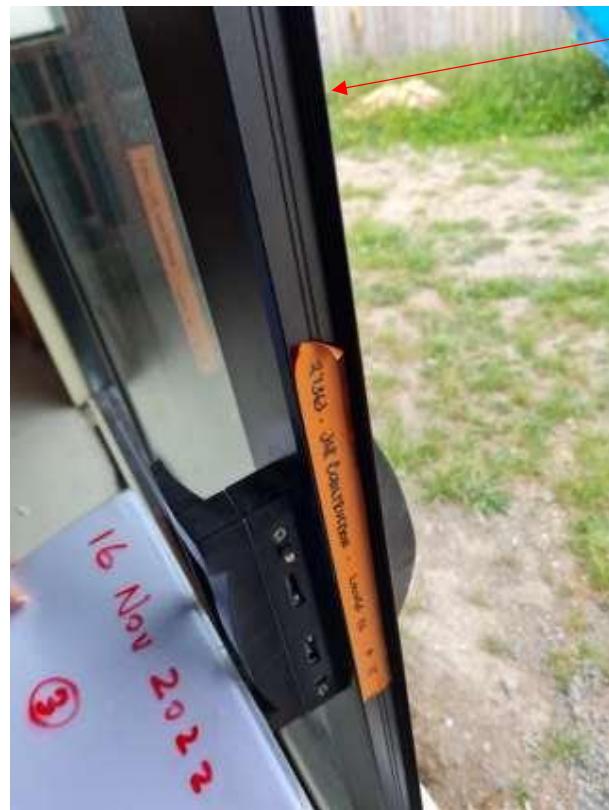
Photo 3 – Typical slide door frame shows that the slide door does not have thermally broken strip

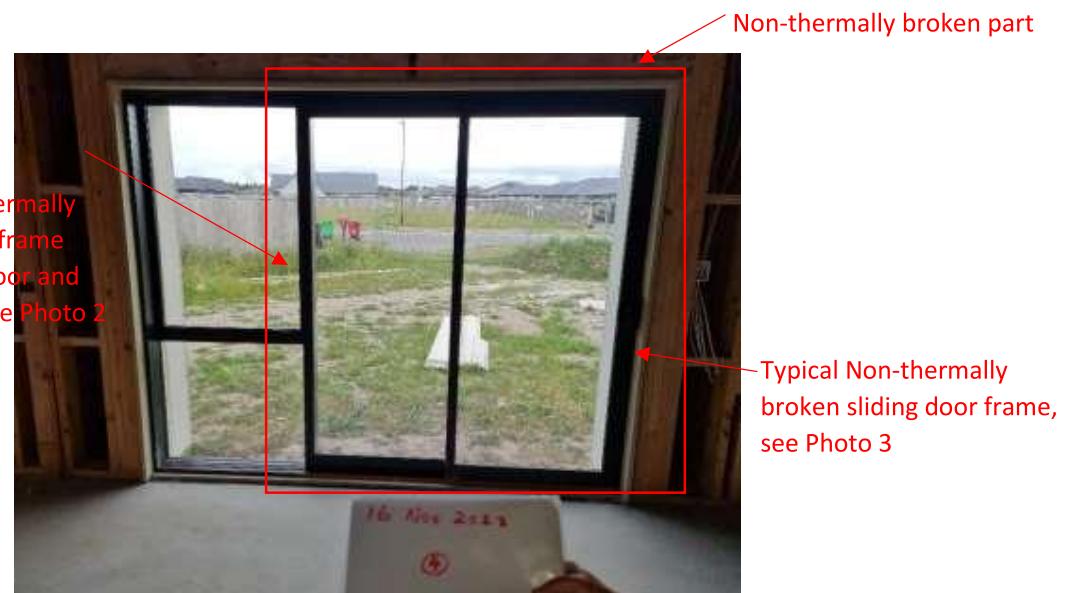
Photo 4 – Indicating the non-thermally broken parts of the Sliding Door “Living D6” (Door number referred to the attached quote no. 27363) (Trim Size: 2130 x 2700; Area: 5.751 m sq.)

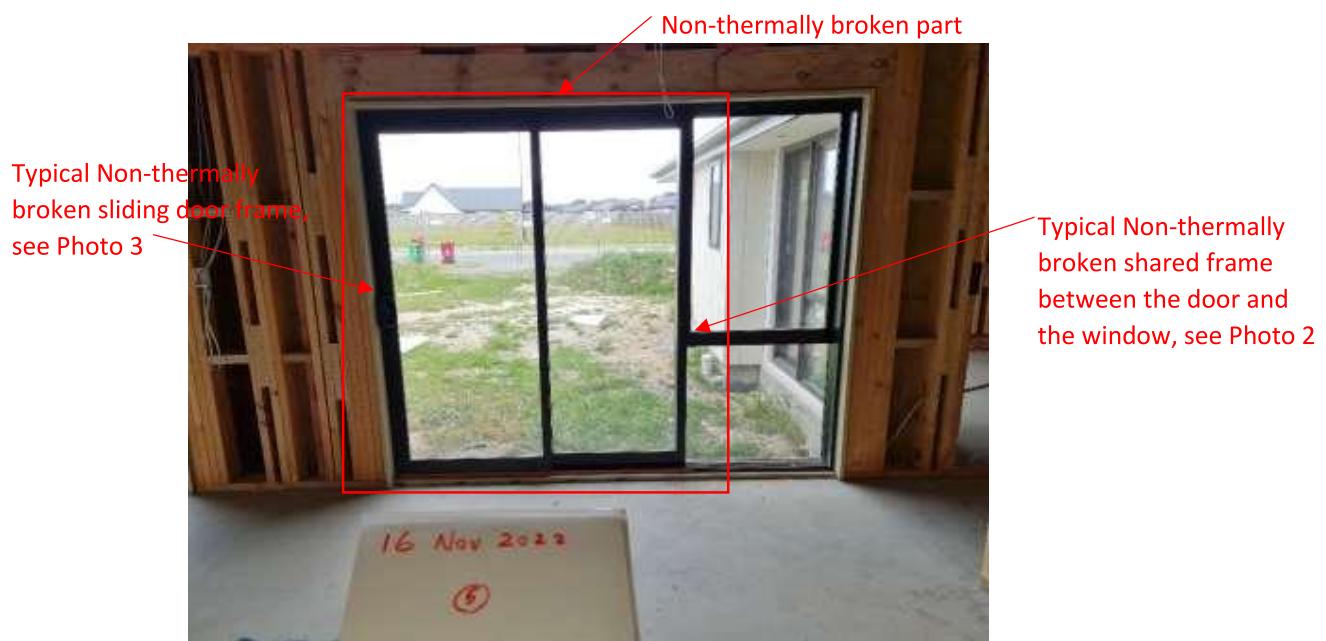
Photo 5 – Indicating the non-thermally broken parts of the Sliding Door “Dining D6” (Door number referred to the attached quote no. 27363) (Trim Size: 2130 x 2700; Area: 5.751 m sq.)

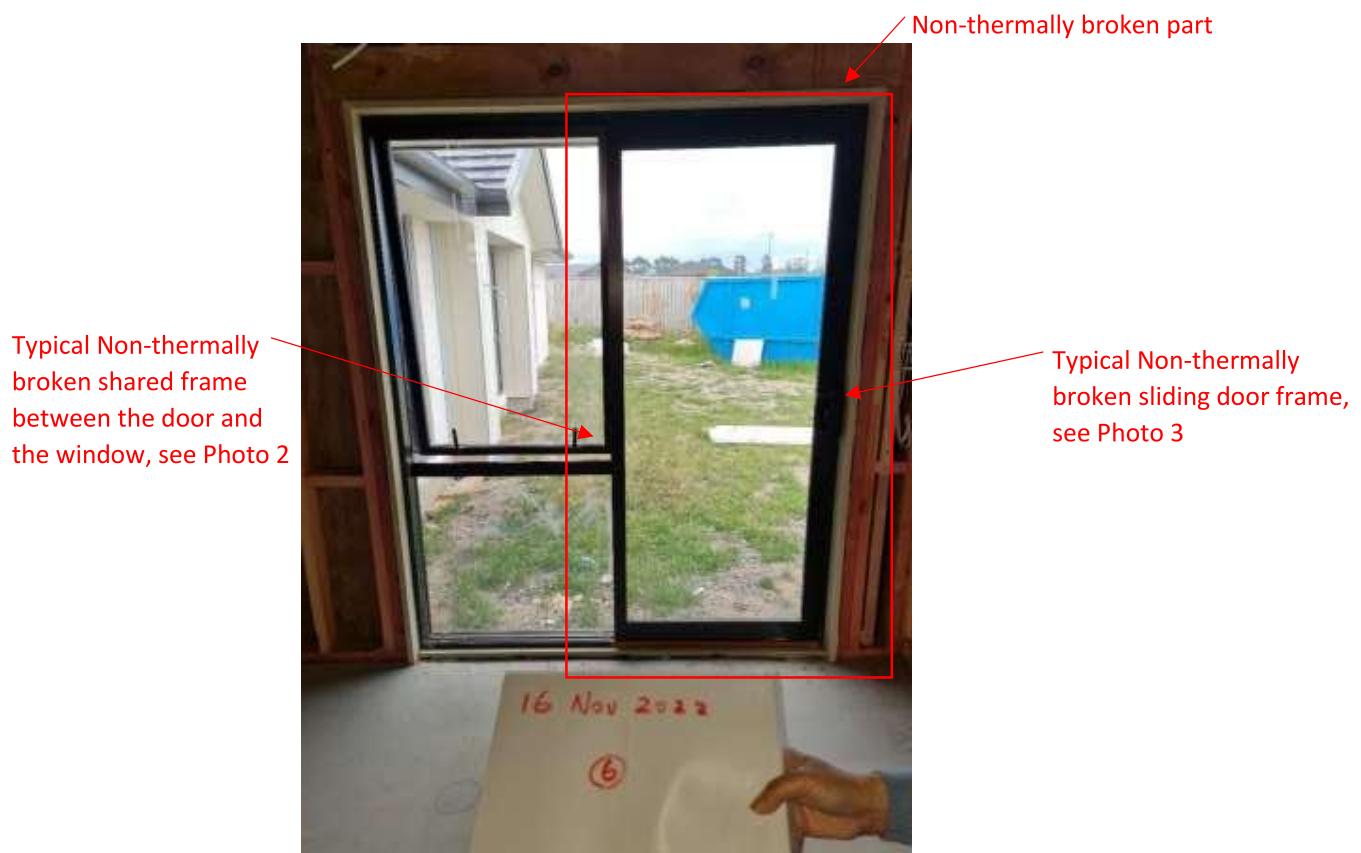
Photo 6 – Indicating the non-thermally broken parts of the Sliding Door “Bedroom 3 D5” (Door number referred to the attached quote no. 27363) (Trim Size: 2130 x 1800; Area: 3.834 m sq.)

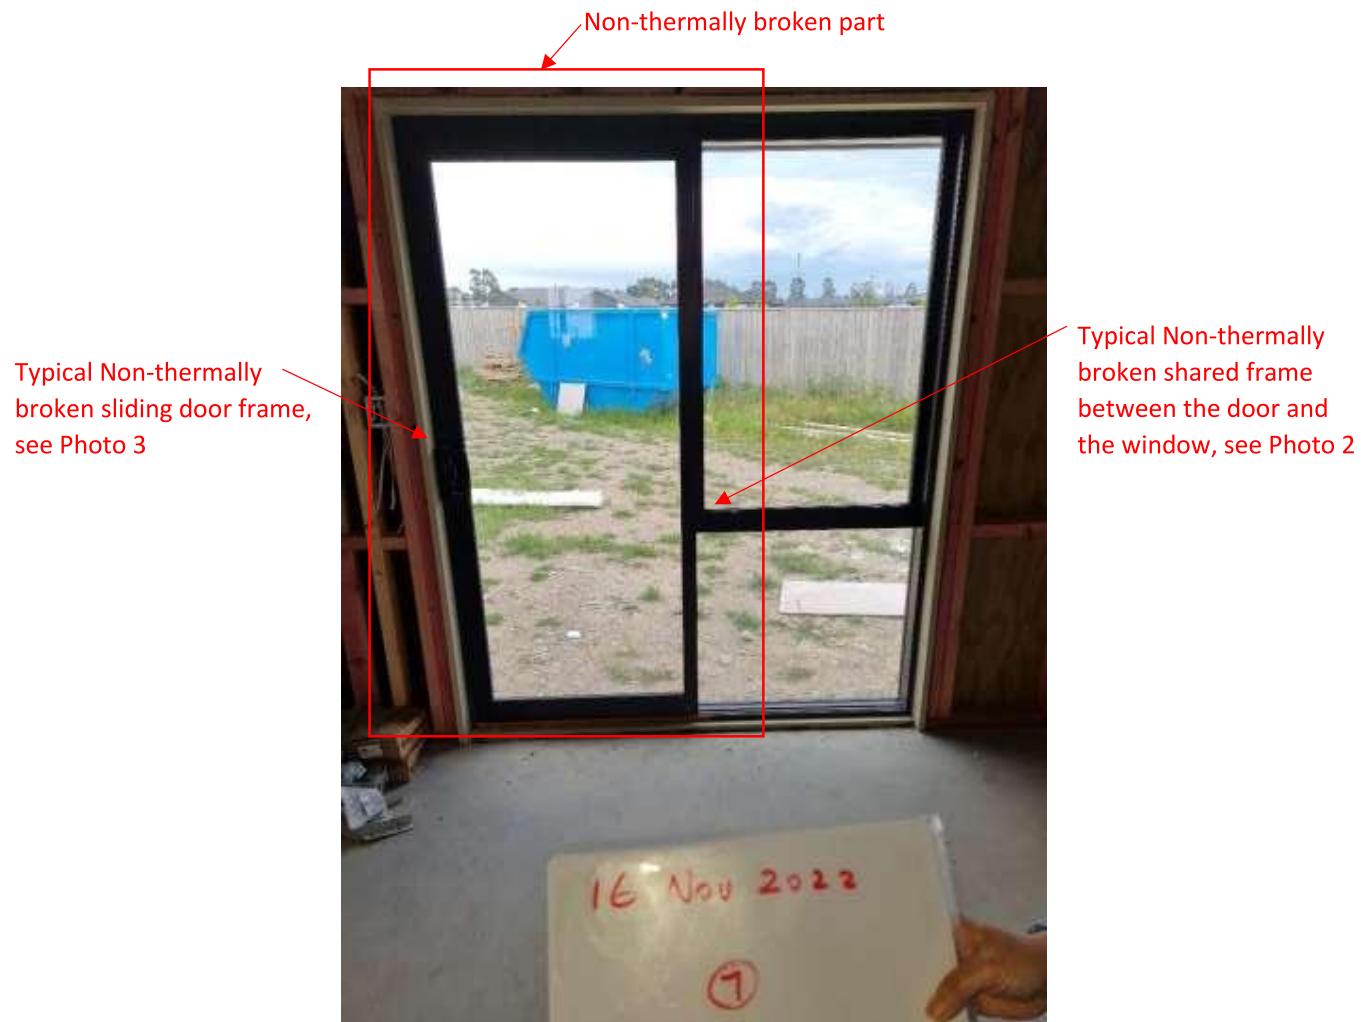
Photo 7 – Indicating the non-thermally broken parts of the Sliding Door “Bedroom 2 D4” (Door number referred to the attached quote no. 27363) (Trim Size: 2130 x 1800; Area: 3.834 m sq.)

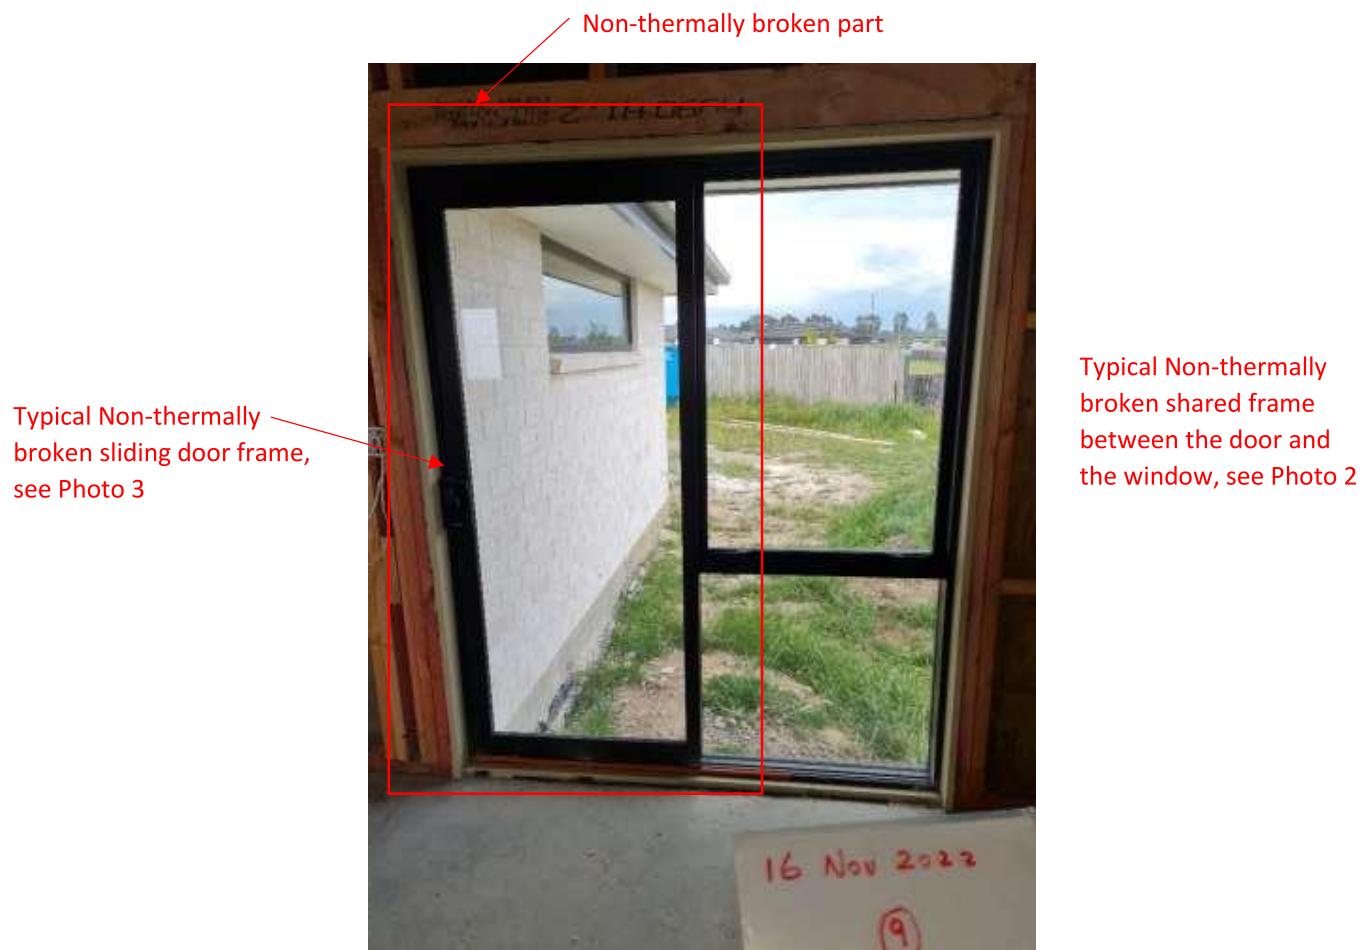
Photo 9 – Indicating the non-thermally broken parts of the Sliding Door “Master Bedroom D3”  
(Door number referred to the attached quote no. 27363) (Trim Size: 2130 x 1800; Area: 3.834 m sq.)

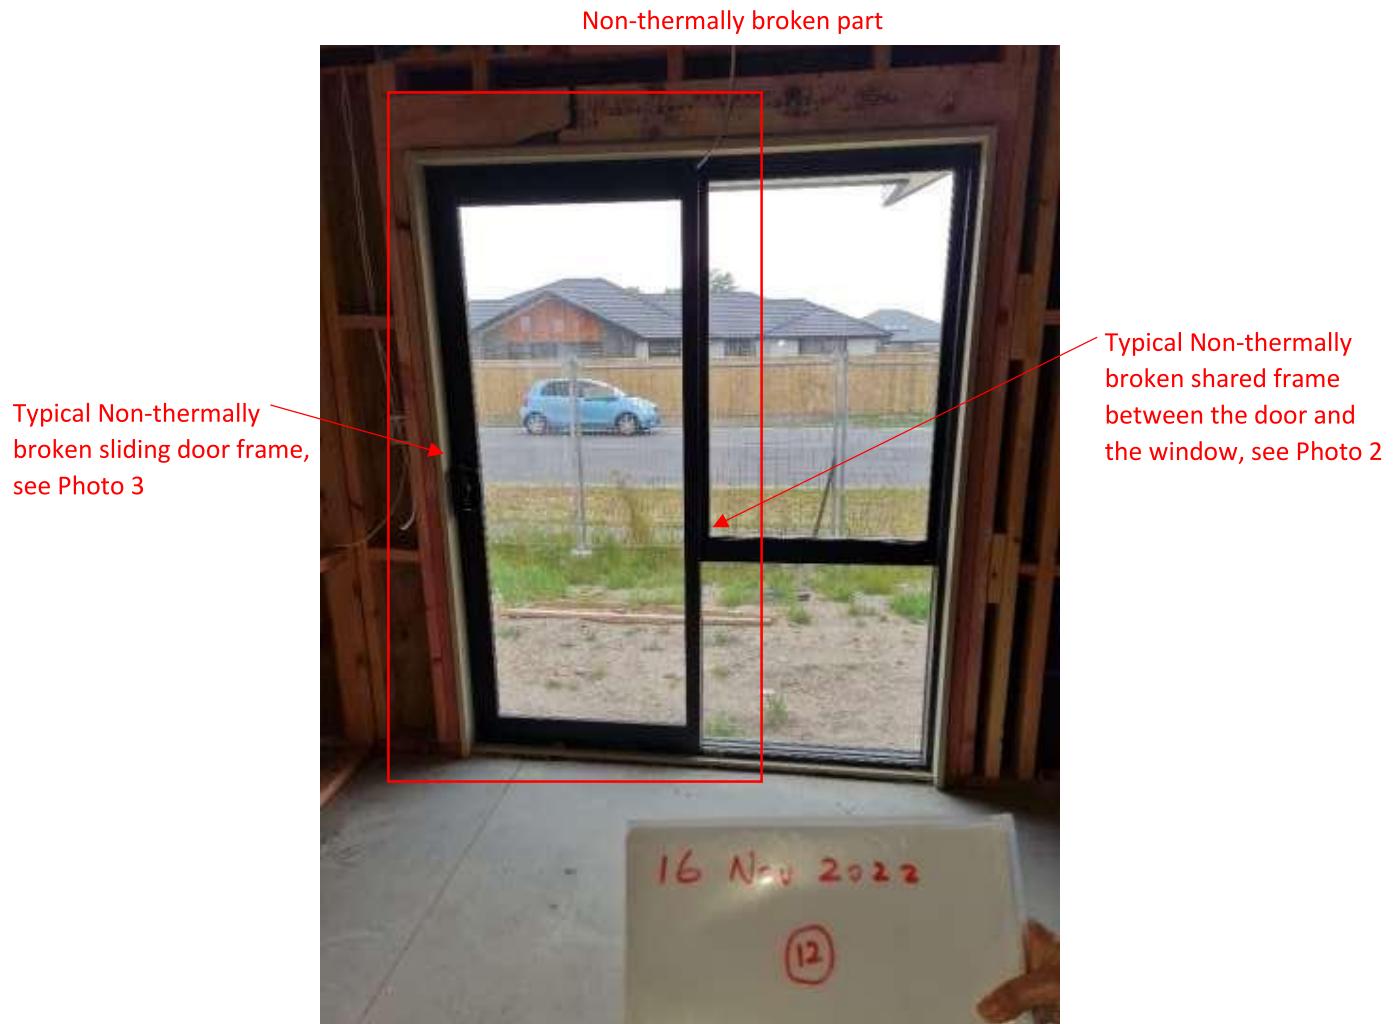
Photo 12 – Indicating the non-thermally broken parts of the Sliding Door “Bedroom 4 D4” (Door number referred to the attached quote no. 27363) (Trim Size: 2130 x 1800; Area: 3.834 m sq.)

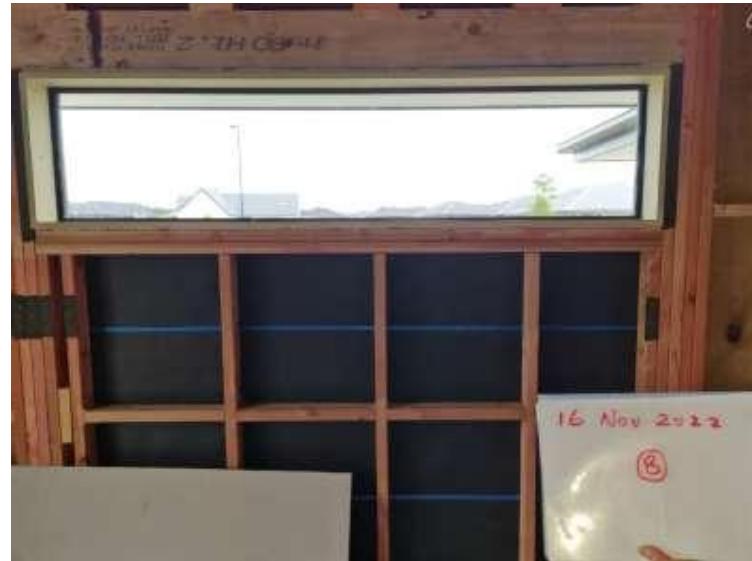
Photo 8 – Indicating uncertain thermally broken window “Bedroom 2 W5” (Door number referred to the attached quote no. 27363) (Trim Size: 600 x 2400; Area: 1.37 m sq.)

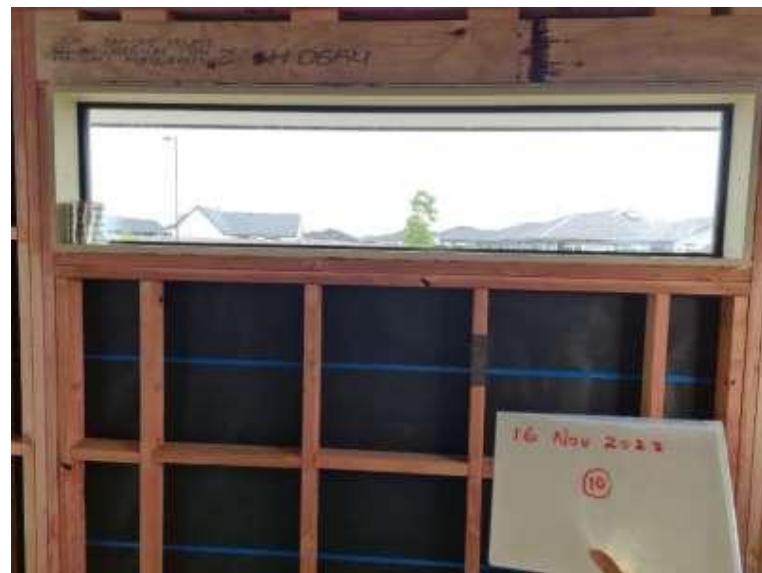
Photo 10 – Indicating uncertain thermally broken window “Master Bedroom W4” (Door number referred to the attached quote no. 27363) (Trim Size: 600 x 2400; Area: 1.37 m sq.)

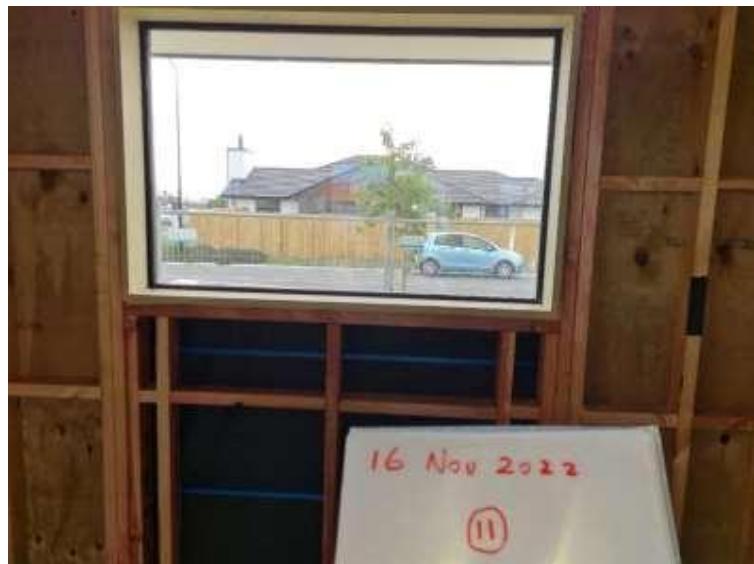
Photo 11 – Indicating uncertain thermally broken window “Master Bedroom W3” (Door number referred to the attached quote no. 27363) (Trim Size: 1000 x 1500; Area: 1.5 m sq.)
