Re: Incorrect Thermal broken Aluminum Joinery: 2 Rapare St. Job No.27363 - JSR Construction.

Subject: RE: Building Dispute MB # 050417 - JSR Construction: Job No.27363

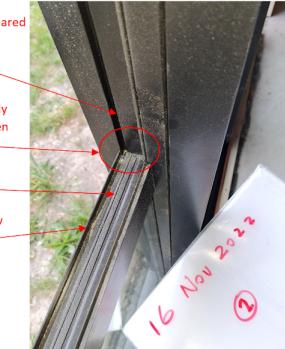
- a) Photo 1 – Indicating the non-thermally broken parts of the Sliding Door "Lounge D6" (Door number referred to the attached quote no. 27363) (Trim Size: 2130 x 2700; Area: 5.751 m sq.)

Photo 1 – Indicating the non-thermally broken parts of the Sliding Door “Lounge D6” (Door number referred to the attached quote no. 27363) (Trim Size: 2130 x 2700; Area: 5.751 m sq.)

You shall provide us with all the satisfied up-to-standard thermally broken aluminium joinery. You are requested to replace and re-install all the incorrect entire windows and doors. Partly replacement of aluminium materials on the site is not acceptable. You are also liable for all our losses of cost including but not limited to the related matters of any material reinstatements, any material variations, any time delay and any opportunity costs incurred by the correction of the aluminium windows and doors. The incorrect and uncertain products are stated below with the corresponding photos and the photo location plan (Figure 1 below). The product quote no. 27363 from your subcontractor is attached for your reference.

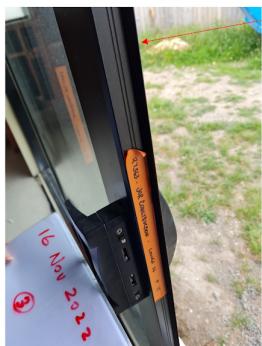
- b) Photo 2 – Typical joint between the vertical frame of the sliding door and the horizontal frame of the window shows that the shared frame between the door and the window do not have the thermally broken strip.

Photo 2 – Typical joint between the vertical frame of the sliding door and the horizontal frame of the window shows that the shared frame between the door and the window do not have the thermally broken strip.

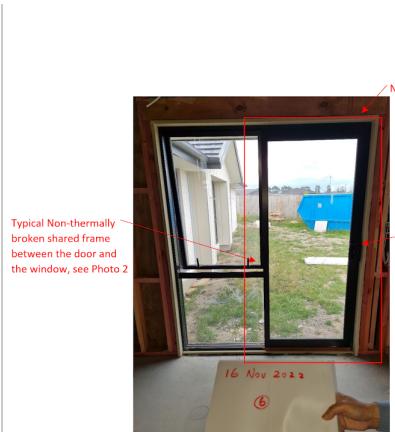
- e) Photo 5 – Indicating the non-thermally broken parts of the Sliding Door "Dining D6" (Door number referred to the attached quote no. 27363) (Trim Size: 2130 x 2700; Area: 5.751 m sq.)

Photo 5 – Indicating the non-thermally broken parts of the Sliding Door “Dining D6” (Door number referred to the attached quote no. 27363) (Trim Size: 2130 x 2700; Area: 5.751 m sq.)

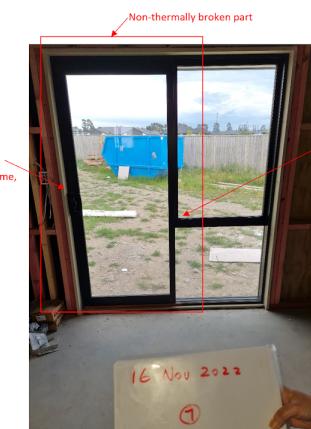
- f) Photo 6 – Indicating the non-thermally broken parts of the Sliding Door "Bedroom 3 D5" (Door number referred to the attached quote no. 27363) (Trim Size: 2130 x 1800; Area: 3.834 m sq.)

Photo 6 – Indicating the non-thermally broken parts of the Sliding Door "Bedroom 3 D5" (Door number referred to the attached quote no. 27363) (Trim Size: 2130 x 1800; Area: 3.834 m sq.)

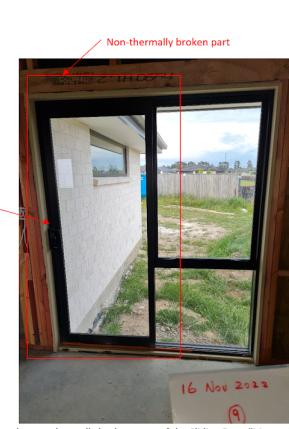
- g) Photo 7 – Indicating the non-thermally broken parts of the Sliding Door "Bedroom 2 D4" (Door number referred to the attached quote no. 27363) (Trim Size: 2130 x 1800; Area: 3.834 m sq.)

Photo 7 – Indicating the non-thermally broken parts of the Sliding Door "Bedroom 2 D4" (Door number referred to the attached quote no. 27363) (Trim Size: 2130 x 1800; Area: 3.834 m sq.)

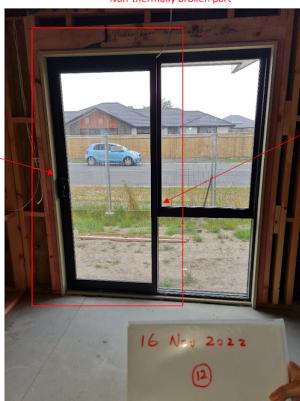
- h) Photo 9 – Indicating the non-thermally broken parts of the Sliding Door "Master Bedroom D3" (Door number referred to the attached quote no. 27363) (Trim Size: 2130 x 1800; Area: 3.834 m sq.)

Photo 9 – Indicating the non-thermally broken parts of the Sliding Door "Master Bedroom D3" (Door number referred to the attached quote no. 27363) (Trim Size: 2130 x 1800; Area: 3.834 m sq.)

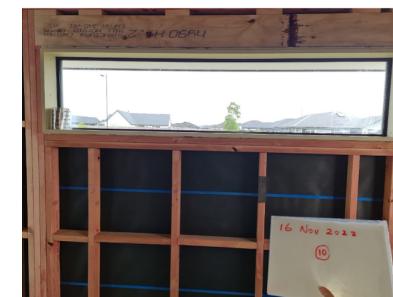
- a) Photo 8 – Indicating uncertain thermally broken window "Bedroom 2 W5" (Door number referred to the attached quote no. 27363) (Trim Size: 600 x 2400; Area: 1.37 m sq)

Photo 8 – Indicating uncertain thermally broken window "Bedroom 2 W5" (Door number referred to the attached quote no. 27363) (Trim Size: 600 x 2400; Area: 1.37 m sq.)

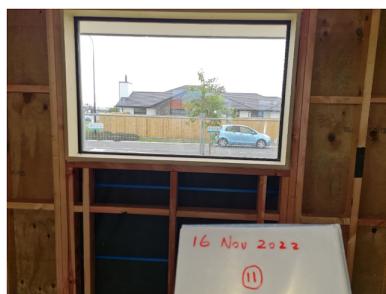
- b) Photo 10 – Indicating uncertain thermally broken window "Master Bedroom W4" (Door number referred to the attached quote no. 27363) (Trim Size: 600 x 2400; Area: 1.37 m sq)

Photo 10 – Indicating uncertain thermally broken window "Master Bedroom W4" (Door number referred to the attached quote no. 27363) (Trim Size: 600 x 2400; Area: 1.37 m sq.)

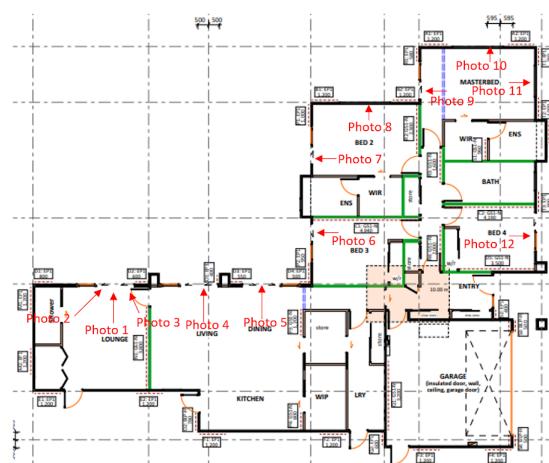
c) Photo 11 – Indicating uncertain thermally broken window “Master Bedroom W3” (Door number referred to the attached quote no. 27363) (Trim Size: 1000 x 1500; Area: 1.5 m sq)

Photo 11 – Indicating uncertain thermally broken window "Master Bedroom W3" (Door number referred to the attached quote no. 27363) (Trim Size: 1000 x 1500; Area: 1.5 m sq.)
