### Fwd: 15-May-2023 New Defects at 2 Rapere Street, Rolleston: Master Build Guarantee No 238598

Subject: 15-May-2023 New Defects at 2 Rapere Street, Rolleston: Master Build Guarantee No 238598

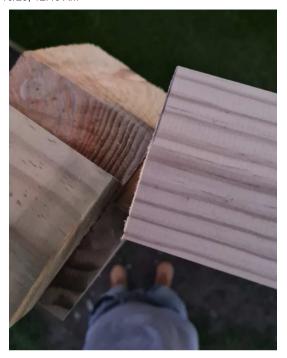
Image 2A: Edge of fence at the hinge is on the way when panel is closing

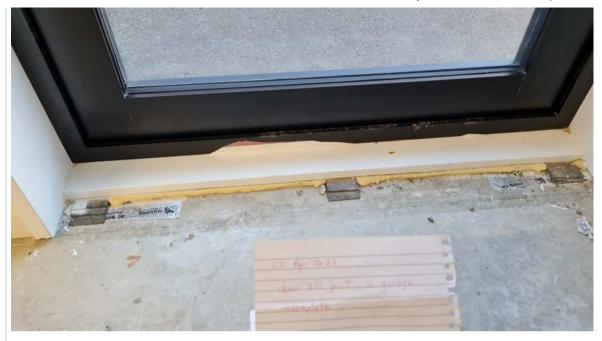
Photo 6: Incomplete door sill joint in garage

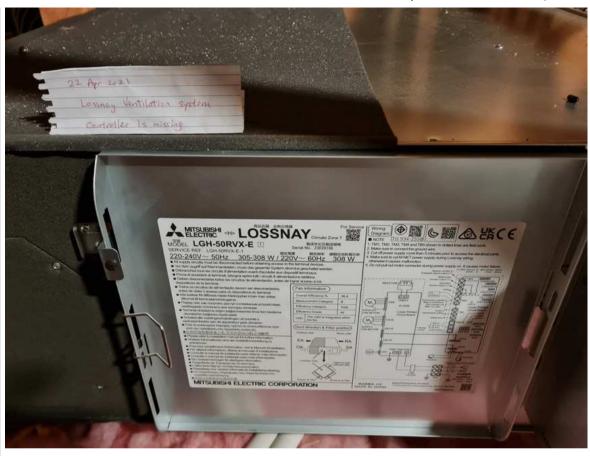
Photo 9: Controller of Mitsubishi Lossnay Ventilation system is missing

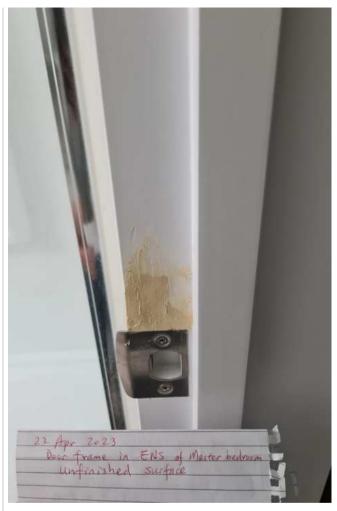
Photo 10: Unfinished surface at the door frame in ENS of Master bedroom

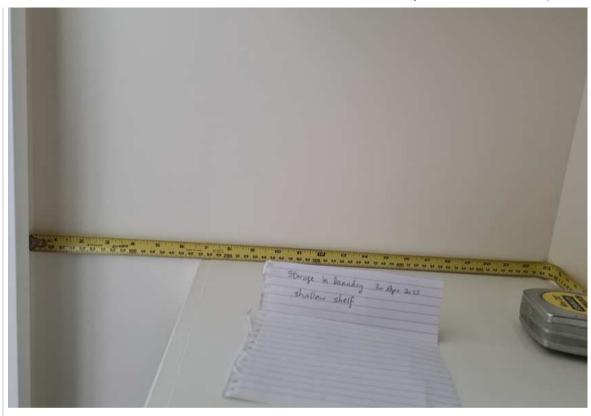
Photo 12: Shelves of storage in laundry are shallow

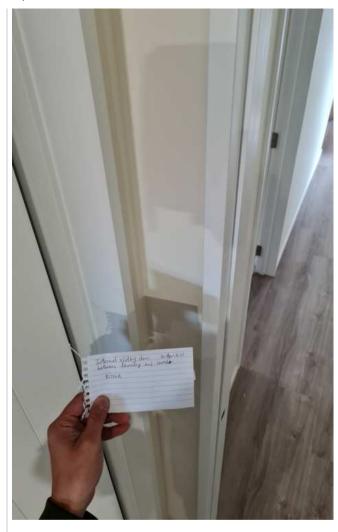
Photo 14: Internal sliding door between laundry and corridor tilted

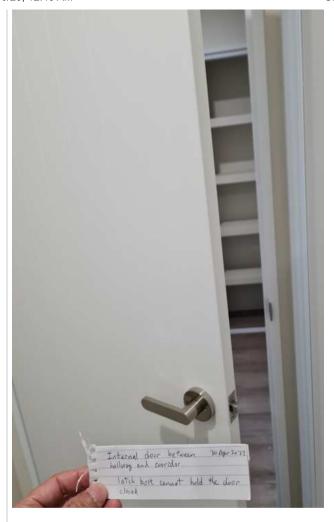
Photo 15: Latch bolt of the internal door between hallway and corridor cannot hold the door closed (i.e. the door can be pushed open)

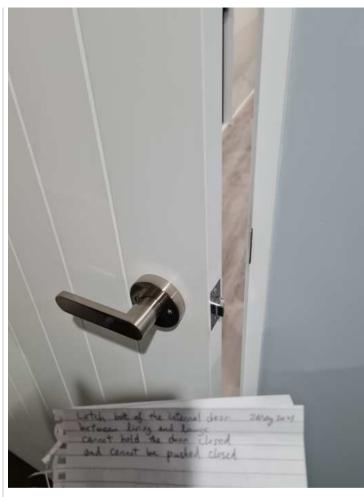
Photo 16: Latch bolt of the internal door between living and lounge cannot hold the door closed (i.e. the door can be pushed open) and cannot be pushed closed

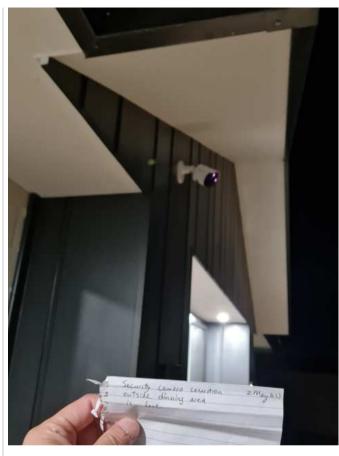
Photo 17: Security camera signal connection outside dining area is lost. It's signal cable connector was got painted and wet

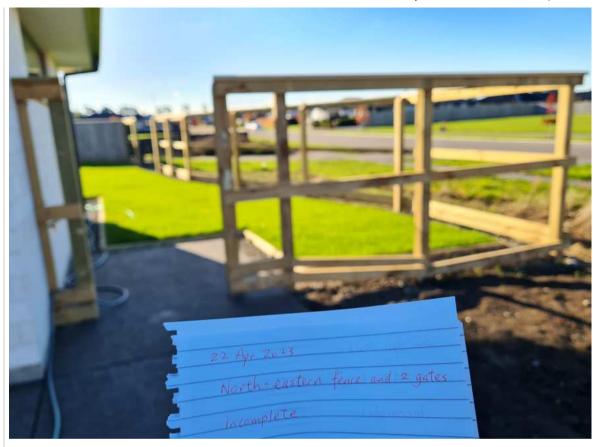
Photo 19: North-eastern fence and 2 gates are incomplete
