Re: (RE: Re: (RE: Building Dispute MB # 050417))

Re: Incorrect Thermal broken Aluminum Joinery: 2 Rapare St. Job No.27363 - JSR Construction.

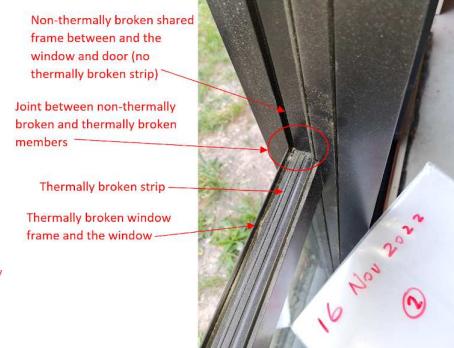
- a) Photo 1 – Indicating the non-thermally broken parts of the Sliding Door "Lounge D6" (Door number referred to the attached quote no. 27363) (Trim Size: 2130 x 2700; Area: 5.751 m sq.)

Photo 1 – Indicating the non-thermally broken parts of the Sliding Door “Lounge D6” (Door number referred to the attached quote no. 27363) (Trim Size: 2130 x 2700; Area: 5.751 m sq.)

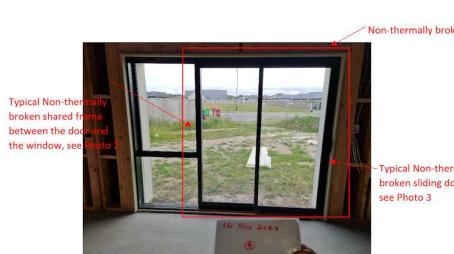
- c) Photo 3 – Typical slide door frame shows that the slide door does not have the thermally broken strip
 - d) Photo 4 – Indicating the non-thermally broken parts of the Sliding Door "Living D6" (Door number referred to the attached quote no. 27363) (Trim Size: 2130 x 2700; Area: 5.751 m sq.)

Photo 3 – Typical slide door frame shows that the slide door does not have thermally broken

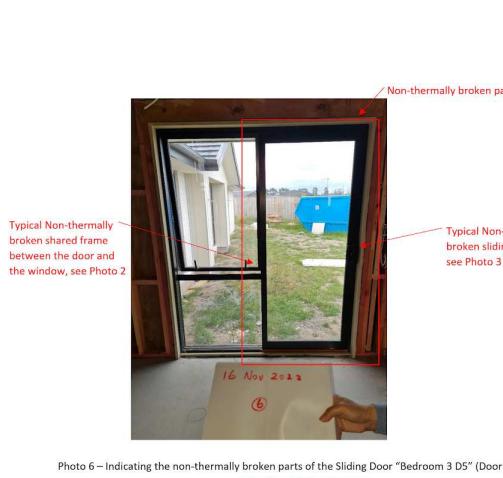
- e) Photo 5 – Indicating the non-thermally broken parts of the Sliding Door "Dining D6" (Door number referred to the attached quote no. 27363) (Trim Size: 2130 x 2700; Area: 5.751 m sq.)

Photo 5 – Indicating the non-thermally broken parts of the Sliding Door “Dining D6” (Door number referred to the attached quote no. 27363) (Trim Size: 2130 x 2700; Area: 5.751 m sq.)

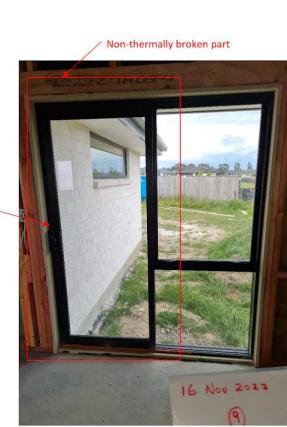
Photo 7 – Indicating the non-thermally broken parts of the Sliding Door "Bedroom 2 D4" (Door number referred to the attached quote no. 27363) (Trim Size: 2130 x 1800; Area: 3.834 m sq.)

Typical Non-thermally broken shared frame between the door and the window, see Photo 2

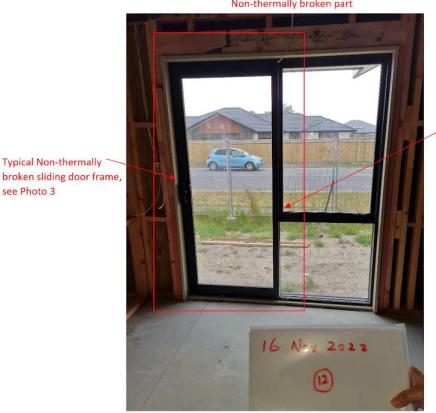
- h) Photo 9 – Indicating the non-thermally broken parts of the Sliding Door "Master Bedroom D3" (Door number referred to the attached quote no. 27363) (Trim Size: 2130 x 1800; Area: 3.834 m sq.)

Photo 9 – Indicating the non-thermally broken parts of the Sliding Door "Master Bedroom D3" (Door number referred to the attached quote no. 27363) (Trim Size: 2130 x 1800; Area: 3.834 m sq.)

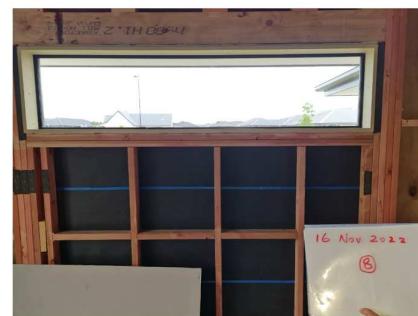
- i) Photo 12 – Indicating the non-thermally broken parts of the Sliding Door "Bedroom 4 D4" (Door number referred to the attached quote no. 27363) (Trim Size: 2130 x 1800; Area: 3.834 m sq.)

Photo 12 – Indicating the non-thermally broken parts of the Sliding Door "Bedroom 4 D4" (Door number referred to the attached quote no. 27363) (Trim Size: 2130 x 1800; Area: 3.834 m sq.)

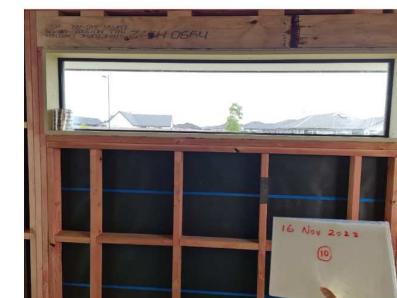
- a) Photo 8 – Indicating uncertain thermally broken window "Bedroom 2 W5" (Door number referred to the attached quote no. 27363) (Trim Size: 600 x 2400; Area: 1.37 m sq)

Photo 8 – Indicating uncertain thermally broken window "Bedroom 2 W5" (Door number referred to the attached quote no. 27363) (Trim Size: 600 x 2400; Area: 1.37 m sq.)

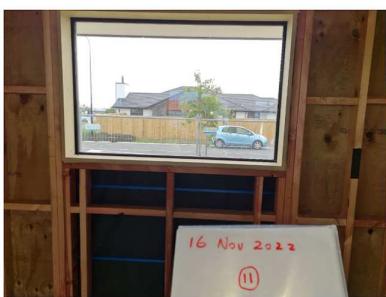
- b) Photo 10 – Indicating uncertain thermally broken window "Master Bedroom W4" (Door number referred to the attached quote no. 27363) (Trim Size: 600 x 2400; Area: 1.37 m sq)

Photo 10 – Indicating uncertain thermally broken window "Master Bedroom W4" (Door number referred to the attached quote no. 27363) (Trim Size: 600 x 2400; Area: 1.37 m sq.)

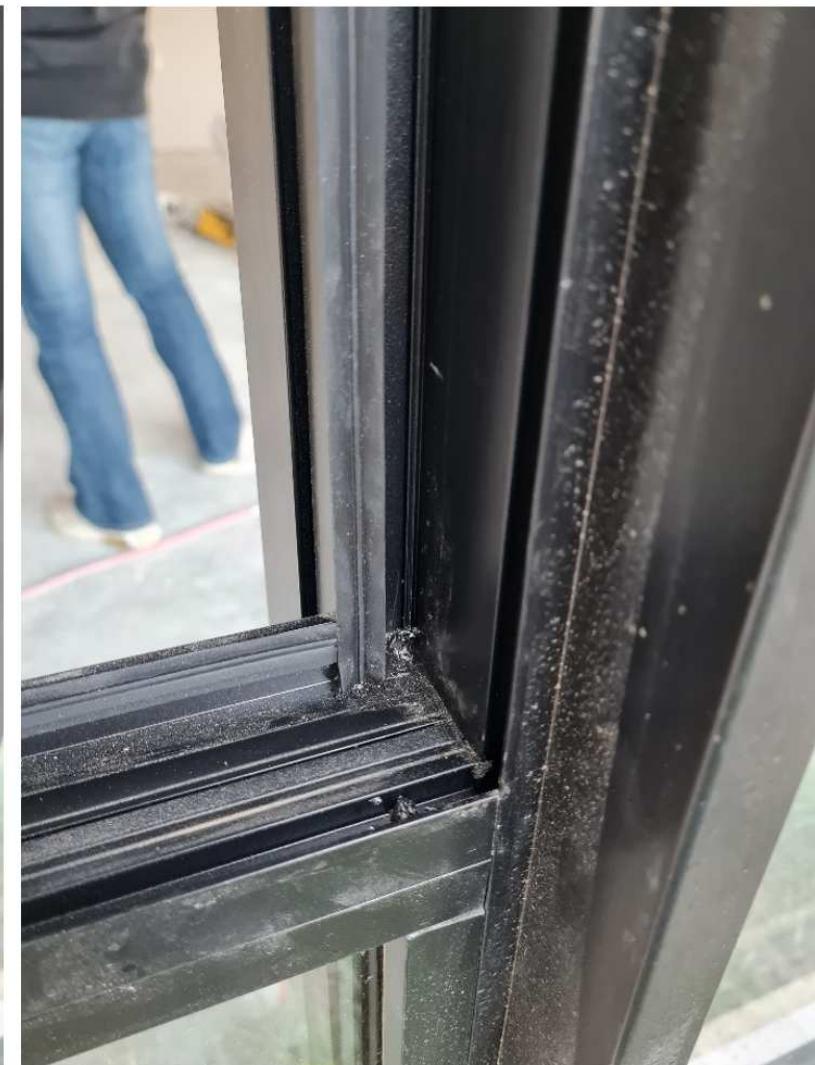
- c) This path of thermal conduction causes no thermal barrier at the joint. This makes the products redundant because it is no longer able to reduce condensation.

Photo 1: Path of thermal conduction at the joint of window transom and sliding-door fixed interlocker and the same photo without marking is given side by side for easy reference

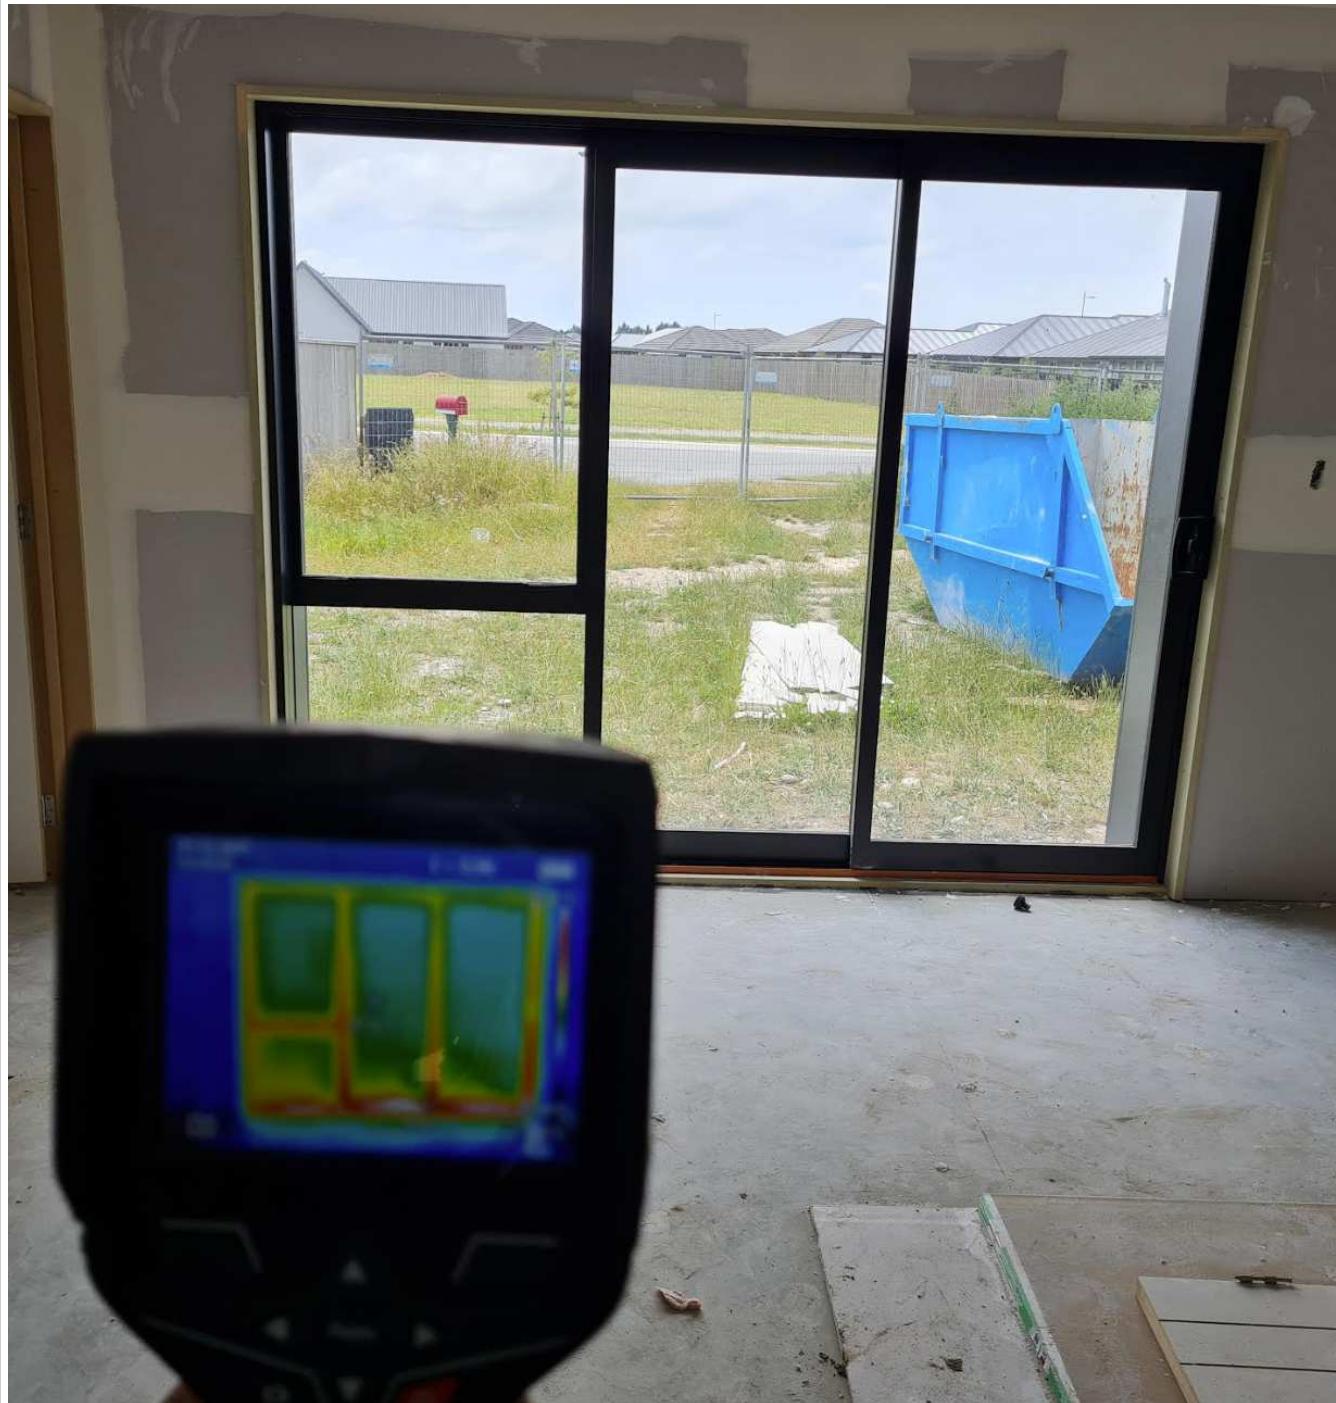
Photo 2: Thermal image of the sliding door and window with the sunshine reaching half the height of the sliding door. It showed that the non-thermally broken components (the joint in between the interlocker and the window transom, and the stile) creating a thermal conduction between the internal and external parts of the thermally-broken members (e.g. bottom of the sliding door frames and the window transom).
