## Fwd: Missing RJ 11 telephone jacks: 12 March: Missed or Concerned Items: Construction of 2 Rapere Street, Rolleston.

Subject: 12 March: Missed or Concerned Items: Construction of 2 Rapere Street, Rolleston.

Subject: Missed or Concerned Items: Construction of 2 Rapere Street, Rolleston.

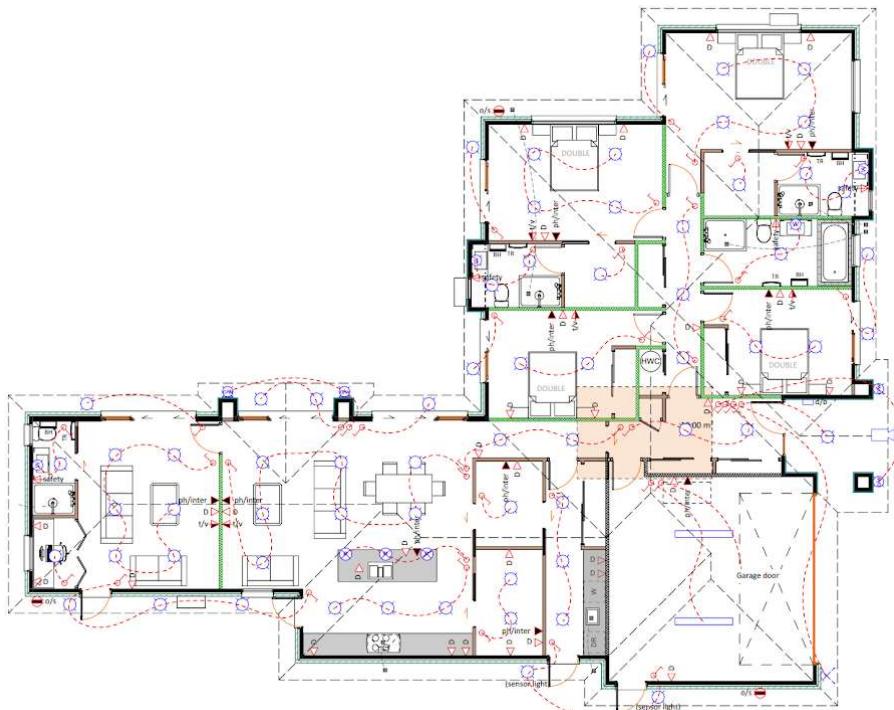
You missed the telephone jack at 10 locations and the internet jack at one location according to the electrical plan below.

Please check and correct it accordingly.

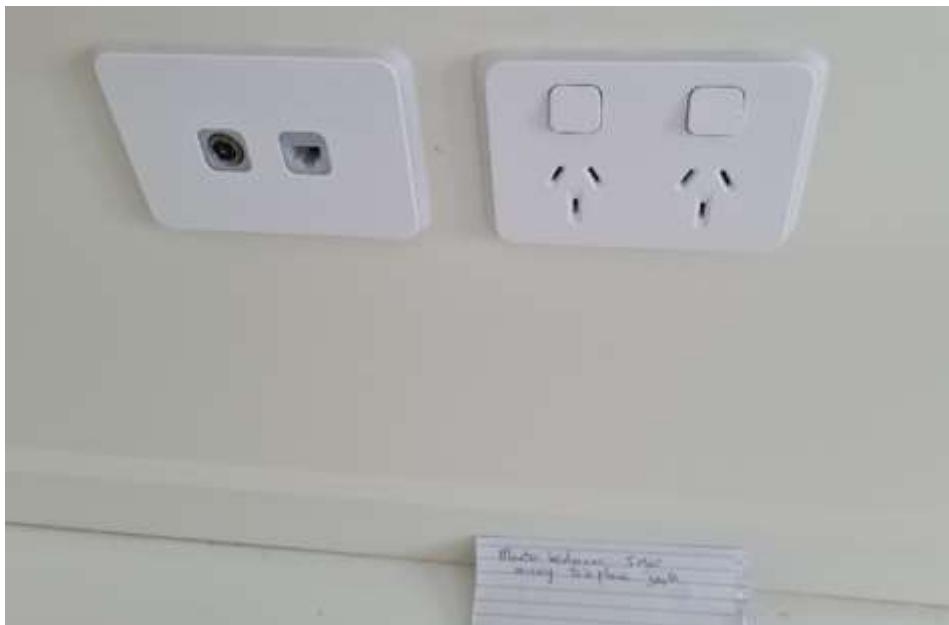
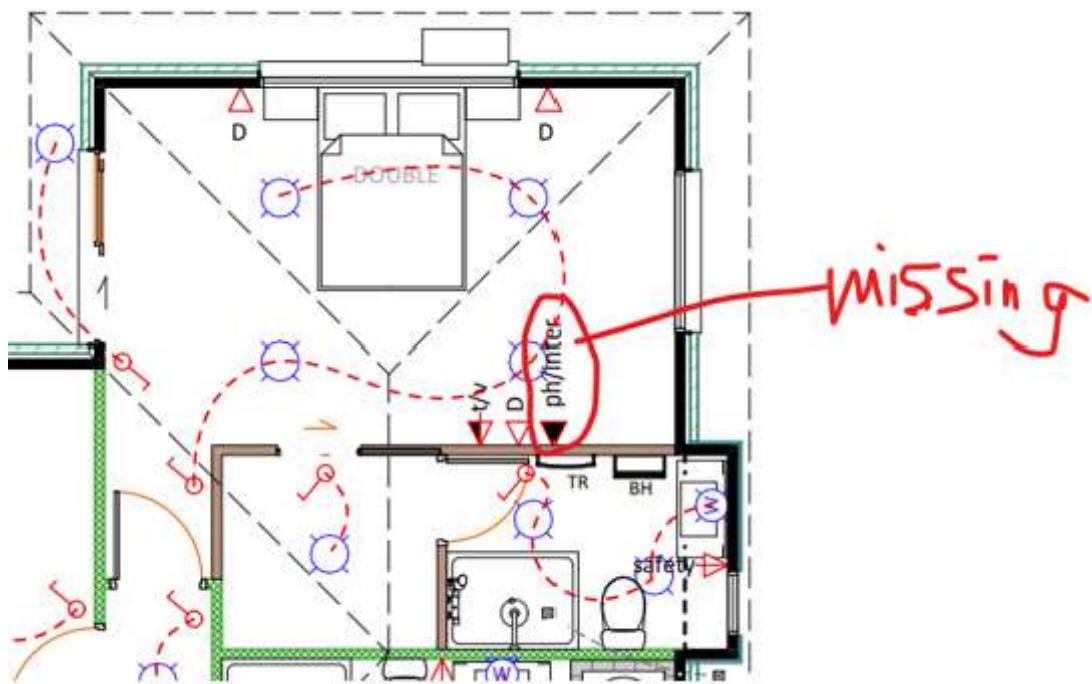
- 1) Missing telephone socket in Master Bedroom

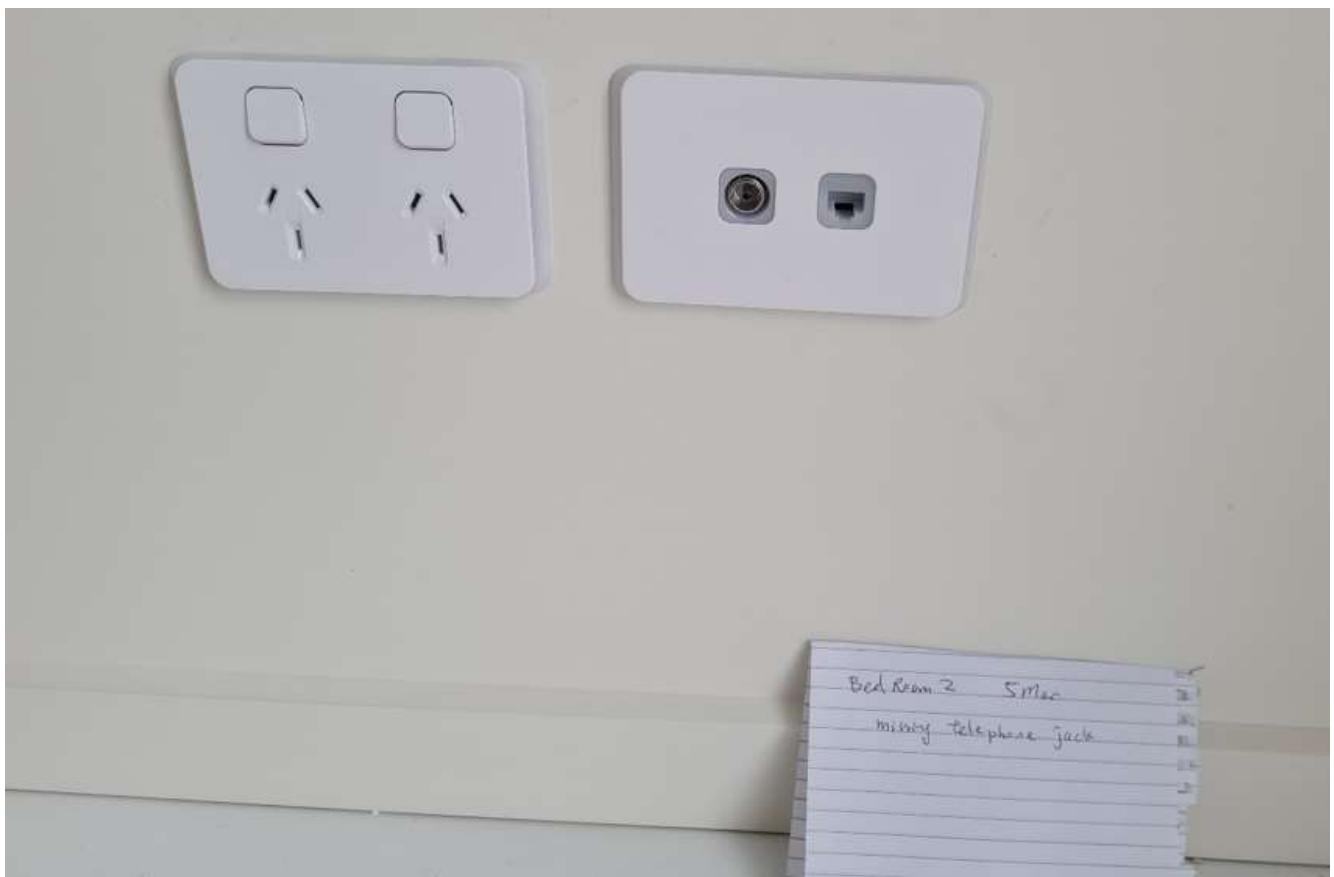
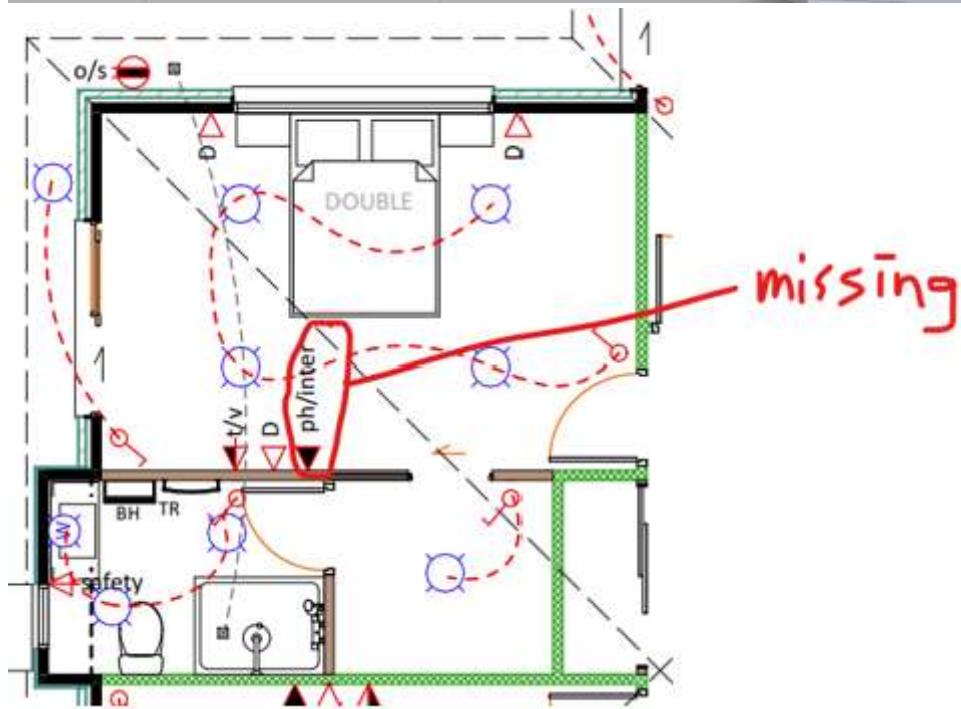
- 2) Missing phone socket in Bedroom 2

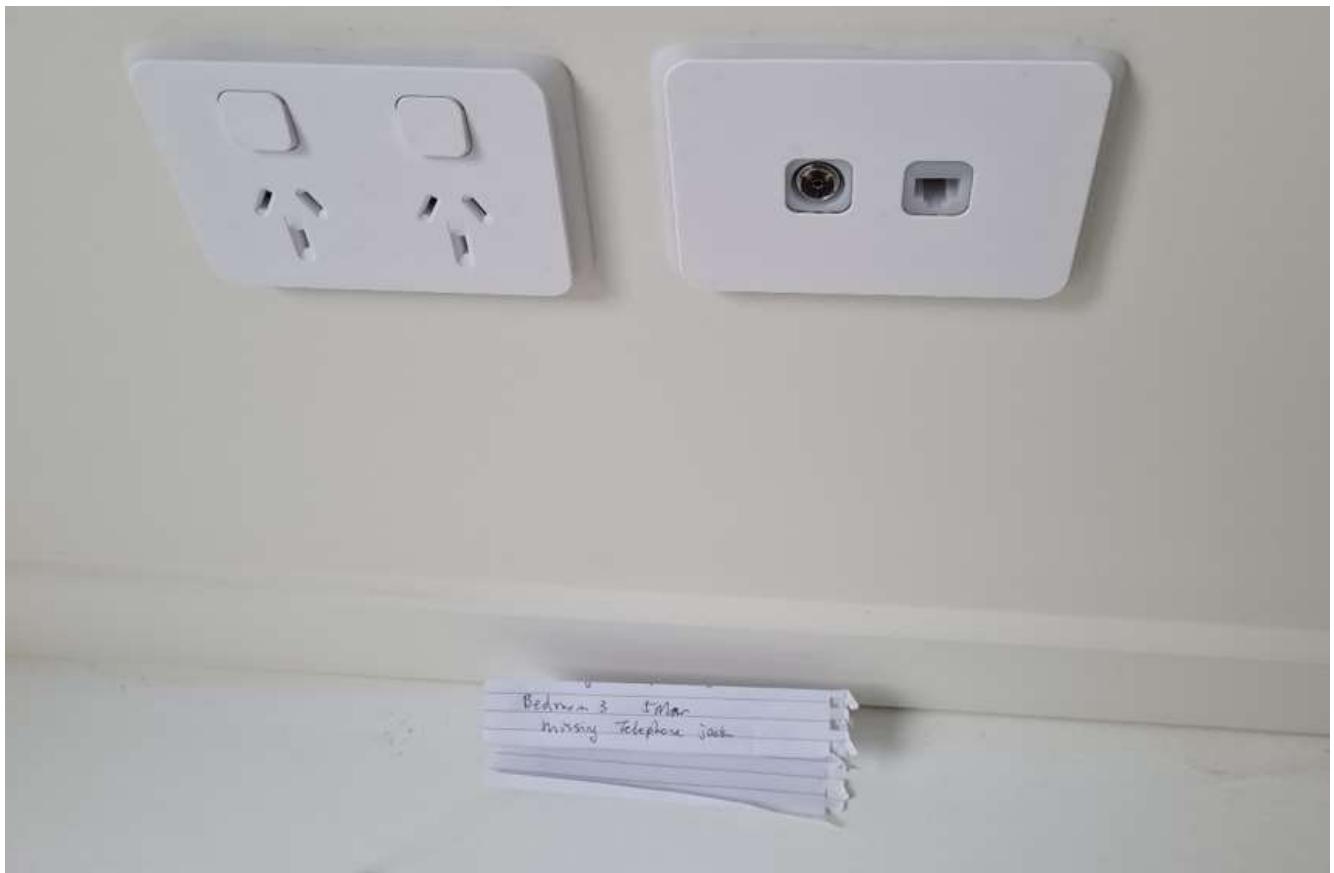
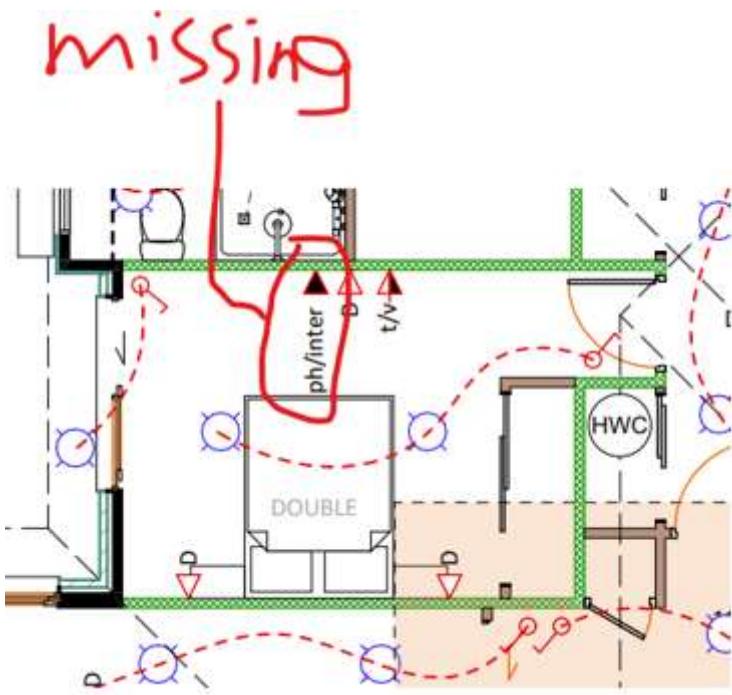
3) Missing phone socket in Bedroom 3

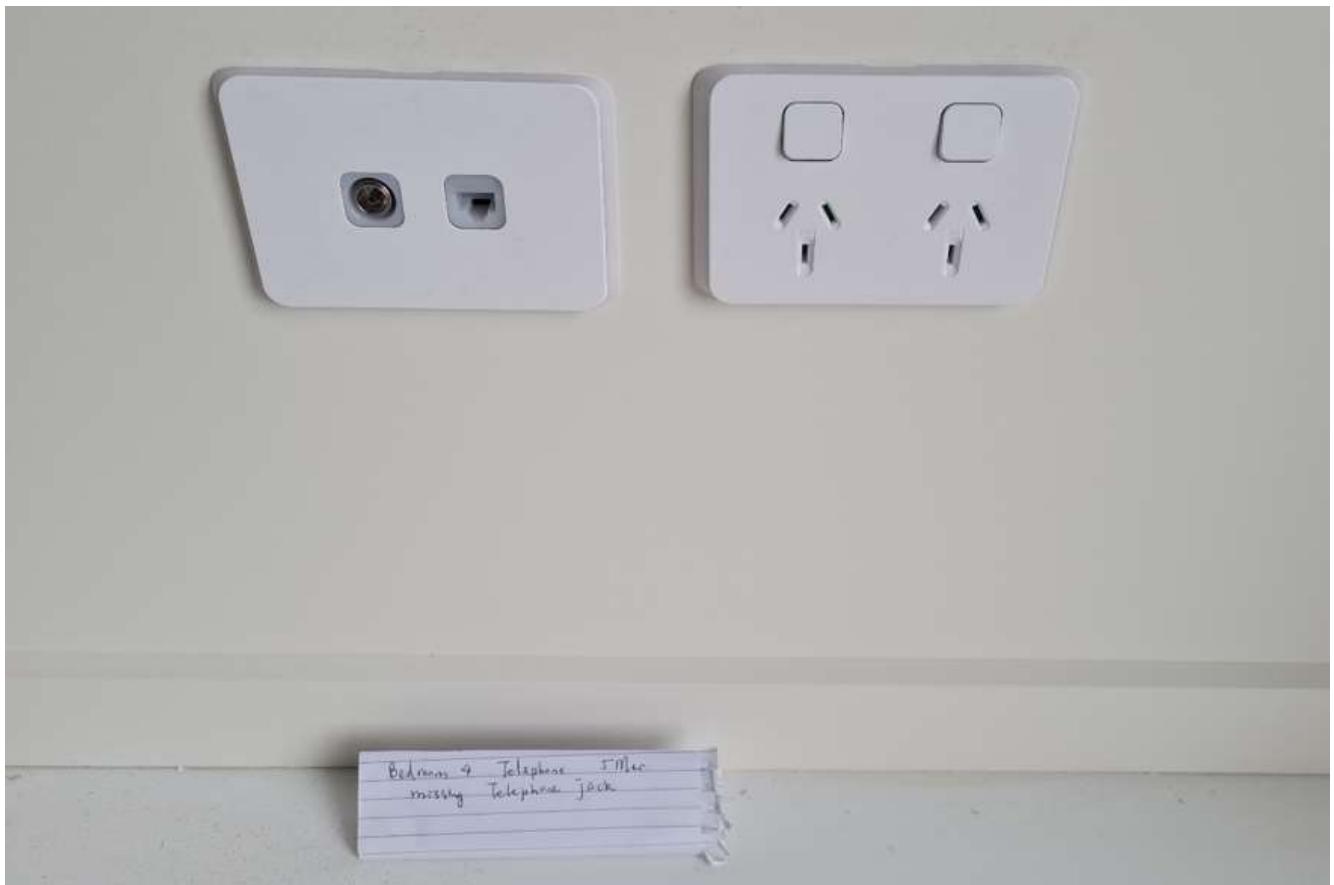
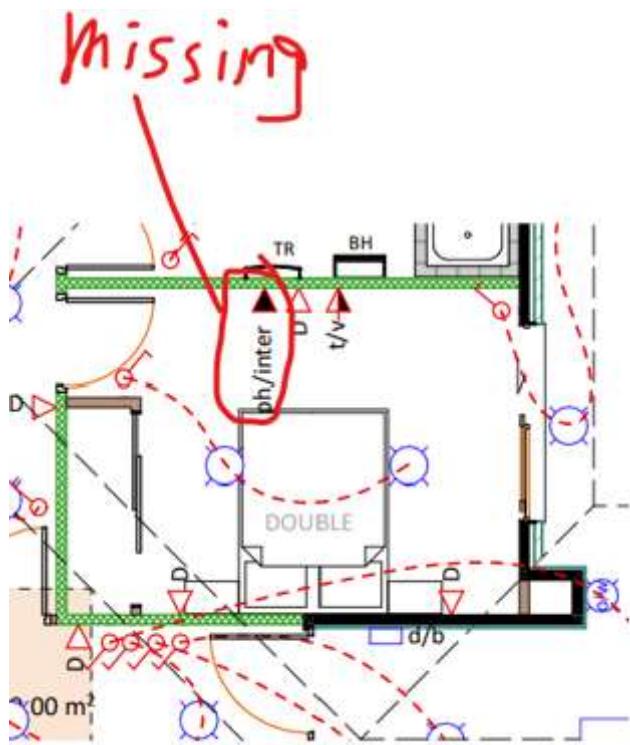
4) Missing phone socket in Bedroom 4

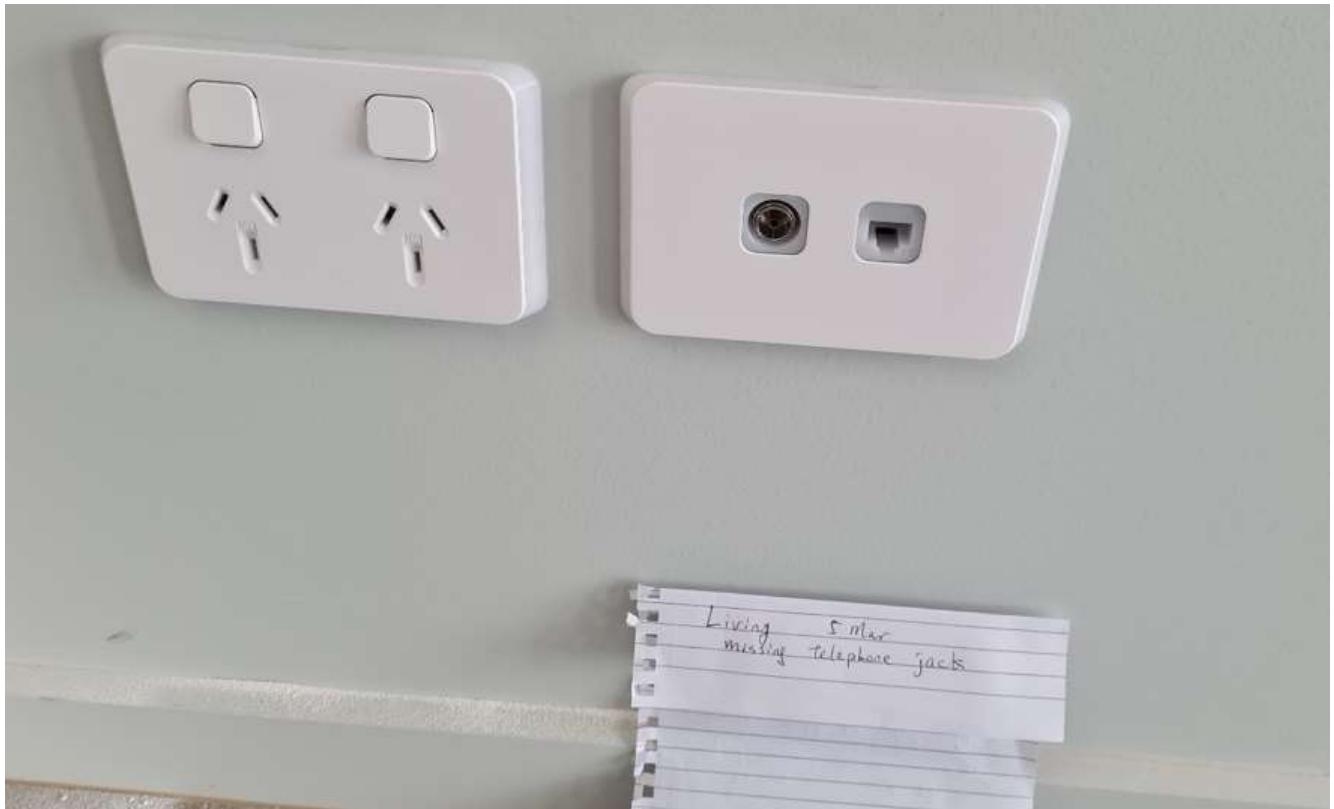
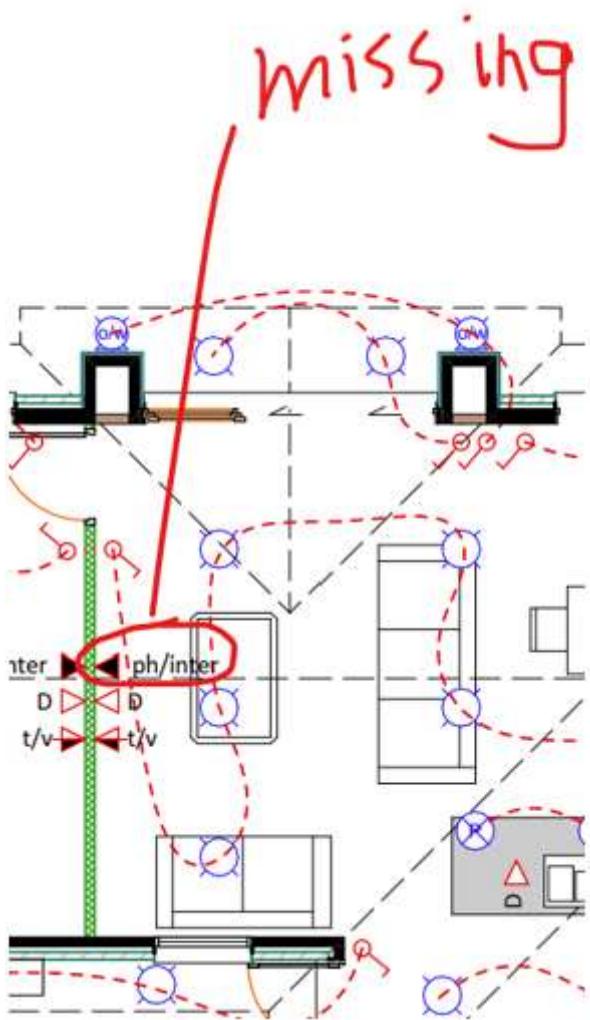
5) Missing phone socket in Living

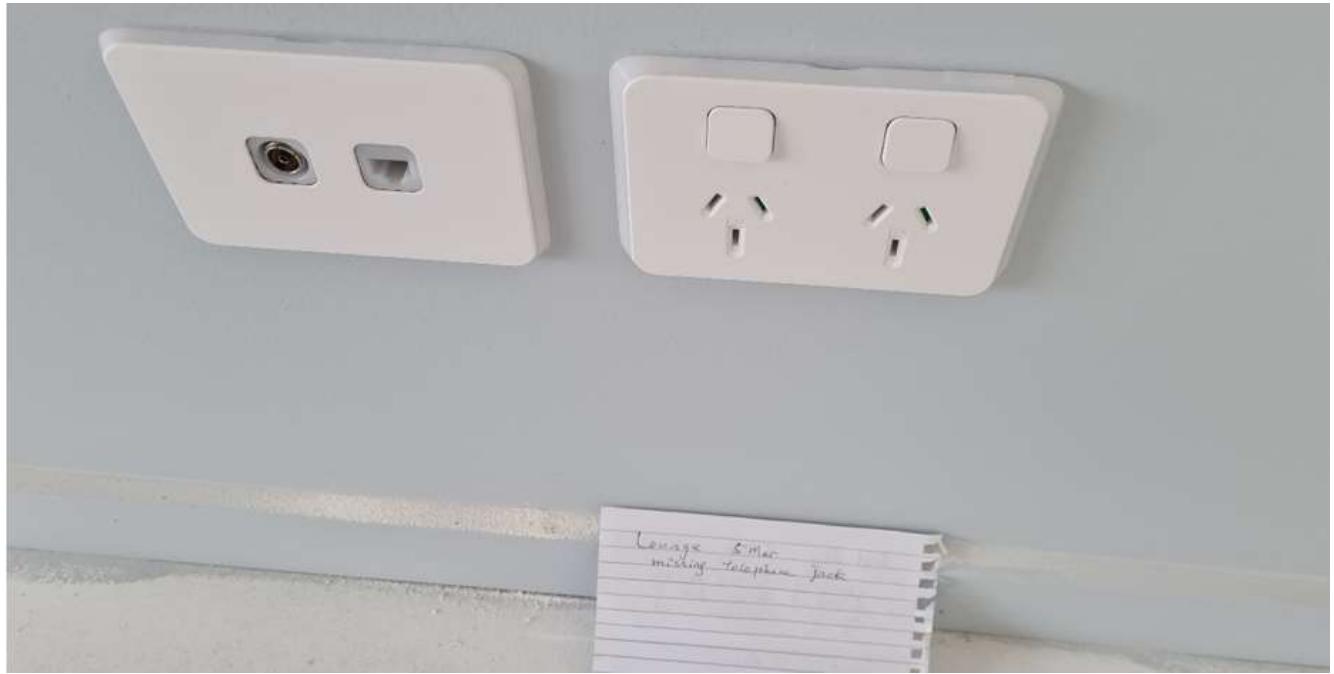
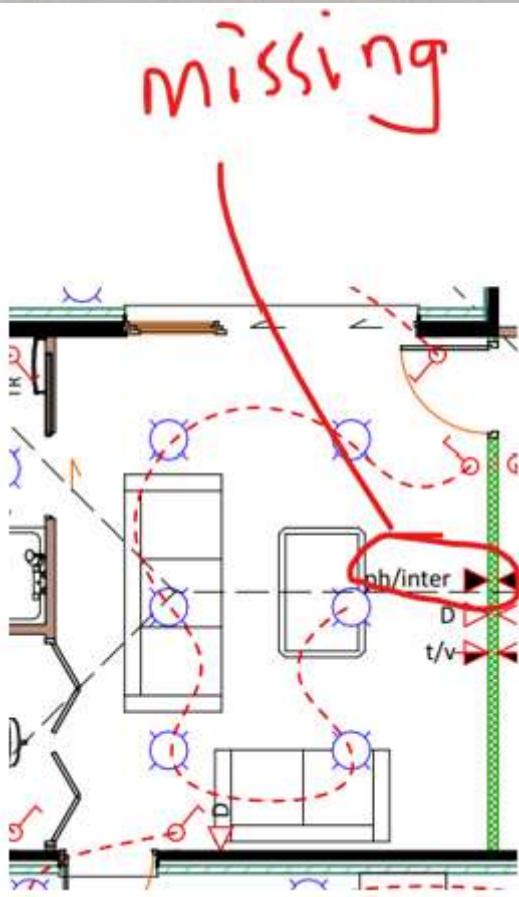
6) Missing phone socket in Lounge

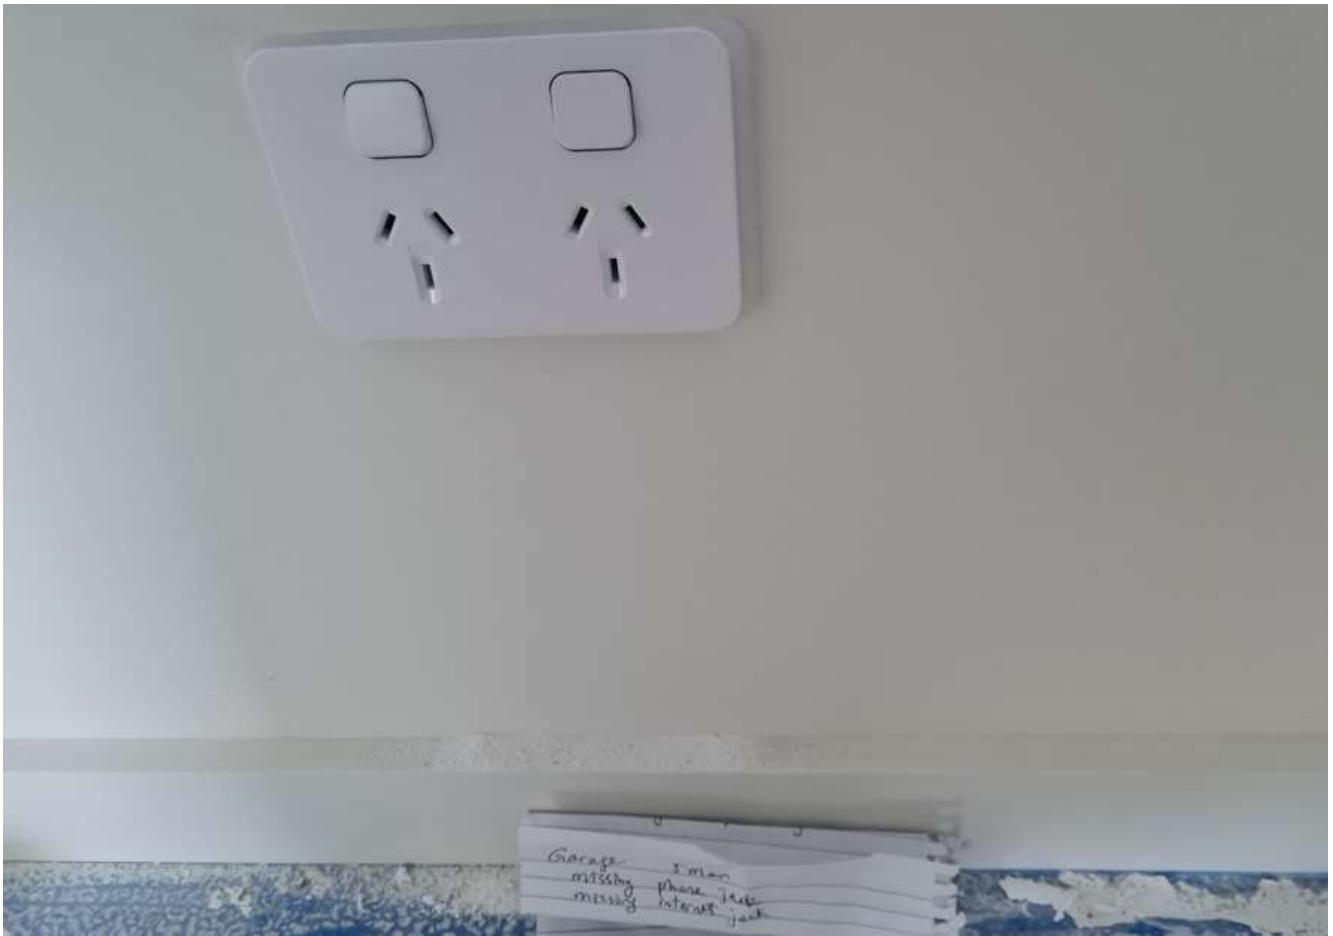
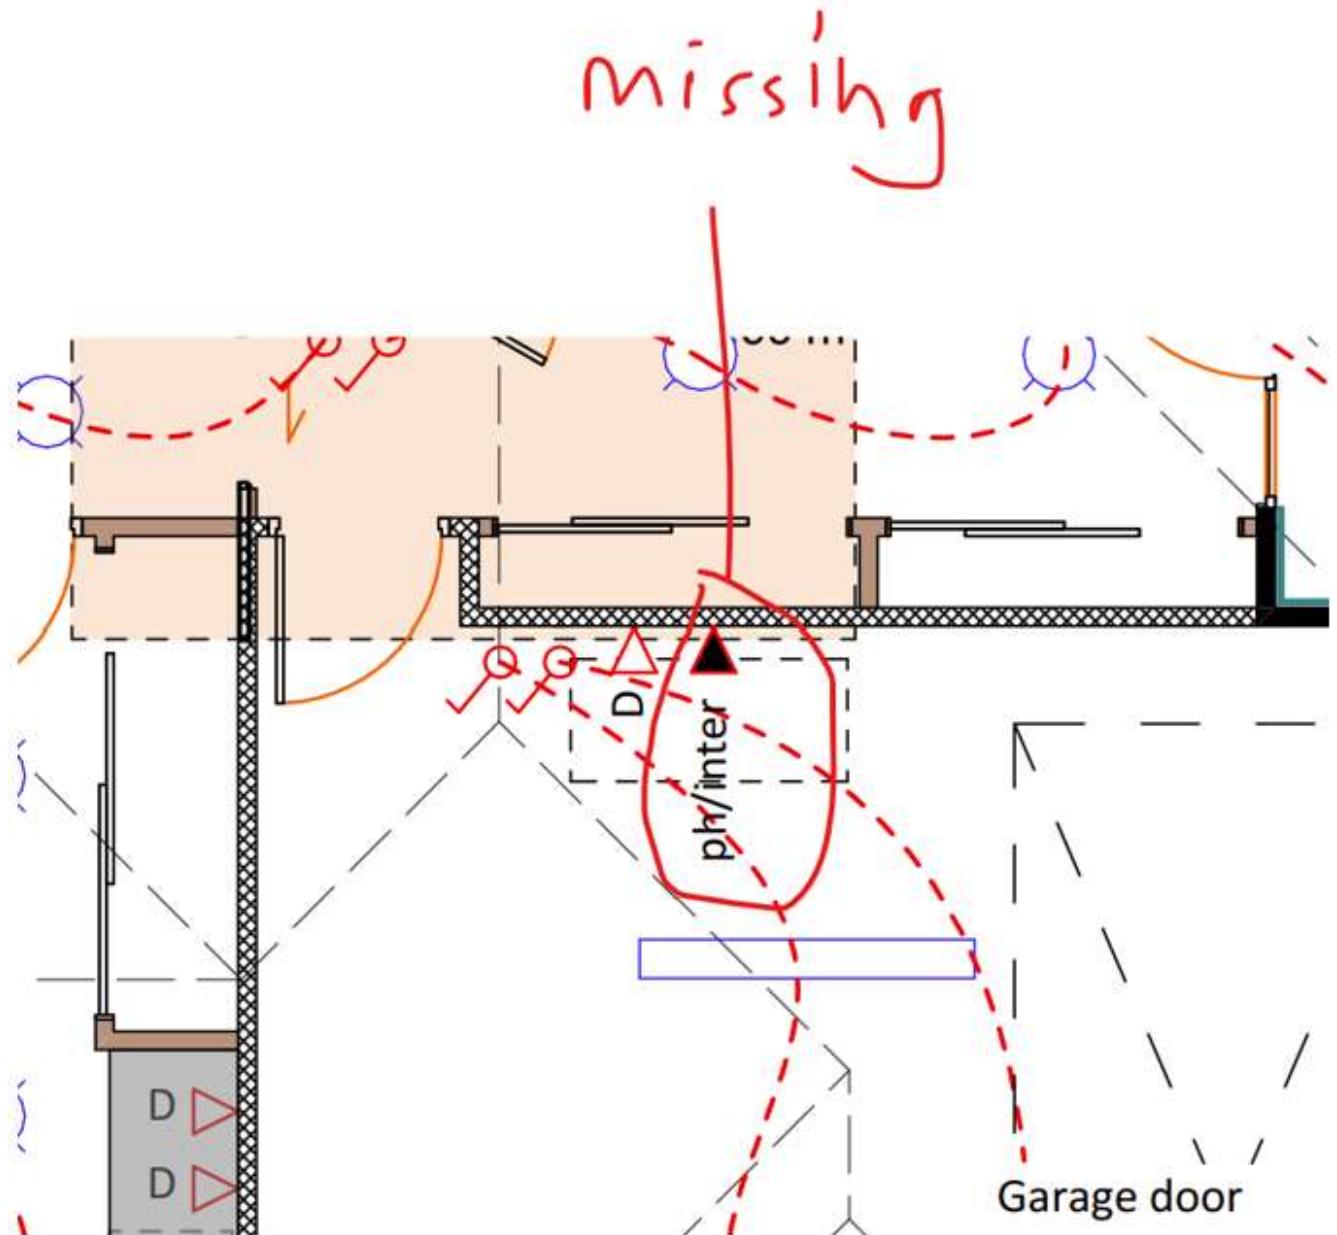
7) Missing phone and internet sockets in garage

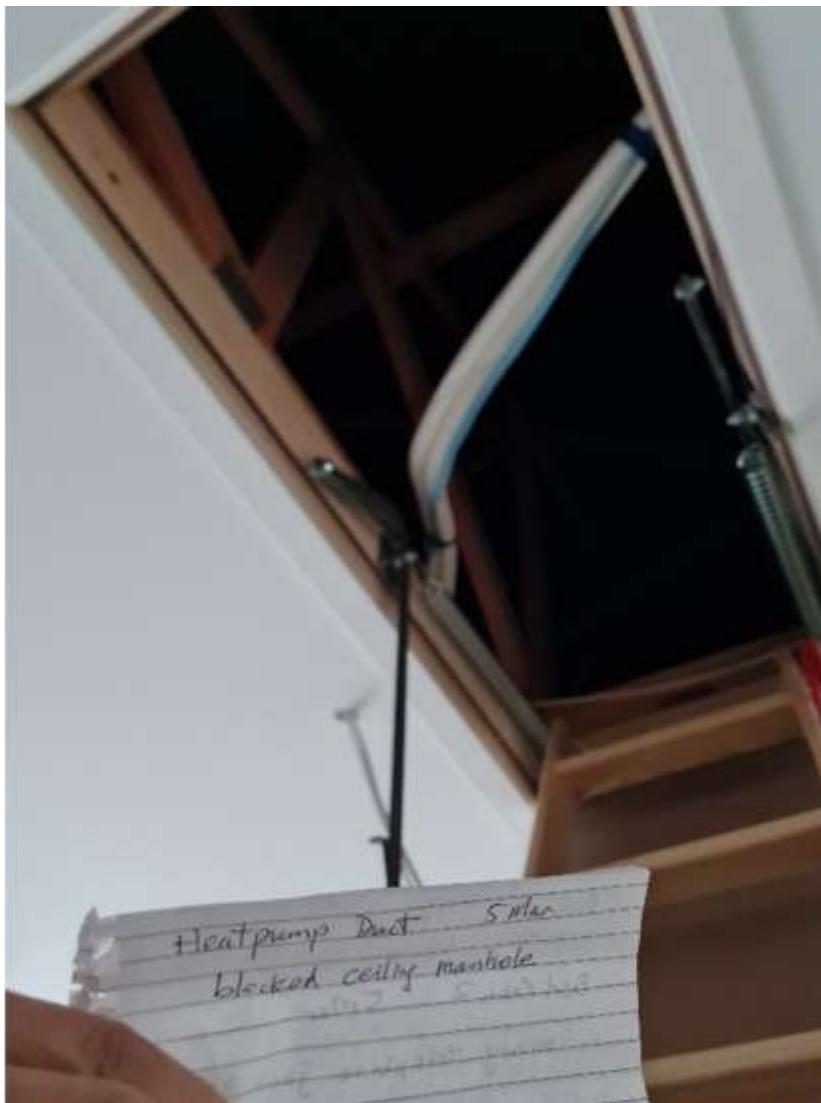
- 8) Heatpump duct and cable blocked ceiling manhole

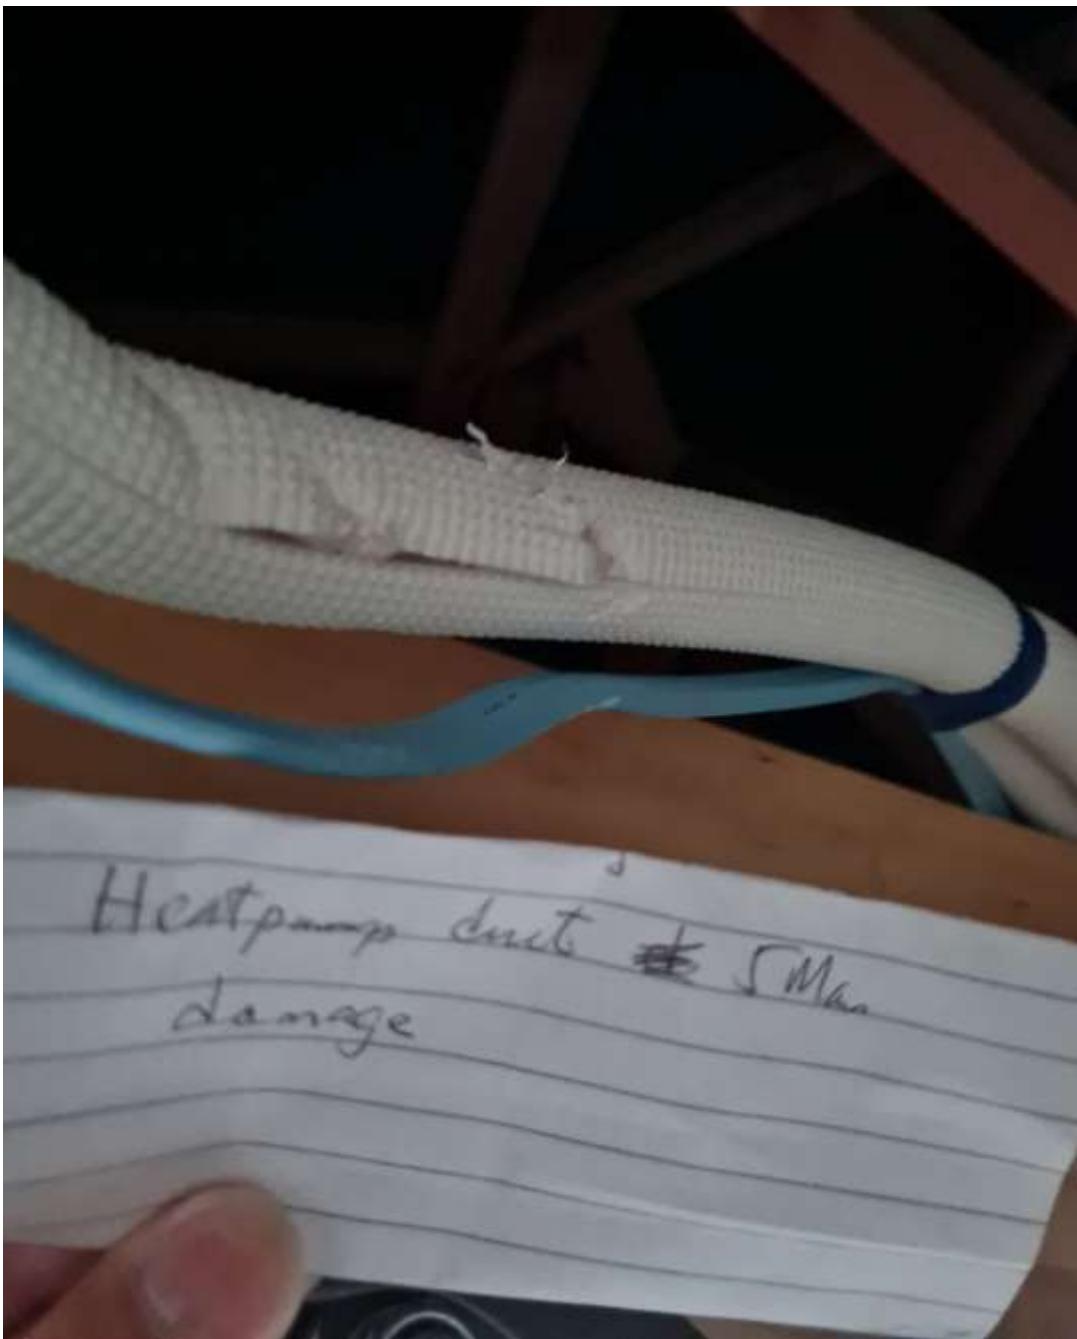
9) Heatpump duct damaged at the ceiling manhole

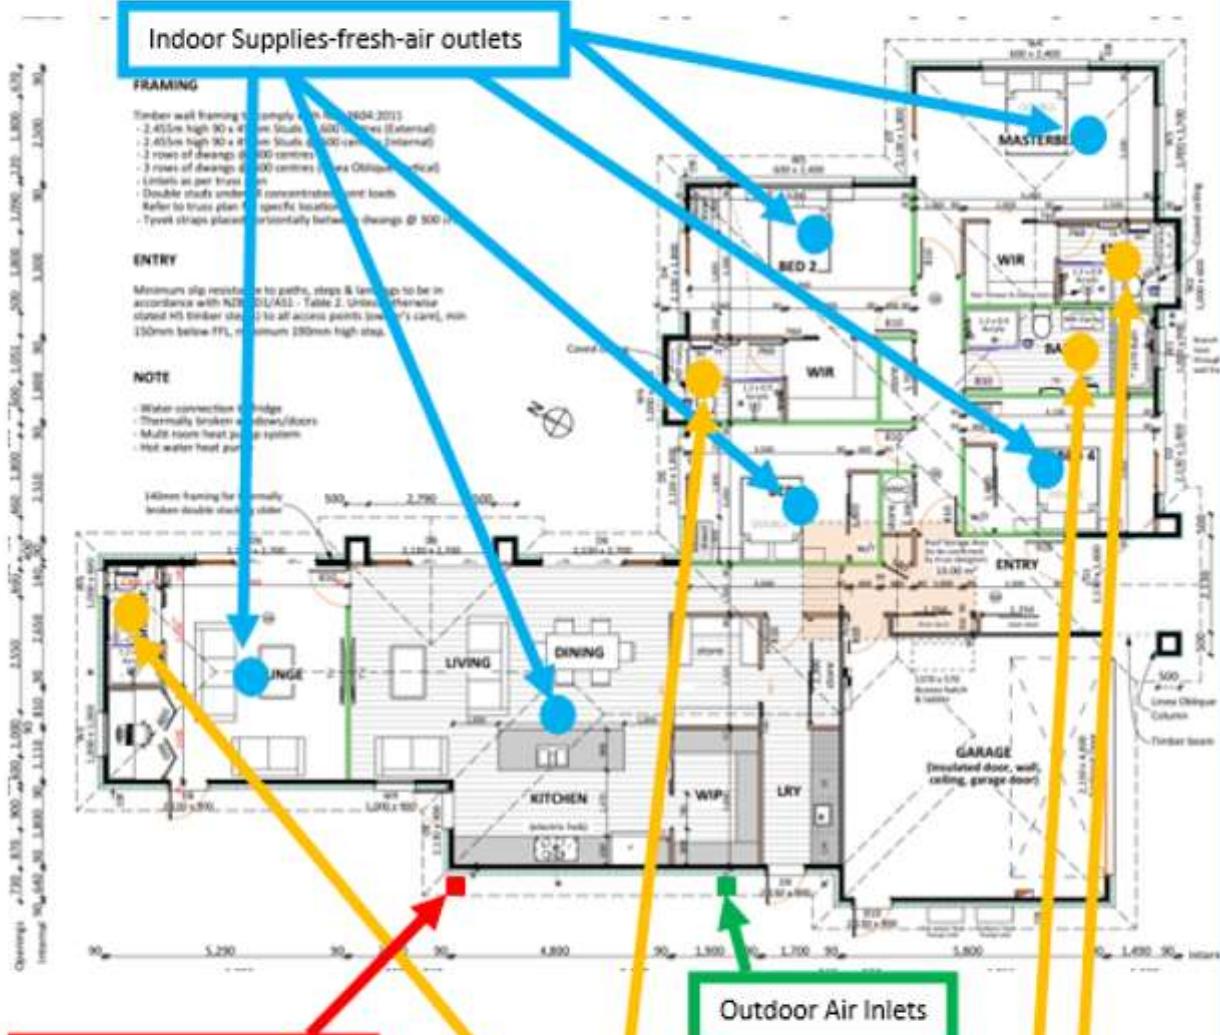
10) Missing Mitsubishi Lossnay Ventilation System (inlets and outlets location plan below for reference)

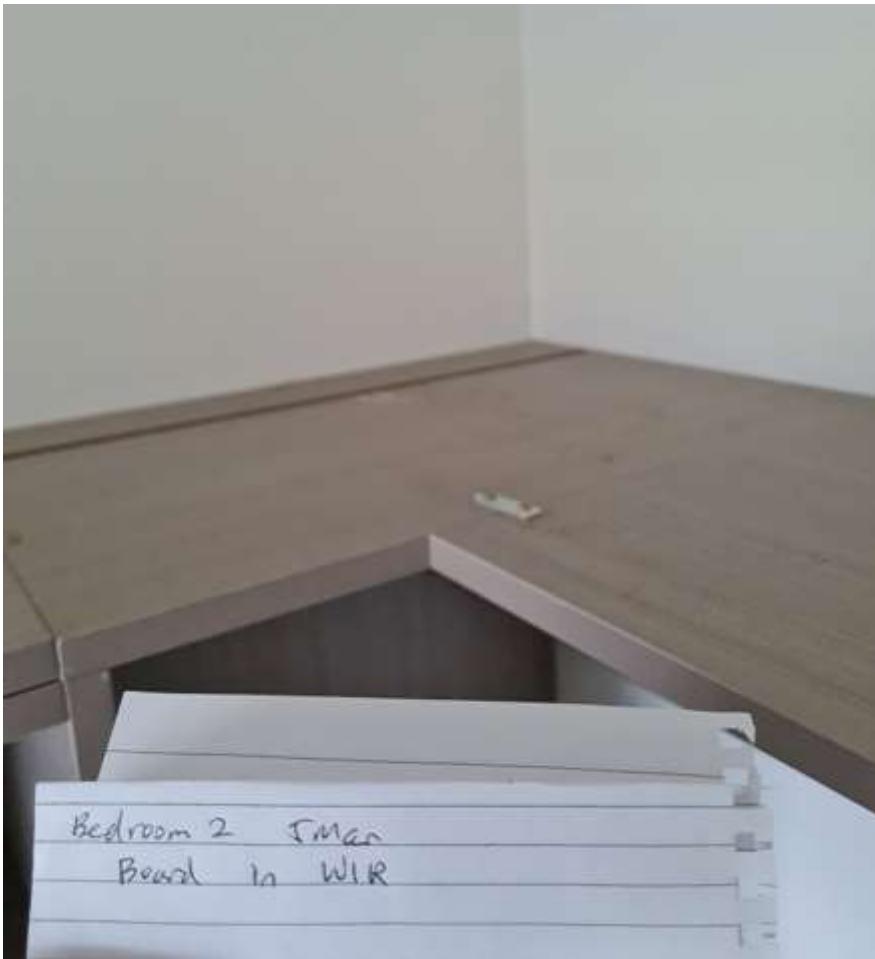
- 11) Replacement of incorrect shelf board on top of wardrobe in the WIR of Bedroom 2 with which your subcontractor has agreed

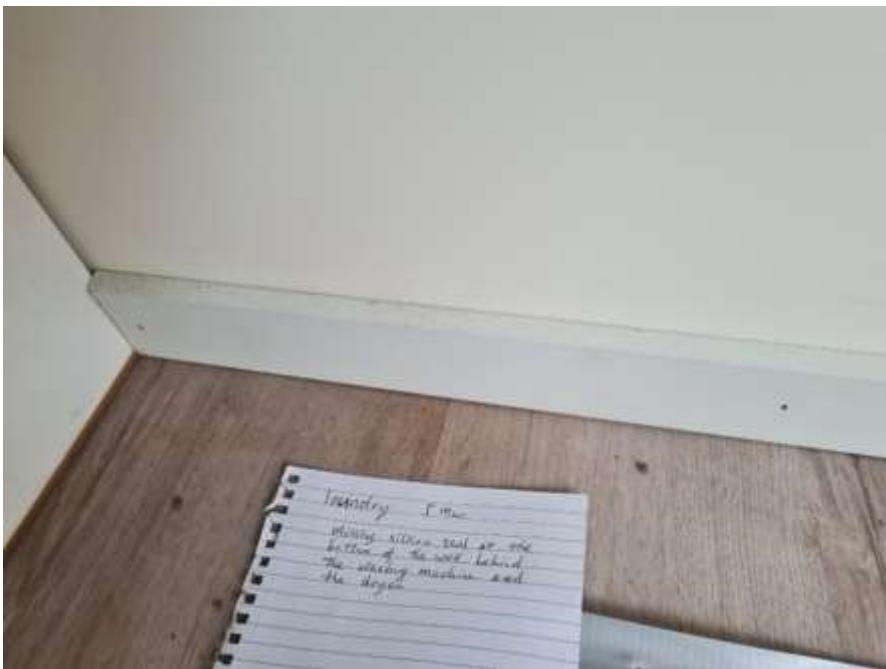
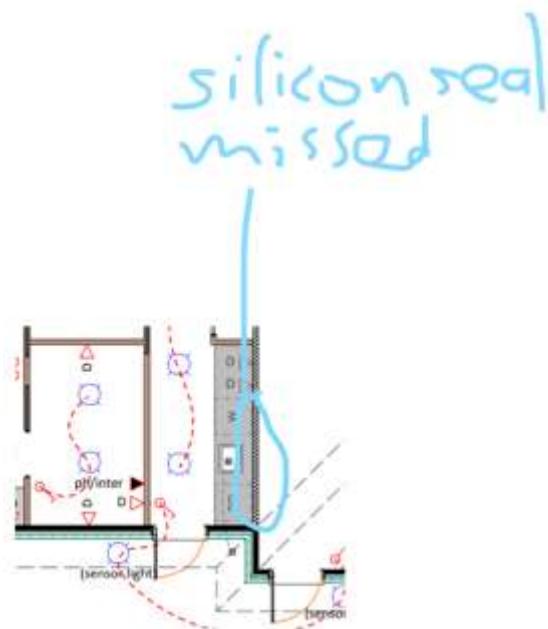
- 12) Silicon seal at the bottom of wall at the back of washing and dryer machine in the laundry is missed

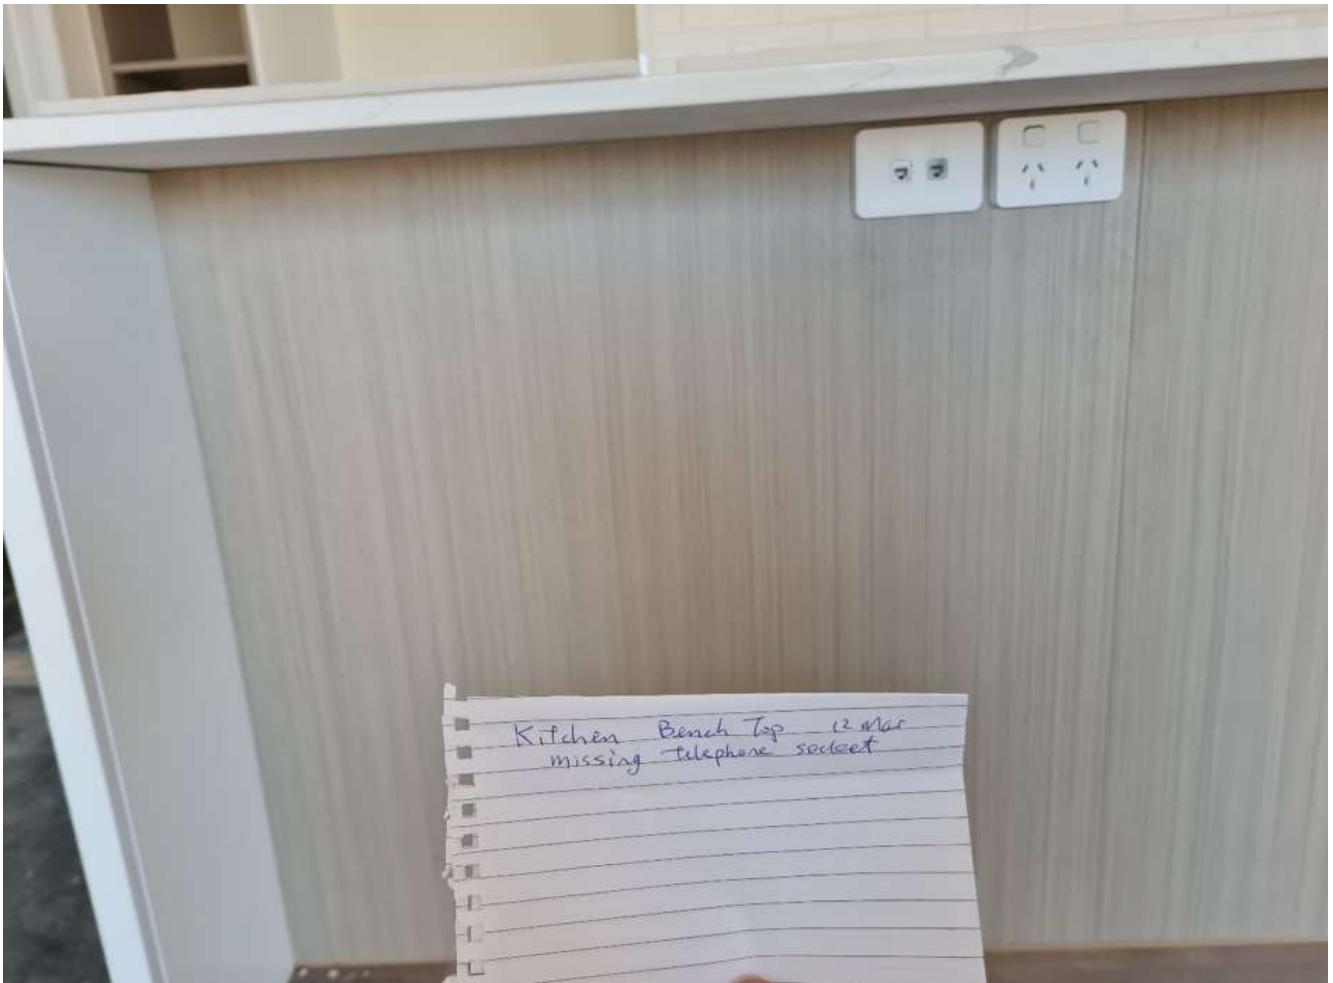
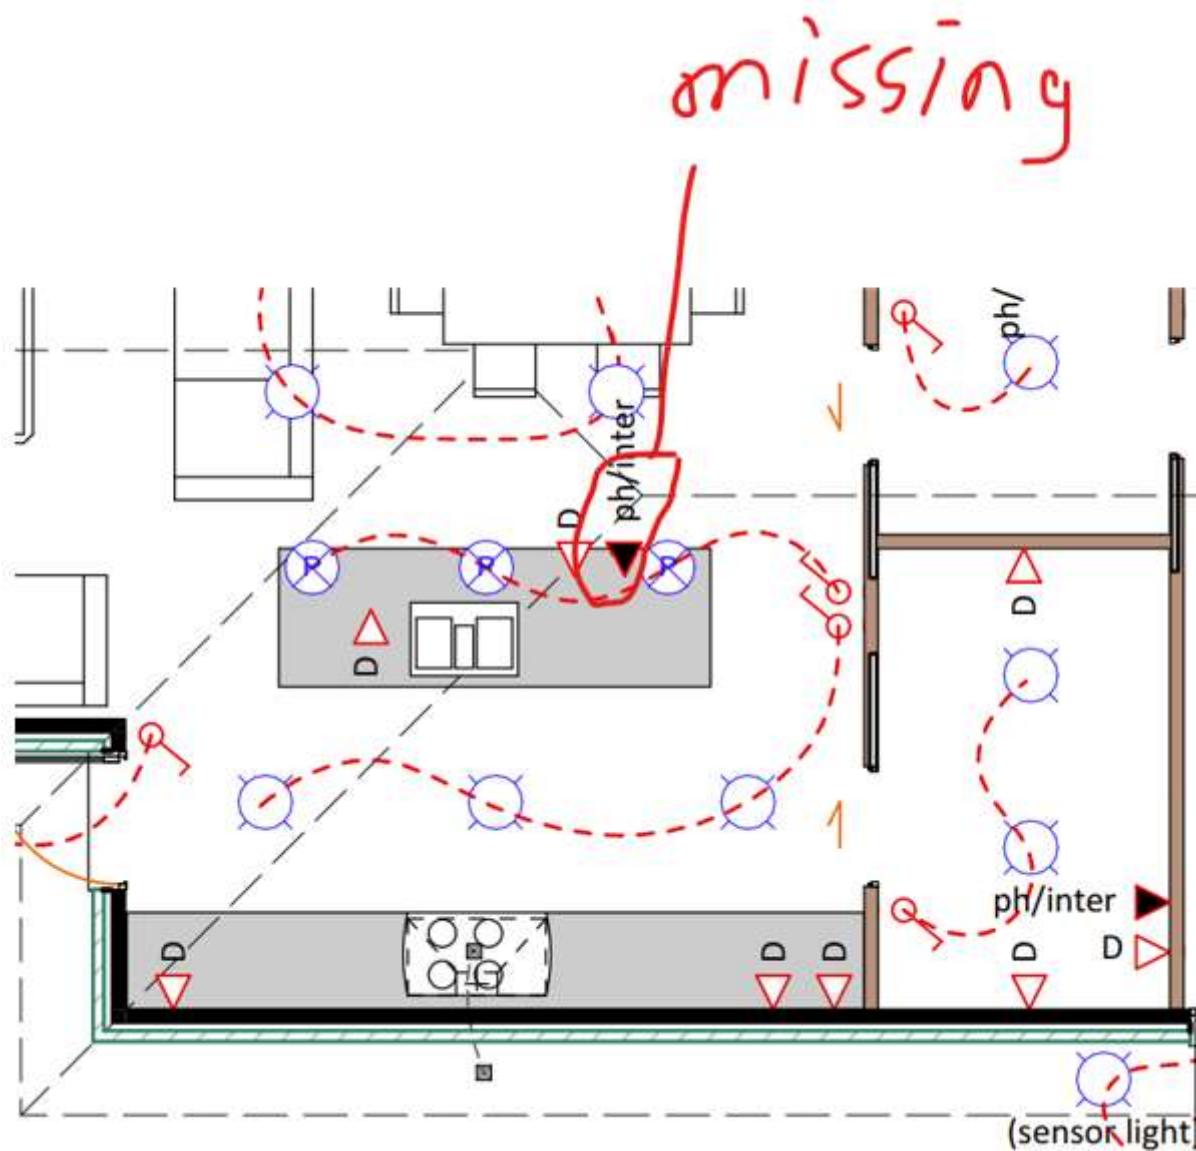
- 13) Missing Phone socket at the back of kitchen bench top

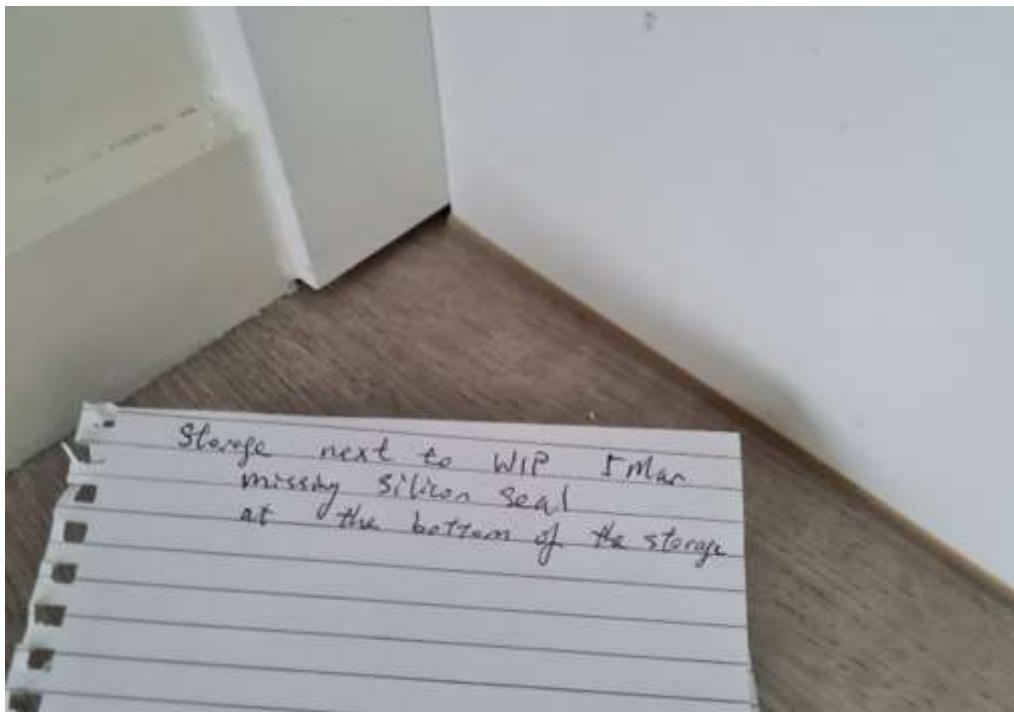
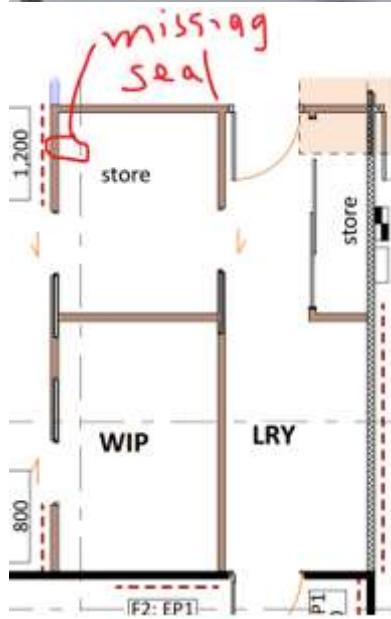
- 17) Missing Silicon seal at the skirt at end of the bench in the storage next to the WIP
