## Fwd: Missing RJ 11 telephone jacks: 12 March: Missed or Concerned Items: Construction of 2 Rapere Street, Rolleston.

Subject: 12 March: Missed or Concerned Items: Construction of 2 Rapere Street, Rolleston.

Subject: Missed or Concerned Items: Construction of 2 Rapere Street, Rolleston.

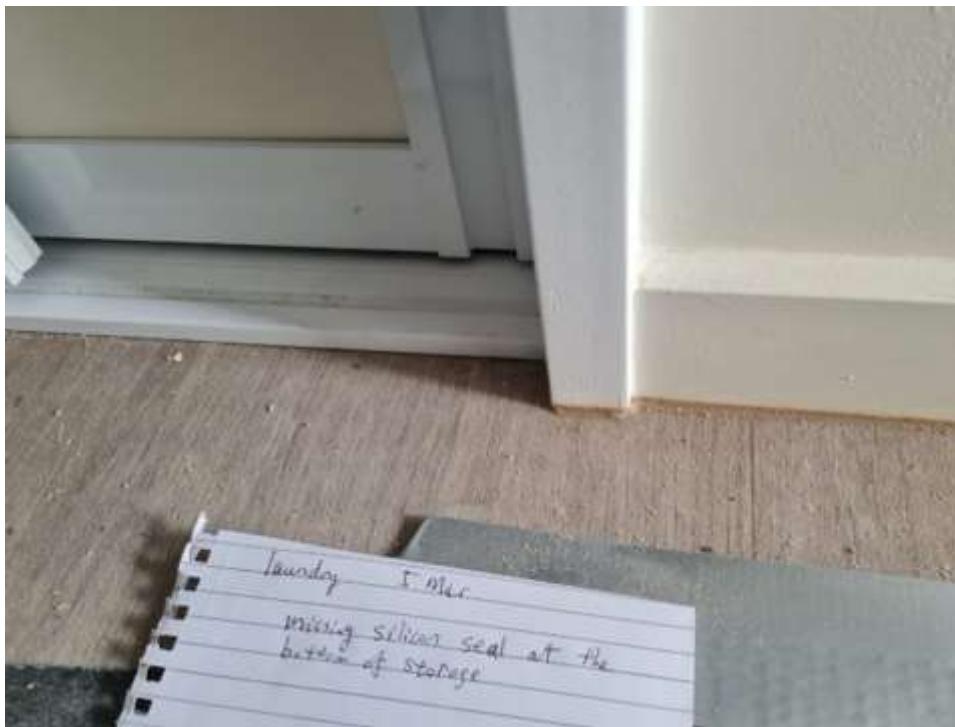
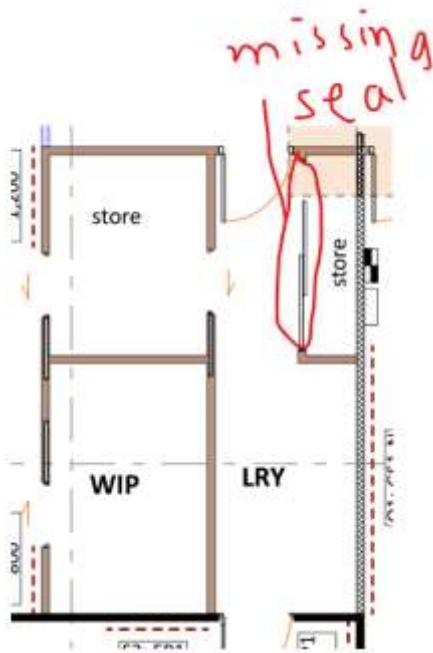
18) Missing Silicon seal under the storage in the laundry

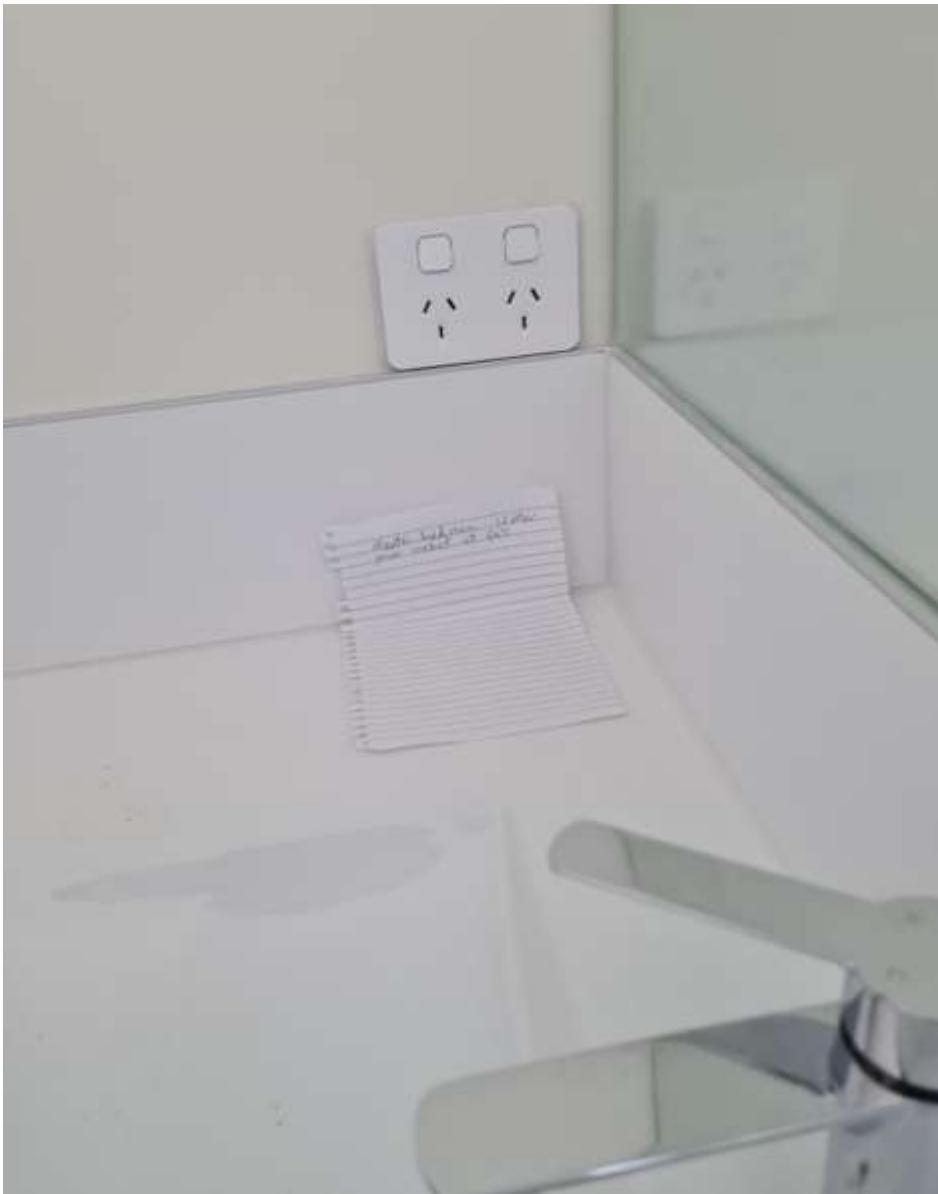
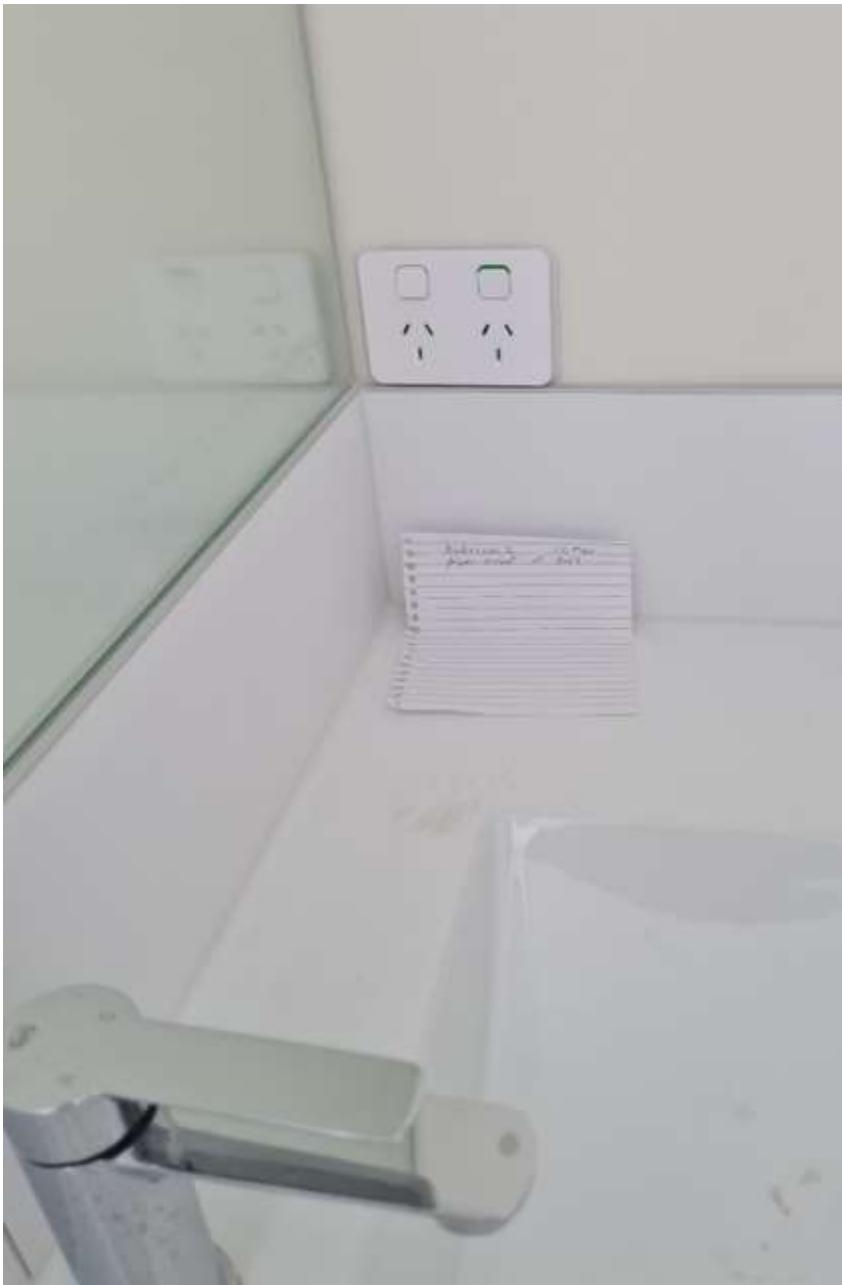
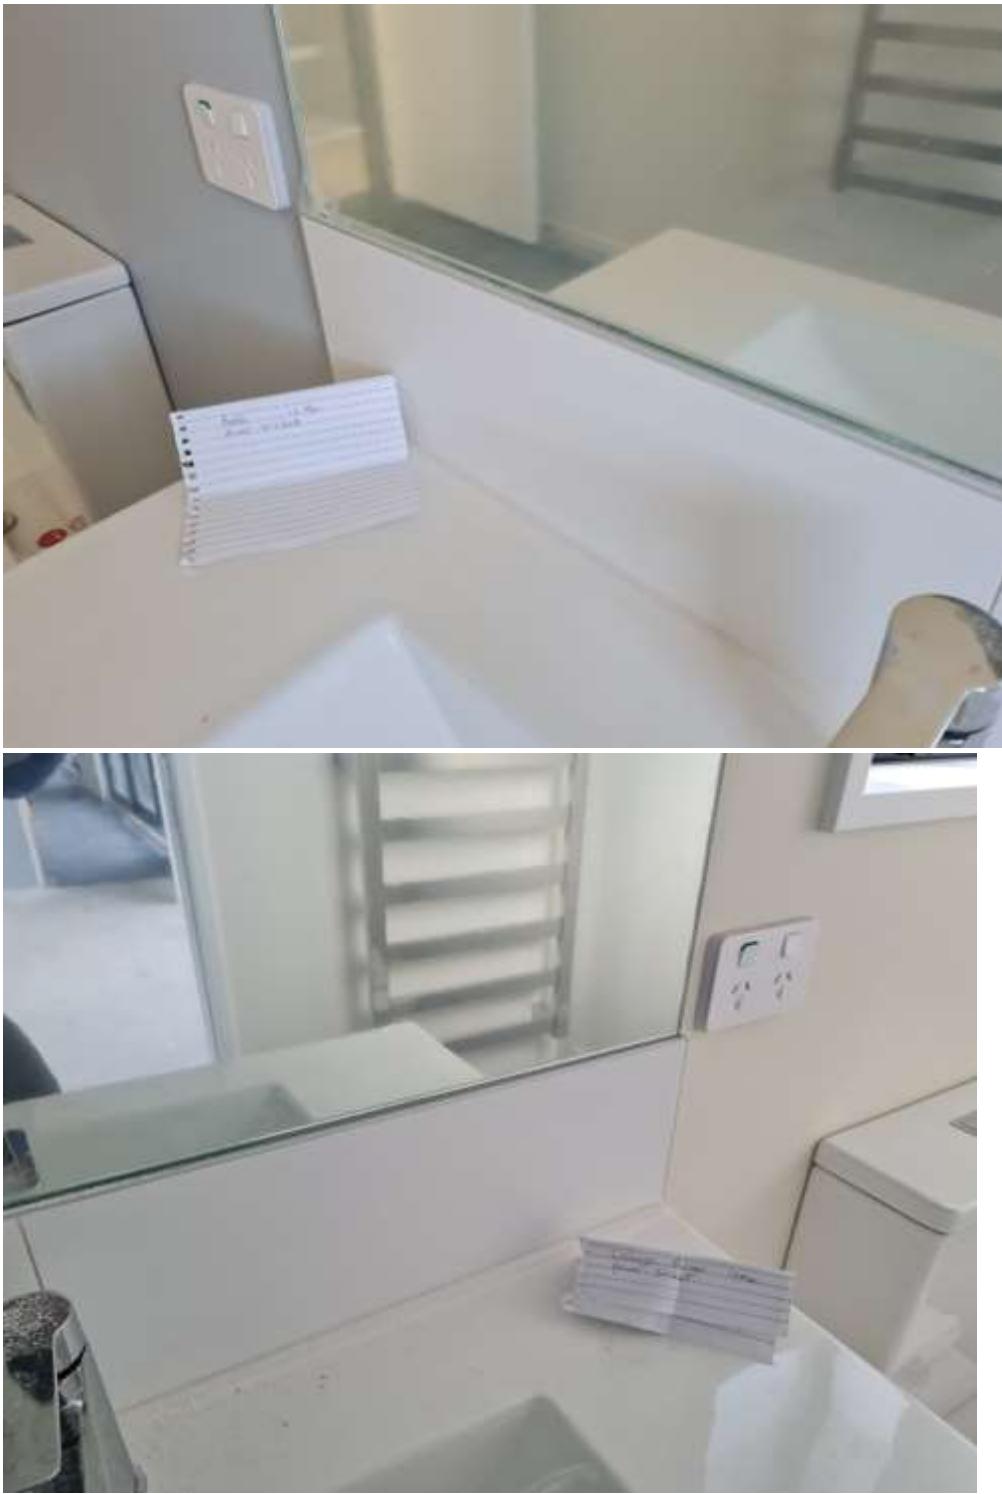
- 19) Do the 4 power sockets below in the Bedroom and shower meet New Zealand Standard?

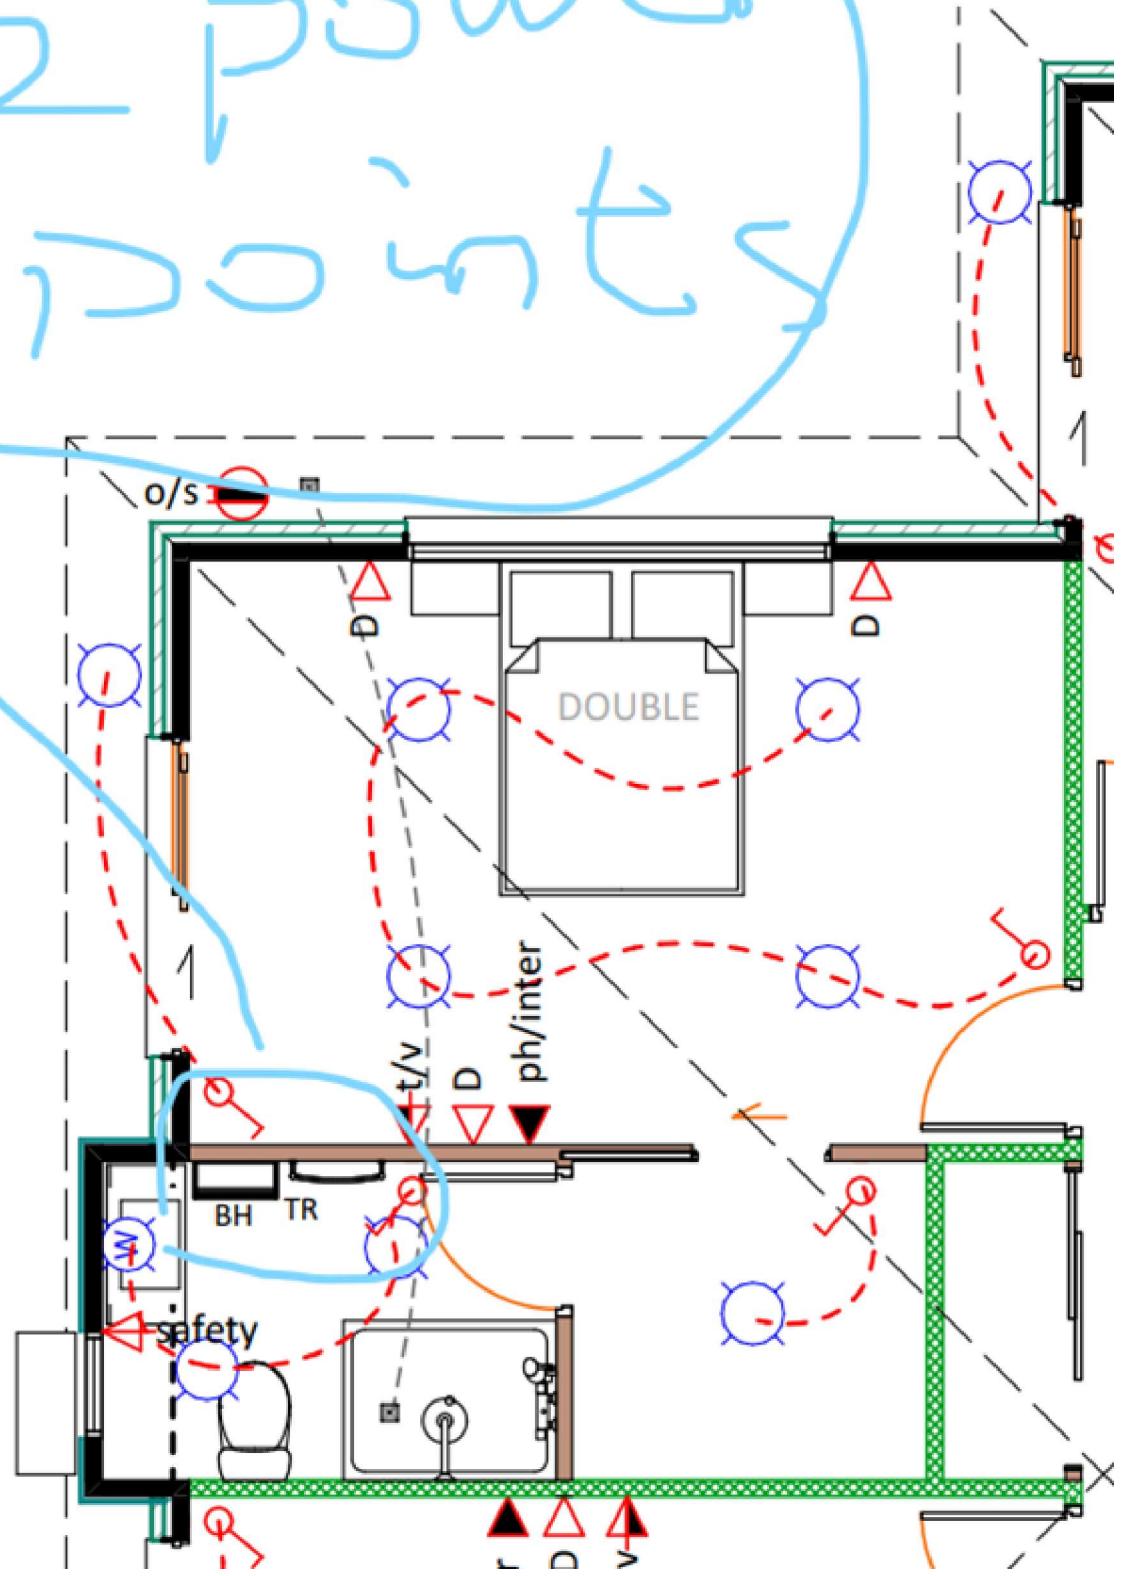
- 6) Power points for heated tower rail and bathroom heater are missed in the ENS of Bedroom 2

missed  
2 power  
points

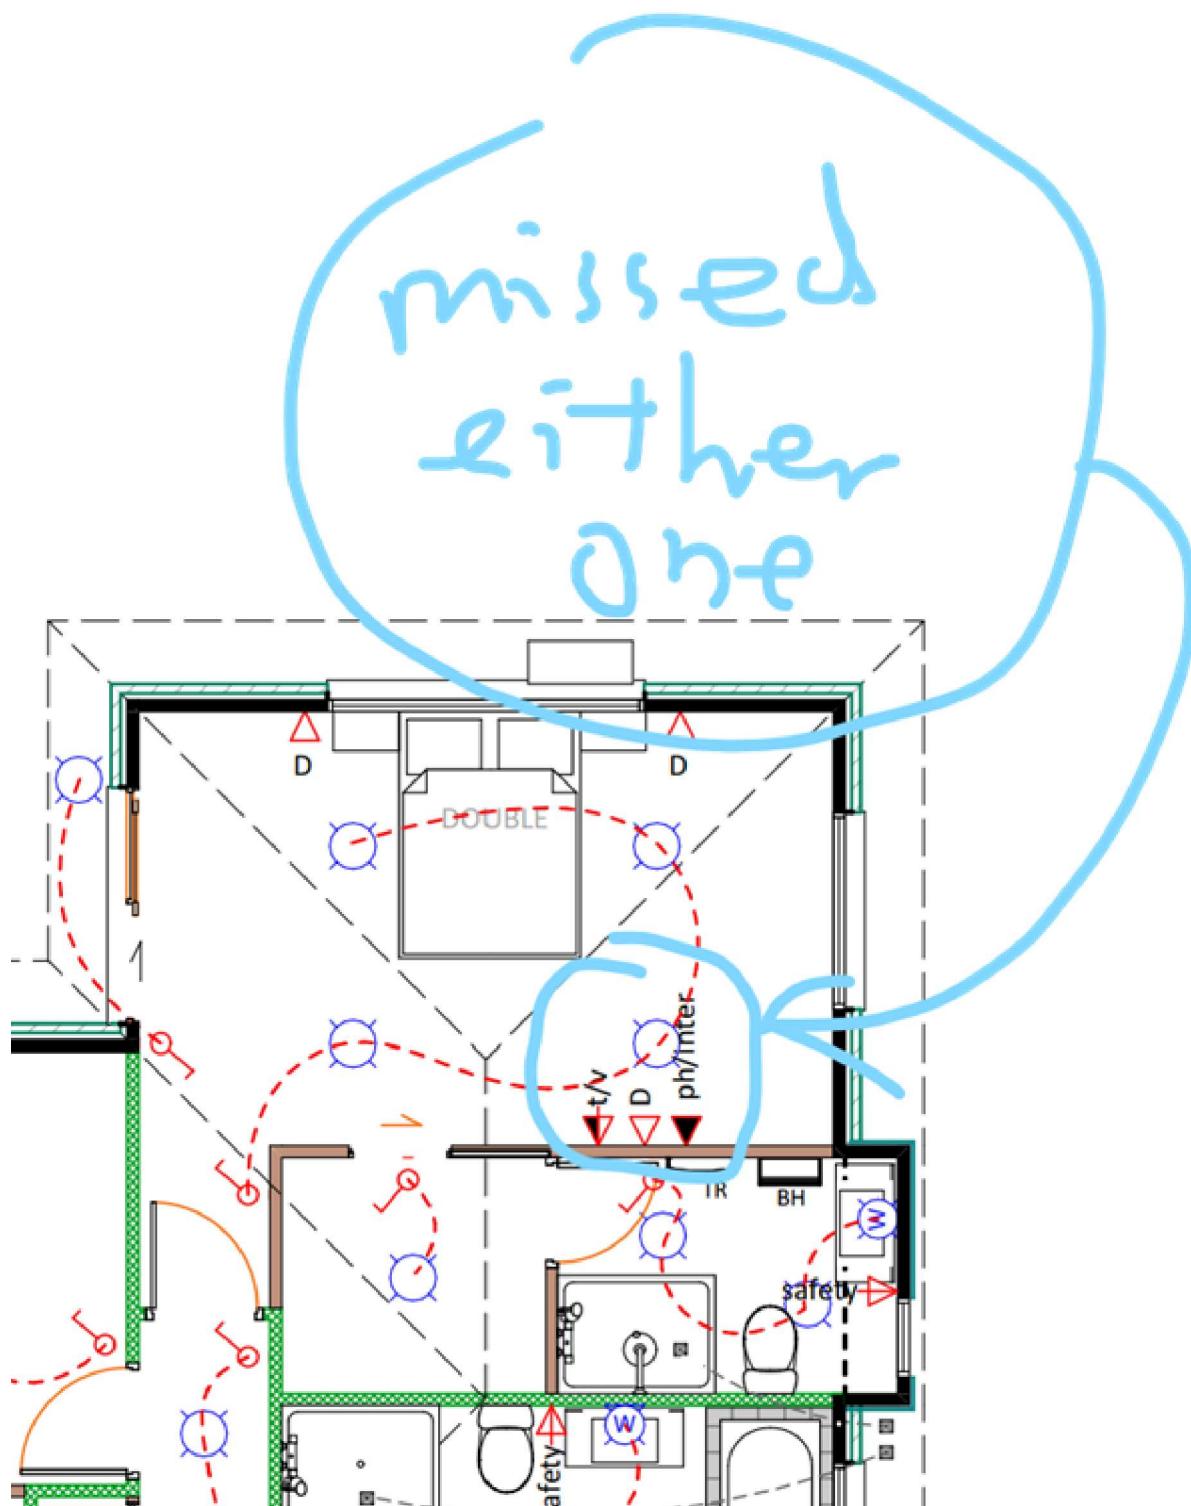
- 7) Either one of the ph/internet, power and TV sockets in Master Bedroom is missed

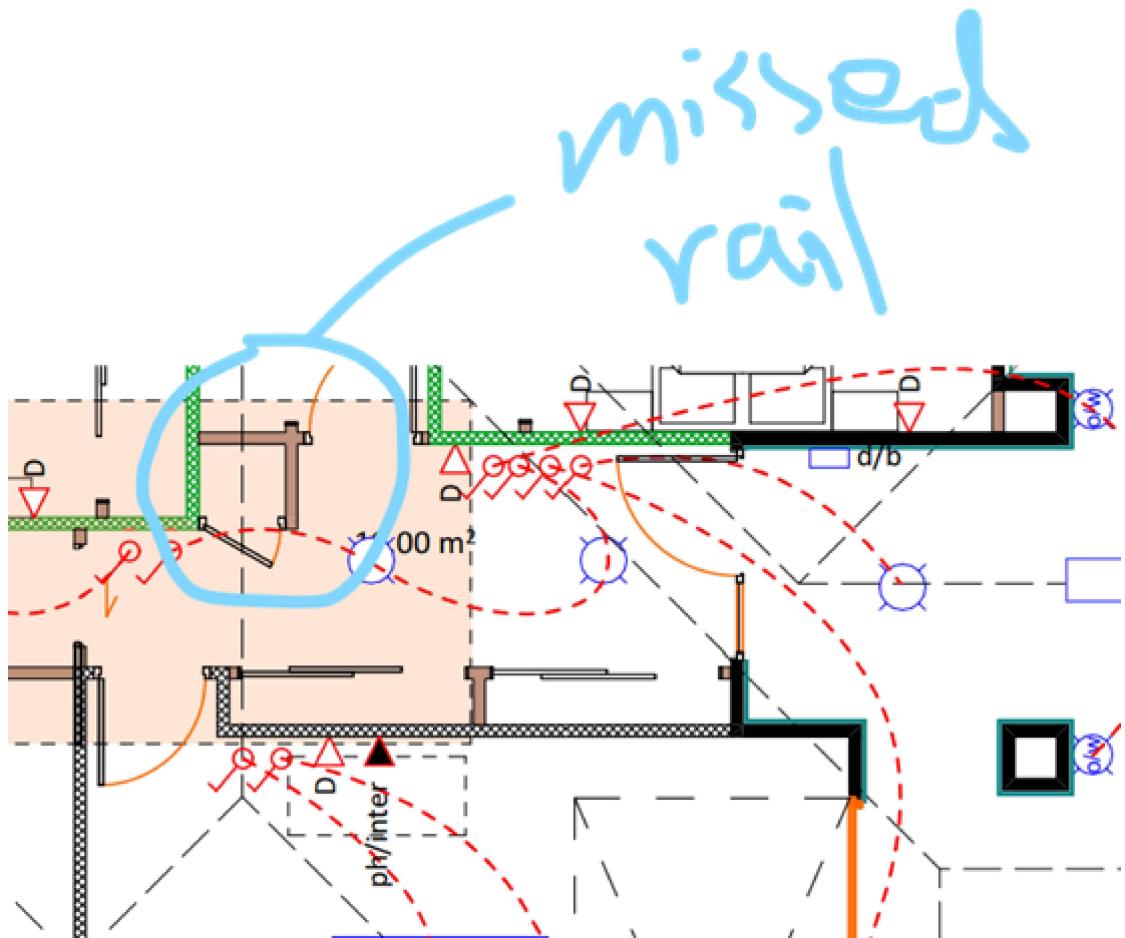
11) Rail for guest hanging clothes inside the small storage near main entrance is missed

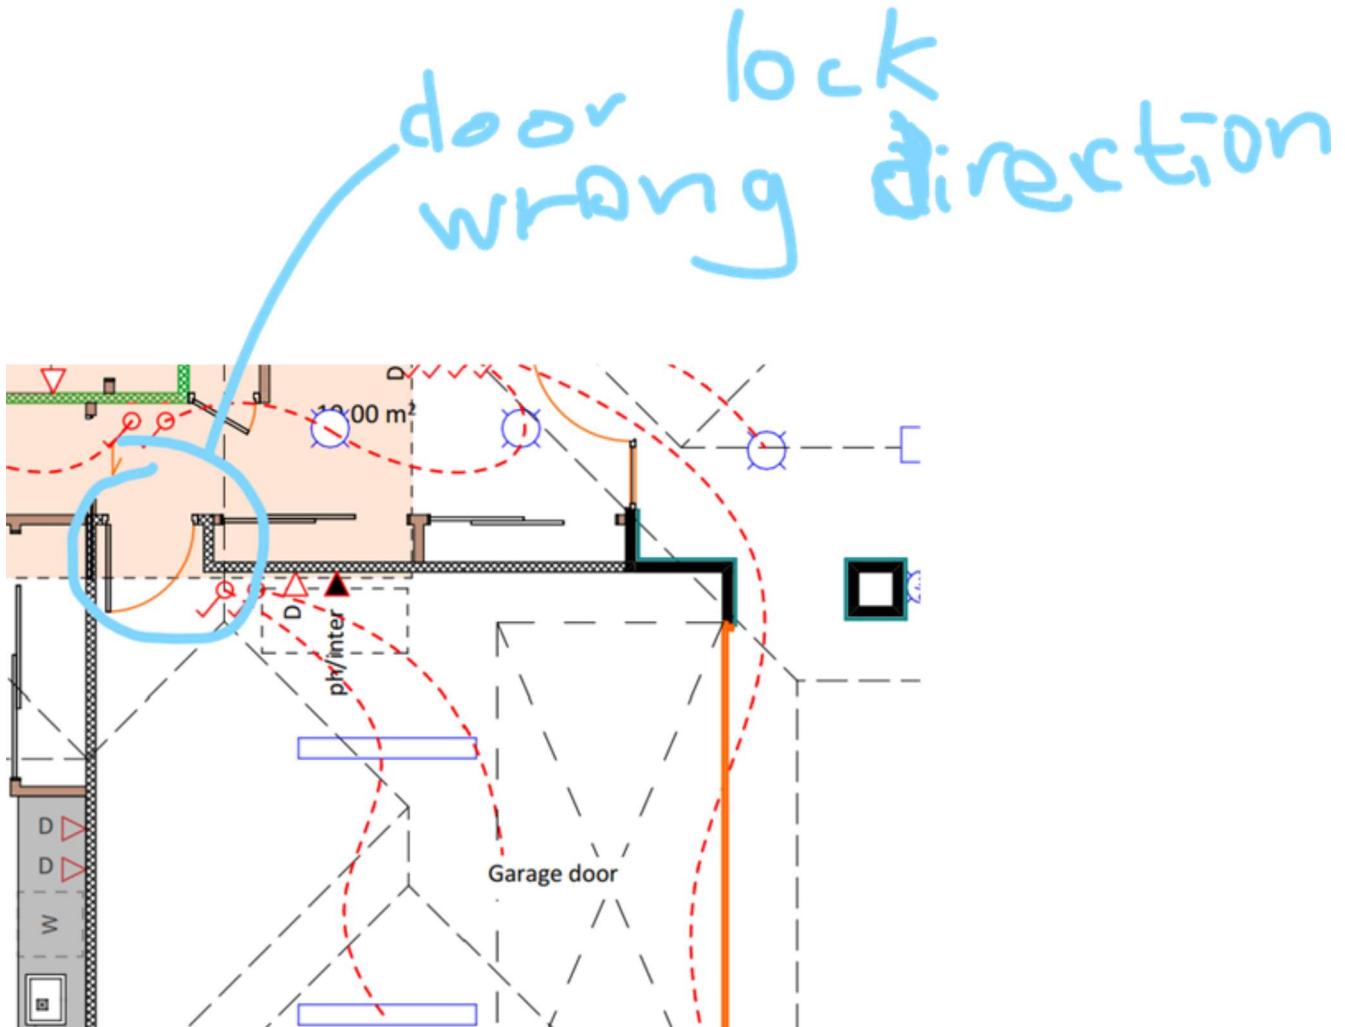
12) Internal door lock for going to garage is installed in a wrong direction

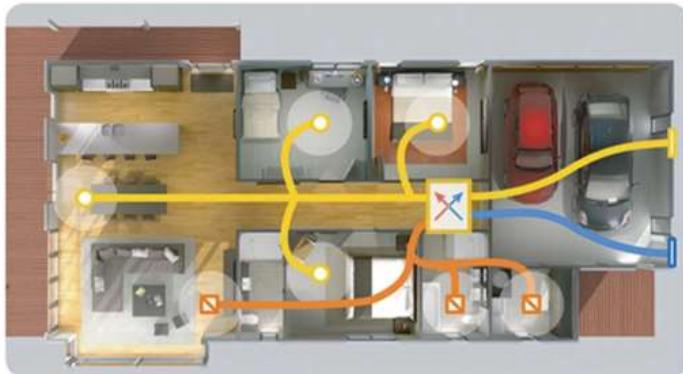
- 13) Heatpump duct and cable blocked ceiling manhole
- 14) Heatpump duct damaged at the ceiling manhole
- 15) Lossnay Ventilation system is missed. It should have at least one air fresh air outlet in each room. See the screenshot below extracted from the Lossnay guide.

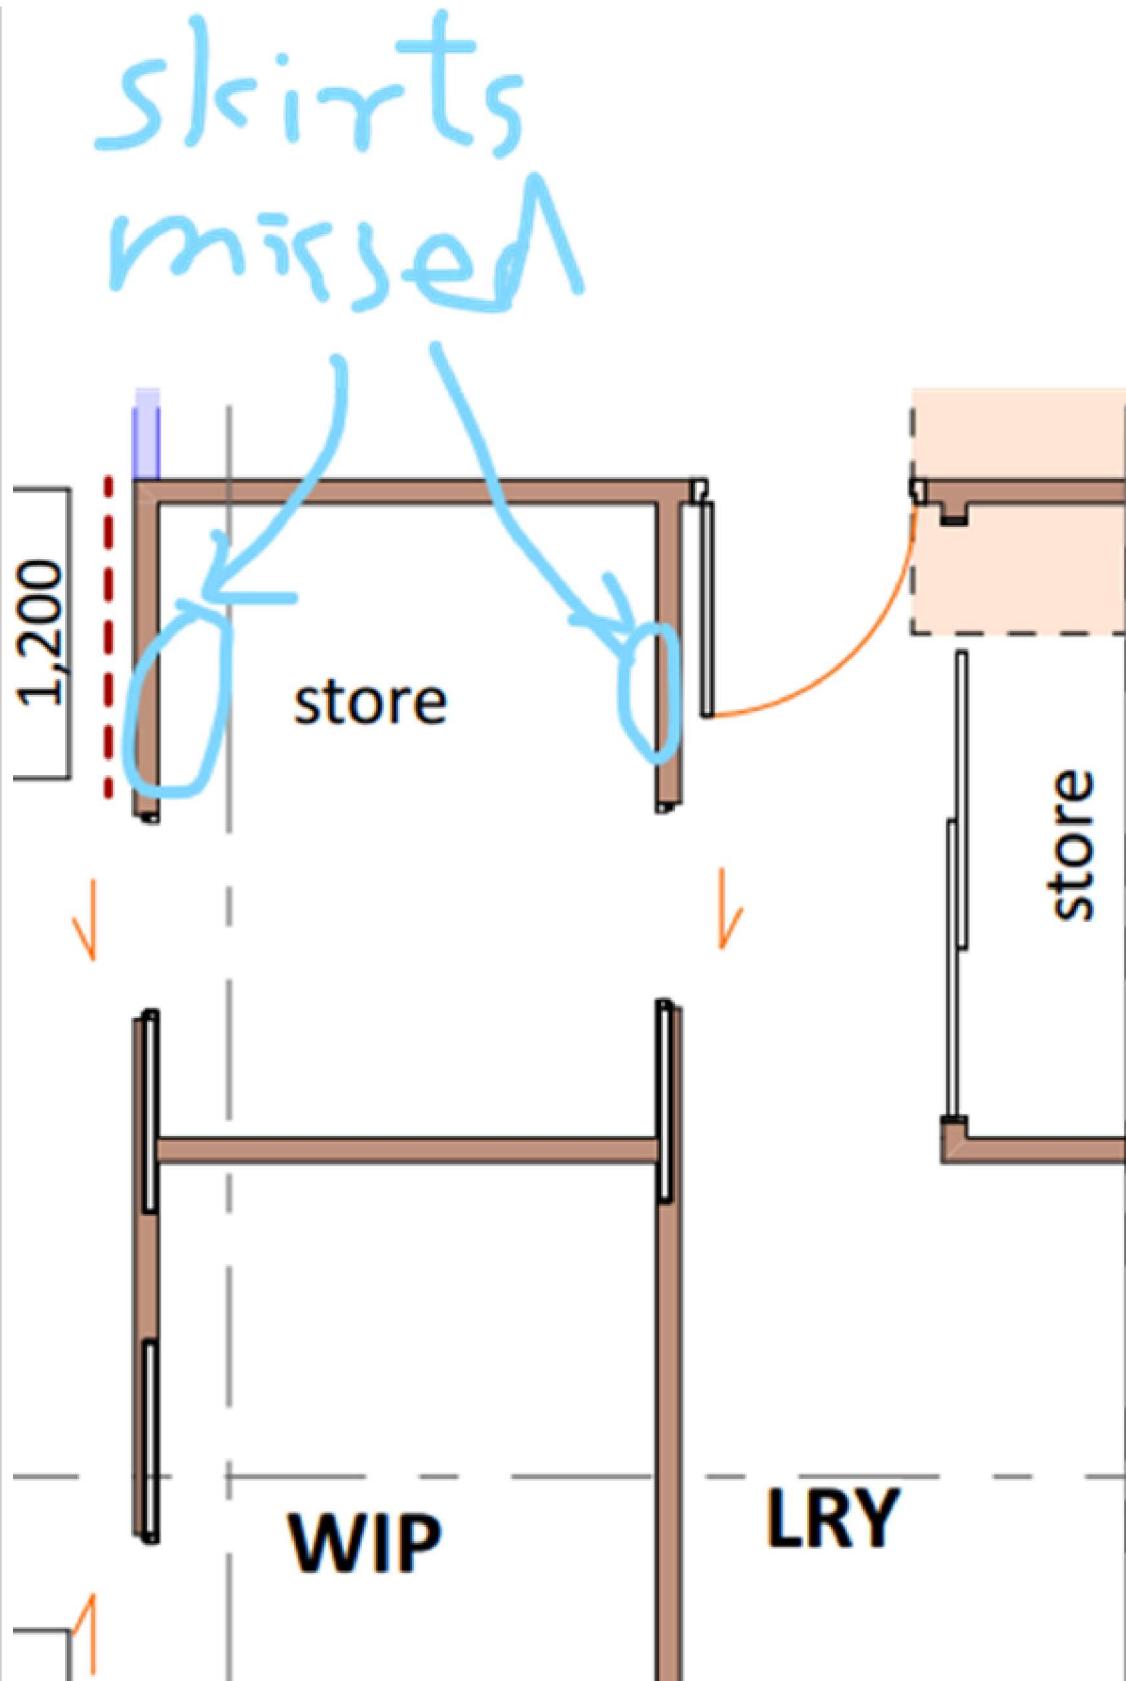
- 22) Skirts next to both end of the bench in the storage next to the WIP are missed

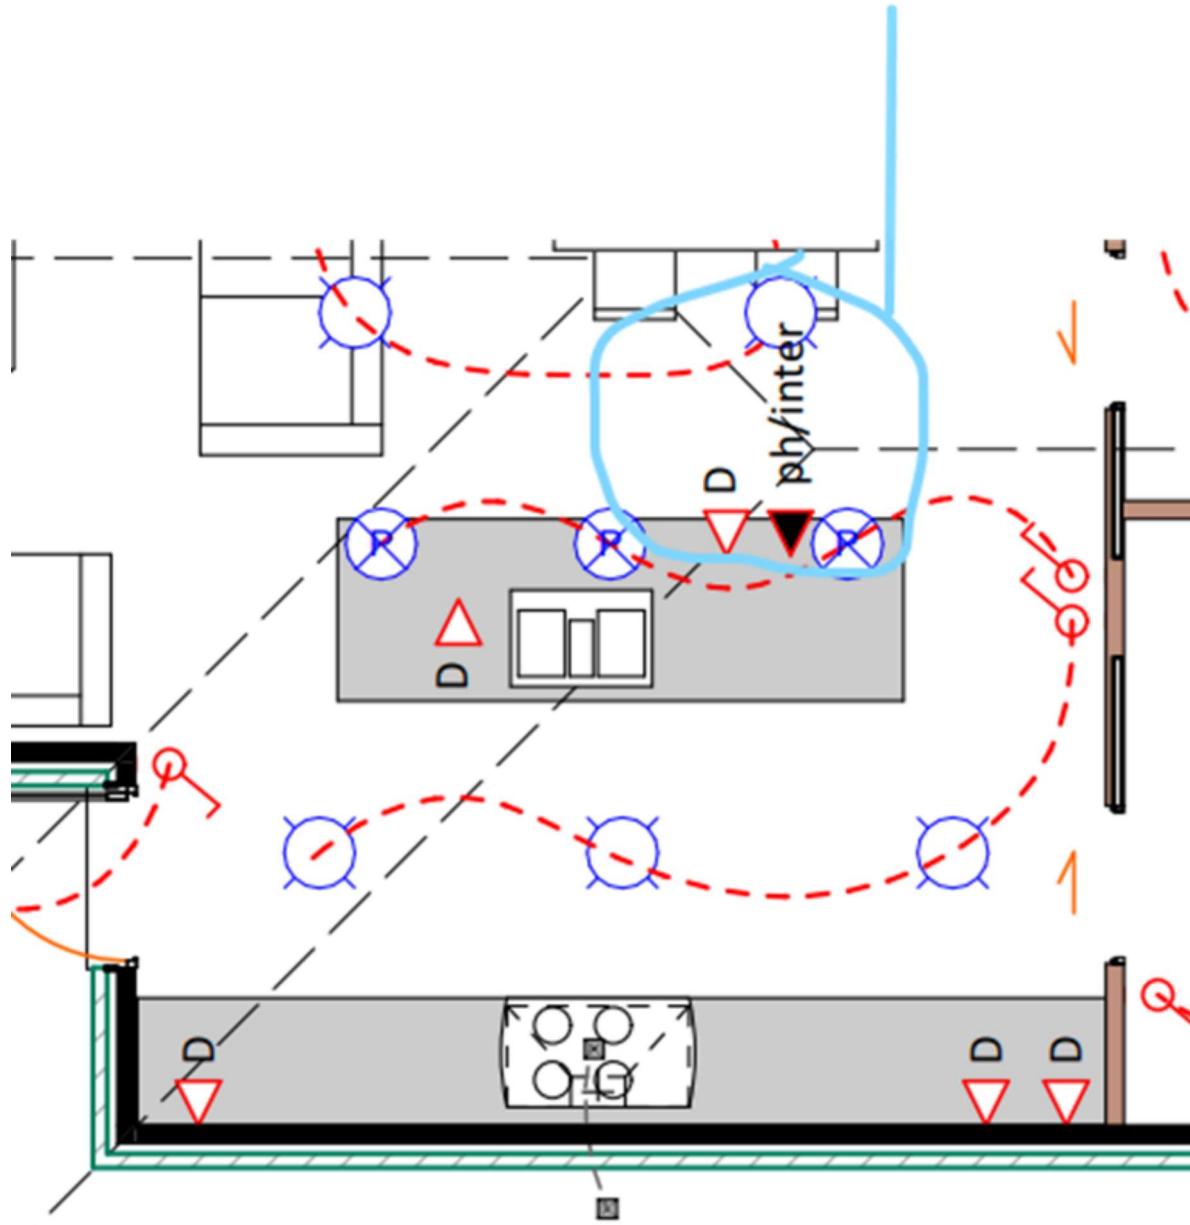
23) Double switch power socket and phone/internet socket at the back of kitchen bench top are missed

missed

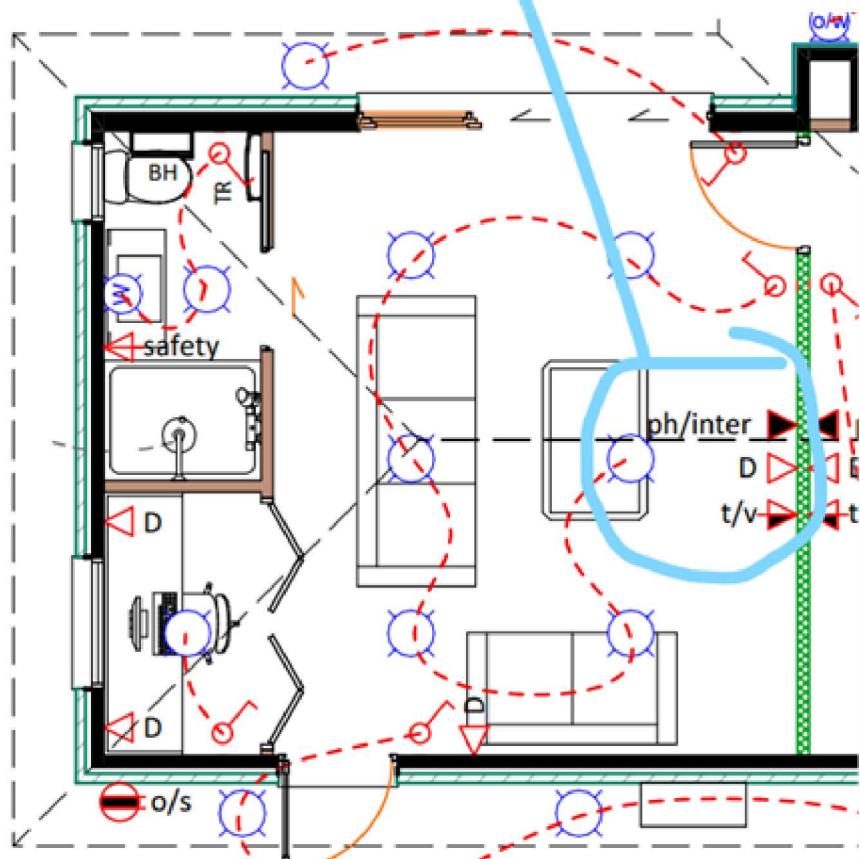
- 26) Either one of the phone/internet, power and TV sockets in Lounge is missed

One of 3 is  
missed

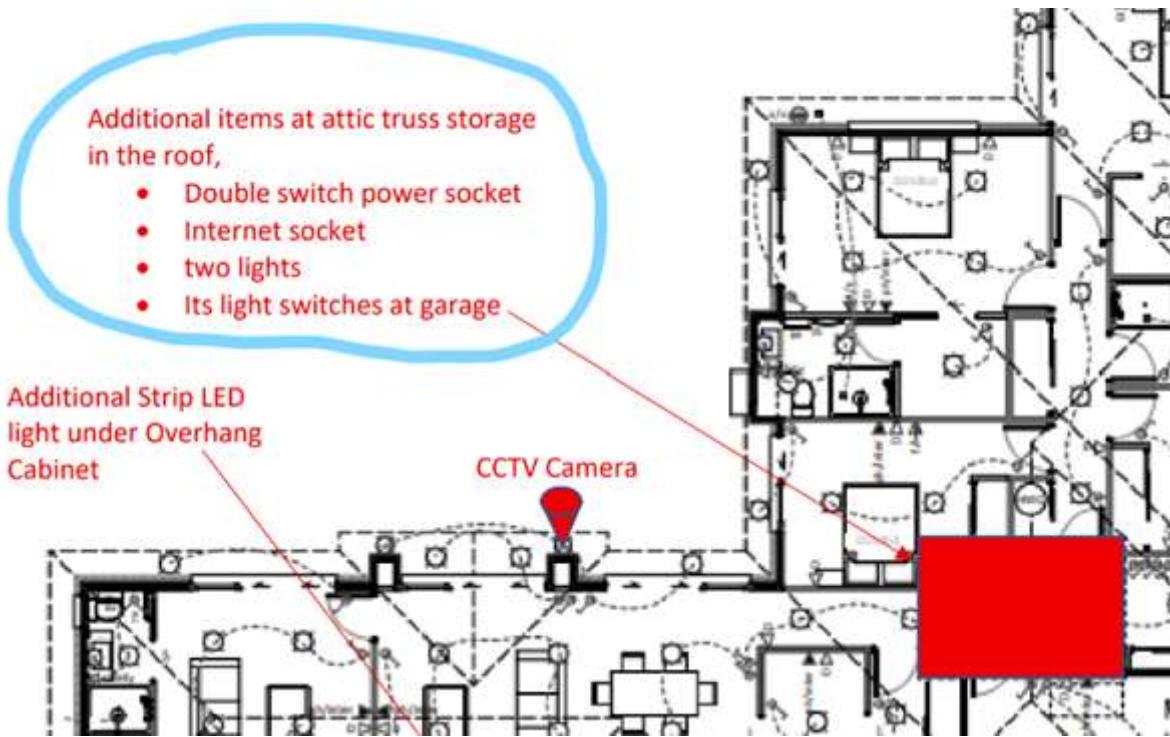
- 27) Have you added the double switch power socket, internet socket, two lights and light switch for the attic truss storage? (see email on Oct 9, 2022, 7:26 PM)

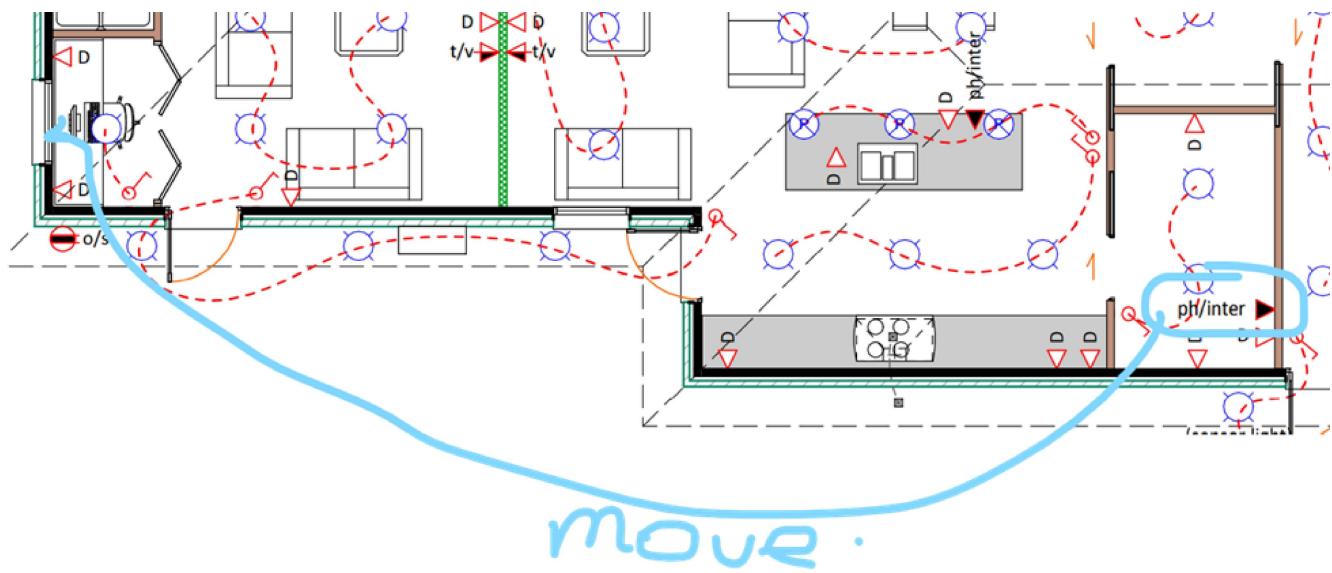
28) Have you move the phone/internet socket from WIP to the study room in the lounge? It was agreed with electrician during the site walk in September 2022.

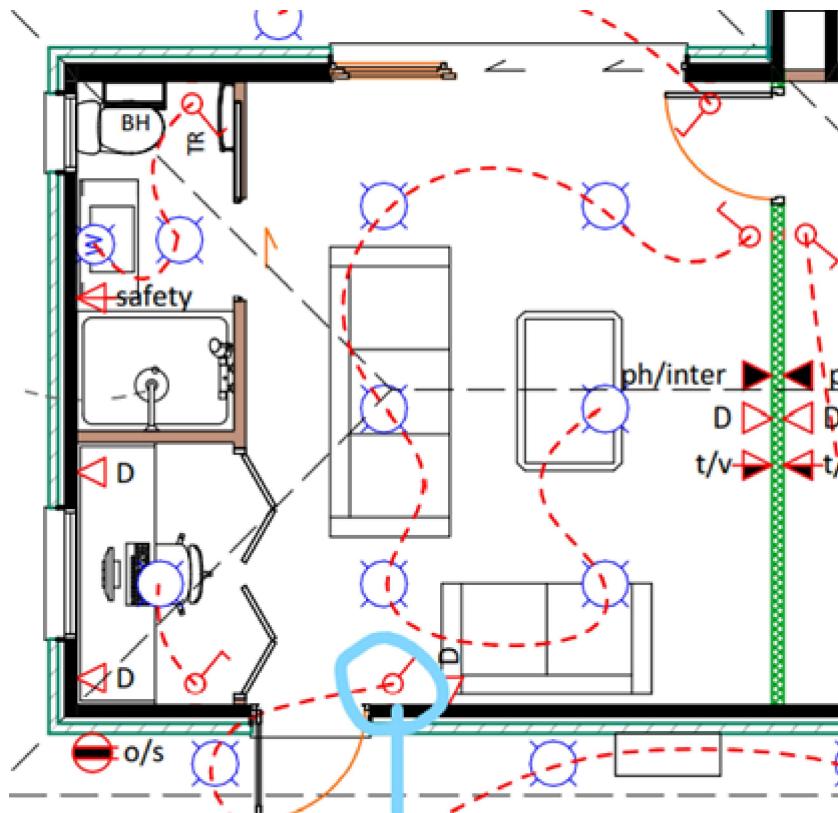
29) Light switch at the back door of the lounge is missed

missed  
switch

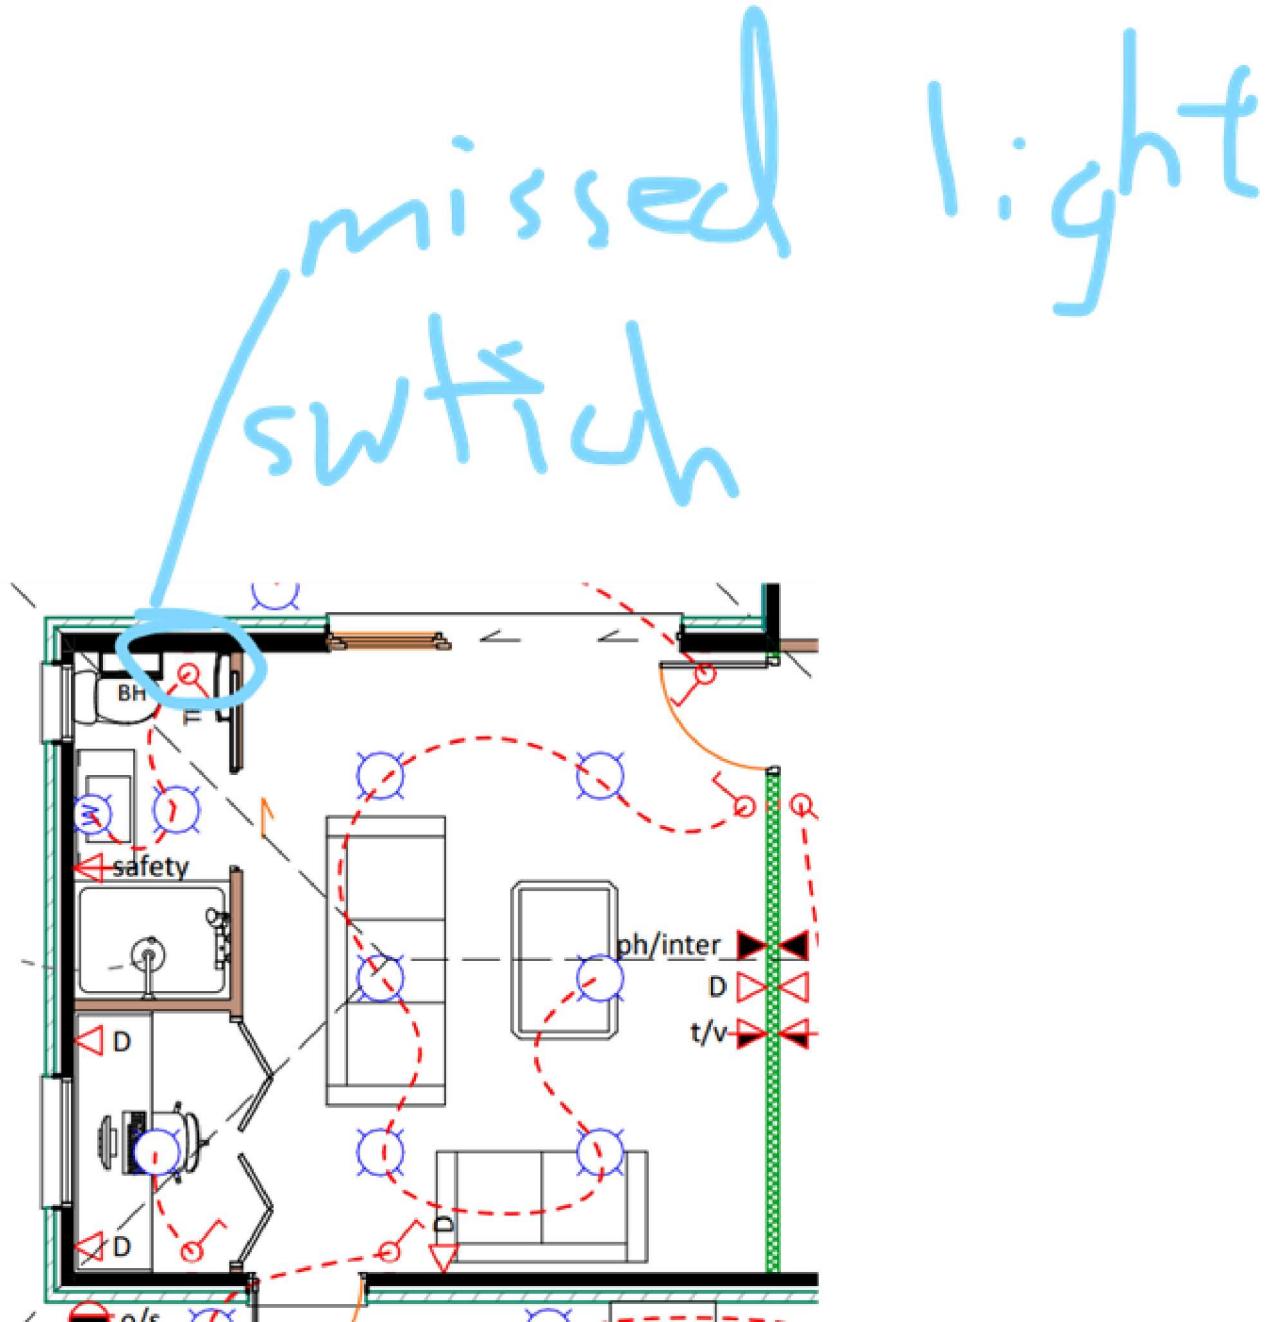
- 30) Light switch at the toilet of lounge is missed
