## Re: Incorrect Thermal broken Aluminum Joinery: 2 Rapare St. Job No.27363 - JSR Construction.

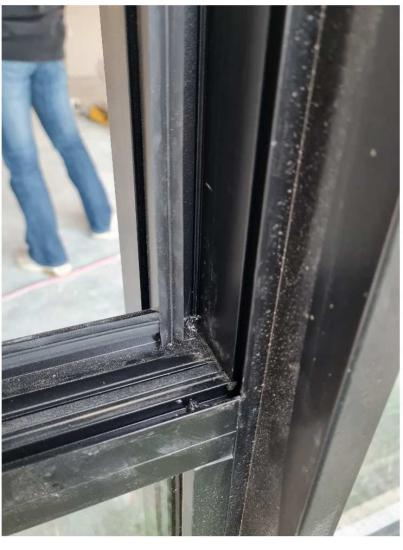
Thank you for your kind help.	
Nga mihi,	
Harry	
Photo 1: Path of thermal conduction at the joint of window transom and sliding-door fixe	ed interlocker and the same photo without marking is given side by side for easy reference

External Window Transom Path of thermal conduction (red line) between internal and external parts of the window transom via the fixed interlocker

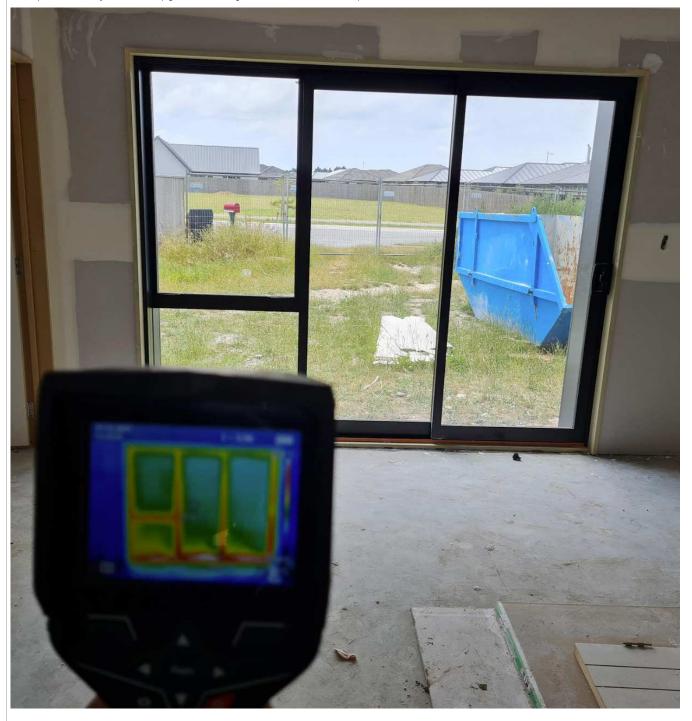
Photo 2: Thermal image of the sliding door and window with the sunshine reaching half the height of the sliding door. It showed that the non-thermally broken components (the joint in between the interlocker and the window transom, and the stile) creating a thermal conduction between the internal and external parts of the thermally-broken members (e.g. bottom of the sliding door frames and the window transom).
