The Town of Hadley requested the Pioneer Valley Planning Commission (PVPC) to conduct a Vulnerable Road User (VRU) Safety study at the intersection of Bay Road (Route 47) and Middle Street (Route 47). The goal of this study is to identify current problems with transportation safety at this intersection with a special focus on multimodal traffic safety. This report details the process of the Vulnerable Road User Safety Assessment (VRUSA) and highlights the key findings of the VRUSA. The following sections provide an overview of the study area, a description of existing conditions around the study area, and a series of recommendations to improve safety for all roadway users.

## Study Area

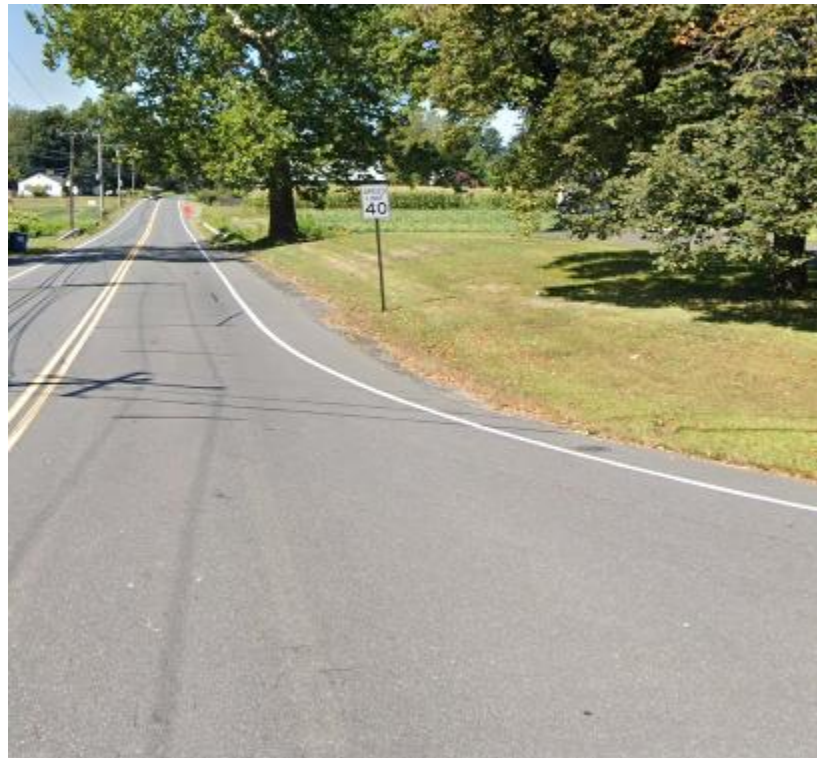
**Figure 2: Speed Limit Sign Along Westbound Bay Road in the Vicinity of the Intersection**

(Speed Limit increases from 30 mph to 40 mph further along the road)

*Existing 40 mph Speed Limit Sign:* This Speed Limit Sign which is intended for westbound traffic along Bay Road is located less than 75 feet west of the intersection. This sign is most likely placed in advance of the actual speed limit change along the corridor and potentially encourages drivers to increase their speed while travelling through this intersection. It is recommended the Town of Hadley investigate the proper location for this sign. If in fact the sign has been placed incorrectly, the sign should be removed and installed at the proper location.

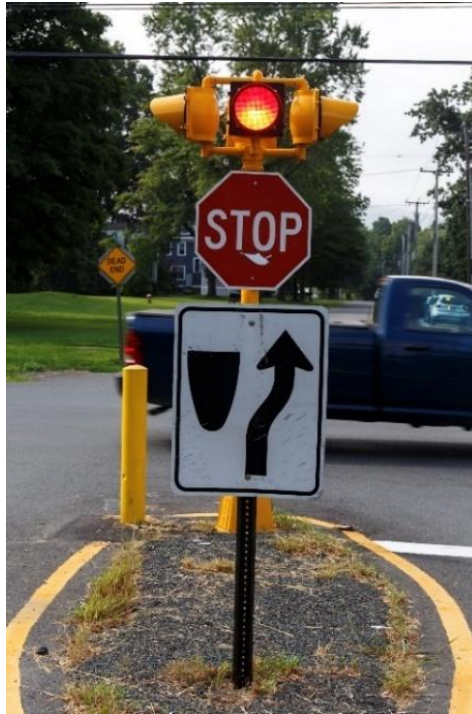
**Figure 3: Pole Mounted Flashing Beacon in the North of the Intersection**

A pole mounted flashing warning beacon signal with a low height Stop Sign is located along the southbound approach of Middle Street. North of the intersection, a flashing red light is displayed for the Middle Street approaches and a flashing yellow light for both approaches of Bay Road. This pole is located in a textured median which appears to have been raised in the past but is almost at the same height as the pavement on Middle Street. This pole is one of the major concerns and safety hazards at this location and has been hit several times in the past by heavy vehicles and farm equipment during single vehicle crashes.

The pole mounted Intersection Control Beacon or Warning Beacon located along the median at the southbound approach of Middle Street has been damaged by multiple collisions in the past. This beacon or the bollard protecting the beacon is offset from the actual intersection; however, it is still in the path of some of the heavy vehicles which require larger turning radii. It is recommended that in long term the Town of Hadley considers installing this beacon overhead above the intersection along a span wire or a mast arm. This will require an engineering study and removal of the post mounted beacon on the median.

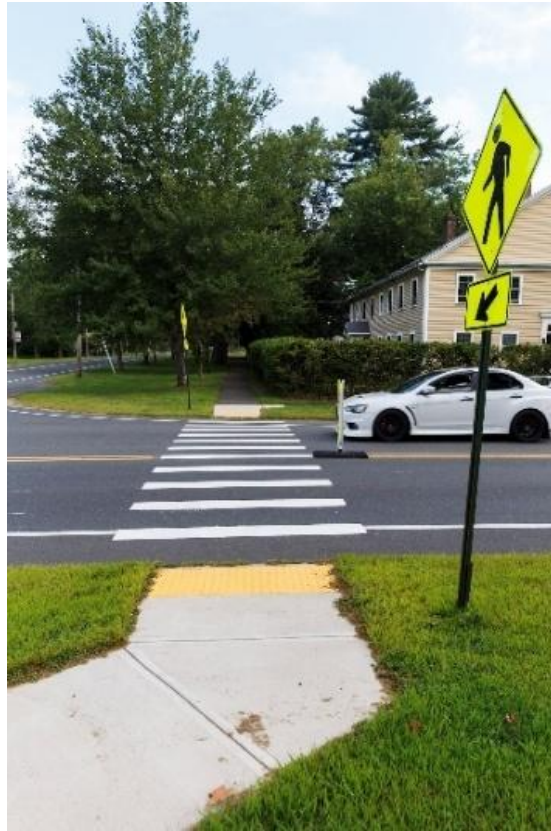
**Figure 4: Crosswalk Across Bay Road**

The intersection of Bay Road and Middle Street is an unsignalized intersection located in the southern area of the Town of Hadley and there is mixed residential and agricultural development in the vicinity of the two intersecting roadways. Hopkins Academy (Town's Middle School and High School) is located in the north of the intersection along Middle Street. Both approaches of Middle Street are controlled by Stop signs while Bay Road has unrestricted traffic flow. A crosswalk is located across the westbound approach of Bay Road.

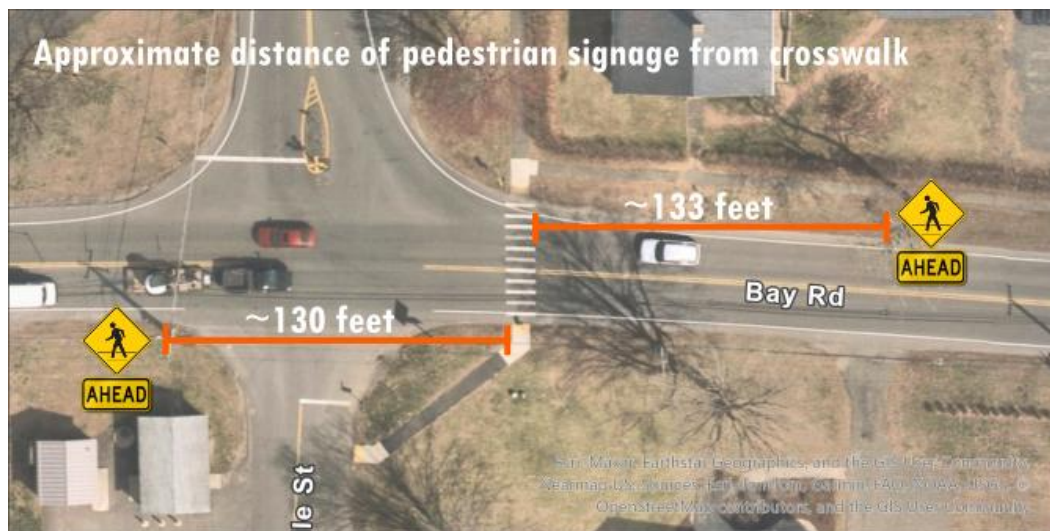
**Figure 15: Distance of Crosswalk Ahead Advance Warning Signs from the Crosswalk**

*Crosswalk Ahead / Pedestrian Crossing Advance Warning Signs:* The current Crosswalk Ahead Warning Signs along Bay Road for eastbound and westbound approaches are located at an approximately 130 ft distance from the existing crosswalk (Figure 15). This distance is not adequate for vehicles travelling above 30 mph.

This intersection has a single travel lane along each approach and the 85<sup>th</sup> Percentile speeds along Bay Road are approximately 40 mph for both directions. Therefore, based on Condition B: Deceleration to the listed advisory speed in the above table, it is recommended that

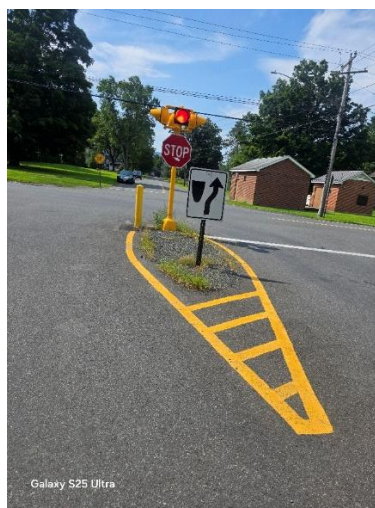
**Figure 16: Existing Median along Middle Street North of the Intersection**

The median on the Middle Street southbound approach lacks vertical deflection features or protective measures due to the absence of curbing and the raised pavement surface resulting from repeated repaving. Vegetative growth was observed along the median during the field visit. This median provides refuge for the pole that supports the supplemental midblock STOP sign and Flashing Beacon. It is recommended that this median be repaired, and proper curbing installed along the edges to provide vertical deflection and protection from turning vehicles.

MassDOT informed the PVPC that the flashing beacon along the median was hit but the overhang of the trucks turning left, therefore curbing may not be completely effective in reducing the risk. Additionally, painting lane line along the intersection to guide turning vehicles was recommended as a measure to reduce possibility of such crashes with large trucks with overhang trailers.
