# HEALTH CHECK

Report generated by Munin Diagnostics · 27 September 2026

**LAND ROVER FREELANDER 2**

**Registration** KB 35350 · **VIN** SALFA28B17H007407

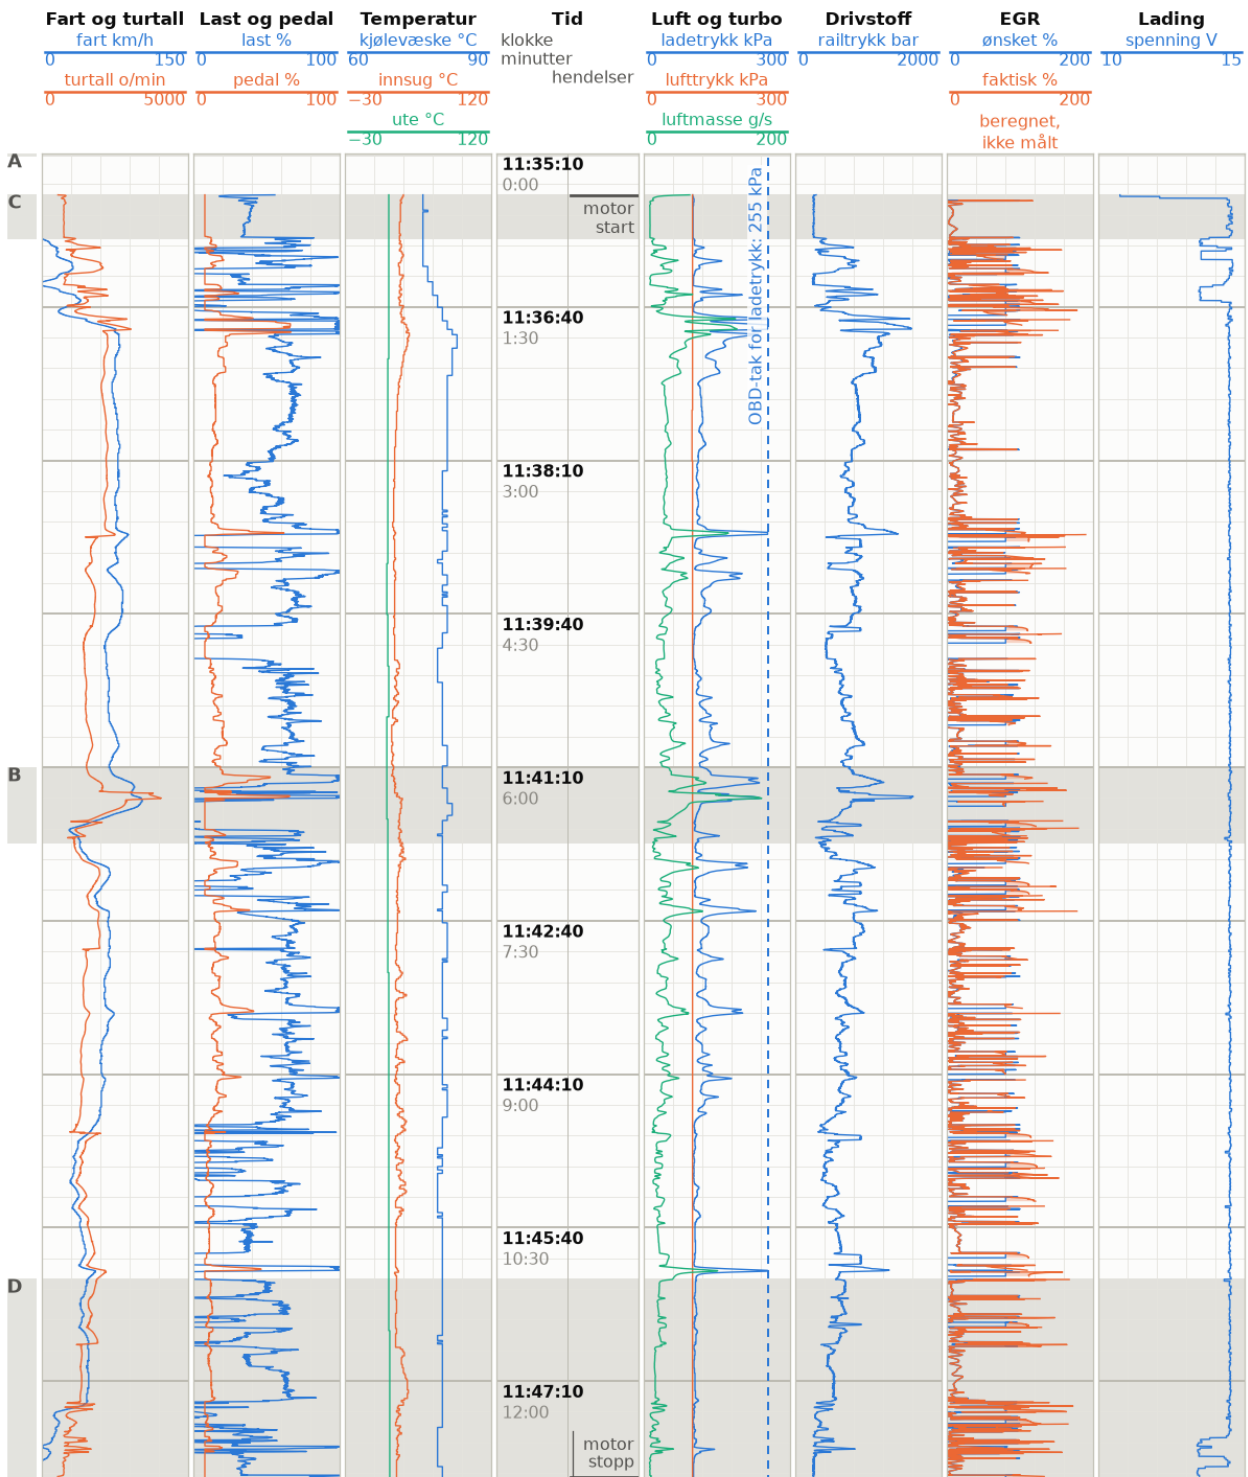
### Hele turen 27.09.2026 kl. 11:35, 13 min. Tiden går nedover.

This was a 13-minute drive on a warm engine, a good mix of steady cruising and one hard pull. The engine reached full boost and revved cleanly to just over 4000 rpm during the strong acceleration around six minutes in, with airflow and fuel pressure rising together the way they should. When you lifted off, everything came back down smoothly. That kind of clean climb and fall through the whole rev range is what I want to see: it tells me the turbo, the fuelling and the throttle are all working together properly.
