# ! THE STALE FRAME TREE COLLISION: FORENSIC ANATOMY

Uncompensated coordinate transform latency ( $\Delta t = 65$  ms) in high-speed surface-mount assembly:  
multiplying real-time joint encoders with stale vision transforms injects 5.85 cm spatial skew, destroying ceramic vacuum tooling.

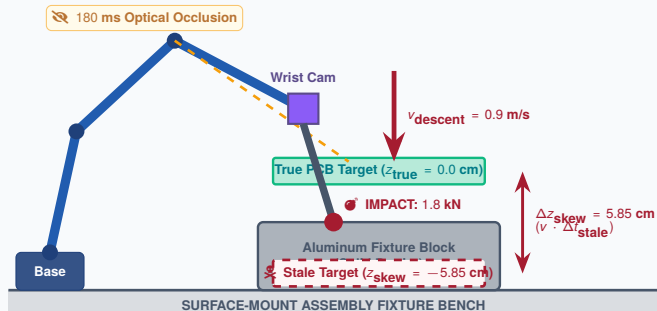
## Physical Workcell & Spatial Skew Geometry

Non-Isochronous Transform Multiplication:

$$\mathbf{T}_{\text{target}}^{\text{base}}(t_{\text{now}}) = \mathbf{T}_{\text{cam}}^{\text{base}}(t_{\text{now}}) \cdot \mathbf{T}_{\text{target}}^{\text{cam}}(t_{\text{now}} - 65 \text{ ms})$$

State engine multiplies real-time joint encoders ( $t_{\text{now}}$ ) by cached 65 ms old transform. Injects vertical skew:  $\Delta z = 0.9 \text{ m/s} \times 0.065 \text{ s} = 5.85 \text{ cm}$ .

Trajectory planner descends targeting phantom coordinates. Vacuum tooling shatters against aluminum block (1.8 kN dynamic impact, \$3,200 damage).

Transforms stored in fixed circular buffers indexed by 64-bit IEEE 1588 PTP hardware timestamps.

State engine evaluates query poses via exact geodesic interpolation in Lie algebra tangent space.

If transform age exceeds  $\tau_{\text{TTL}}$ , engine emits `TRANSFORM_EXPIRED` triggering safe stop.
