# UCL Mechanical Engineering

## MECH0015

### Failure Analysis Case Study of a Car Suspension Spring

May 25, 2021

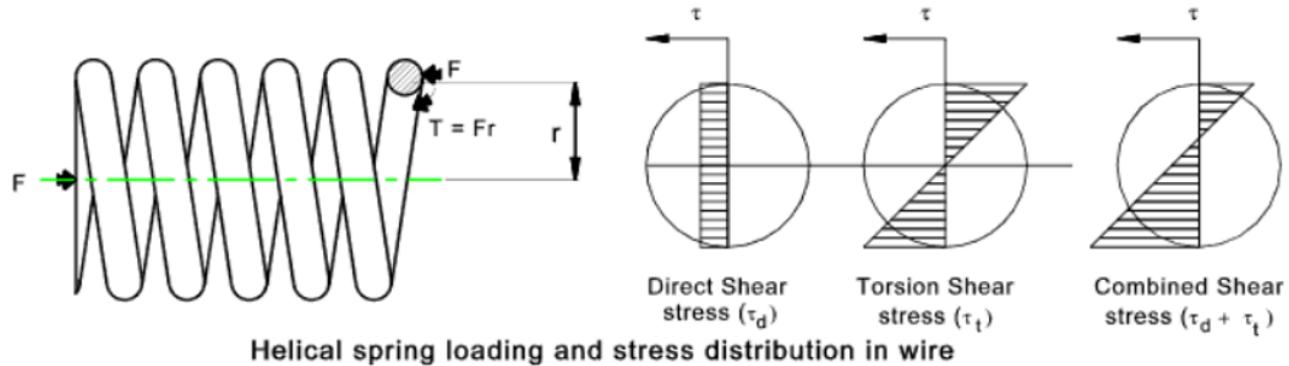
This is one of the 4 springs from a car suspension system, which therefore supported at least  $\frac{1}{4}$  of the weight of the car, plus the absorption of the varying vertical acceleration while the car is driven. Figure 1 shows the analysis of the resultant shear stresses that the compressive spring experienced while it is loaded. It is the combination of the direct and the torsion shear stress. So, this material selected by the designer should be high in toughness in order to withstand the many cycles of large loads. The desirable high strength is to maximise its elastic deflection which absorbs these impacts. Meanwhile, as a component of a mass-produced type of vehicle, it suggests that this should be a material that is low in both the cost of the material itself and the cost of manufacture, as well as its ease of manufacture.

Figure 17: The stress of the loaded spring [11].

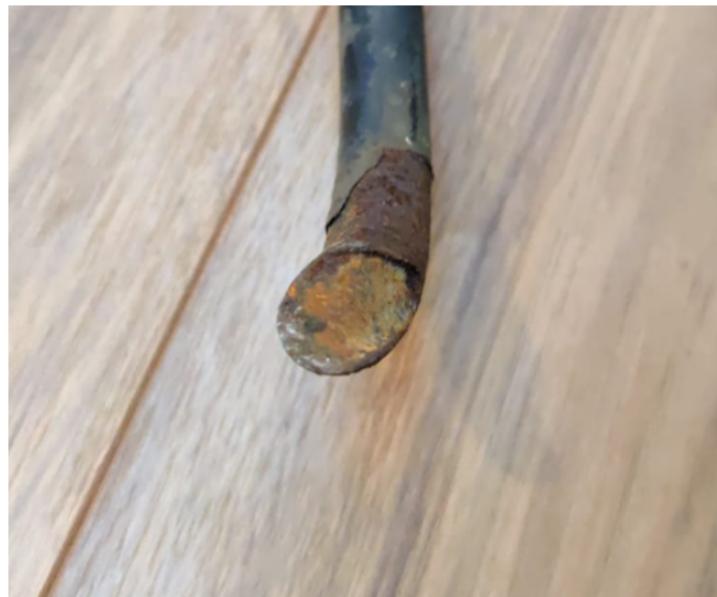
One possible cause of failure is corrosion on the surface of the spring, as the material (steel) tends to rust easily. Corrosion occurs due to the interaction of the material with its environment, leading to a loss of the material. Corrosion on the surface combines with other types of failure, such as fracture and fatigue, and can worsen them. A coating such as paint is used to protect the surface and prevent corrosion. The flexibility of the paint allows it to withstand and adhere to the surface even under the compressive movement of the component. However, this property is limited to the expected range of loading on the part, impurities, acidity and temperature. Use of the paint longer than the expected lifespan can be the cause in the long term. Moreover, any careless handling of the component by a technician or user can be the reason for coating failure in a shorter time.

Figure 22: Fracture surface.

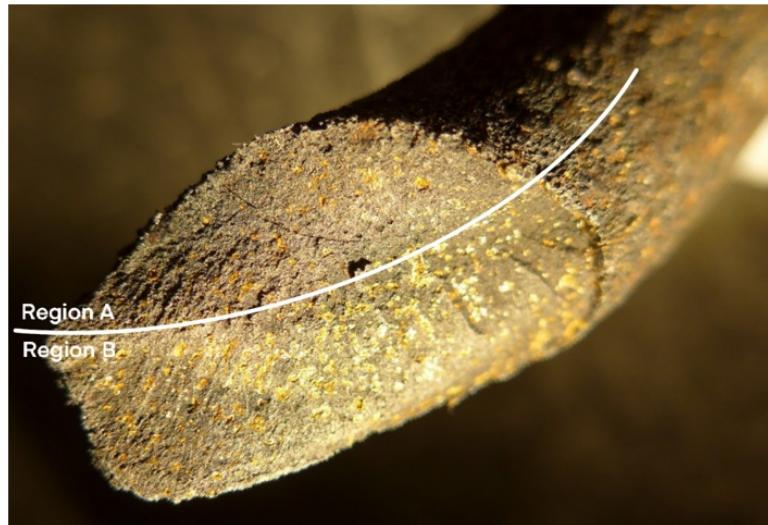
Figure 26: Surface of the fracture.

We can identify two regions with different surface patterns from the observations: region A with a smooth and flat surface and region B with a rough and ridged texture. Region A is smoother than region B suggesting brittle fracture in this region. This fracture occurs instantaneously below the maximum yield strength. Unlike region A, region B is not smooth, suggesting the possibility of ductile fracture and the cause of the crack. The chevron crack pattern of the surface indicates the direction of crack propagation. Combining these two regions, we cannot say it is a definite brittle fracture but more of a moderately ductile fracture.

influence fatigue crack. There could have been inconsistencies in the checking of the suspension springs where they could have detected the defect in the spring, as they check for corrosion so that the spring can be replaced before the crack propagates further. There are also non-destructive evaluation tests that are done to both detect defects and size defects which help to determine the remaining lifetime via a mathematical framework. Methods like X-ray inspection, ultrasound inspection, eddy-current methods, magnetic particle inspection and dye penetrant methods could be used to size the defects. This would allow for replacement of the spring, repair by welding or remove cracks by polishing.
