# UCL Mechanical Engineering

## MECH0015

### Failure Analysis Case Study of a Car Suspension Spring

Group 10

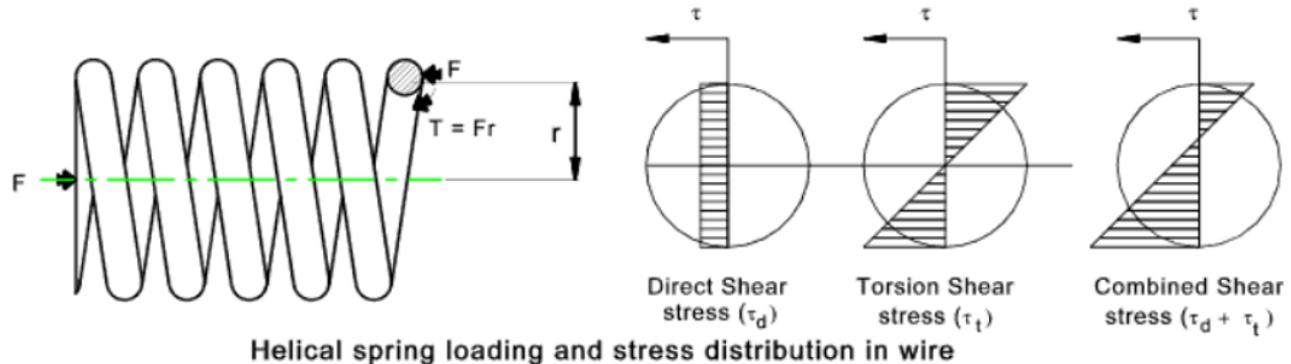
Figure 17: The stress of the loaded spring [11].

This is one of the 4 springs from a car suspension system, which therefore supported at least  $\frac{1}{4}$  of the weight of the car, plus the absorption of the varying vertical acceleration while the car is driven. Figure 1 shows the analysis of the resultant shear stresses that the compressive spring experienced while it is loaded. It is the combination of the direct and the torsion shear stress. So, this material selected by the designer should be high in toughness in order to withstand the many cycles of large loads. The desirable high strength is to maximise its elastic deflection which absorbs these impacts. Meanwhile, as a component of a mass-produced type of vehicle, it suggests that this should be a material that is low in both the cost of the material itself and the cost of manufacture, as well as its ease of manufacture.
