MECH0015

Failure Analysis Case Study of a Car Suspension Spring

Group 10

May 25, 2021

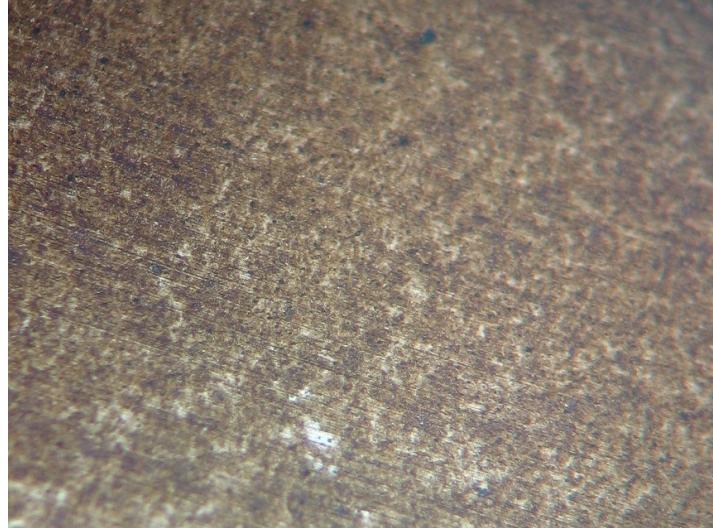
The raw material comes in large spools of high-quality spring steel. Based on our analysis of the spring, an annealed steel (that is unquenched) is used as there is evidence of subsequent heat treatment. The steel is then hot worked in order to draw them out into long wires. This is evident from the crystalline structure of the steel which shows that they are aligned along the axis of the spring. These spools are then unwound and fed into a cold forming spring coiler.

Figure 9: Crystal structure of the spring showing that it is also aligned along the axis confirming that the wires were first drawn out.
