UCL Mechanical Engineering

MECH0015

Failure Analysis Case Study of a Car Suspension Spring

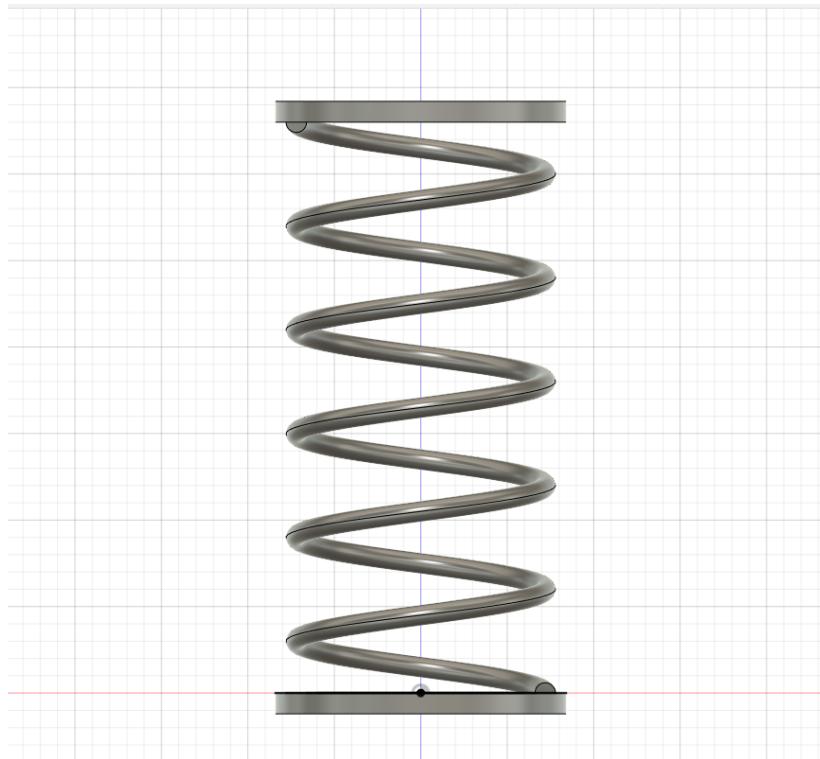
Figure 3: Screenshot from Fusion 360, showing CAD model of a spring, with compression plates.

A suspension coil with the exact dimensions as the case study is produced and loads imitating average conditions that a sedan car experiences were placed on the model.
