MECH0015

Failure Analysis Case Study of a Car Suspension Spring

Group 10

May 25, 2021

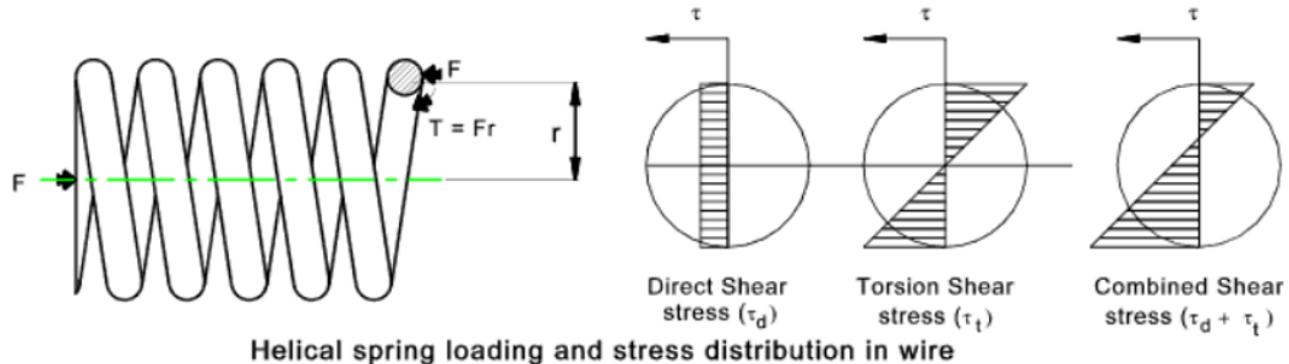
This is one of the 4 springs from a car suspension system, which therefore supported at least $\frac{1}{4}$ of the weight of the car, plus the absorption of the varying vertical acceleration while the car is driven. Figure 1 shows the analysis of the resultant shear stresses that the compressive spring experienced while it is loaded. It is the combination of the direct and the torsion shear stress. So, this material selected by the designer should be high in toughness in order to withstand the many cycles of large loads. The desirable high strength is to maximise its elastic deflection which absorbs these impacts. Meanwhile, as a component of a mass-produced type of vehicle, it suggests that this should be a material that is low in both the cost of the material itself and the cost of manufacture, as well as its ease of manufacture.

Figure 17: The stress of the loaded spring [11].
