# UCL Mechanical Engineering

## MECH0015

### Failure Analysis Case Study of a Car Suspension Spring

Group 10

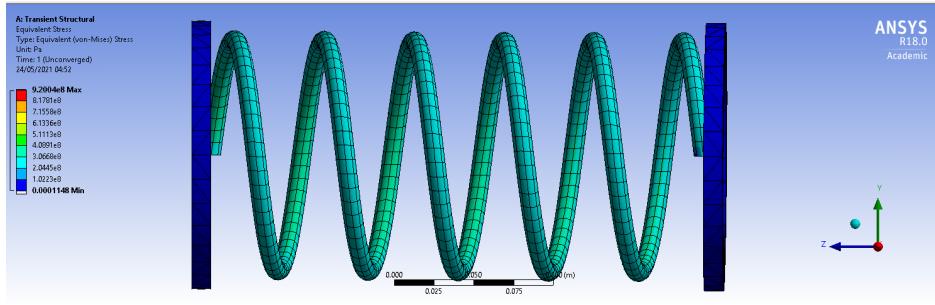
From the FEA conducted on ANSYS, the results seen in Figure 5 and 23 were produced. We can observe that the stress experienced by the entire coil is rather even, with the inner sections of the coil experiencing marginally higher stress compared the outer sections. The maximum stress recorded was  $2.1 \times 10^8$  Pa, lower than the compressive yield strength of structural steel.

Figure 5: Screenshot from ANSYS, showing the stress in the spring when under load.

This indicates that under normal circumstances, the stresses experienced by the coil are not sufficient to cause failure. Therefore, it can be deduced that the cause of failure – fatigue crack arose due external factors that may have produced a stress concentrator on the coil. Due to the nature of the surroundings of the coil, the layer of paint protecting the steel may have been damaged from an oncoming object while the vehicle was moving or due to poor maintenance conducted, allowing corrosion to occur within the layer of paint that was meant to protect the coil.

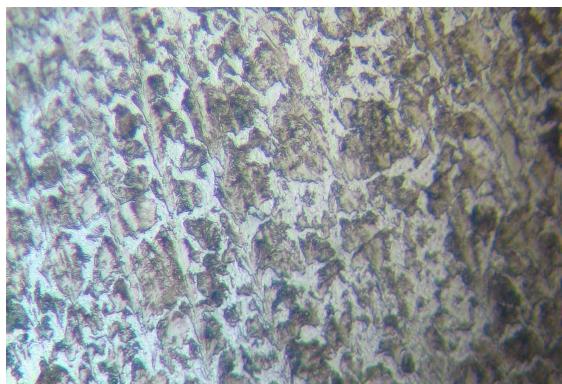
It is evident from the microstructure of the spring that it has been quenched and tempered as the microstructure shows fine martensite laths. From the material analysis, we have discovered that the carbon content is about 0.8% which means it has a composition of 50:50 ferrite and pearlite. Therefore, this is consistent with the notion that the spring is manufactured from a steel that is quenched and tempered to obtain a desirable high strength that it needs to maximise elastic deflection to support the shock loading of the vehicle's suspension.

Figure 7: Microstructure of spring steel that has 0.8% carbon content and has a 50:50 ferrite to pearlite ratio.

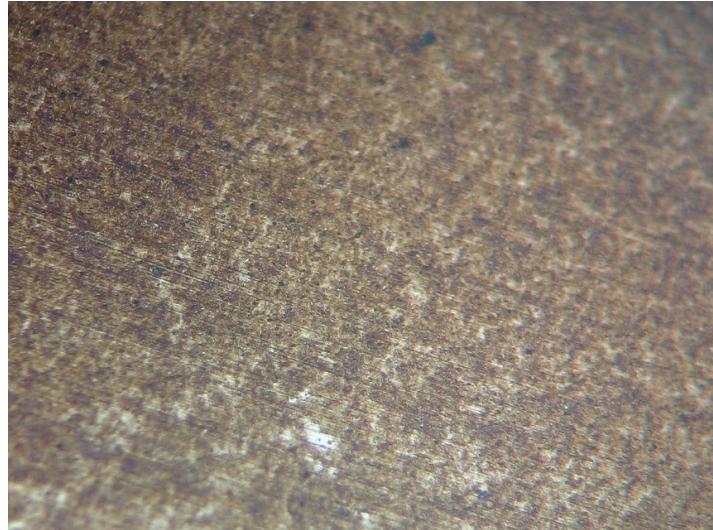
The raw material comes in large spools of high-quality spring steel. Based on our analysis of the spring, an annealed steel (that is unquenched) is used as there is evidence of subsequent heat treatment. The steel is then hot worked in order to draw them out into long wires. This is evident from the crystalline structure of the steel which shows that they are aligned along the axis of the spring. These spools are then unwound and fed into a cold forming spring coiler.

Figure 9: Crystal structure of the spring showing that it is also aligned along the axis confirming that the wires were first drawn out.

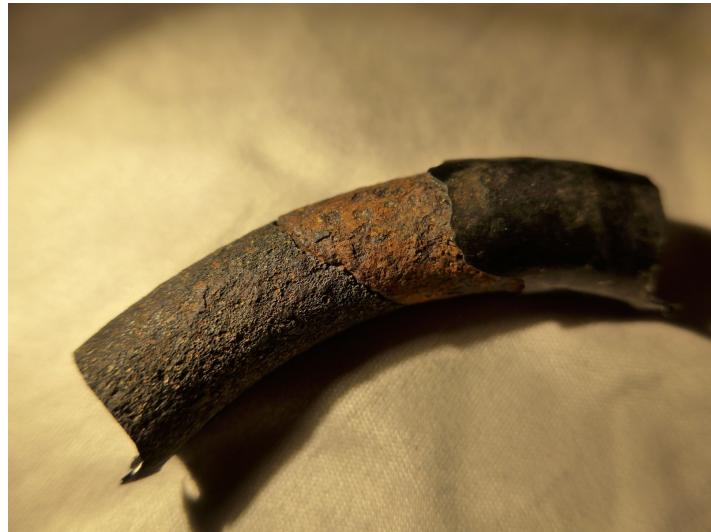
The corrosion patterns on the surface of the spring, the reddish-brown oxide is shown in Figure 18, is rust. This is formed by the reaction of iron with oxygen, which is also called oxidisation, usually presences in water or moist air mixture. The chemical equation is The chemical equation of the formation of the rust is  $4 \text{Fe} + 3 \text{O}_2 + 6 \text{H}_2\text{O} \longrightarrow 4 \text{Fe(OH)}_3$ . This reaction consists of two steps. The first step is the dissolution of the solid iron in the water,  $\text{Fe(s)} \longrightarrow \text{Fe}^{2+}(\text{aq}) + 2\text{e}^-$ . For the second step, the reaction of  $\text{Fe}^{II}$  and hydroxide ( $\text{OH}^-$ ) ions in the water  $\text{Fe}^{2+}(\text{aq}) + 2\text{OH}^-(\text{aq}) \longrightarrow \text{Fe(OH)}_2(\text{s})$ , produces the green rust. Also, this reaction produces the  $\text{Fe}^{III}$  ions, as  $4\text{Fe}^{2+}(\text{aq}) + 4\text{H}^+(\text{aq}) + \text{O}_2(\text{aq}) \longrightarrow 4\text{Fe}^{3+}(\text{aq}) + 2\text{H}_2\text{O(l)}$ . The  $\text{Fe}^{III}$  will then combine with extra hydroxide,  $\text{Fe}^{3+}(\text{aq}) + 3\text{OH}^-(\text{aq}) \longrightarrow \text{Fe(OH)}_3$ , which forms the  $\text{Fe}^{III}$  hydroxide. This then dehydrates to become rust.

Figure 18: The corrosion patterns on the surface of the spring.

The corrosion is severe, as shown in Figure 18. The paint on the surface is heavily damaged. It is likely to be difficult for the suspension system to be dry since it is located under the car in a semi-closed environment. The moisture remains in the air, which raised the rate of corrosion.

To prevent corrosion from occurring, the only way is to coat the surface. The use of polymer paint that has the flexibility to move along with the motion of the spring may decelerate the initiation of the corrosion. Another factor that can be considered for the prevention is driving in an ideal condition: preventing any sudden shock to the car. A lot of sudden motion change and collision of the car is caused by the user driving fast over the road bump causing a sudden large shock to the coil. Careful and standard driving could prevent the thinning of the paint and corrosion on the surface. Furthermore, constant clean-up of the drainage tray can prevent the accumulation of salt and water near the suspension coil.

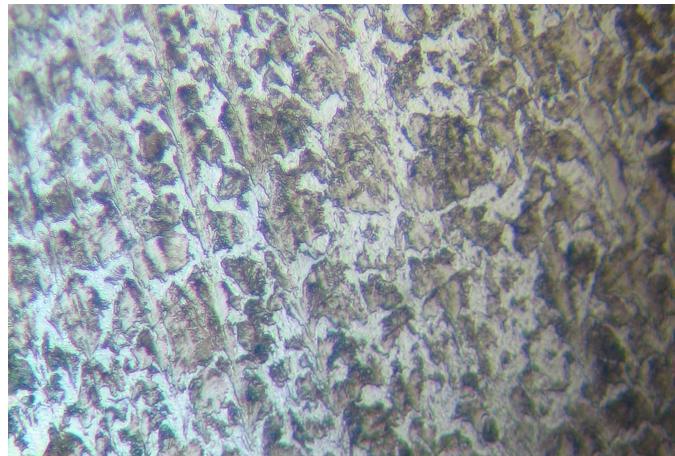
For the microstructure analysis, the heat treatment of the spring needs to be ‘removed’ to recover the original microstructure. This piece of material was heated up to about 700 °C using a blow torch and allowed to cool slowly. The slow cooling should give the equilibrium microstructure. The x100 magnified cross-section is then shown in Figure 20, which could help to get the carbon content of the steel. The specimen was etched in Nital. The pearlite has a lamellar structure with alternating layers of two phases, the ferrite and the cementite. Because the cementite looks darker after etching, the pearlite is then shown as the darker patches in Figure 20. Hence the ferrite is shown as the lighter regions. So, from Figure 20, it appears that the ratio of ferrite to pearlite is about 50:50.

Figure 20: The microstructure after etching in Nital and ‘removing’ of the heat treatment.

And therefore, checking the corresponding carbon content in the phase diagram of Figure 21, it is about 0.8% (0.83%). At this eutectic point, the pearlitic microstructure has the most layers of ferrite and cementite, which helps to prevent the propagation of the dislocation. This material is strong and cheap steel, which allows the subsequent heat-treatment after drawing to the rod and then forming the coil.

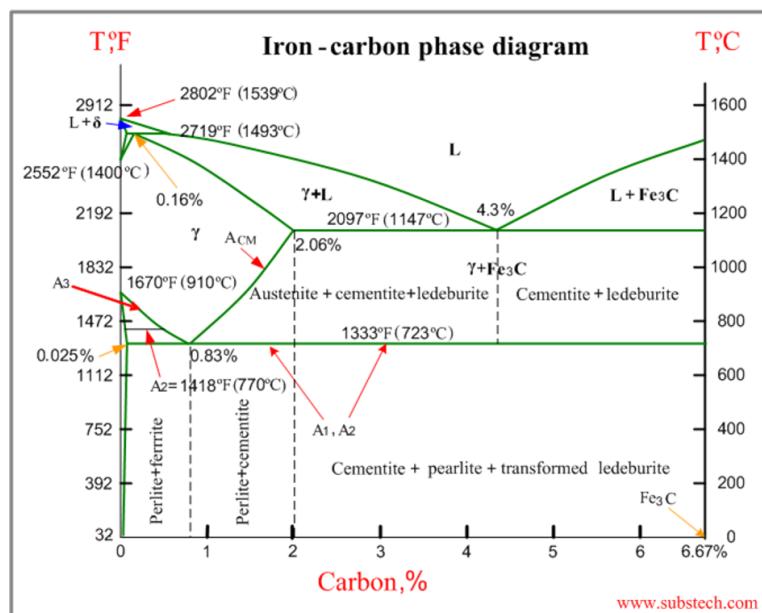
Figure 21: The phase diagram of iron-carbon [12].

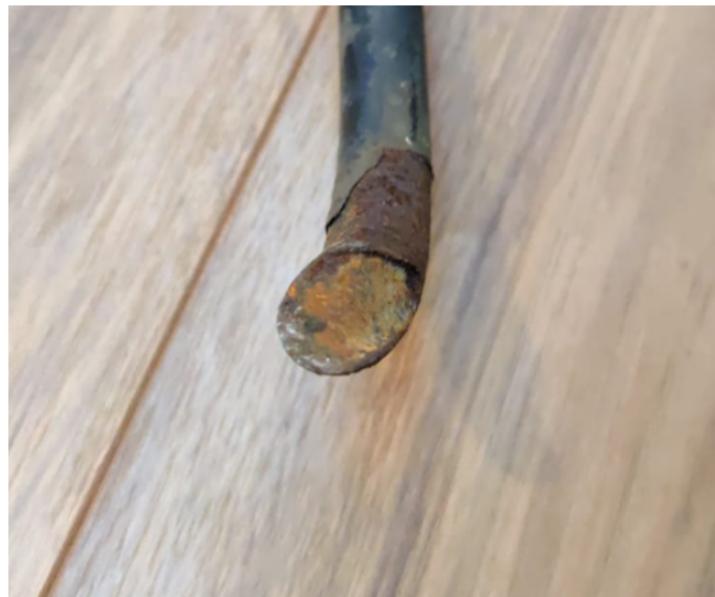
Figure 22: Fracture surface.

One of the mishandling would be the overloading on the component, such as compression for suspension spring. Over-compression due to a large number of road bumps or going over the bump with non-ideal speed could lead to a collision and abrasion between coils. Collision over time may have caused thinning of the paint and eventually exposed the component's surface. A single deep scratch due to the collision could have also caused surface exposure. The exposure of the surface to both water and oxygen in the atmosphere and direct contact could have led to corrosion—initiation of the corrosion results in the propagation on the whole surface of the spring. In Figure 22, the corrosion on the fracture surface can be shown. The corrosion on the existing hole or crack surface could have accelerated the weakening of the steel structure and cause a further crack and corrosions. Another possibility is the presence of corrosion pits, an area with greater rate of corrosion. From these pits, corrosion at grain boundaries could have initiated the cracks and further corrosions on the surface. The crack gives the site of stress concentration resulting fracture of the component.

Corrosion cannot be the only reason and factor that contributed to the failure but one of initiative or accelerator of the fracture. Environmental factors such as direct contact with water or temperature could have also been the initiative to the failure as these could initiate corrosion. These factors are synergistic, and each mechanism enhances each other beyond what damage would normally be expected to occur.

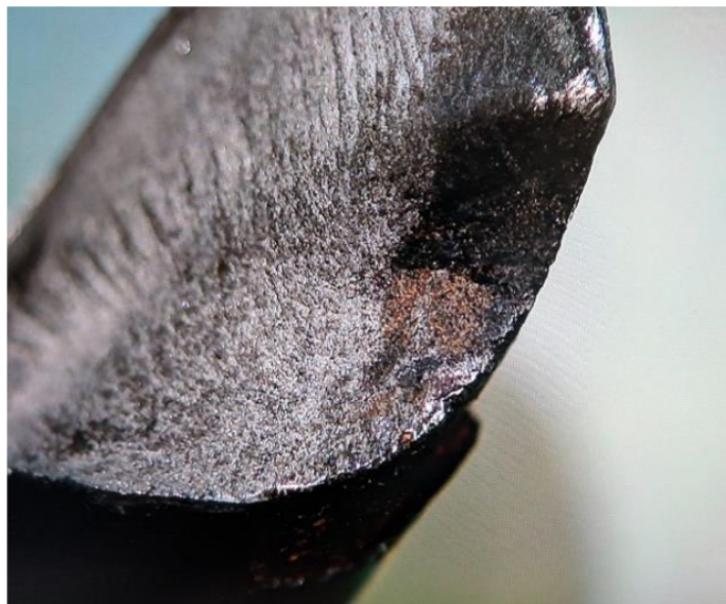
The fracture of the spring developed due to localized stress which introduces stress concentrators at a particular point on the coil of the suspension spring. The stress concentrators that lead to the crack could be in the form of sharp edges, machined holes, scratches, dents, machining marks, material defects, grain boundaries or in our particular case corrosion pits. The fatigue crack growth mechanism, for an existing defect in the spring material, is when the stress concentration increases,  $\sigma$ , the crack opens and the localised stress ( $\sigma_{local}$ ) increases to be greater than the global stress ( $\sigma_{global}$ ) induced by the load supported, but limits at  $\sigma_Y$ , because any higher is not possible as yielding occurs first. The area of high concentration around the crack tip reaches  $\sigma_Y$  generating plastic deformation locally which creates extra surface internally. When the cycle moves into compression, the extra surface will have to be folded inwards and extends the crack in the process. This process repeats for each cycle and the crack propagates giving striations that is visible under very high magnitude on an electron microscope. Therefore, the mating surfaces are very flat, and this generate hair-line cracks which are difficult to spot. The cracks will grow until fast fracture occurs as the crack gets to critical crack size  $a_c$  which causes the coil to fracture. As this happens in the coil of the spring the fractured surface is indicative of fatigue. Beach marks are created because of minor variations in the loading cycle, for example changes in stress amplitude ( $\sigma_a$ ), mean stress ( $\sigma_{mean}$ ), maximum stress ( $\sigma_{max}$ ) and minimum stress ( $\sigma_{min}$ ). The beach marks are also a positive indication of fatigue.

Figure 24: Fatigue failure of the coil with corrosion - bright, smooth regions show fatigue; darker and rough regions show fracture.

In the case of this car suspension spring, it always experiences a compressive load due to the weight of the car. There are dampers present to ensure that the motion of the spring is smoothed and to ensure that it does not move vigorously up and down which could cause damage from fatigue crack growth. However, the fatigue crack can grow due to the presence of residual stress. As the compressive load can generate a residual tensile stress at the crack tip, which helps the external stress to propagate the defect. In this case, a single underload can reduce lifetime of the spring so fewer cycles are required to failure. Most engineering fatigue scenarios contain existing defects, so we assume that the spring has an existing defect and the fatigue over time causes propagation.

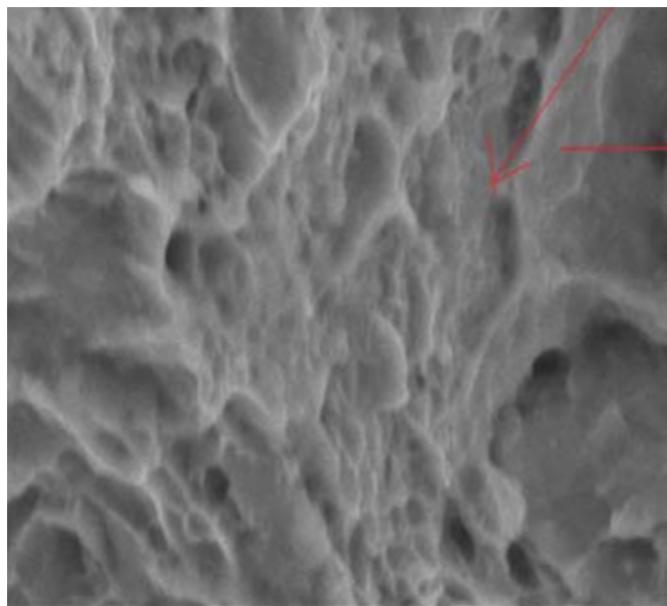
Figure 25: Holes in the coil spring [14].

The small hole and crack on the surface causes imperfection which could be due to manufacturing or tempering process. Any hole or change in shape of the material can act to magnify global stress therefore help to initiate cracks. There could also be inter granular surface covered by an oxide due to trapped quench oil being heated in tempering furnace. The oxides trapped in the microstructure, can be angular and sharp in shape hence very effective stress concentrators. The defects cause the local yield stress to increase to become greater than the yield stress, causing failure to occur after a while. This type of defect takes place when the heating system was not properly done, the quenching crack and holes reduce the life of the suspension coil spring, hence causing premature failure.

To design against fracture, the material of the coil has to be carefully selected as the engineers need to be aware of how these can either help or hinder fatigue crack initiation and propagation by paying careful attention to the quality of the supplied materials. They need to ensure that they consider the existing fatigue data and research on the material, as often small changes in alloy composition or specification can have commensurate change in fatigue properties.

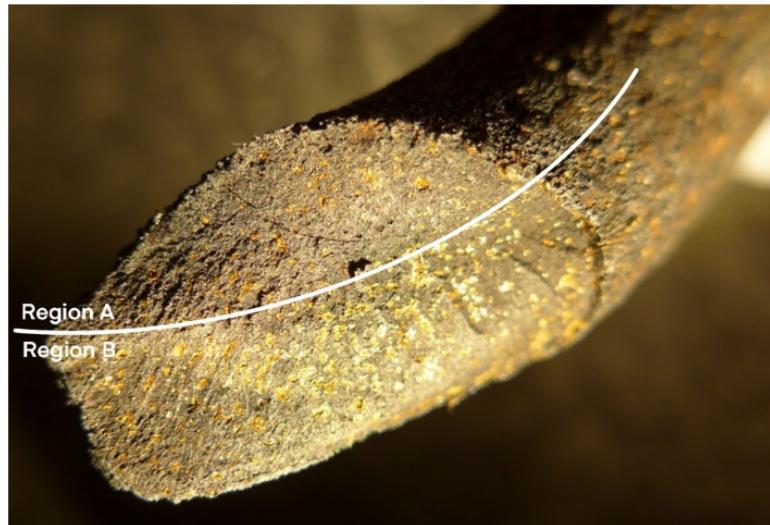
Figure 26: Surface of the fracture.

We can identify two regions with different surface patterns from the observations: region A with a smooth and flat surface and region B with a rough and ridged texture. Region A is smoother than region B suggesting brittle fracture in this region. This fracture occurs instantaneously below the maximum yield strength. Unlike region A, region B is not smooth, suggesting the possibility of ductile fracture and the cause of the crack. The chevron crack pattern of the surface indicates the direction of crack propagation. Combining these two regions, we cannot say it is a definite brittle fracture but more of a moderately ductile fracture.
