# COFFEE PACKAGING QUALITY INSPECTION REPORT

Real-Time AI Seal Inspection and Physical Leak Detection

| Packet ID | PKT-20260829094755-0AAF |
| Report ID | RPT-20260829-CED983 |

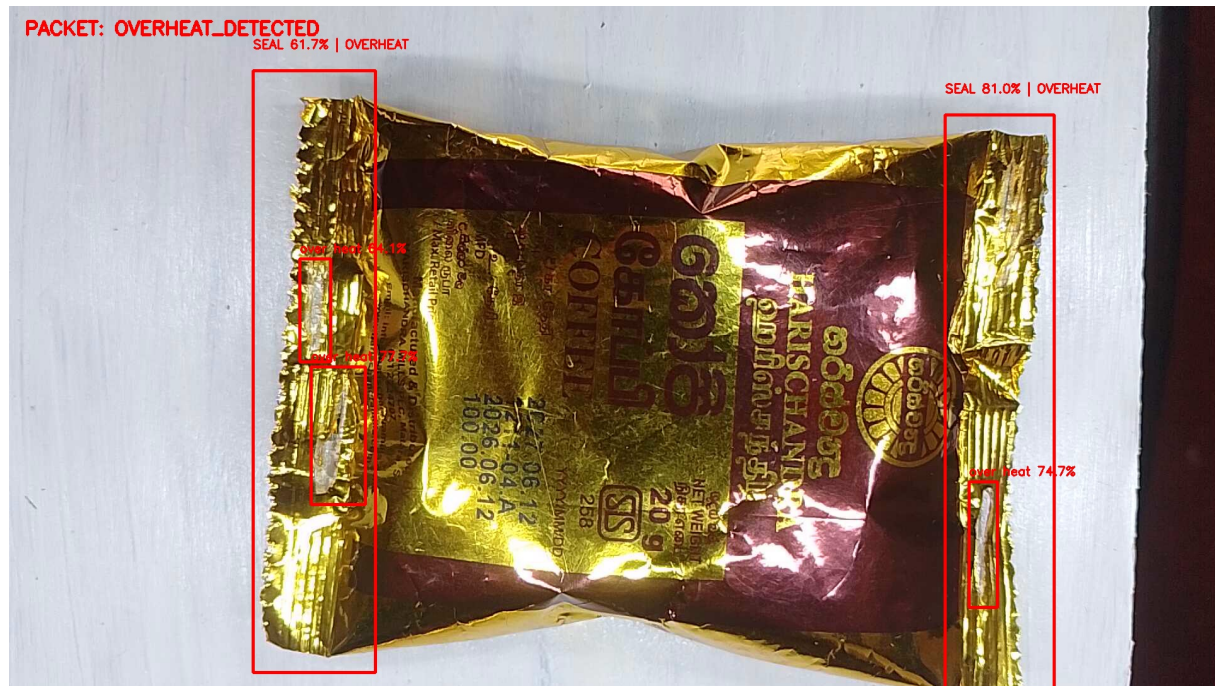
## Real-Time Inspection Evidence

Potential overheat defect was detected by the real-time AI inspection system.

| Highest Overheat Confidence | 77.7% |
| AI Inspection Status | OVERHEAT_DETECTED |

- Hold or reject the affected packet.
- Inspect sealing temperature settings.
- Verify sealing dwell time and heater condition.
- Inspect subsequent packets from the same batch.
