# COFFEE PACKAGING QUALITY INSPECTION REPORT

Real-Time AI Seal Inspection and Physical Leak Detection

| Packet ID | PKT-20260830021558-A684 |
| Report ID | RPT-20260830-FD27CA |

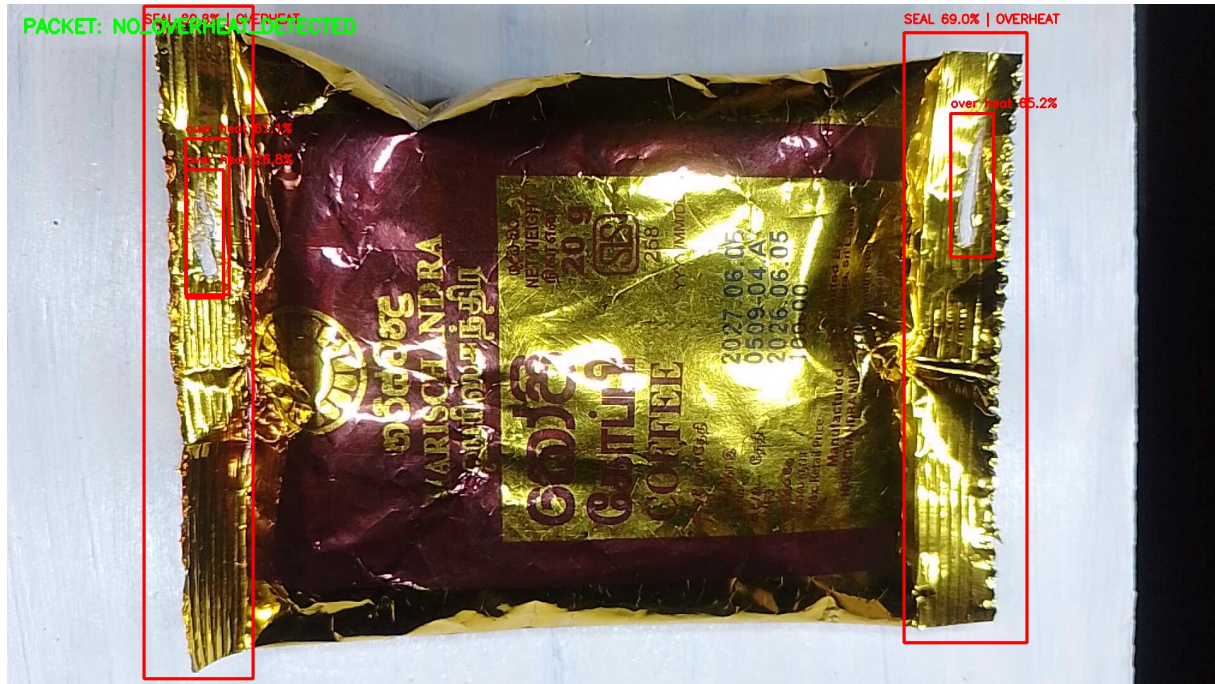
## Real-Time Inspection Evidence

No overheat defect was detected during the real-time inspection and the packet passed the physical leak test.

| Detected Seal Regions | 2 |
| Overheat Detected | NO |

| Seal | Seal Confidence | Overheat | Overheat Confidence |
|---|---|---|---|
| Seal 1 | 80.8% | NO | - |
| Seal 2 | 69.0% | NO | - |

- Packet passed the current automated quality checks.
- Proceed according to the normal production quality-control process.
