# COFFEE PACKAGING QUALITY INSPECTION REPORT

Real-Time AI Seal Inspection and Physical Leak Detection

| Packet ID | PKT-20260828023108-E54C |
| Inspection Date | 28 August 2026 |

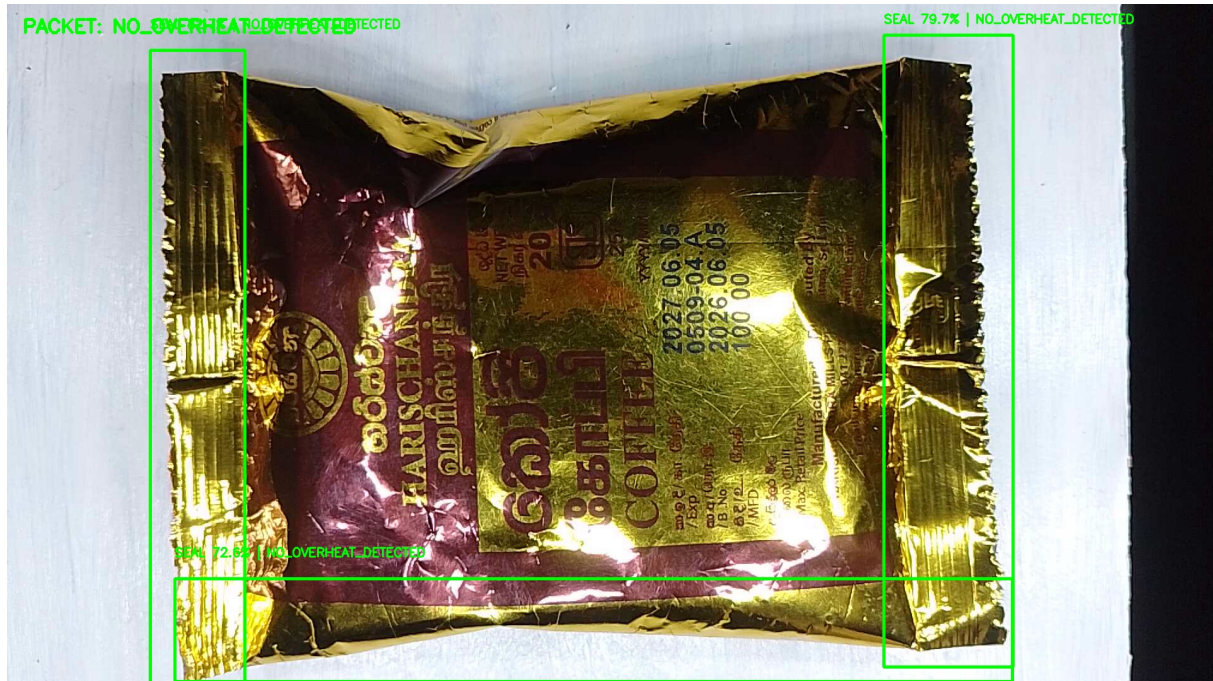
## Real-Time Inspection Evidence

No overheat defect was detected during the real-time inspection and the packet passed the physical leak test.

| Seal | Seal Confidence | Overheat | Overheat Confidence |
|---|---|---|---|
| Seal 1 | 82.8% | NO | - |
| Seal 2 | 79.7% | NO | - |
| Seal 3 | 72.6% | NO | - |

- Packet passed the current automated quality checks.
- Proceed according to the normal production quality-control process.
