# COFFEE PACKAGING QUALITY INSPECTION REPORT

Real-Time AI Seal Inspection and Physical Leak Detection

| Packet ID | PKT-20260830092002-D6AC |
| Report ID | RPT-20260830-92DC97 |

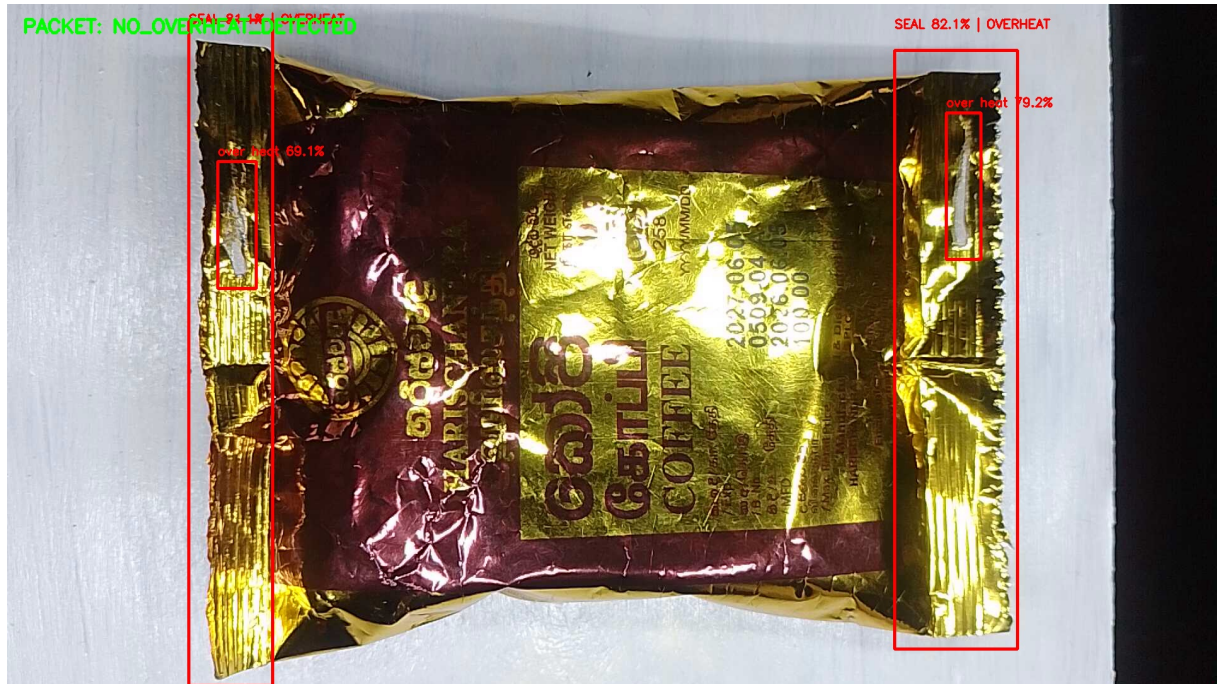
## Real-Time Inspection Evidence

No overheat defect was detected during the real-time inspection and the packet passed the physical leak test.

## Seal-by-Seal Results

| Seal | Seal Confidence | Overheat | Overheat Confidence |
| Seal 1 | 82.1% | NO | - |
| Seal 2 | 81.1% | NO | - |

- Packet passed the current automated quality checks.
- Proceed according to the normal production quality-control process.
