# COFFEE PACKAGING QUALITY INSPECTION REPORT

Real-Time AI Seal Inspection and Physical Leak Detection

| Packet ID | PKT-20260830092435-2F62 |
| Report ID | RPT-20260830-6E9487 |

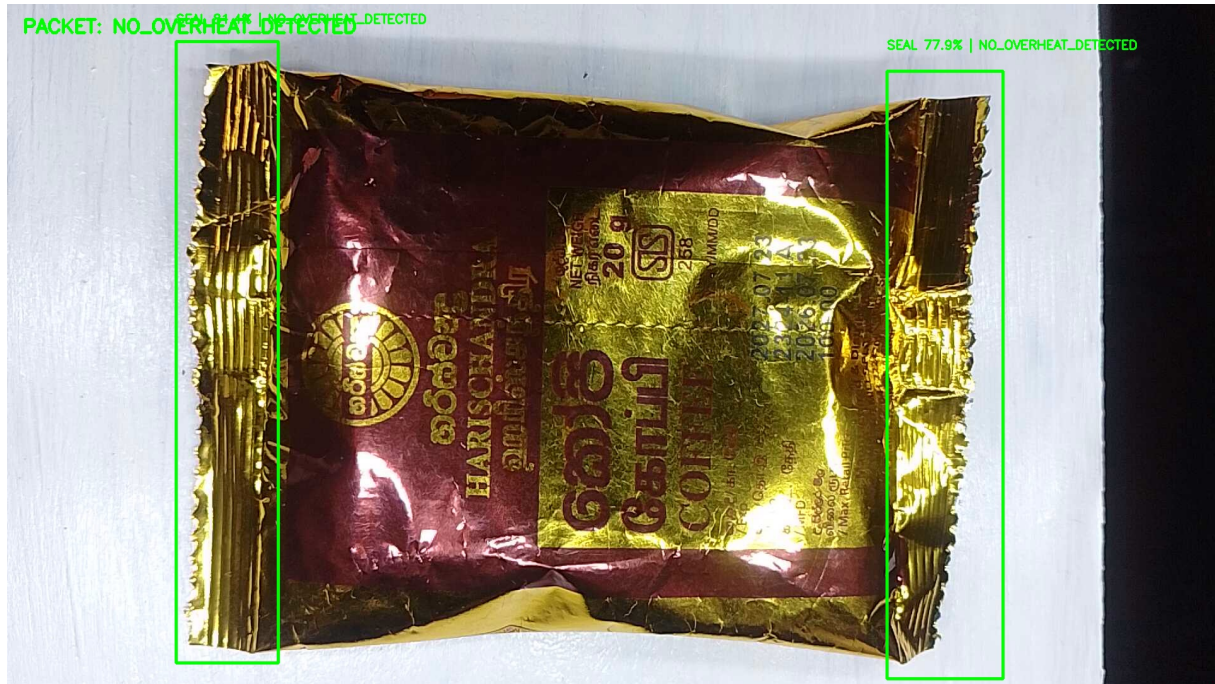
## Real-Time Inspection Evidence

The packet failed the physical leak detection test.

| Detected Seal Regions | 2 |
| Overheat Detected | NO |

| Seal | Seal Confidence | Overheat | Overheat Confidence |
|---|---|---|---|
| Seal 1 | 81.5% | NO | - |
| Seal 2 | 77.9% | NO | - |

- Reject the leaking packet.
- Inspect sealing pressure and seal alignment.
- Check the packaging material for damage.
