# COFFEE PACKAGING QUALITY INSPECTION REPORT

Real-Time AI Seal Inspection and Physical Leak Detection

| Report ID | RPT-20260821-B9F982 |

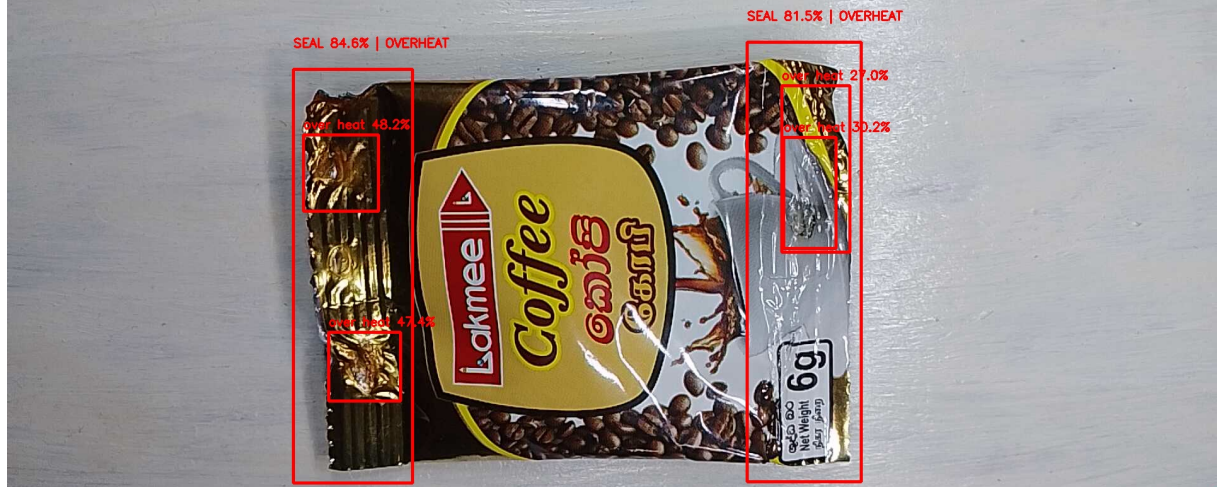
## Real-Time Inspection Evidence

Potential overheat defect was detected by the real-time AI inspection system.

| Highest Overheat Confidence | 48.2% |

PACKET: OVERHEAT\_DETECTED

- Hold or reject the affected packet.
- Inspect sealing temperature settings.
- Verify sealing dwell time and heater condition.
- Inspect subsequent packets from the same batch.
