REBREATHER SAFETY

Comprehensive Database of Top Down Rebreather Failure Modes FMECA Volume 6:

All Rebreathers for In-Water Diving

DOCUMENT NUMBER: FMECA_OR_V6_190910.doc

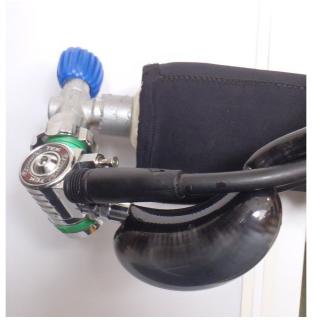
The outer sheath of helium and oxygen hoses need to be vented to allow gas that migrates through the core to dissipate, otherwise offgasing will cause the hose to fail after long exposures to pressurized gas. See example below: gas is OFF and the end of the hose is open as the hose in the photograph expands!

Figure 5-1: Hose sheath over-expansion because it is a multi-layer hose where the outer sheath has not been ventilated.

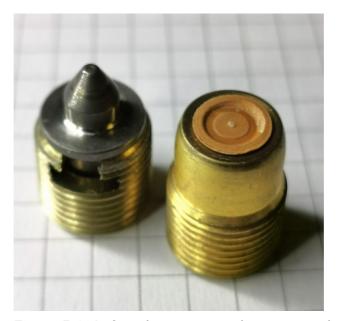
Figure 5-2: Left is the progressively opening valve seat fitted to all rebreathers sold by Open Safety, and the right seat is a standard seat with hard plastic seating material, e.g. PEEK. The progressive seat is made from Iconel which does not combust in oxygen, and is tapered giving a valve opening action that allows gas pressure in the outlet to build up more gradually. The Iconel seat is also much more resistant to over-tightening damage seen on the plastic seat on the right.

Fit progressively opening valve seats to all rebreather cylinder valves.

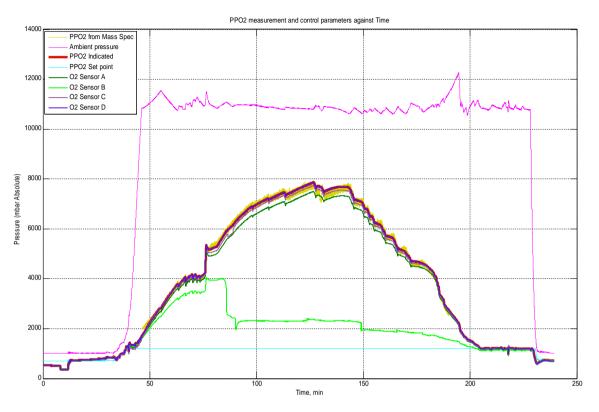
Figure 10-4. Example of good functional safety behaviour during a test dive, to 100m depth. The four O2 cells are 2 years old yet the indicated PPO2 matches that of the mass spectrometer almost perfectly throughout the dive. The PPO2 monitor using these cells shows it is accurate to a PPO2 of at least 7.8 atm (well beyond that which may occur in diving), except one (Sensor B) which fails with a classical ceiling fault (current limiting) shortly after the descent. The less accurate sensors are rejected immediately by the sensor fusion system. The small ticks in the response is the oxygen injector self test, which is also used to test the sensors.

Use sensor fusion algorithm that can detect one good sensor among faulty sensors.

Provide means to check sensors automatically when a sensor failure occurs, such as injecting a known quantity of O2. This requires a calibrated O2 injector: this can be done automatically during pre-dive checks.

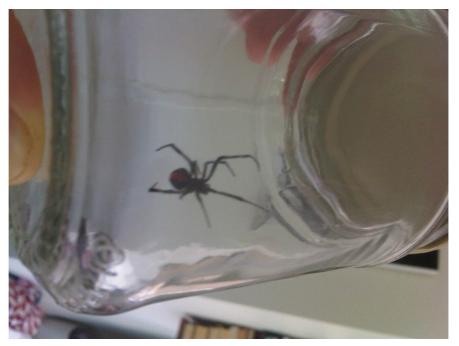
Open ports into a rebreather, seem to attract insects. During Deep Life test diving, there were several incidents where insects were found inside the breathing loop before or, worse, immediately after a dive: a cockroach, ants, and the spider below have been seen coming out rebreathers.

Figure 13-5: Diver noticed a spider in the mouthpiece, identified as female Redback spider (*Latrodectus hasselti*), considered one of the most dangerous spiders in Australia. It crawled out of the rebreather mouthpiece immediately before the dive near Sydney.
