HAZARD AND OPERABILITY STUDY (HAZOP) REPORT

Subject: Rebreather hoses including all hose attachments and counter lungs.

Site: St.Petersburg, Russia Design Centre

Time: 10:00 -19:00 Project: O.R. Rebreathers

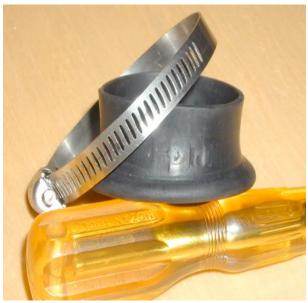
The cable ties were changed from twin cable ties to stainless steel jubilee clip as a consequence of the previous design and safety review. The meeting asked to see how the jubilee clip fails, to see whether the clip failed in a safe manner. For this purpose, a clip was tightened on a port. The grub screw failed without any failure of the overall function. The hose was then pulled until failure occurred. The port was then disassembled and it could be seen that the clamp had not torn the hose: pictures below – the failure point was the small cuts the forming tool makes on each ring, extending around the ring.

Fig 1:: Hose with jubilee clip, after tensioning the clip until the grub screw failed, then tensioning the hose until the hose failed. Hose failure point is at the same point observed in the tests reported in the FMECA Vol 4

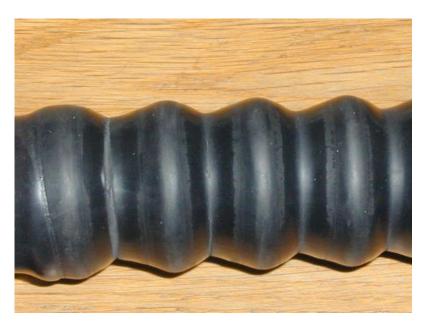
Fig 2:: Hose under tension showing cracks caused by forming tool during manufacture, from which failures extend around the hose.
