NORTH VANCOUVER PIPE BURST REQUIRES CAREFUL PLANNING

Close proximity to storage silos, poor ground conditions and clogged storm sewer pipe puts trenchless contractor to the test

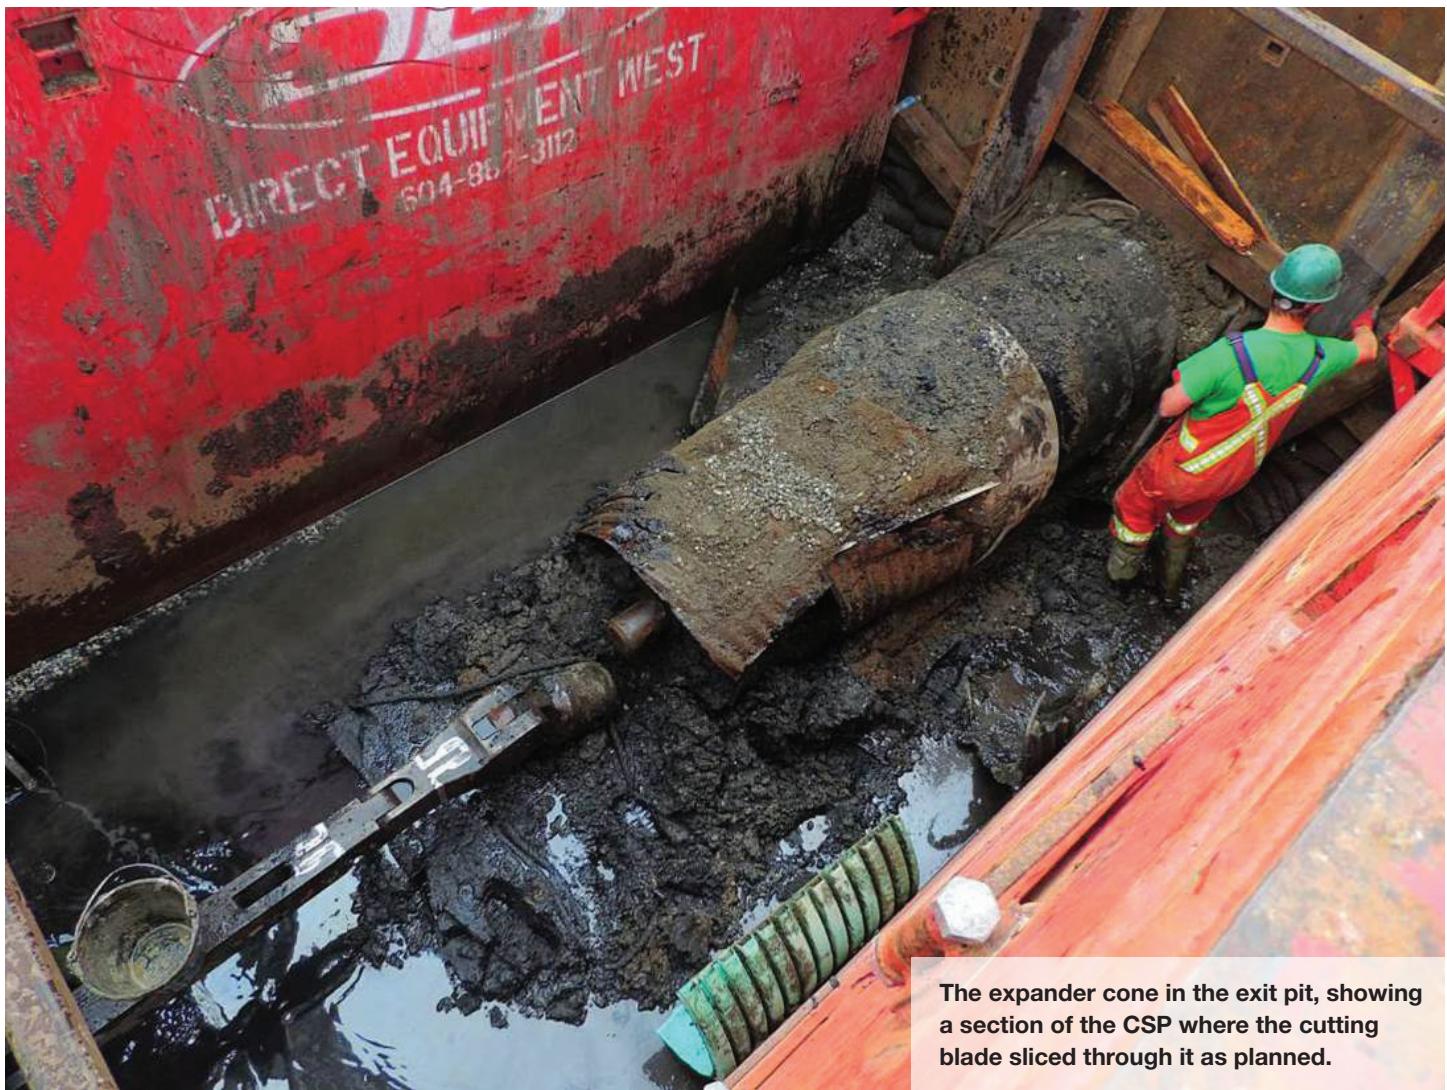
The expander cone in the exit pit, showing a section of the CSP where the cutting blade sliced through it as planned.

The pipe now ready to be burst, the contractor cut the CSP using a sharp blade on the expander cone. PW Trench-

less also reduced the size of the expander cone to limit any ground movement. The latter was important to ensure that a series of storage silos on the Fibreco side of the site did not become structurally compromised during the pipe burst. North Vancouver recognized that it would probably lose the silos if it elected to go with an open-cut method of pipe replacement.

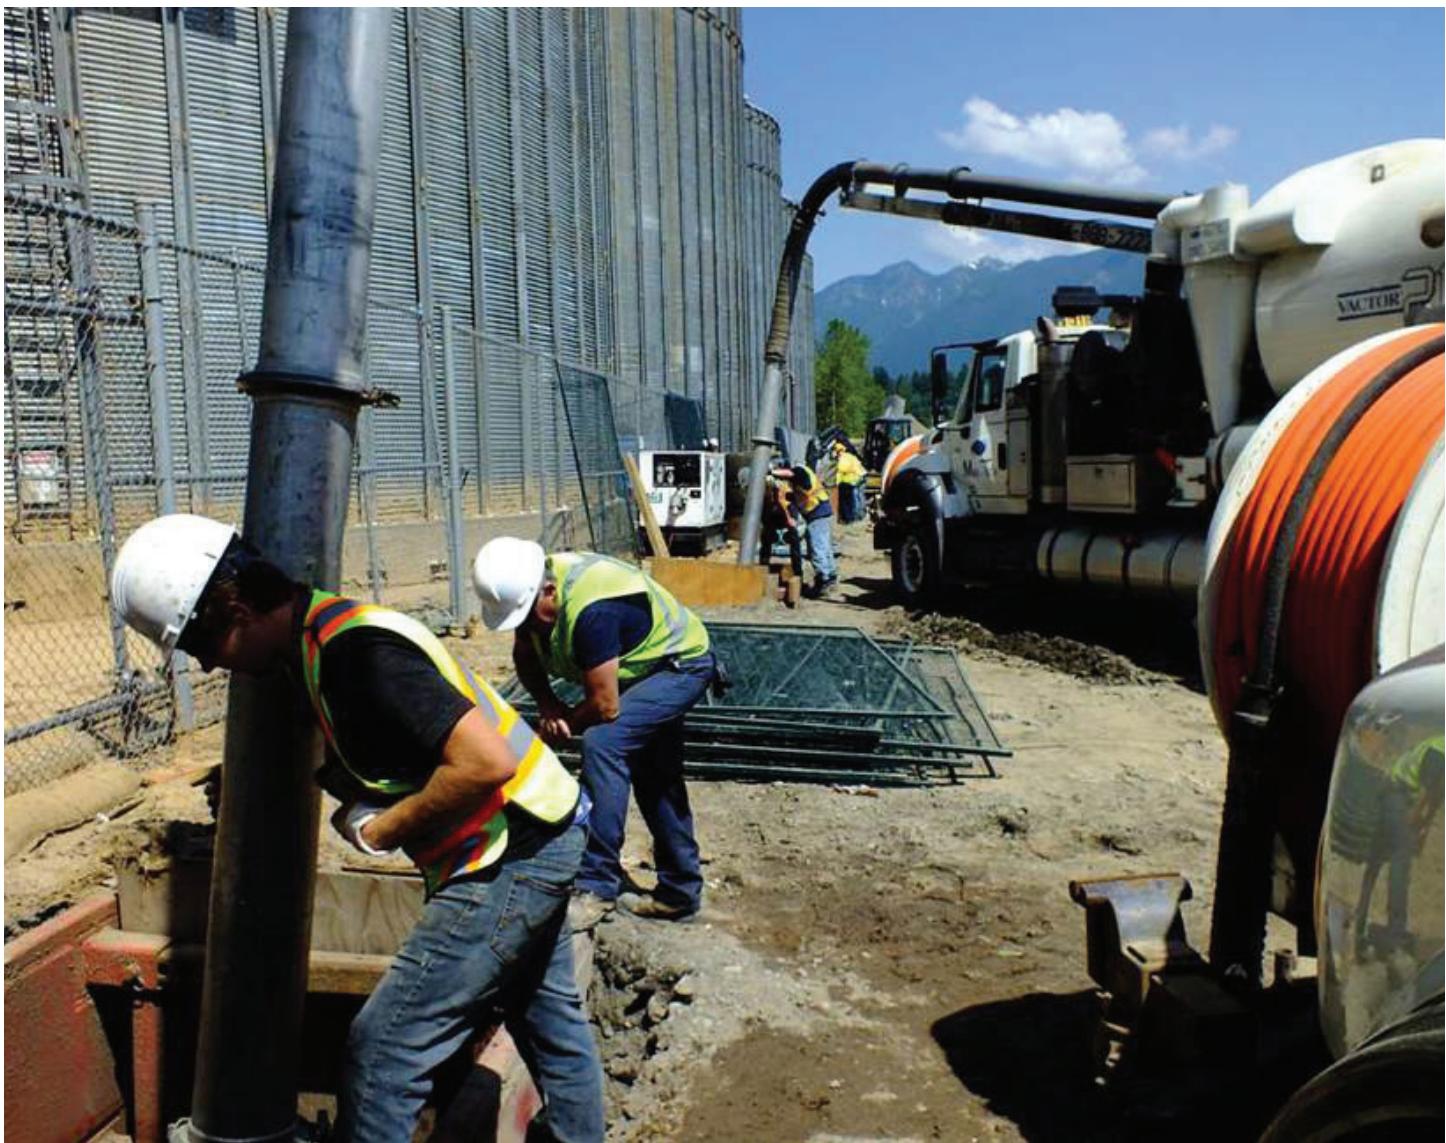
Almost immediately, Surrey-based PW Trenchless Construction ran into difficulties as they tried to get a camera into the pipe. A series of test pits showed the ground conditions in extremely poor shape, evidenced by sinkholes and contaminated soils – the site sits on reclaimed land.

"The top of the pipe would collapse and material would come in. There were large sections of the pipe missing and groundwater started coming into the pit after around 30 seconds," said Greg Deacon, project manager for PW Trenchless Construction.

The solution was to break up the pipe burst into three sections of 100-m bursts. A series of portable water treatment plants were set up to treat the groundwater, since it was not deemed to be suitable for discharging into the sanitary sewer system.

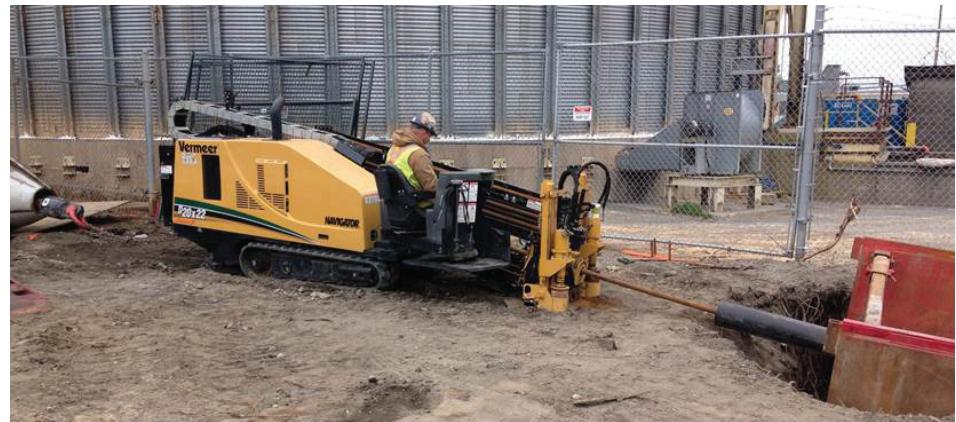
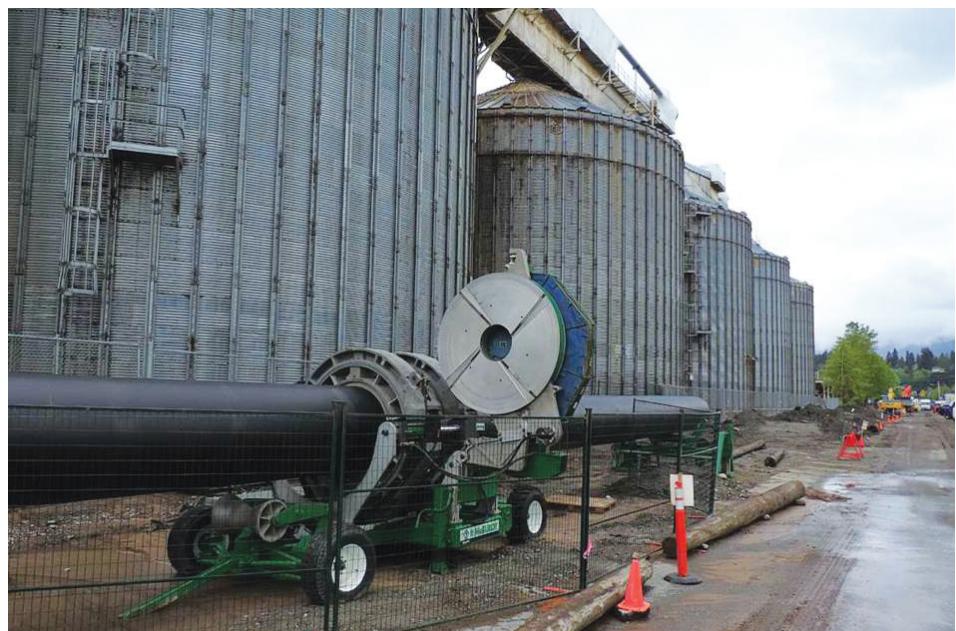
Top: The Vermeer Navigator HDD drill used to drill through the existing CSP pipe to pull through the bursting rods. **Right:** The McElroy 1648 fusing machine that was used to fuse the pipe together. Note the proximity of the silos to the pipe.

PW Trenchless Construction was concerned that the 2500G could push the rods through the sides, top or bottom of the CSP. To get around the problem, they used an HDD rig to drill through the pipe from the entry pit to the exit pit, thus removing the debris that was in the pipe this risk. "This allowed us to attach the bursting rod, and use the drill rig to pull it through the pipe," said Deacon.
