DOLPHIN PILE CONDITION ASSESSMENT AND REPAIR RECOMMENDATIONS REPORT, HERRON ISLAND, WA

Prepared for HMC Management

KPFF Project No. 114157
October 10, 2014

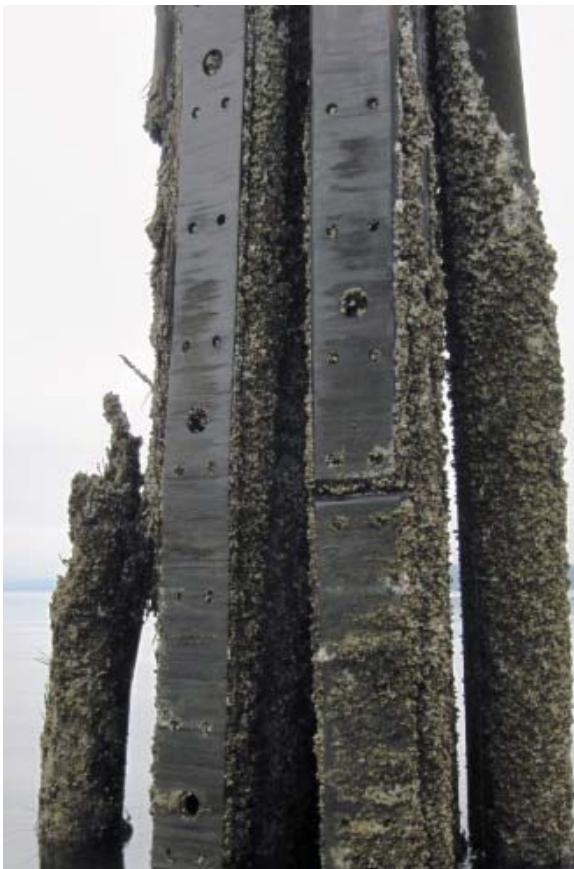
- **Mainland Ferry Terminal Dolphins:** Observations indicate that the outermost piles that were added in 1999 are starting to deteriorate near the mean tide line, with exception of two of the piles in the Northwest dolphin. These two piles were observed to have deterioration to such an extent that they are considered to have little remaining strength. One of these piles has essentially broken off and the other pile has holes in the piles at the holes in the fender material. See **Photo 1**. However, the dolphin as a whole was observed to be solid.

Photo 1: Mainland Ferry Terminal,
Northwest Dolphin: broken pile

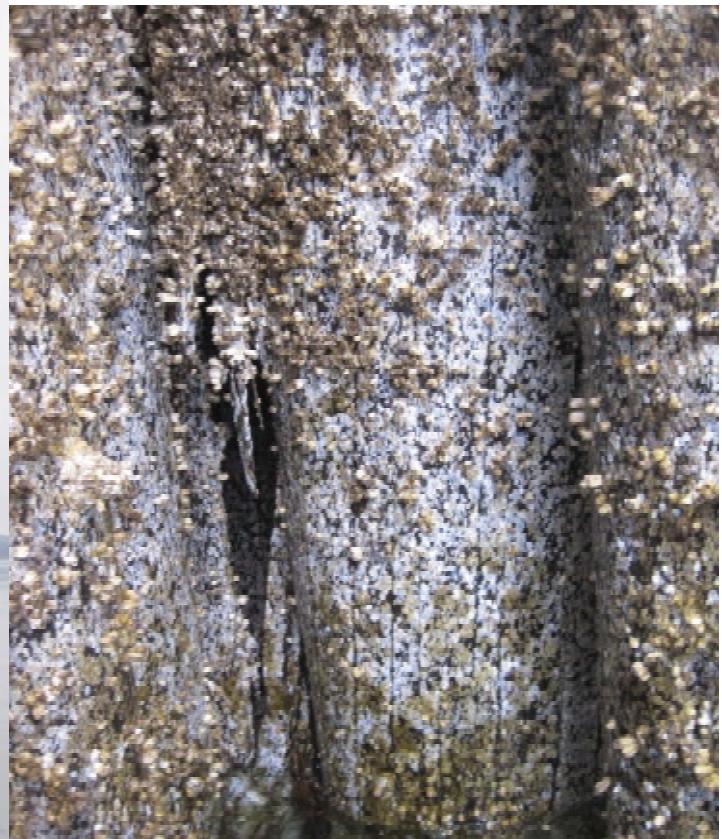
Photo 2: Mainland Ferry Terminal, Northeast
Dolphin: deteriorated center pile

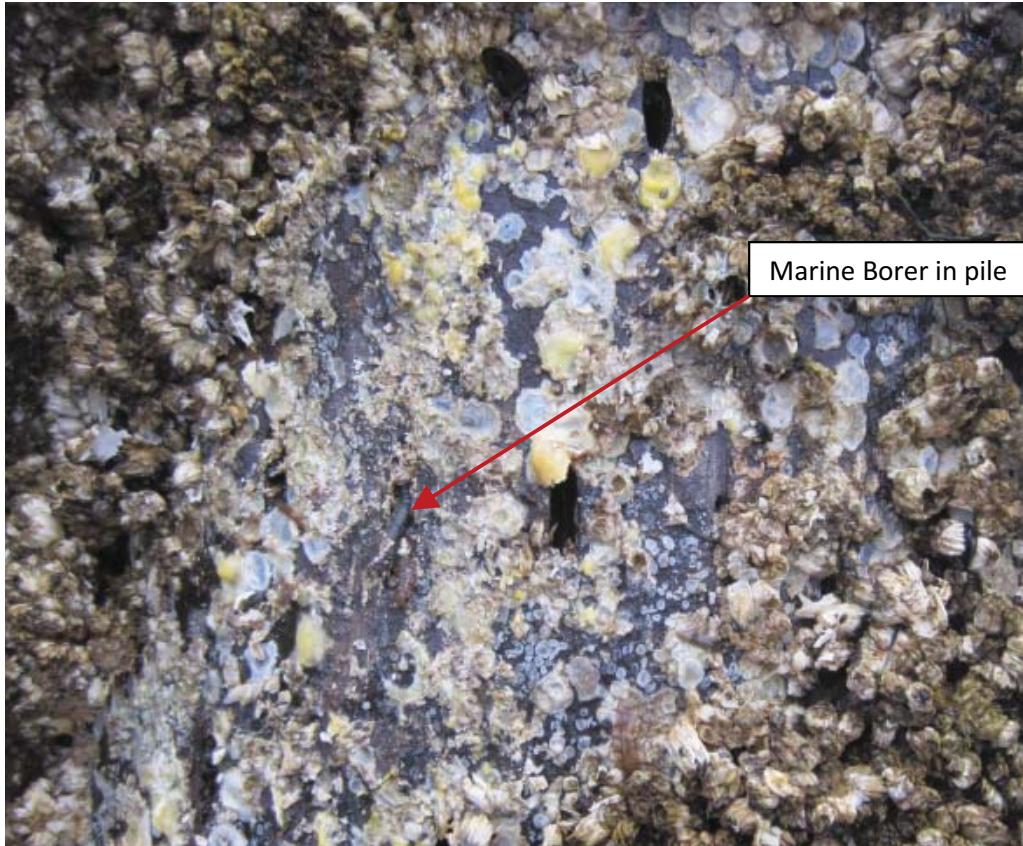
At the Northeast dolphin the handle of the hammer was inserted approximately 16" through the hole in the fender material to the backside of one of the exterior piles (**photos 5 & 6**). At another exterior pile a hole that appeared to have marine life living in it was observed (**photo 3**). A different exterior pile had several small holes with marine borers coming out of them (**photo 4**).

Photo 4: Mainland Ferry Terminal, Northeast Dolphin

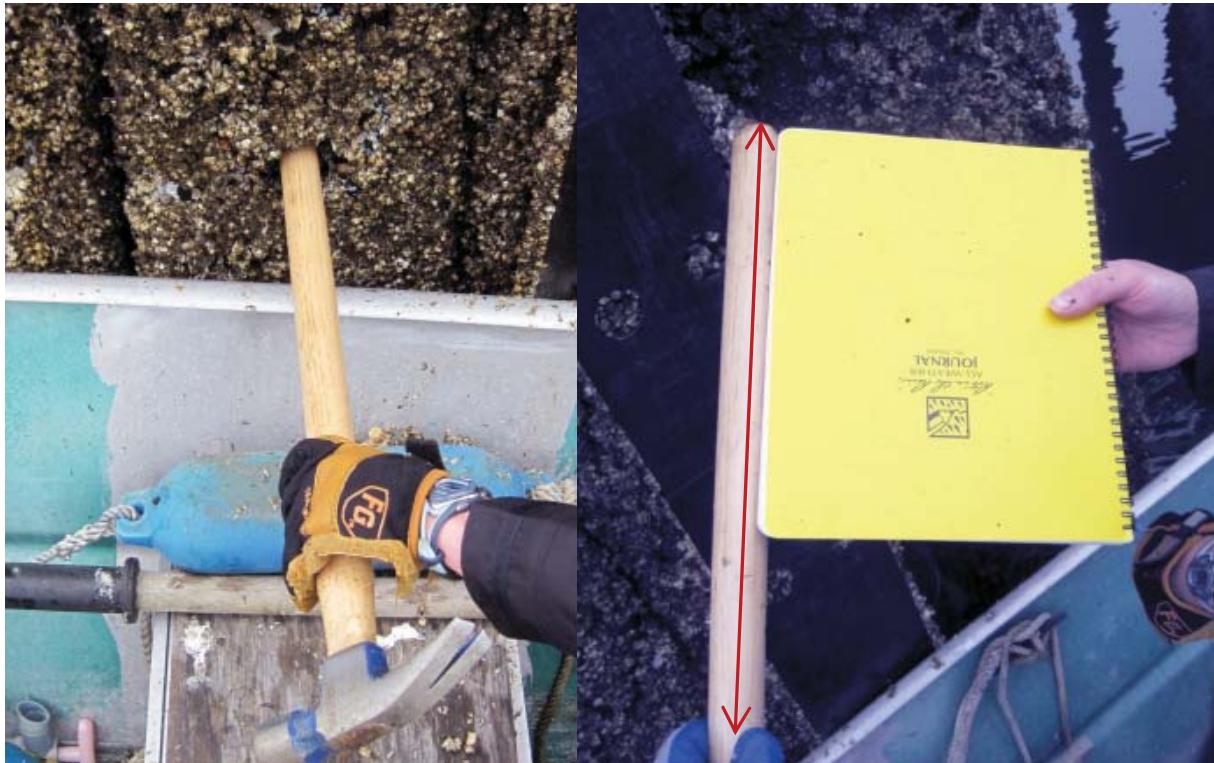
Photo 5: Mainland Ferry Terminal,
Northeast Dolphin: Hammer in hole

Photo 6: Mainland Ferry Terminal, Northeast
Dolphin: Length of hammer in hole

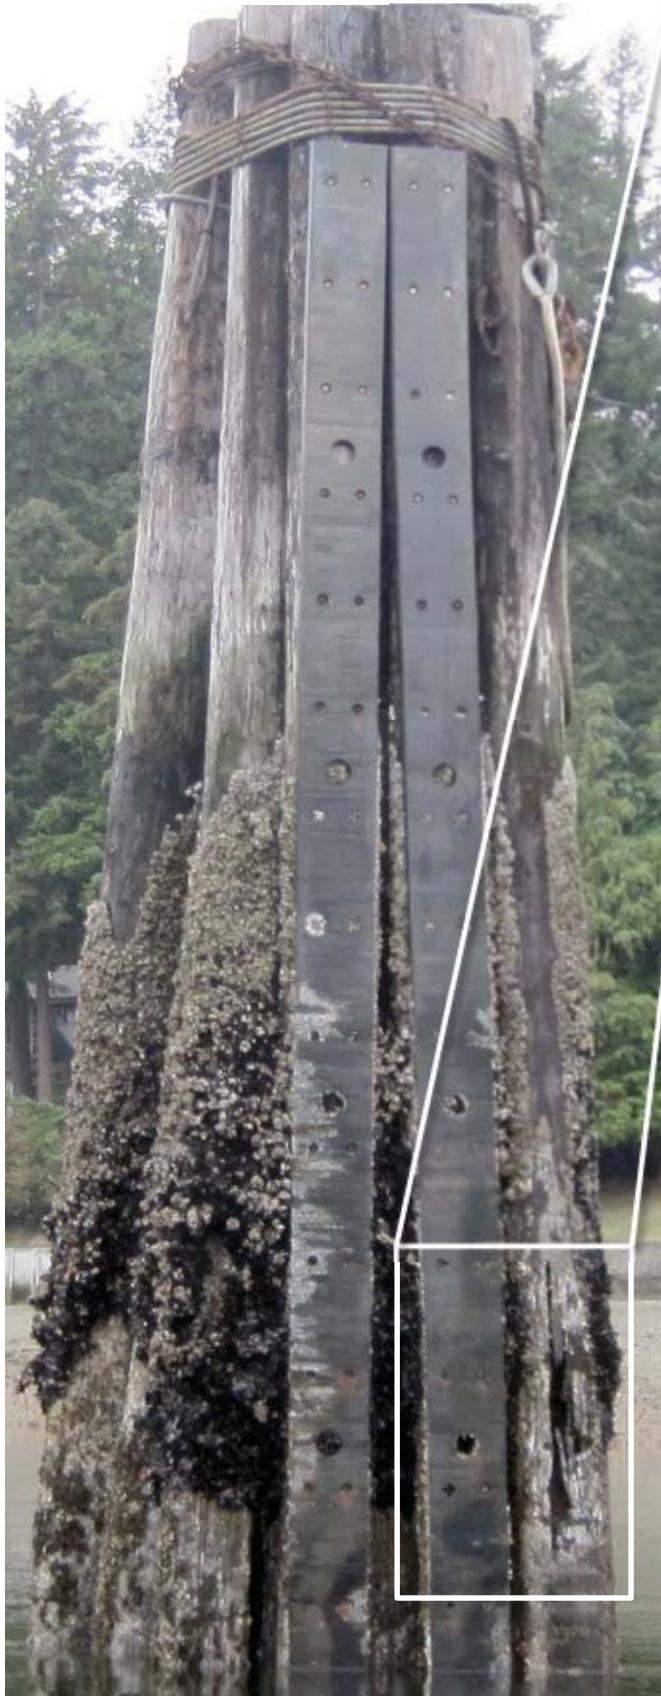
The Southwest dolphin is in the worst condition of all of the dolphins. The center pile is 99% deteriorated (**photo 10**). On the fender side, one of the piles is 50% deteriorated (**photos 7 & 8**) and on the west side 2 of the piles are considered to have no reliable capacity (**photo 9**).

Photo 7: Island Ferry Terminal, Southwest
Dolphin

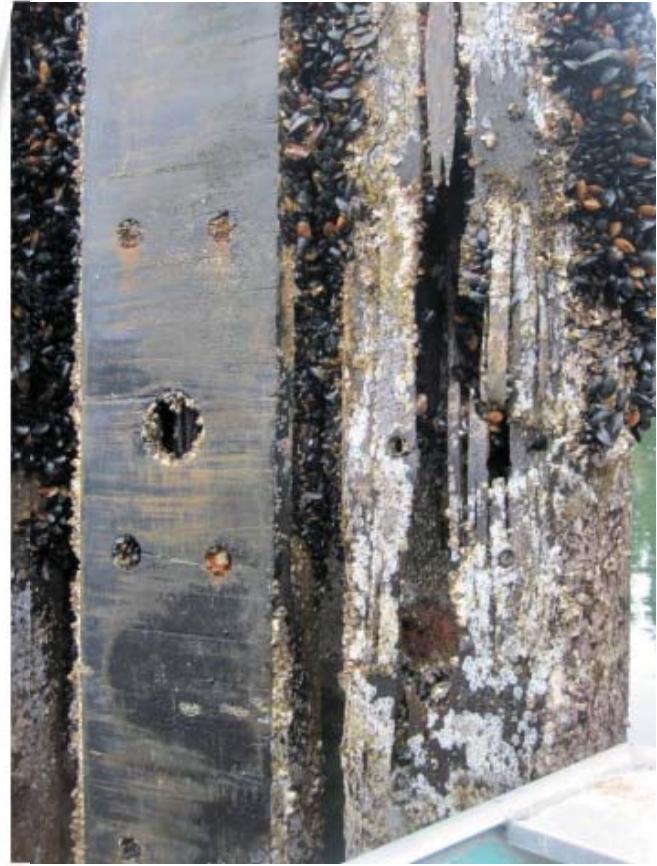
Photo 8: Island Ferry Terminal, Southwest
Dolphin

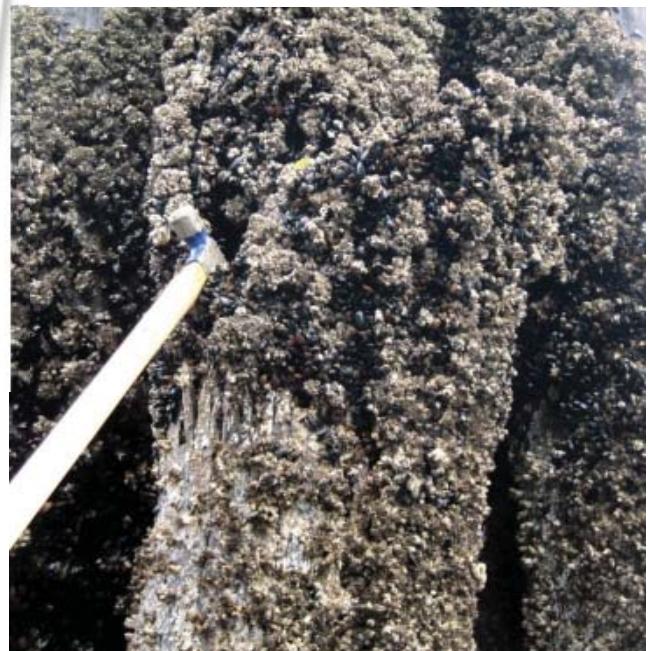
Photo 9: Island Ferry Terminal, Southwest
Dolphin, Broken Pile

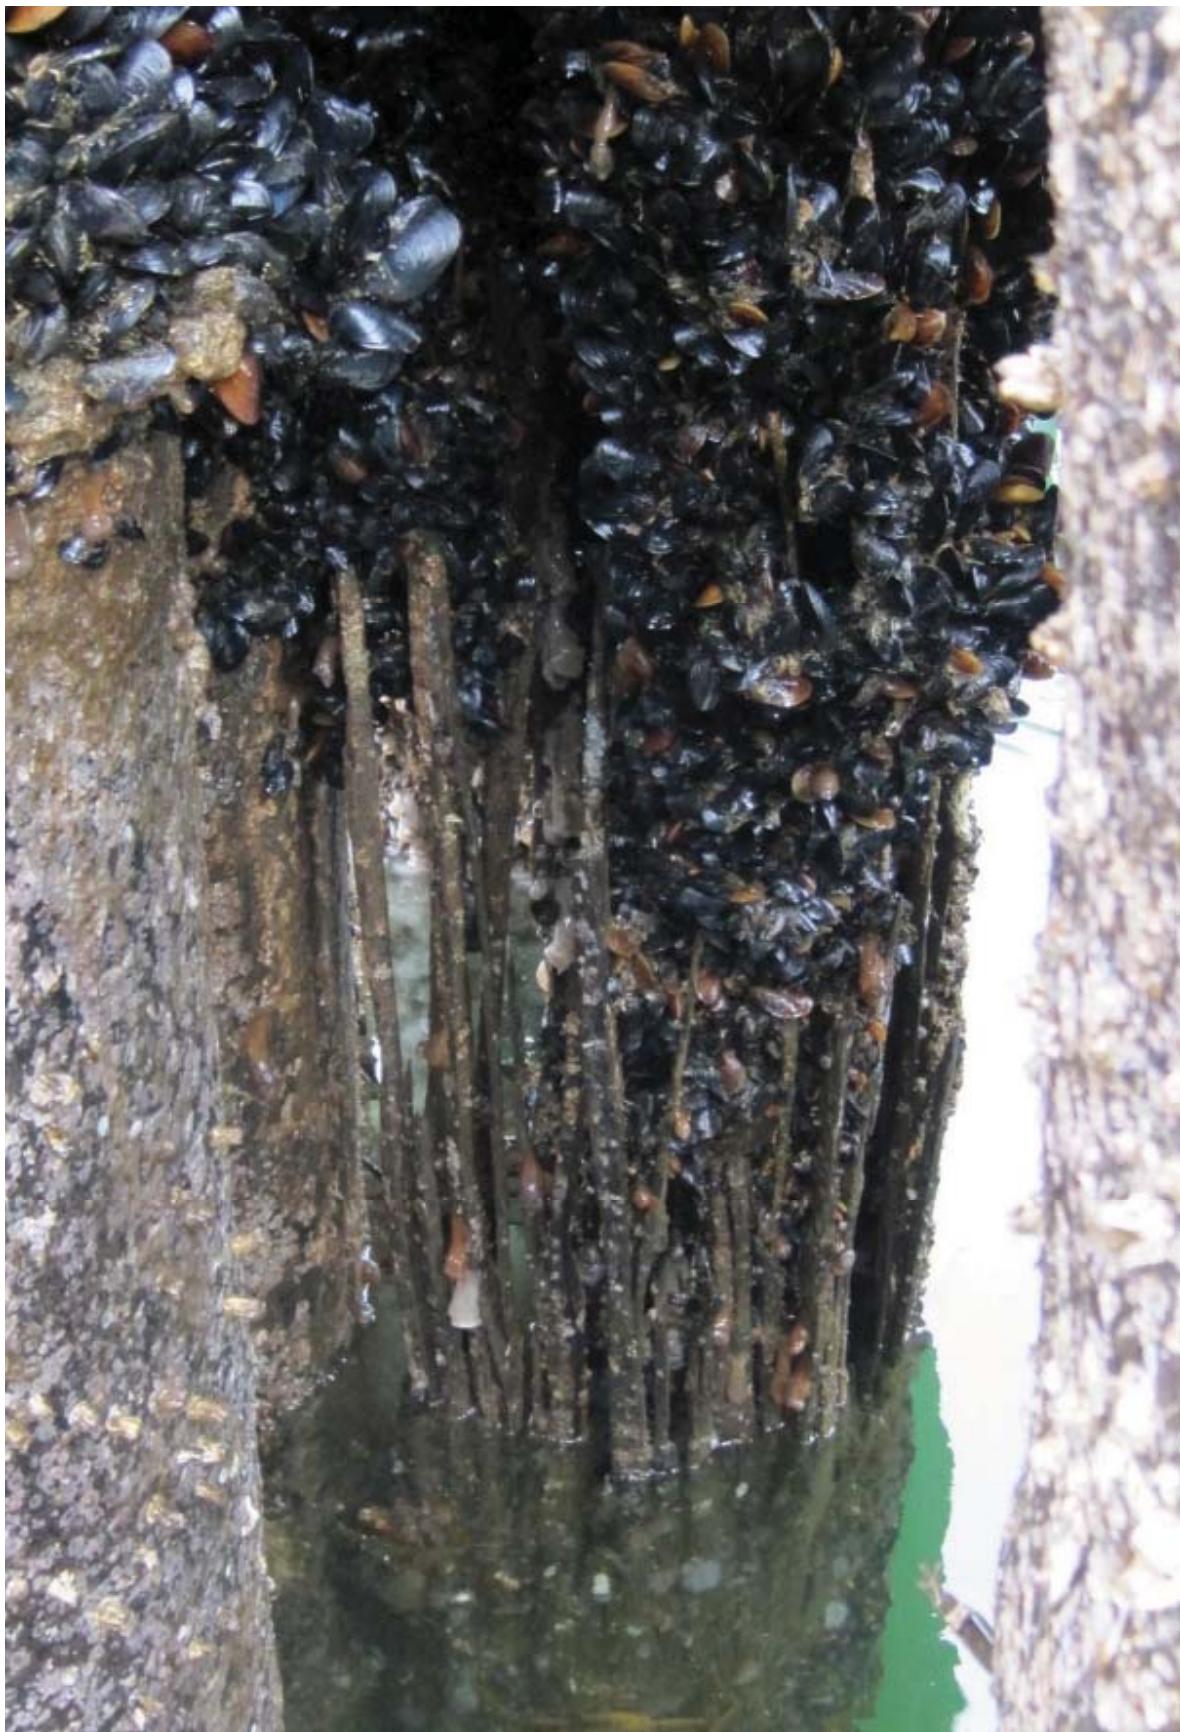
Photo 10: Island Ferry Terminal, Southwest Dolphin: 99% Deteriorated Pile

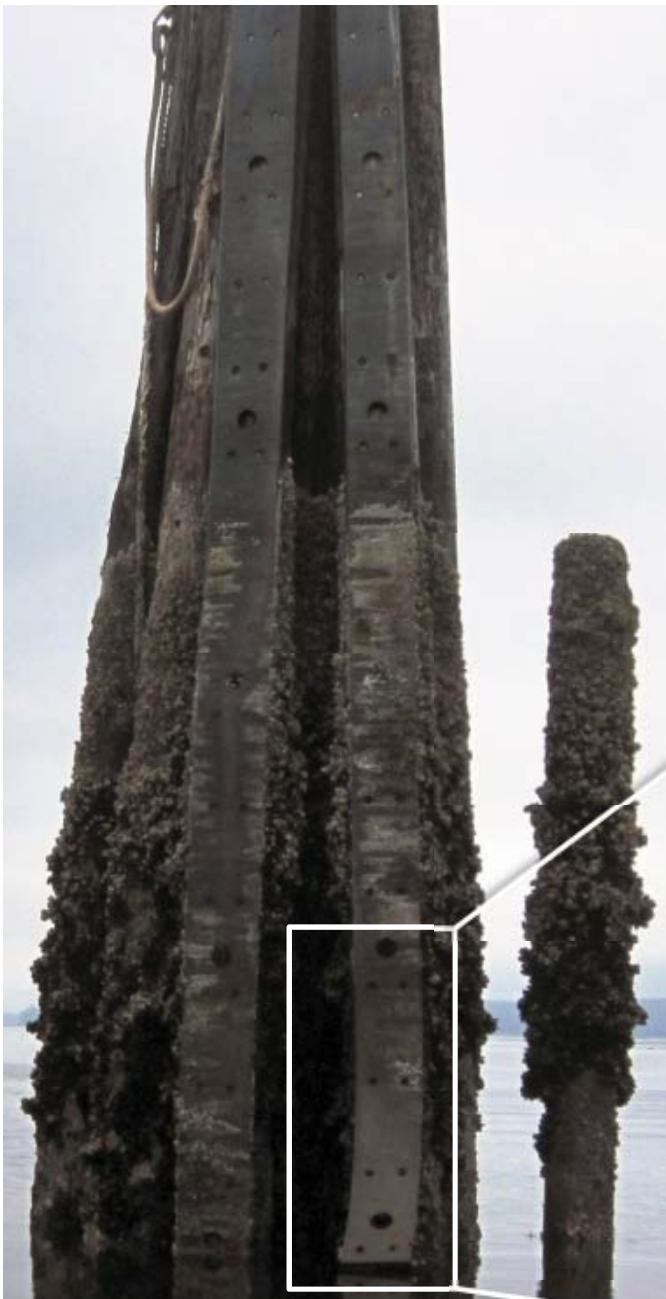
The Southeast dolphin (**photo 11**) also has a severely deteriorated center pile. The fender material from one of the piles was able to be pulled back to reveal that

Photo 11: Island Ferry Terminal, Southeast
Dolphin

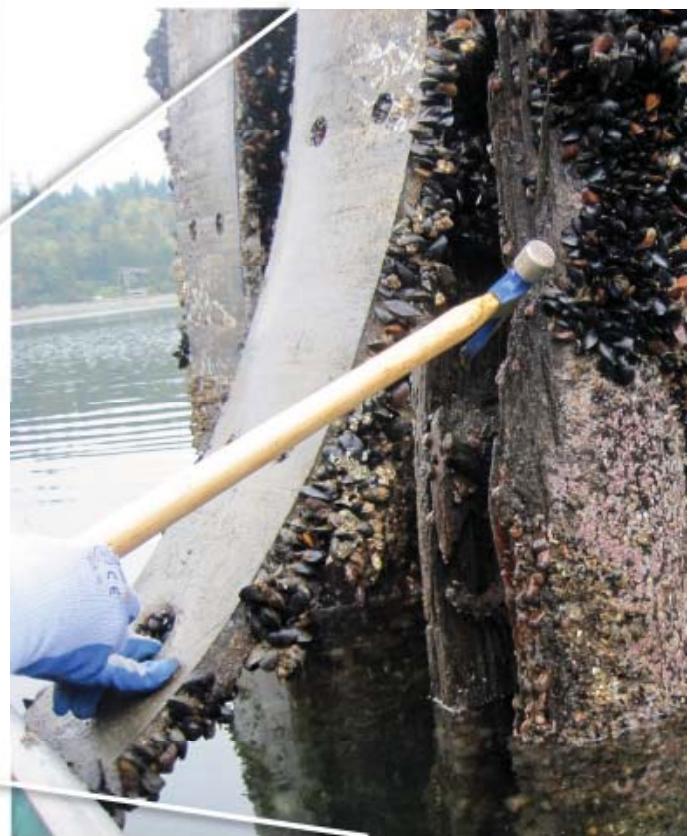
Photo 12: Island Ferry Terminal, Southeast
Dolphin: Section loss at fender

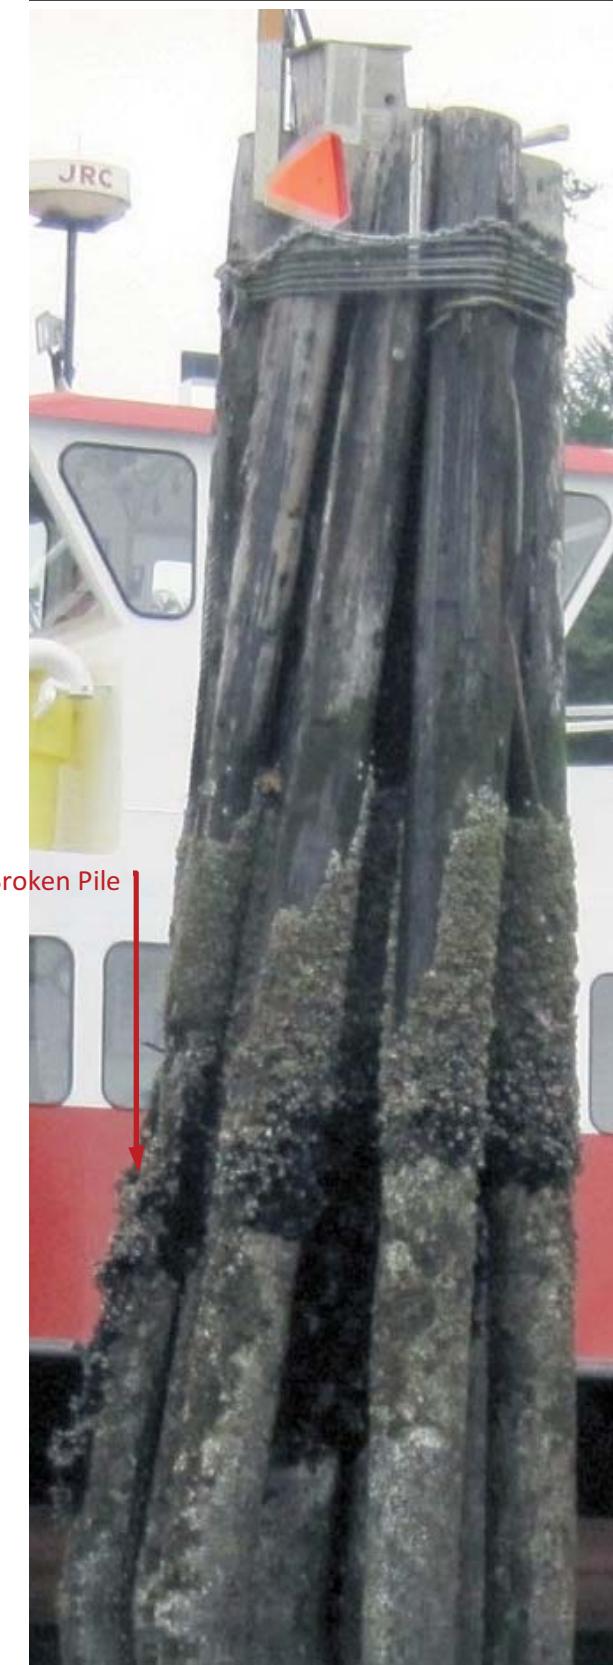
The Northeast dolphin (**photo 13**) has one severely deteriorated, broken pile on the east side, but the remaining piles are in fair condition. Based on hammer soundings, the piles are deteriorated at about the mean tide level.

Broken Pile

Photo 13: Island Ferry Terminal,
Northeast Dolphin

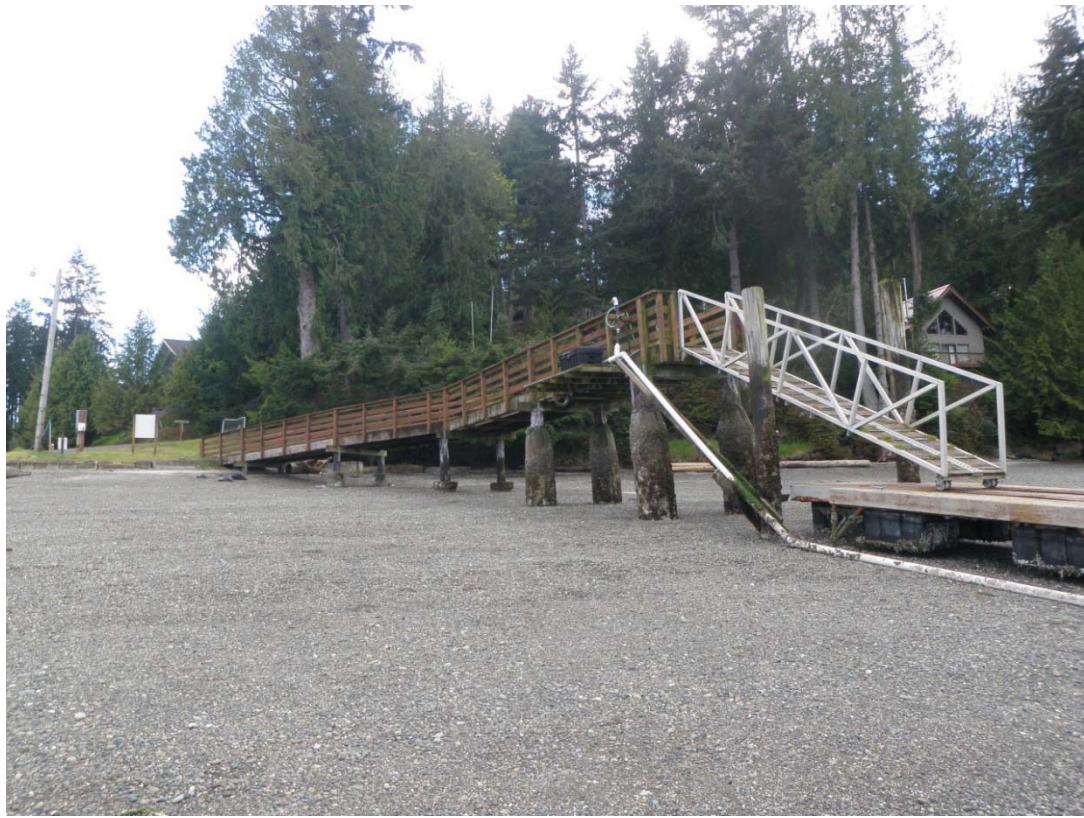
- **North Beach Marina Timber Trestle:** The timber framing of the fixed trestle is generally in good condition. See **Photo #1 and #2**. Wood members were observed to be sound from probing and hammer sounding. All of the timber piles supporting the trestle were also observed to be sound. Two of the four concrete pipes that the trestle piles are cast in are deteriorated and breaking apart. See **Photo #3**. The other two concrete pipes are covered with marine growth. See **Photo #4**.

Photo 1 Timber Trestle at North Beach Marina at low tide

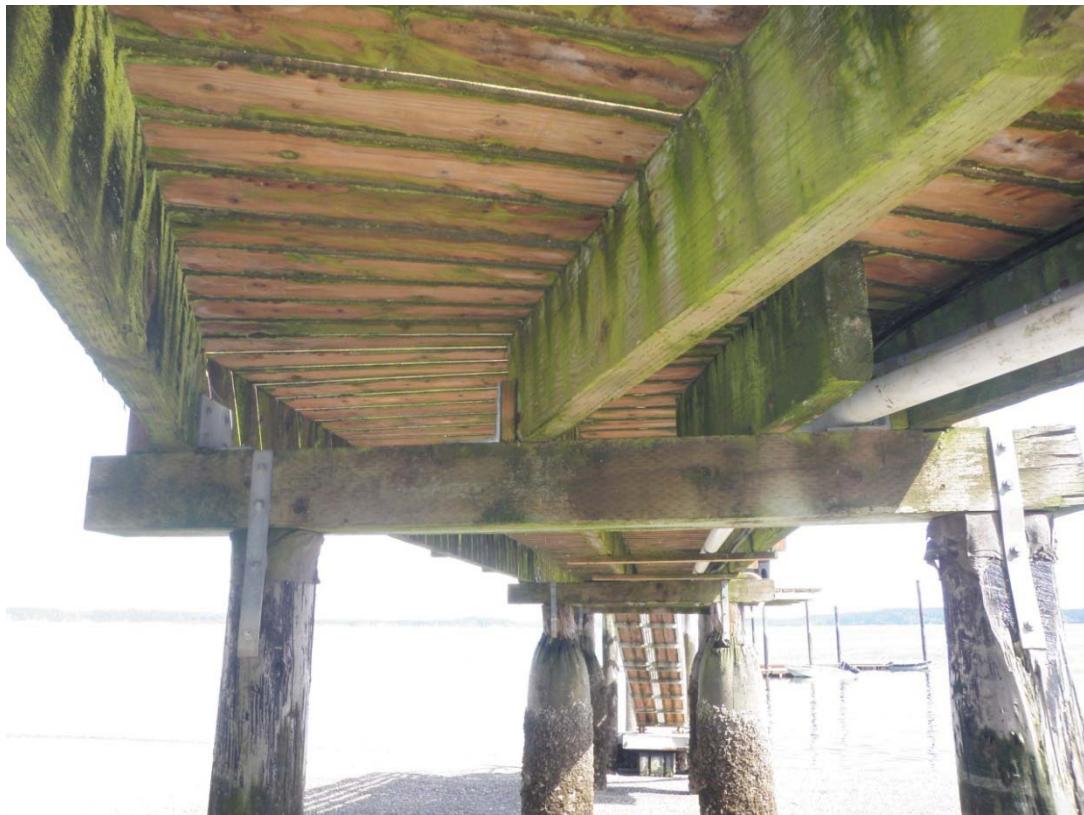
Photo 2 Underside view of Timber Trestle

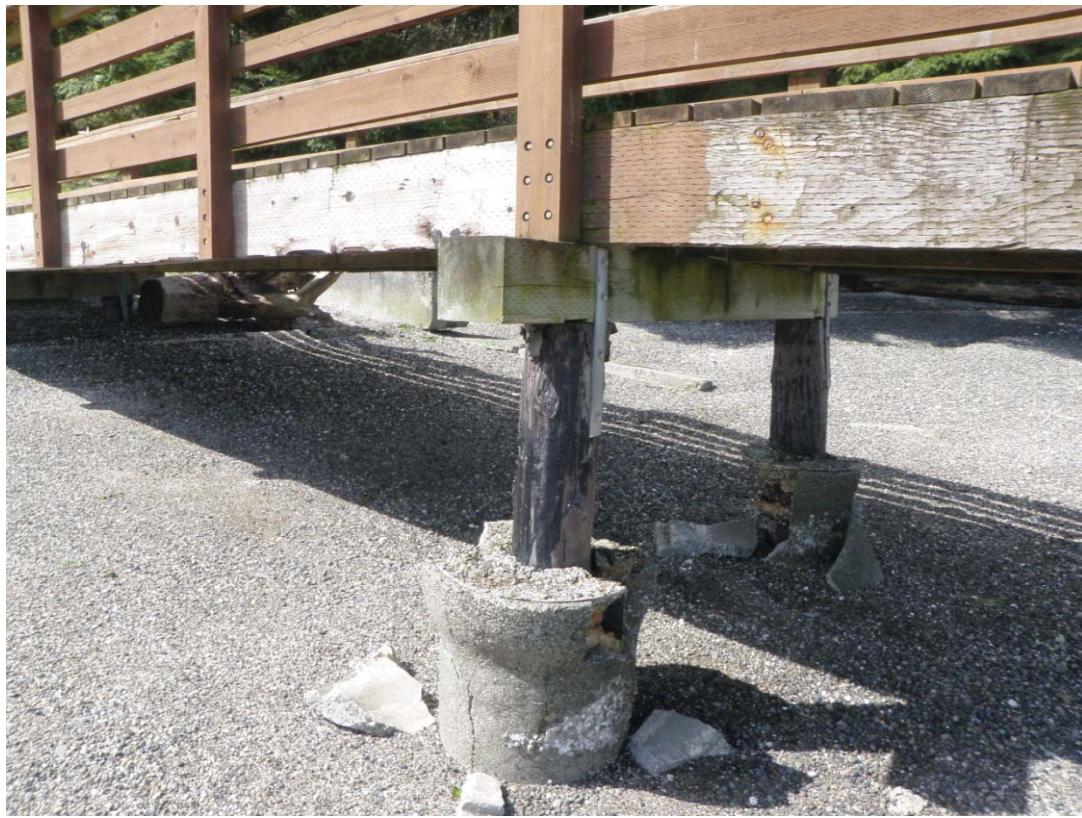
Photo 3 Broken concrete trestle piles set in broken concrete pipe

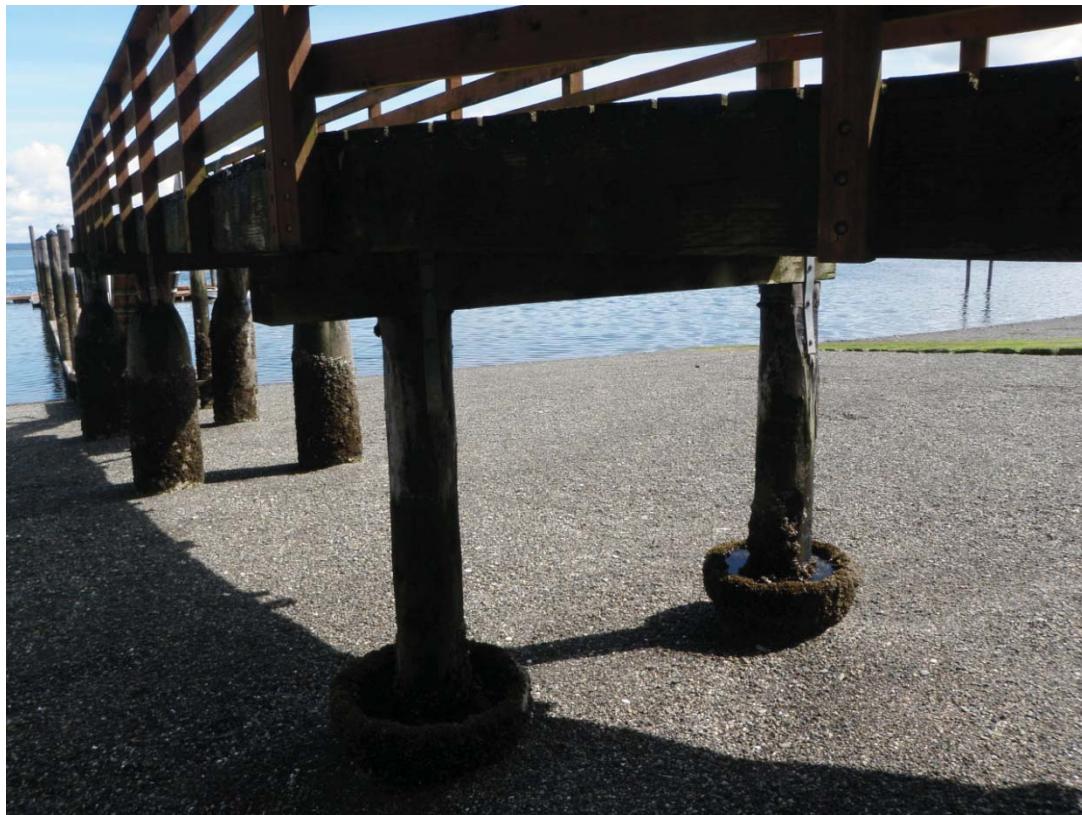
Photo 4 Timber Trestle

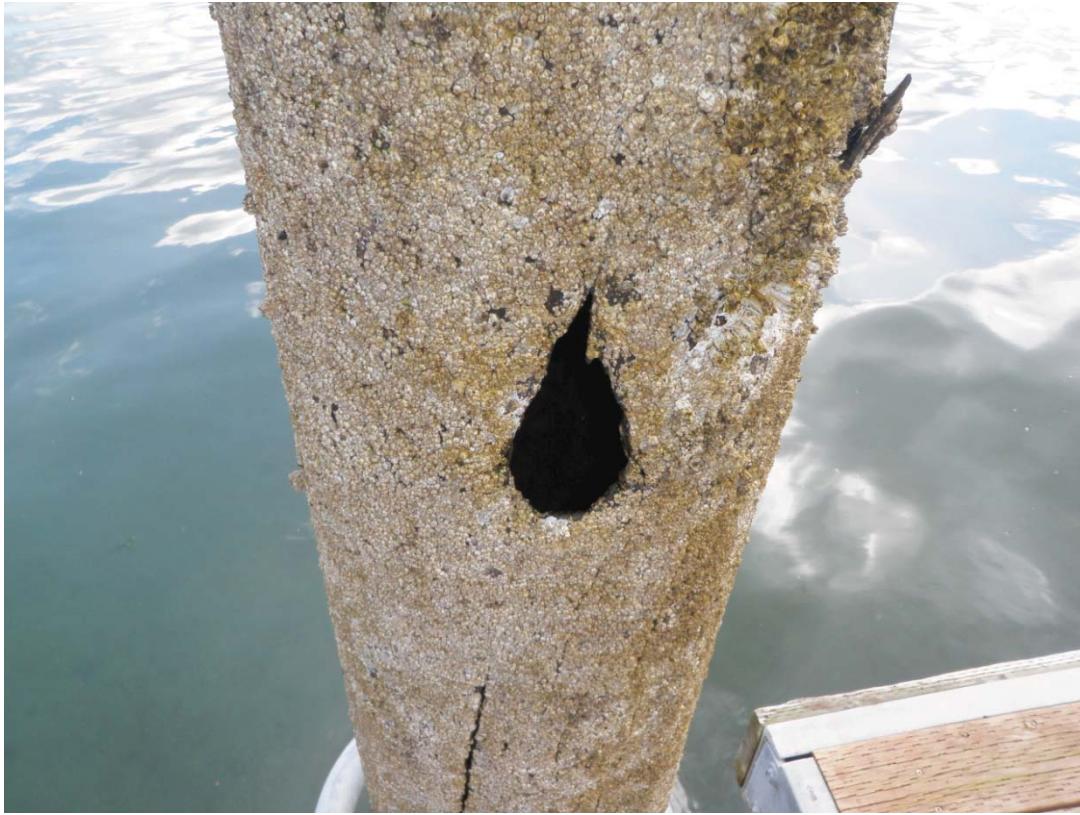
- **North Beach Marina Timber piles:** Of the 29 piles, six piles were visually observed to have significant deterioration. See **Photos #5, #6, and #7** for examples of such conditions. An additional five piles were observed by hammer sounding to have some interior deterioration. At these five piles core samples were taken to observe the interior condition of the timber. In some of the core samples, the timber was observed to show signs of decay. In some instances, clear water flowed freely from the hole created from taking the core sample indicating that a void exists at the interior. Similar conditions were observed at the two piles to the East of the boat dock. Due to tide conditions at the time of the field work, KPFF

Photo 5 North Beach Marina Boat Dock example of deteriorated Pile

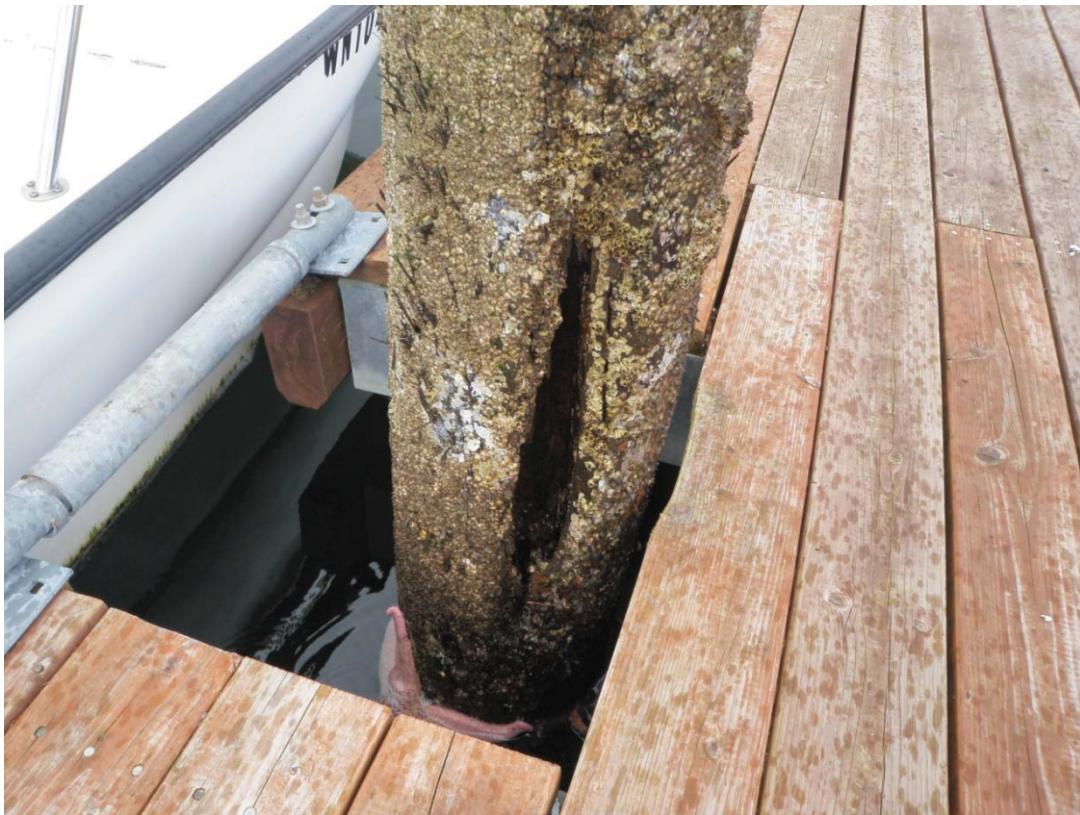
Photo 6 North Beach Marina Boat Dock example of deteriorated Pile

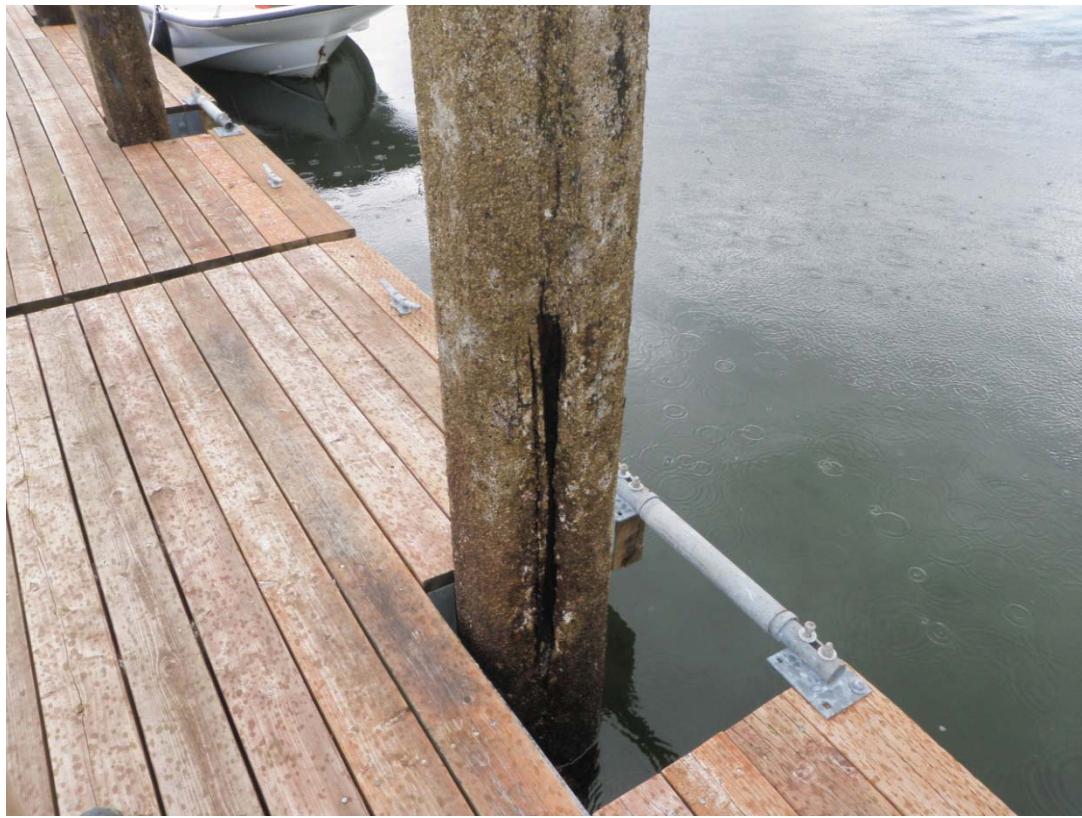
Photo 7 North Beach Marina Boat Dock example of deteriorated Pile

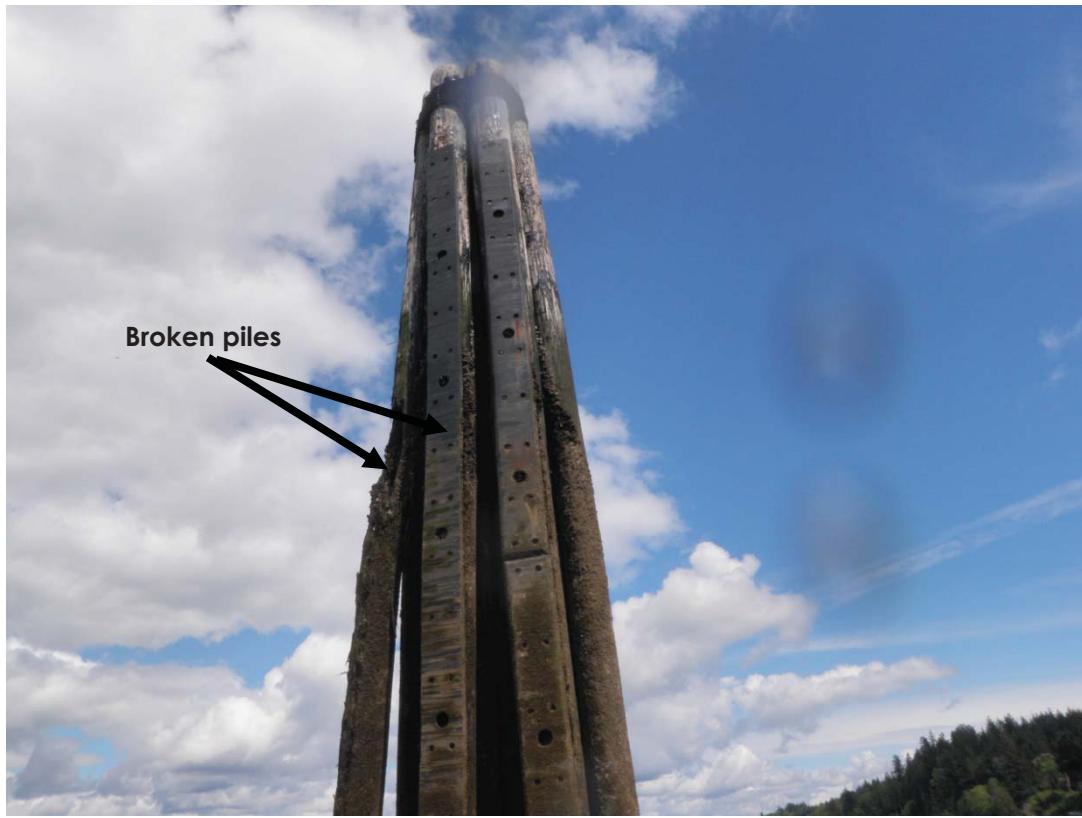
- **Mainland Ferry Terminal Dolphins:** Observations indicate that the outermost piles that were added in 1999 are mostly in good condition, with exception of two of the piles in the Northwest dolphin. It is our understanding that the Northwest dolphin receives the most impact from the ferry and from observation the two piles in question are the first to come in contact with the incoming ferry. These two piles were observed to deflect due to impact from the incoming ferry to such

an extent that they are considered to have little remaining strength. See **Photo #8**. However, the dolphin as a whole was observed to be solid.

Photo 8 North-West timber dolphin at the Mainland Ferry Terminal

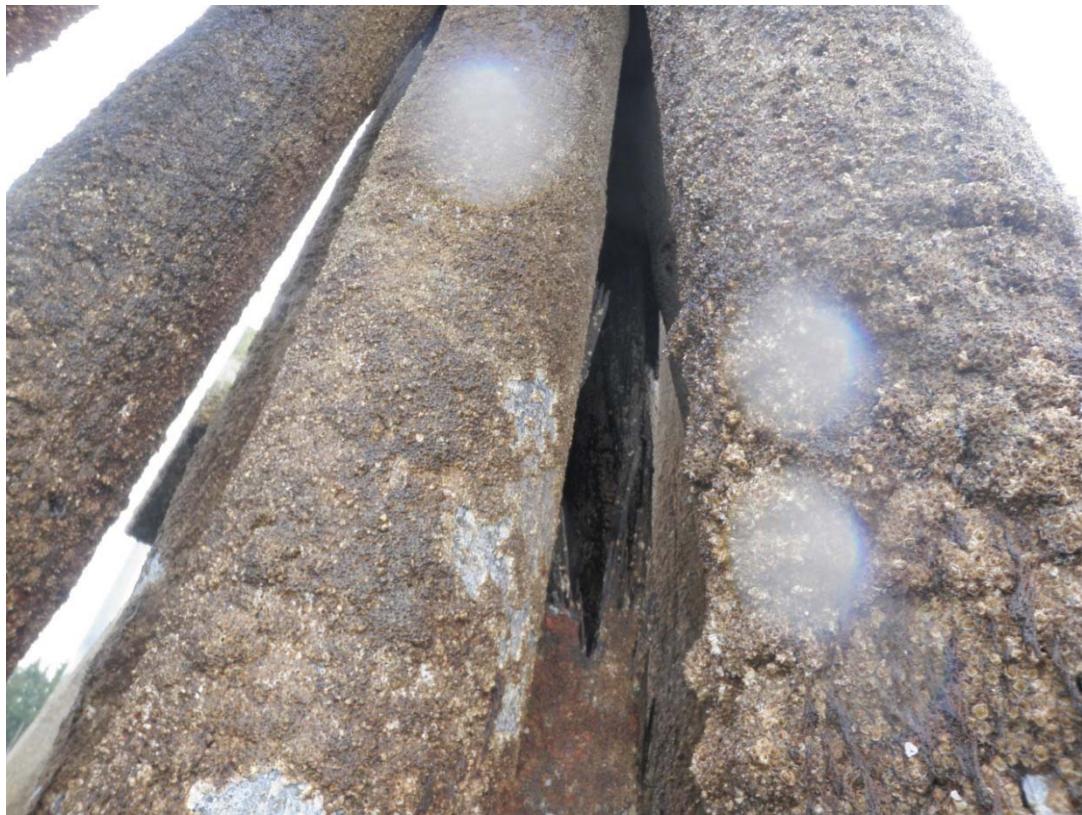
In all of the dolphins, deteriorated piles were observed. In most instances the deteriorated piles were at the interior of the cluster. See **Photos #9 and #10**. With the exception stated previously, the perimeter piles were observed to be in good condition by means of hammer sounding and probing.

Photo 9 Typical example of timber dolphins with deteriorated interior pile

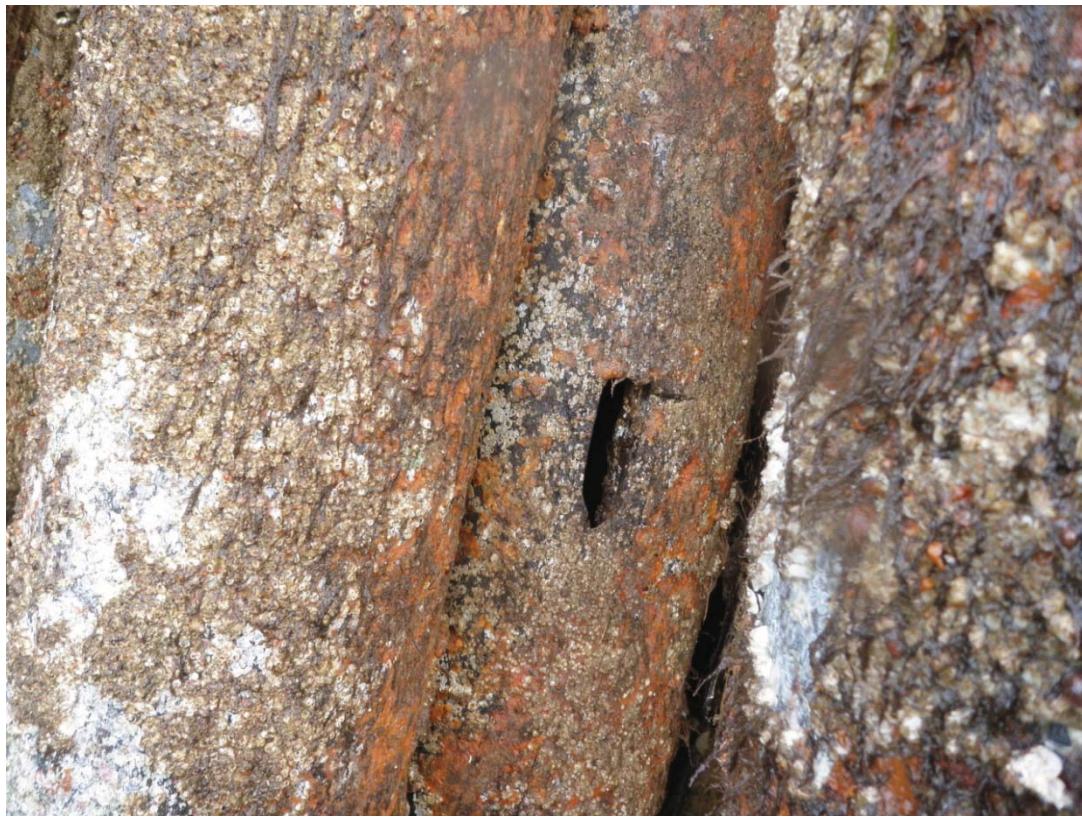
Photo 10 Typical example of timber dolphins with deteriorated interior pile

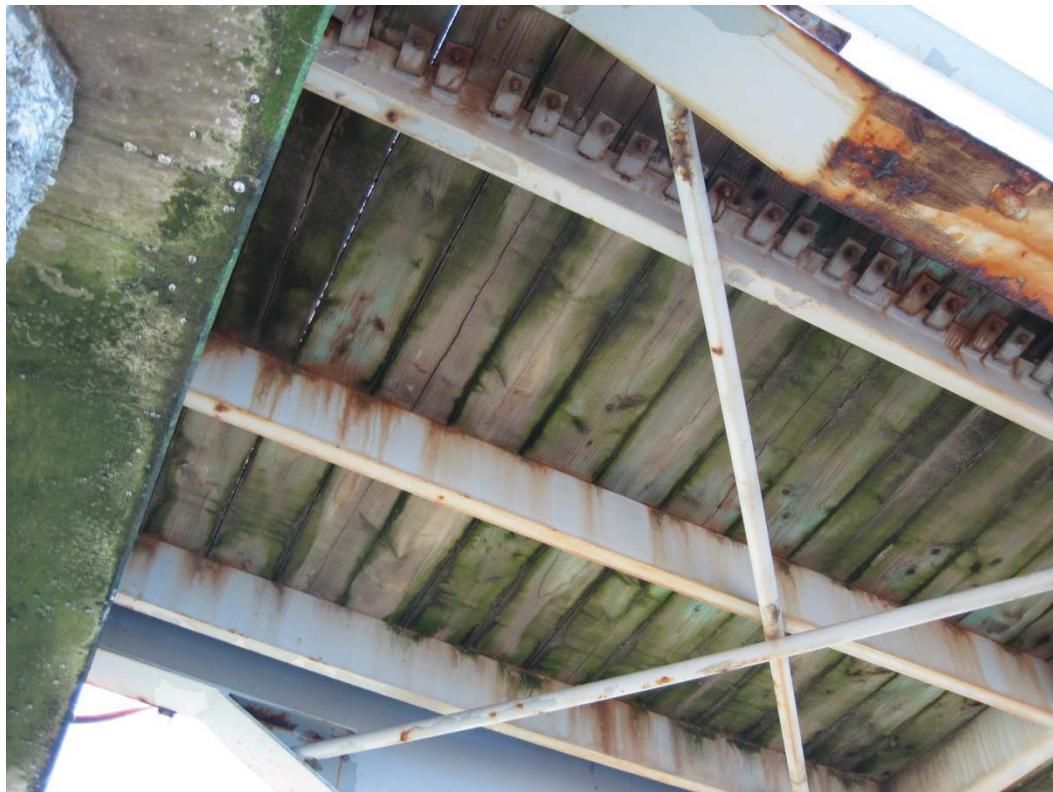
"The painted steel stringer has rust stains washing down from the seam between stringers and the deck. Vehicle traffic is most likely causing the deck planks to wear the paint from the tops of the stringers. Several stringers have dark rust stains along their weld connections to the floor beams. No significant corrosion was observed in these joints or on the stringers. There are many local paint failures throughout the stringers, allowing surface corrosion. There are two main girders in this span. These girders are considered fracture critical because they are steel and there is no load path redundancy. I.E., if one girder were to fail, the entire span would fail. The girders appear to receive more salt spray than the stringers and girders, as a result there are several areas of blistering paint and surface corrosion. Most blistering is along the bottom flange of the girders." (pg. 3), (See Photo #11)

Photo 11 Underside view of steel draw span

- FT-4:** The scope of option FT-4 includes spot cleaning the deteriorated areas of paint on the steel draw span and repainting the entire draw span (does not include stripping of paint if good condition). This would require the removal of the timber decking and the galvanized guardrail. In order to minimize the impact to island residence, the work for this option would be scheduled to coincide with the ferry maintenance schedule. Therefore, the contractor would be required to deliver all materials to the island before the ferry is taken out of service. The contractor would then have to access the island by use of a small boat. This access restriction will increase the cost. Therefore, the cost estimate for this work is separated by the Mainland terminal and the Island terminal. The estimated cost for this option at the Mainland side terminal is \$91,000. The estimated cost for this option at the island side terminal is \$121,000. The cost estimates include overtime costs to limit the work period to two weeks.
