## Update “With Site-Visit” Reserve Study

## HMC Management Lakebay, WA

Report #: 24901-3  
For Period Beginning: October 1, 2016  
Expires: September 30, 2017

Date Prepared: June 2, 2016

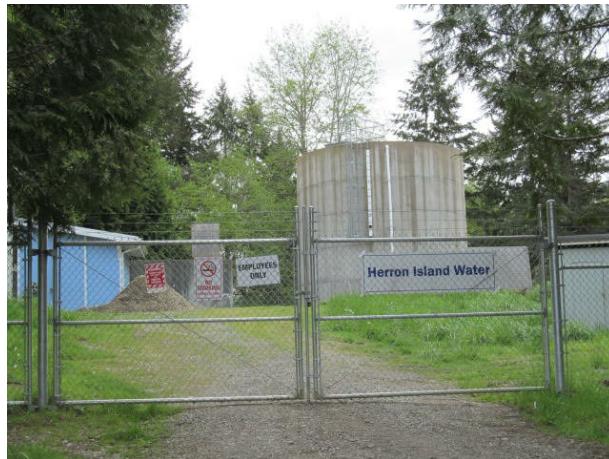
**Comp #:** 100 Water System - Maintain/Repair      **Quantity:** Extensive systems

Evaluation: Herron Island has an extensive water system, which is a separate entity with a segregated budget/reserves. Extensive 2012 renovation at expense of \$1,738,000 was indicated. Any assets needed to sustain that operation are not included within the scope of this analysis; no impact upon HMC maintenance reserves is factored.

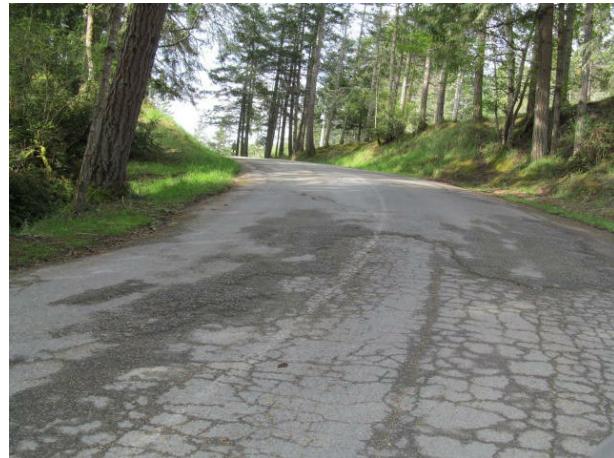
Evaluation: Note; an access easement was observed at the Mainland Terminal but assumption is that the asphalt road (Isted) is maintained by Pierce County, so no impact upon reserves needs to be factored for that location. Otherwise, the only area of HMC asphalt exhibited general deterioration and wear along with local alligatoring (cracking) and damage. Anticipate renovation, resurface project in the near future. Expect some full depth repairs and underlying improvements will be needed. After resurface, provide timely cycles of inspection, cleaning and spot repair when needed for maximum design life; fund from the operating budget.

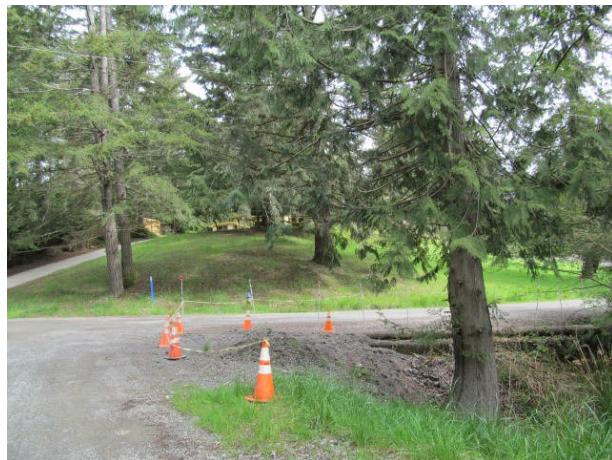
<b>Comp #:</b>	<b>204 Gravel Roads/Lots - Maintain/Repair</b>	<b>Quantity:</b>	<b>Approx 500,000 surface SF</b>
Funded?:	Yes. Meets National Reserve Study Standards criteria for Reserve Funding		
History:	Delivery of barge loads of gravel occurred last in FY 2014/2015 at an expense of ~\$42,300		
Location:	Common areas, Island and Mainland		
Evaluation:	Majority of surfaces are without significant damage or instability but local repair needs were indicated. Gravel-topped access and parking areas have historically received annual maintenance from the operating budget. Delivery of barge loads of gravel occurred last in FY 2014/2015 at an expense of ~\$42,300 to facilitate such. Reserve funding is factored for gravel delivery roughly every 5 years going forward. We assume provision for other significant expenses for surface grading, application of gravel, vegetation control, dust control, local road and drainage repairs will continue as annual maintenance items. Update in future reserve study updates as conditions merit.

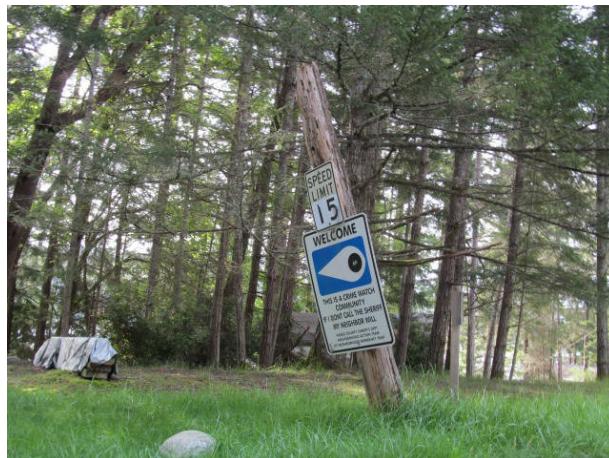
Evaluation: Assorted ages/types of signs in varying condition. Majority are fair and legible; some local repair needs and appearance of the small "Welcome To Herron Island" sign would benefit from refurbishing. Evaluate all regularly, repair and replace individually or in small groupings from the operating budget.

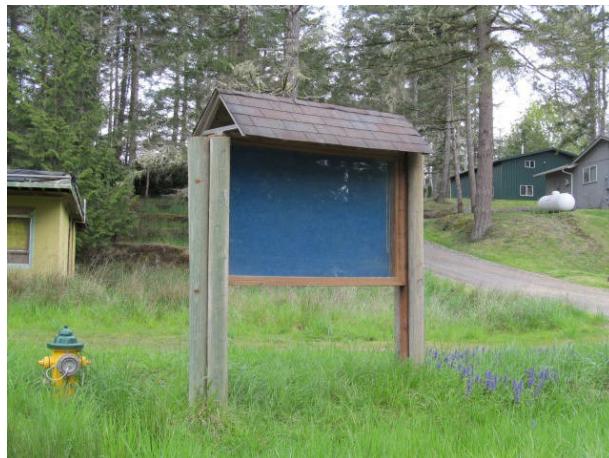
Evaluation: Stable condition continues. Ongoing maintenance should include considerations for uniform aesthetics to ensure quality appearance. Individual replacement expense is too small for reserve designation.

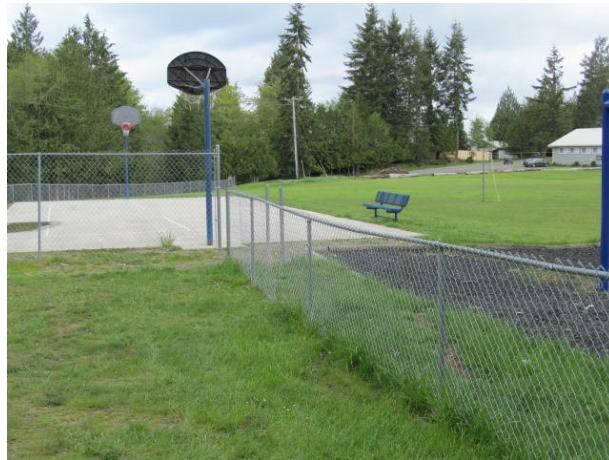
Evaluation: Assorted ages and condition for small quantity of chain link fencing. Addition by basketball court, playground and also replacement where former locations with old telephone poles were used as border in FY 2014/2015 at reported expense of only \$2,800 (materials only). Mainland generator fencing was installed in 2007 and is fair condition. Older fencing at Goodpastor Park backstop is without instability but exhibits general deterioration and some surface corrosion. Inspect, repair and replace individual locations as needed from operating funds. No reserve funding suggested. Note; fencing near Ferry access road is excluded since it belongs to Pugh family (easement over HMC property) .

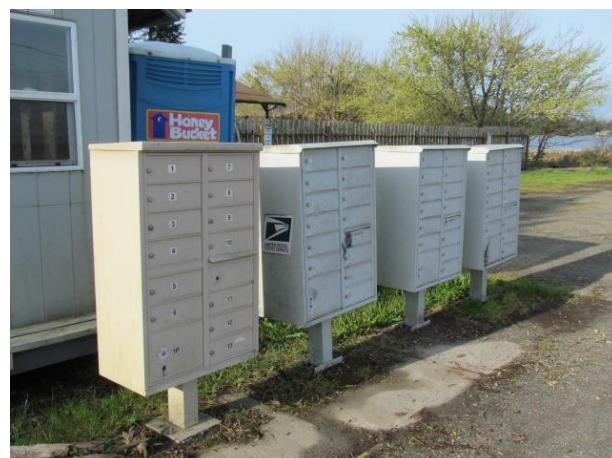
Evaluation: Age and condition varies somewhat. Research informed us that individual lot owners that are benefited are responsible to maintain, repair and replace these mailbox clusters. In our experience, typical installed cost for each cluster is ~\$1,400 but no HMC reserve funding is required with present assignment of expense.

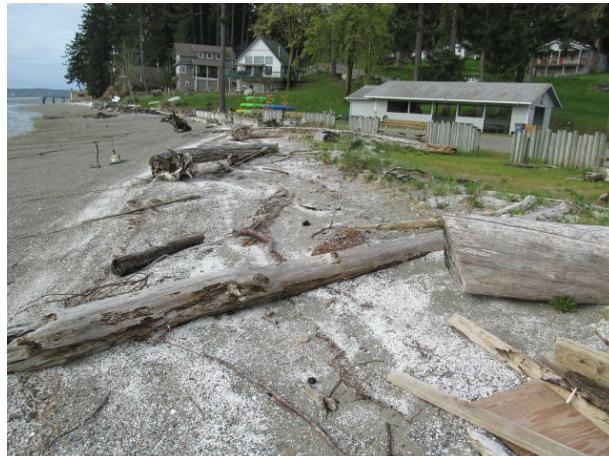
<b>Comp #:</b>	<b>300 Beach Armor/Bulkhead - Add</b>	<b>Quantity:</b>	<b>Extensive square feet</b>
Funded?:	No. Annual cost best handled as operating expense		
History:			
Location:	North Beach		
Evaluation:	Some concern with erosion were indicated for North Beach area. No anticipation for large scale project to add significant additional structures for beach armor or bulkheads at the moment. Current plan is to improve drainage measure and rehabilitate landscaping as operating budget items in the near term. Carefully track needs, expense patterns and update in future reserve updates as conditions merit. Note; image is only representative of general area; not necessarily indicative of project needs.

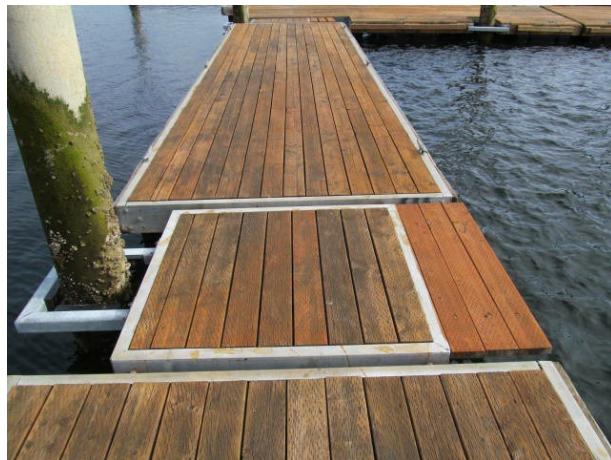
Evaluation: Varying levels of general aging and deterioration were observed; overall fair condition. Historical maintenance includes prudent measure of annual removal for storm season, cleaning and minor repair utilizing volunteers and operating budget. Retaining collars were replaced in 2012. It is our understanding that substantial replacement occurred last in 1997 along with another project in 2006 for finger expansion indicated. Going forward, continue to provide ongoing maintenance as operating budget item but anticipate eventual significant replacement (structural members, floats, deck boards, etc...) intervals at roughly the 20-30 time frame indicated below to ensure safety and quality appearance.

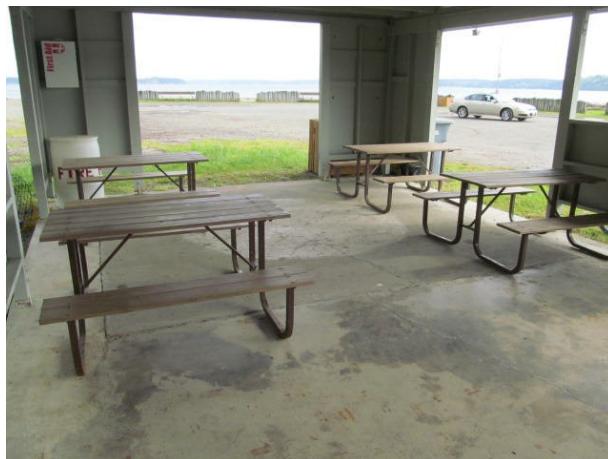
Evaluation: Age, condition and type of picnic assets vary; most are still in fair condition. No large scale additions/replacements reported since our previous 2.19.2013 site inspection. It is our understanding that some picnic assets have been donated and that volunteer labor has historically occurred as well. No other specific cost or project history was provided. No anticipation for reserve expenditure; timely replacements (under \$6,000 threshold) should occur as annual operating item to maintain a quality, uniform aesthetic.

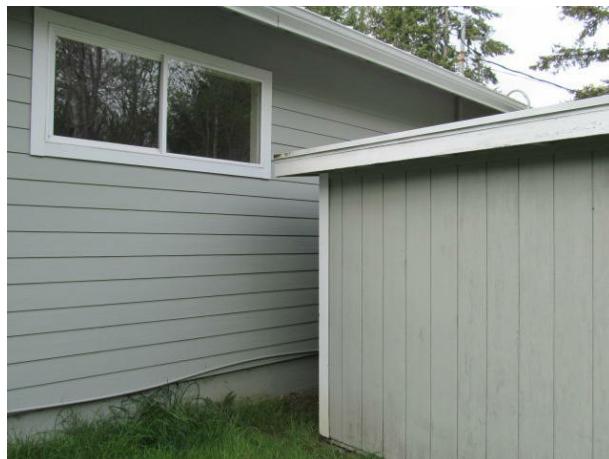
Evaluation: Surface finishes upon building were in good condition; painting reportedly occurred last in FY 2015/2016 at expense of \$2,000. Adjacent shed appears to still need painting. Prior building exterior painting projects in FY 2005/2006 with installation of new siding and prior to that paint project was donated in 2000. In event, expense is too small to merit reserve funding even when professional contractor is selected. Treat as operating item as needed.

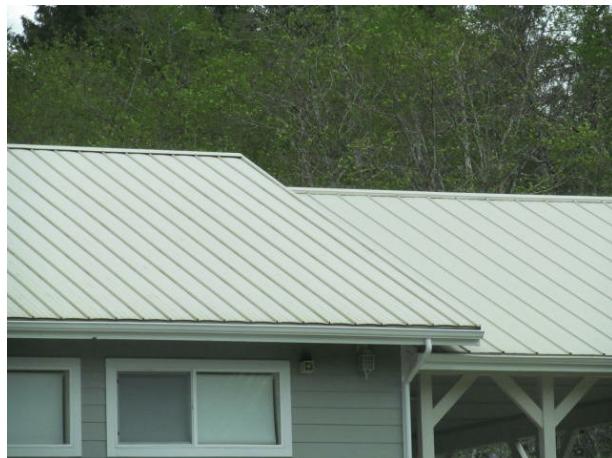
<b>Comp #:</b>	<b>430 Community Building Roof - Replace</b>	<b>Quantity:</b>	<b>Approx 2,700 GSF</b>
Funded?:	Yes. Meets National Reserve Study Standards criteria for Reserve Funding		
History:			
Location:	901 West Yew Blvd KPN		
Evaluation:	No apparent or reported problems. Metal roofing is a long lived product but eventual replacement near the 40 year mark of life due to typical material deterioration of roofing and underlayment is predictable. Also, replace gutter/downspouts along with this project. Long term budgeting dictates assumption for professional installations for this type of project.

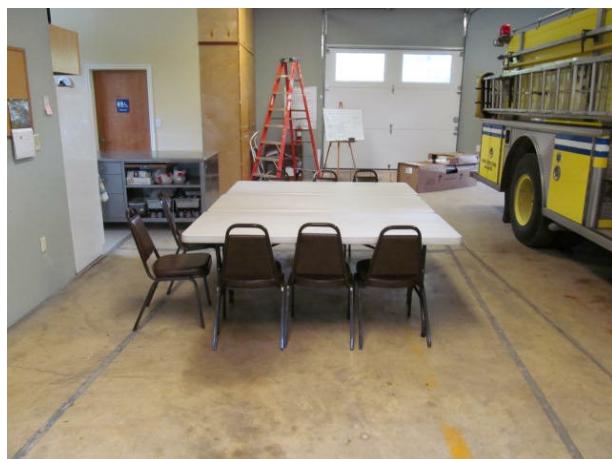
<b>Comp #:</b>	<b>450 Community Bldng Interior-Refinish</b>	<b>Quantity:</b>	<b>Moderate GSF</b>
Funded?:	No. Cost projected to be too small		
History:			
Location:	901 West Yew Blvd KPN		
Evaluation:	Utility appearance. Assumption regarding interior maintenance utilizing volunteers and/or operating funds will apply for individual projects such as repainting, furniture, lighting, assorted flooring, etc.... No reserve funding recommended under current pattern of care and level of interior finishing.

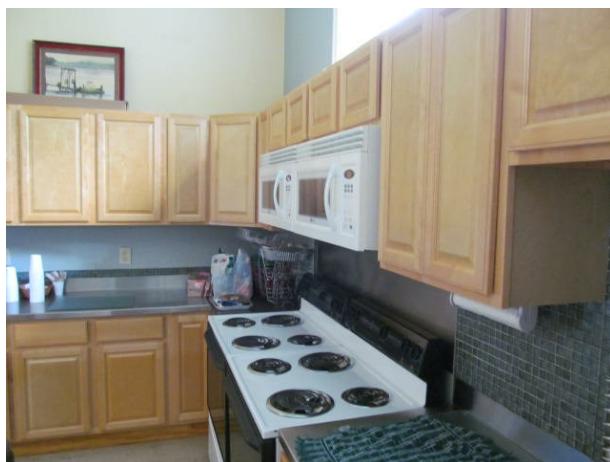
**Evaluation:** No signification changes apparent since our previous 2012 site inspection. Simple layout was clean and without noteworthy deterioration. Appliances of varying age and brand were apparent. The Maytag microwaves and the Whirlpool refrigerator were likely installed in 2005 or 2006 and the Crosley electric ranges appear to be older units. Large stainless steel work station was in fair condition; kitchen cabinets appeared to likewise. No desire for large scale refurbishing was expressed. Individual replacements of appliances, cabinetry, etc... are likely to continue as operating budget items.

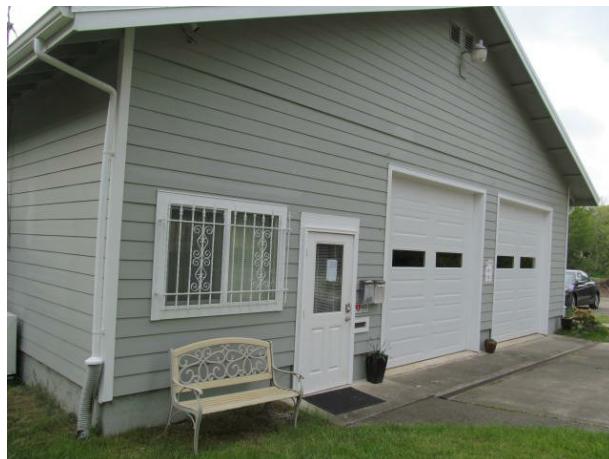
<b>Comp #:</b>	<b>464 CB Windows/Doors-Replace</b>	<b>Quantity:</b>	<b>Moderate quantity</b>
Funded?:	No. Annual cost best handled as operating expense		
History:			
Location:	901 West Yew Blvd KPN		
Evaluation:	Insulated garage doors replaced older units in 2012; volunteer (Booster Club) funds paid expense of \$3,100. Also, FY 2014/2015 improvement project to add another garage door at back of building (again with volunteer/Booster Club donations). Lastly, front door was replaced in FY 2014/2015 from operating monies. Otherwise, fair condition for small quantity of assorted windows and doors. Going forward, no anticipation of large scale expenses requiring reserve designation.

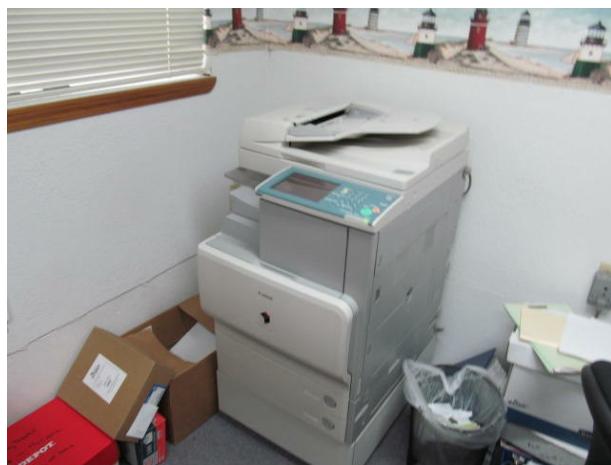
<b>Comp #:</b>	<b>510 Office Equipment/Furniture-Replace</b>	<b>Quantity:</b>	<b>Minor equipment</b>
Funded?:	No. Annual cost best handled as operating expense		
History:			
Location:	Community Building		
Evaluation:	Assorted ages and conditions apparent. Small quantity of office equipment includes a few desktop computers with monitors, some small all-in-ones and (1) large Canon C3380i printer. Schedule appears largely the same as our 2012 site inspection but research with Management confirmed community needs will likely continue to be met with individual equipment purchases treated as an operating expense. Note; surveillance system was added for Community Building in FY 2015/2016 at modest expense; treat future replacements as annual budget item.

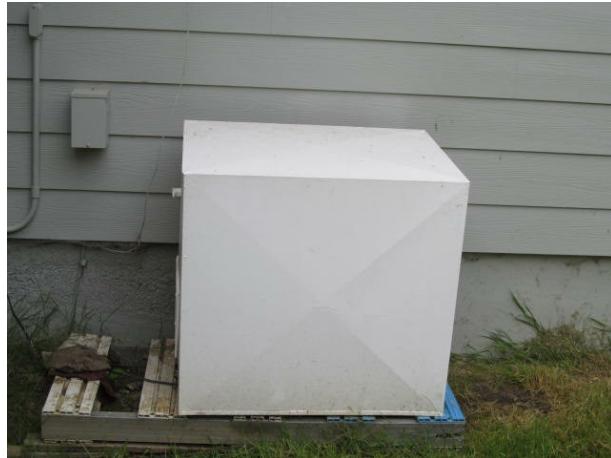
<b>Comp #:</b>	<b>520 Small Equipment/Tools - Replace</b>	<b>Quantity:</b>	<b>Minor equipment</b>
Funded?:	No. Annual cost best handled as operating expense		
History:			
Location:	Community and Pavilion Buildings		
Evaluation:	Small tools/equipment such as portable generator don't merit reserve designation. Evaluate such minor replacement needs as ongoing maintenance and provide from annual operating funds.

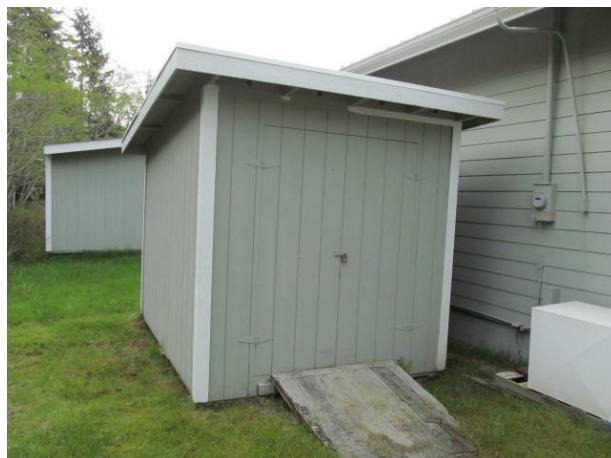
<b>Comp #:</b>	<b>530 Utility Tractor/Mower - Replace</b>	<b>Quantity:</b>	<b>(1) small riding mower</b>
Funded?:	No. Cost projected to be too small		
History:	2014/2015 replacement at only \$3,260 expense		
Location:	Community Building Shed		
Evaluation:	Storage shed was locked on date of scheduled site inspection; no image of equipment available. Small riding mower was reportedly purchased new in FY 2014/2015 at expense of \$3,260; prior mower replacement in 2005. Previous consideration was given for larger utility tractor (used equipment in the \$12,000-\$15,000) but apparent election to continue using small riding mower instead. Treat small expense under \$6,000 as operating expense. Adjust in future reserve update as conditions merit.

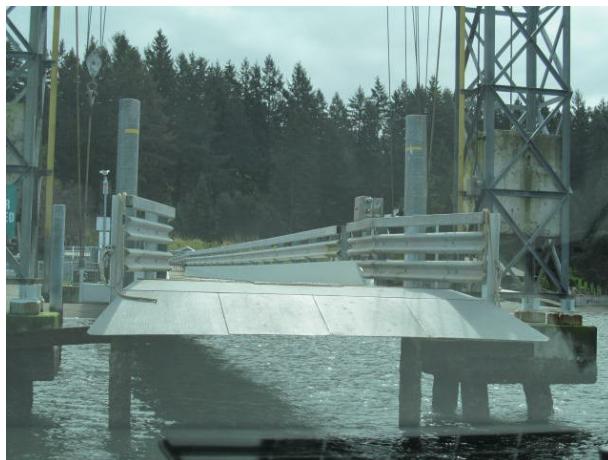
<b>Comp #:</b>	<b>700 Ferry Terminals - Inspect/Repair</b>	<b>Quantity:</b>	<b>Approx 6,100 square feet</b>
Funded?:	Yes. Meets National Reserve Study Standards criteria for Reserve Funding		
History:			
Location:	Island and Mainland Terminals		
Evaluation:	Ferry terminal ramps consist of concrete fixed approach structure supported by concrete piles and also utilize articulating steel ramps hung from steel support towers. Wood decking is traffic surface atop the steel ramps. Four sets of cluster pile dolphins are located near each terminal and used as vessel positioning aides. Mainland Terminal inspection is required at every two year interval; research with Management confirmed next event in FY 2016/2017. We recommend reserve funding for regular inspection and minor repair for both Ferry Terminals to ensure cost efficiency, functionality and safety at the interval below. Minor repair may include projects such as spot replacements of local concrete repairs, steel hardware, individual winch motors, future local wood decking, etc... As the structures continue to age, track expenses for consideration of further segregation of individual maintenance events in future reserve updates.

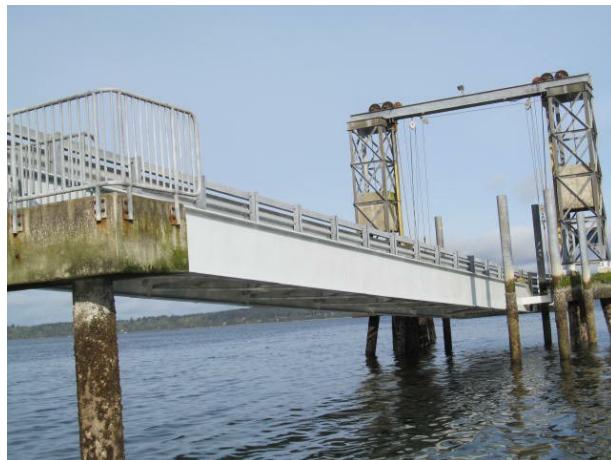
Evaluation: Good condition where recently painted at steel lift spans. Project occurred in FY 2015/2016; segregated construction cost was reportedly \$155,000 plus a portion of \$46,000 for other costs such as engineering and oversight. Going forward, we recommend planning for timely intervals of cleaning/painting at the interval indicated below. The reader should note that recent project included needed spot stripping of material, if entire steel spans would have needed paint removed the cost would have increased substantially. Update in future reserve study updates as conditions warrant.

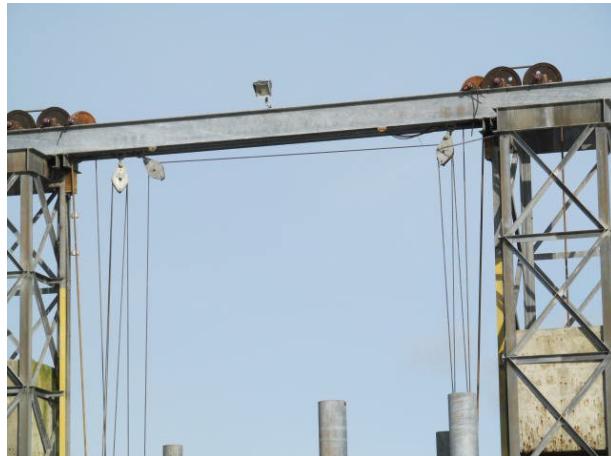
Comp #:	704 Ferry Terminal Cables - Replace	Quantity:	Extensive linear feet
Funded?:	Yes. Meets National Reserve Study Standards criteria for Reserve Funding		
History:	FY 2014/2015 replacement at \$27,200 expense		
Location:	Island and Mainland Terminals		
Evaluation:	Previous history includes FY 2014/2015 replacement at \$27,200 expense. Also, all counterweight and lift cables were replaced in 2007 and then lift cables at the Mainland Terminal only in FY 2011/2012. For purposes of long term budgeting, best to plan for proactive and simultaneous replacement of all cables every 5-7 years (utilize galvanized product) to ensure smooth, safe operation and cost efficiency.

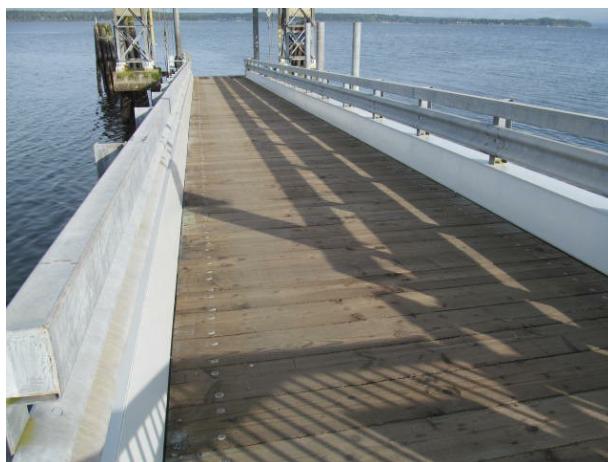
<b>Comp #:</b>	<b>706 Ferry Terminal Wood Decks - Replace</b>	<b>Quantity:</b>	<b>Approx 2,940 square feet</b>
Funded?:	Yes. Meets National Reserve Study Standards criteria for Reserve Funding		
History:	FY 2014/2015 replacement at \$144,000 plus portion of \$46,000 "soft" costs		
Location:	Island and Mainland Terminals		
Evaluation:	As new condition. FY 2014/2015 replacement at \$144,000 plus portion of \$46,000 "soft" costs. Previous discussion regarding possible transition to steel planking with apparent decision to replace again with wood timbers instead. We understand that removal of wood decking is required when each painting project occurs but assume decking will only be recommended for similar large scale replacement as indicated below. Spot replacements to sustain in between are already factored within Component # 700, Ferry Terminals - Inspect/Repair.

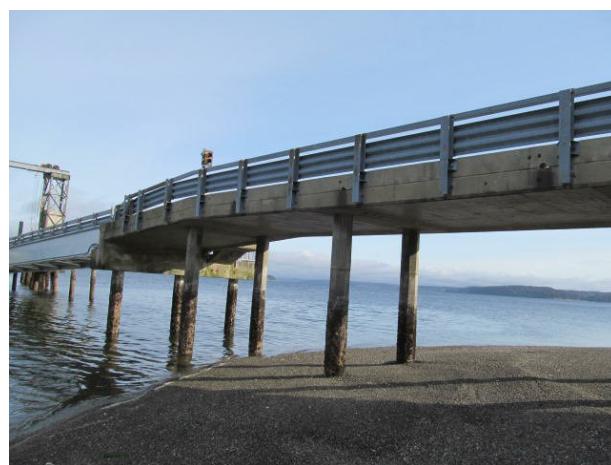
Evaluation: It is our understanding that terminals were built in 1994; no unexpected deterioration was apparent. Previously provided 2012 condition report (for Mainland Terminal only) indicated that concrete approach structure and pilings were in good condition. Likewise good condition for galvanized steel lift tower and bridge rails. Presently fair condition for painted steel structure (stringers, girders, floor beams, etc...) of lift spans. If properly maintained, working assumption is that terminal structures will achieve full design life of between 50-75 years as projected below. Note; distant replacement assumption is timed to coincide with a future paint project for cost efficiency.

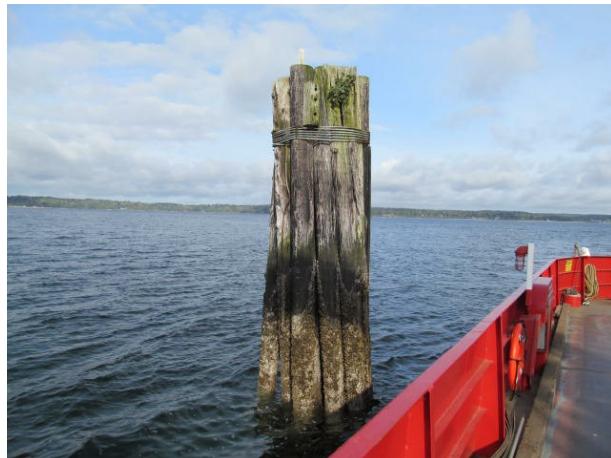
Evaluation: Advanced deterioration for existing wood dolphins. Recent comprehensive expert evaluations were indicated; BOD representative and Management confirmed current plans for FY 2016/2017 replacement. Total projected expense is reportedly ~\$1,700,000 (including construction, design, oversight, etc...) with apparent intention to procure long term USDA loan for sum of ~\$1,500,000 to finance vast majority of project (\$200,000 monies are already committed/earmarked). Current projection is that total of annual P&I payments will likely be somewhere near \$69,000 with a 40 year term. No future impact upon HMC maintenance reserves is factored since collections and payments will reportedly be handled in a separate account for this debt obligation (similar to separate Water System indebtedness).

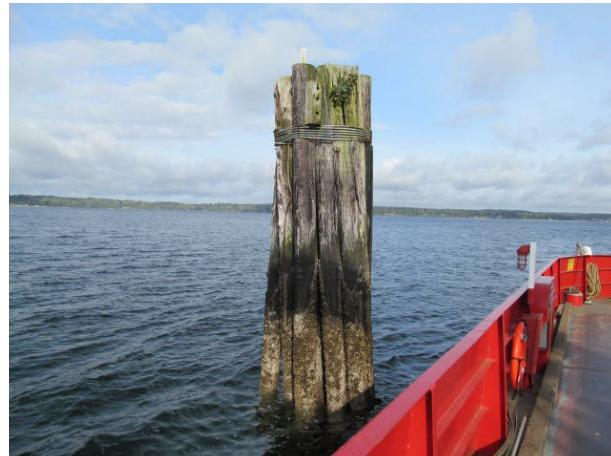
<b>Comp #:</b>	<b>708 Ferry Ramp Dolphins-Future Replace</b>	<b>Quantity:</b>	<b>(8) assemblies</b>
Funded?:	Yes. Meets National Reserve Study Standards criteria for Reserve Funding		
History:	Assumes planned FY 2016/2017 project/USDA financing occurs		
Location:	Island and Mainland Terminals		
Evaluation:	Assuming planned FY 2016/2017 project and USDA financing occurs, future replacement intervals of new steel dolphins are projected below. The reader should note that one of the key concepts of adequate reserve funding is to collect appropriate contributions from membership to offset deterioration as it occurs (in this particular instance, over many years) and fairly distribute the burden of expense between current and future owners. That is, members pay only their fair share as individual reserve components are "used up" during their individual ownership period. Additionally, note that HMC reserve monies accrued for future projects should continue to earn interest and grow as opposed to paying out interest and loan fees.

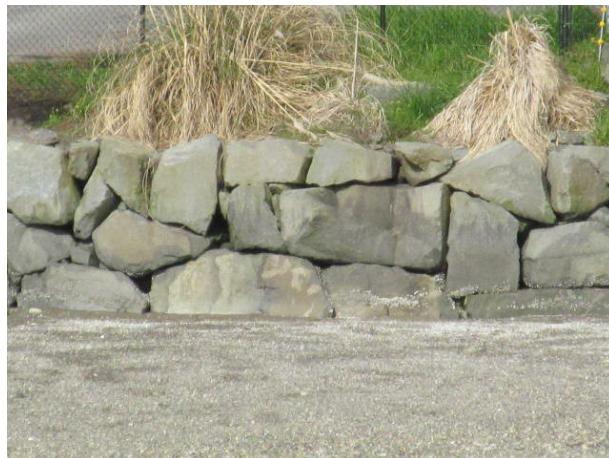
<b>Comp #:</b>	<b>710 Ferry Ramp Bulkhead - Repair</b>	<b>Quantity:</b>	<b>Moderate square feet</b>
Funded?:	No. Useful life not predictable or extended		
History:	Some repair occurred in 2006; no further project history was provided		
Location:	Island Terminal		
Evaluation:	No apparent instability, sloughing, deterioration of rip-rap, etc... Some repair occurred in 2006; no further project history was provided. Geo-technical evaluation is beyond the scope of our service and extent / timing of future event is difficult to predict. Consult with appropriate engineering firm as conditions warrant.

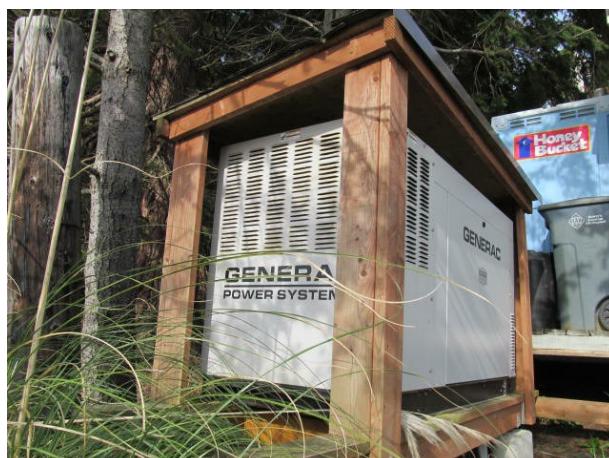
<b>Comp #:</b>	<b>712 Ferry Ramp Generators - Replace</b>	<b>Quantity:</b>	<b>(2) Generac 35kw</b>
Funded?:	Yes. Meets National Reserve Study Standards criteria for Reserve Funding		
History:	Installed in FY 2007/2008 at an expense of \$33,000		
Location:	Island and Mainland Terminals		
Evaluation:	No reported problems. Installed in 2007/2008 at an expense of \$33,000, equipment is utilized for emergency back up power for Ferry Ramps. Regular inspections, confidence testing and maintenance is assumed. Typical useful life is somewhat dependent upon usage; average life of 15-20 years is factored below.

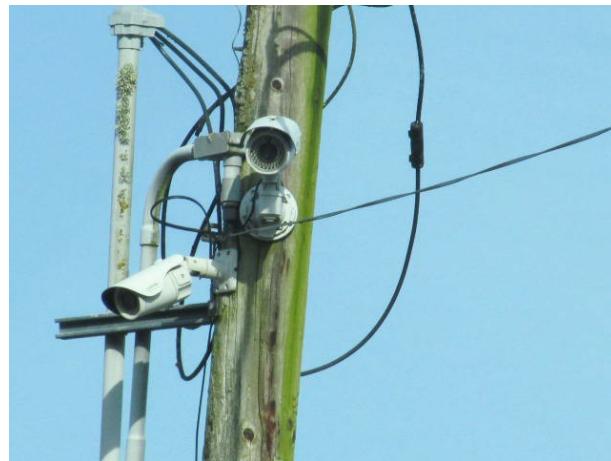
<b>Comp #:</b>	<b>718 Ferry Ramp Surveillance - Replace</b>	<b>Quantity:</b>	(2) camera, DVR
Funded?:	No. Cost projected to be too small		
History:	Modest system installed at Mainland Terminal in 2012 at an expense of \$2,300		
Location:	Select common areas		
Evaluation:	Modest system installed at Mainland Terminal in 2012 at an expense of \$2,300. Research indicated no plans to substantially increase system that would merit reserve designation. Treat minor replacements as an operating expense.

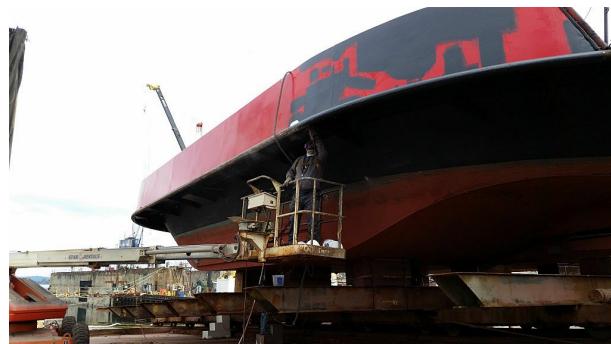
<b>Comp #:</b>	<b>740 Ferry Vessel - Shipyard</b>	<b>Quantity:</b>	<b>65' LOA</b>
Funded?:	Yes. Meets National Reserve Study Standards criteria for Reserve Funding		
History:	FY 2014/2015 expense was \$84,600		
Location:	M/V Charlie Wells		
Evaluation:	Welded steel hull and framed vessel was built in 1989. Our research informed us that dry dock and significant maintenance occurs every two years on the even year, so next event in FY 2016/2017 is factored below. Comprehensive inspections and projects including such as paint, zinxs, seals, prop and shaft repairs, etc....are indicated. FY 2014/2015 expense was \$84,600 and included significant painting among other maintenance. Carefully track needs and expenses for consideration of possible segregation of individual maintenance events in future reserve updates. Note; image below provided from HMC archive.

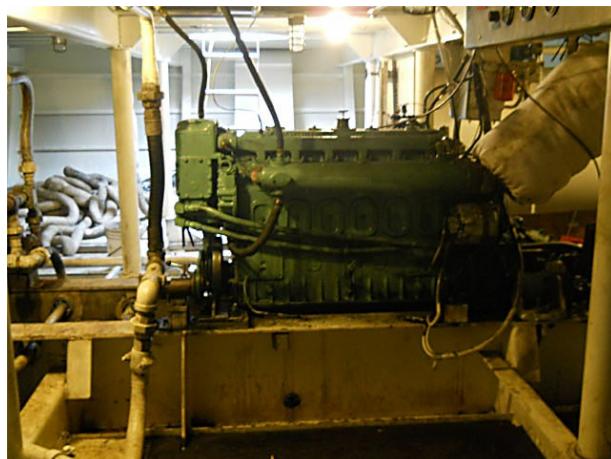
Evaluation: Replacement of previous two-cycle GM diesel engine with new four-cycle John Deere units in FY 2013/2014. Research informed us that likely overhaul schedule will improve to every four year to six year interval (from previous historical average of every three years). Future overhaul anticipated next in FY 2018/2019; monitor and update assumption in future reserve updates as conditions warrant. Note; image below provided from HMC archive.

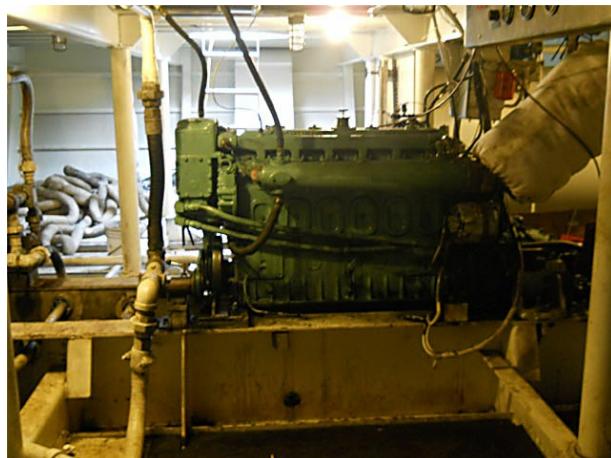
**Comp #:** 746 Ferry Vessel - Replace Engines      **Quantity:** (2) GM 300 HP, diesel  
Funded?: Yes. Meets National Reserve Study Standards criteria for Reserve Funding  
History: New four-cycle John Deere units in FY 2013/2014 at \$152,000 expense  
Location: M/V Charlie Wells  
Evaluation: As already mentioned, engine replacement in FY 2013/2014 at \$152,000 expense. Benefits of last transition were assumed to include fuel efficiency, reduced operational expense and noise levels. Notwithstanding proactive maintenance and durable equipment, prudent planning dictates replacement assumption due to eventual parts and technological obsolesces.

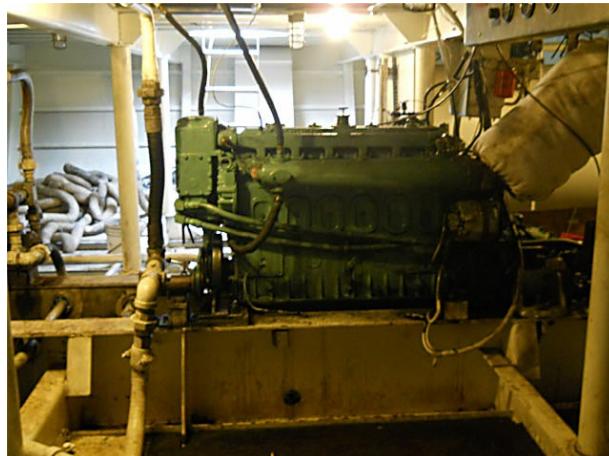
Evaluation: New transmissions were also included during FY 2013/2014 re-power. Anticipate significant transmission overhaul every four to five year interval. Future overhaul anticipated next in FY 2018/2019; monitor and update assumption in future reserve updates as conditions warrant. Note; image below provided from HMC archive.

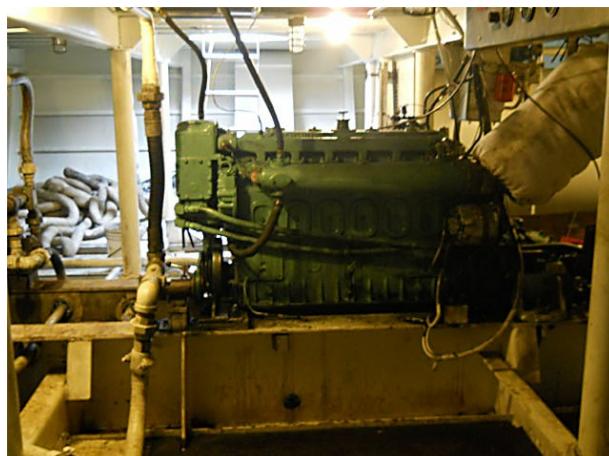
Evaluation: Expense for new transmissions is factored below; expect roughly 25 years of useful life going forward. Note; image below provided from HMC archive.

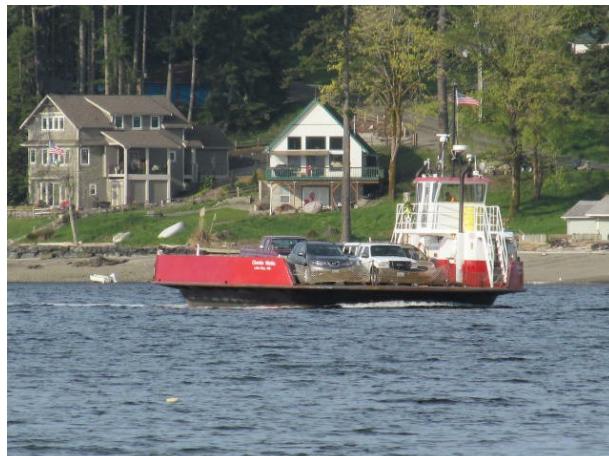
Evaluation: Previous research with Marine Surveyor familiar with your vessel indicated to anticipate eventual vessel replacement cycles of between 50-60 years as projected below (assuming proactive maintenance and current usage schedule continues). As occurred last in 1989, replacement with new is factored for purposes of long term budgeting
