Herron Island Mainland and Island Ferry Terminal

ROUTINE STRUCTURE INSPECTIONS – 2014

Inspection Date: April 1st and 2nd, 2014

**RE: Ferry Terminal Observation
Project No.: A14111.00**

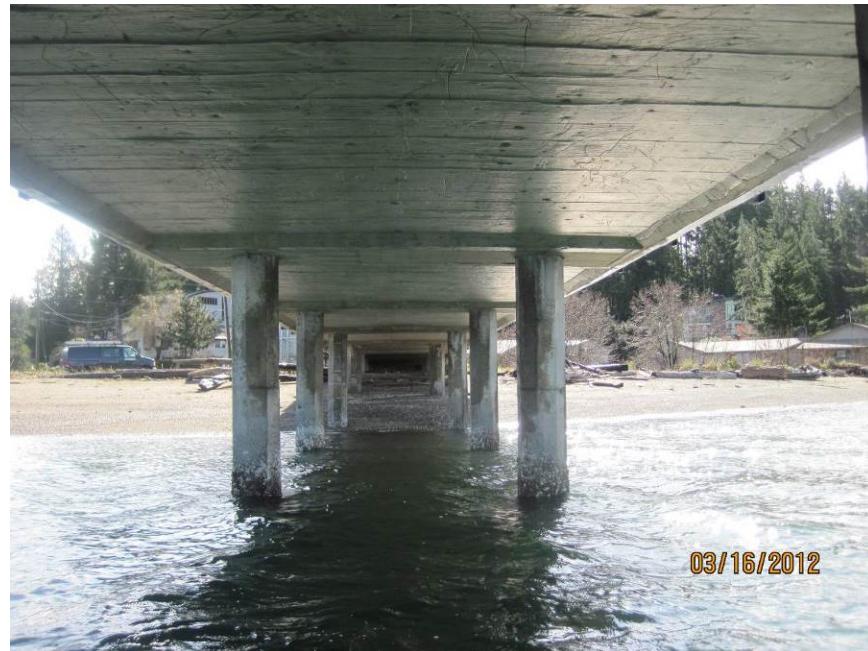
- Good condition, small concrete patches in several columns, patches are in good condition.

Image 1: Reinforced concrete approach spans.

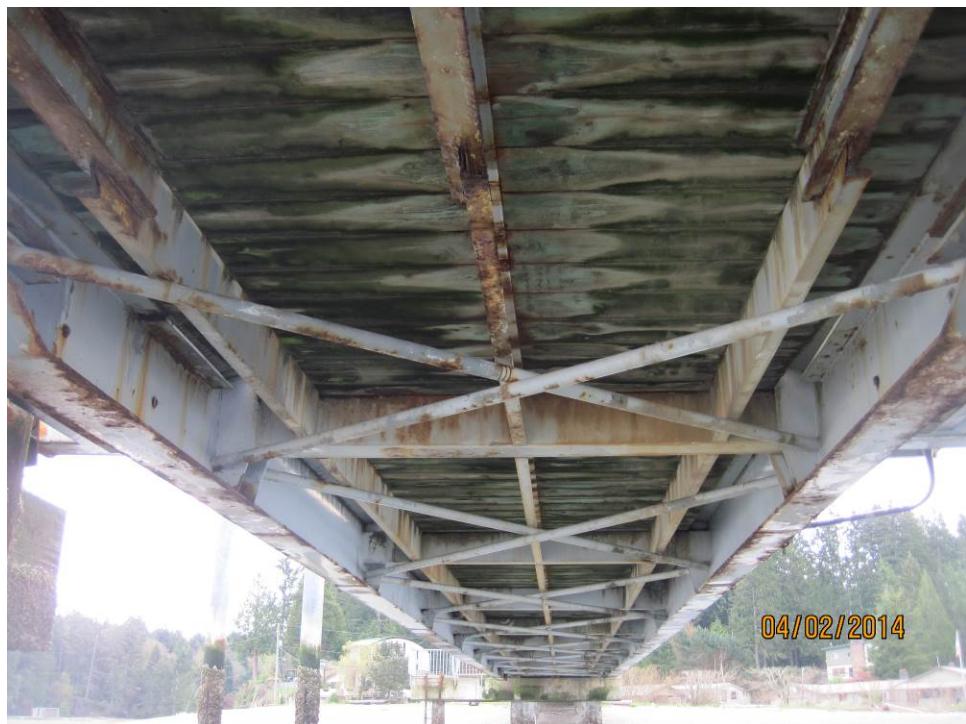
Image 7: General paint condition of steel members located beyond counter weight towers.

1. Blast clean and spot paint or fully re-paint the steel members of the mainland terminal within the next two years
2. Blast clean and spot paint or fully re-paint the steel members of the island terminal within the next two to three years.

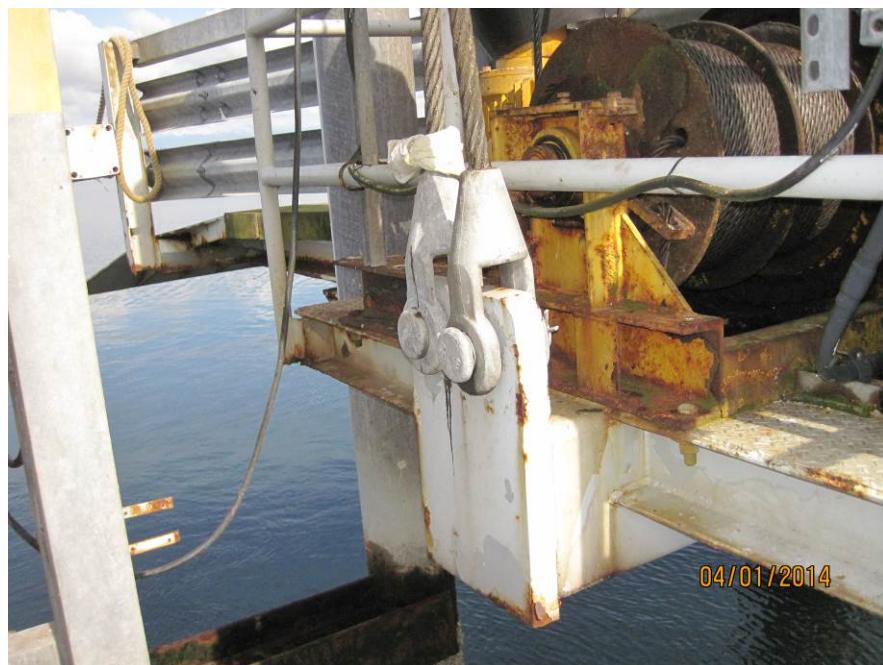
- The paint condition of the steel outriggers, which connect the girders to the lifting cables, is generally in fair condition. There is failed paint along the edges and along the underside. No cracking in the outriggers or welds were observed.

Image 15: 2014 – Painted steel outrigger.

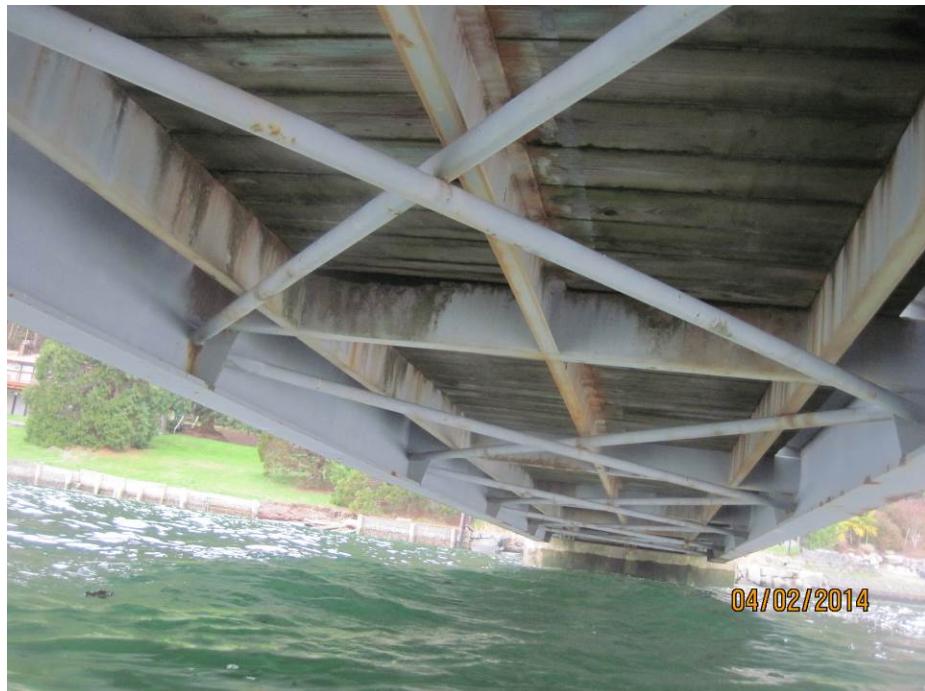
- Like the mainland stringers, the paint on the steel members on the land side of the counterweight towers is in better condition than the paint on the steel members beyond the towers. The locations of paint deterioration are the same as the mainland, though overall the degree of corrosion is less. This is attributed to the fact that the island terminal is somewhat sheltered by the island from the southwest winds, where the mainland terminal

Image 19: General paint condition of steel members located inland of counter weight towers.

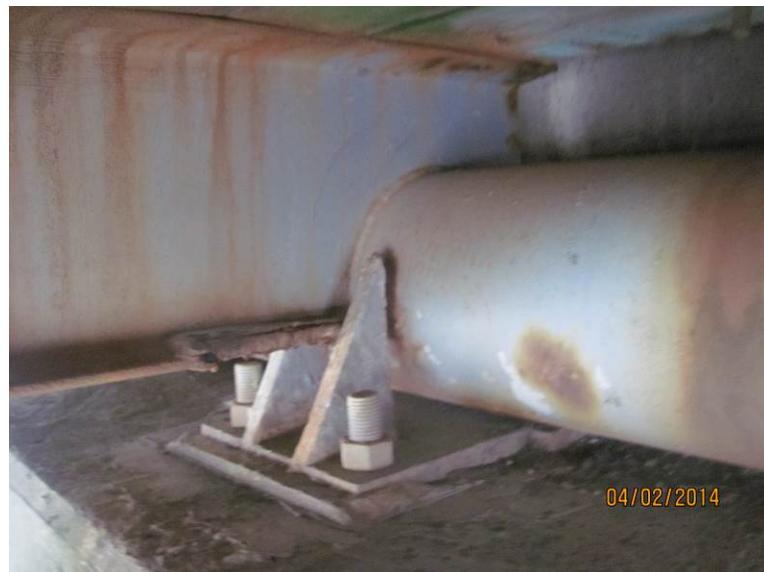
- The bearings are in fair condition. The movable painted steel bearings appear to be free and in good service condition. There is minor paint deterioration and corrosion along the edges of the bearings.

Image 24: Typical of the corrosion around the girder bearing.

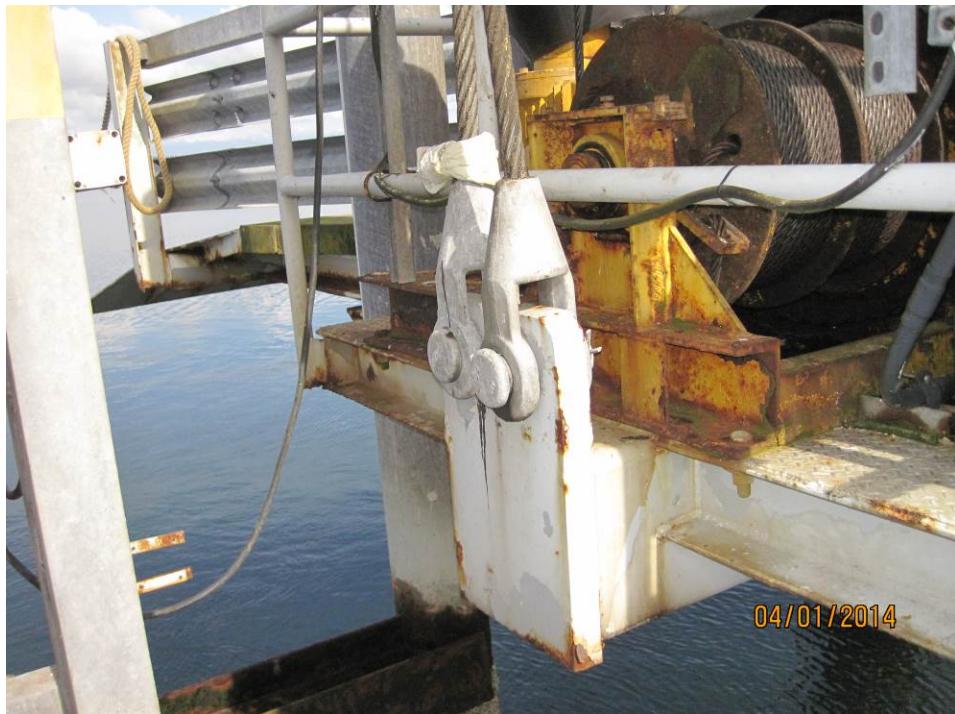
Image 32: Typical lifting cable anchor. Note grease at the spelter socket breaking down.

7. Continue to periodically clean out the cavity on the top side of the reinforced concrete counter weights.
8. Continue cable and grease maintenance schedule. Increase frequency of greasing on the mainland terminal. Include greasing top of spelter sockets.

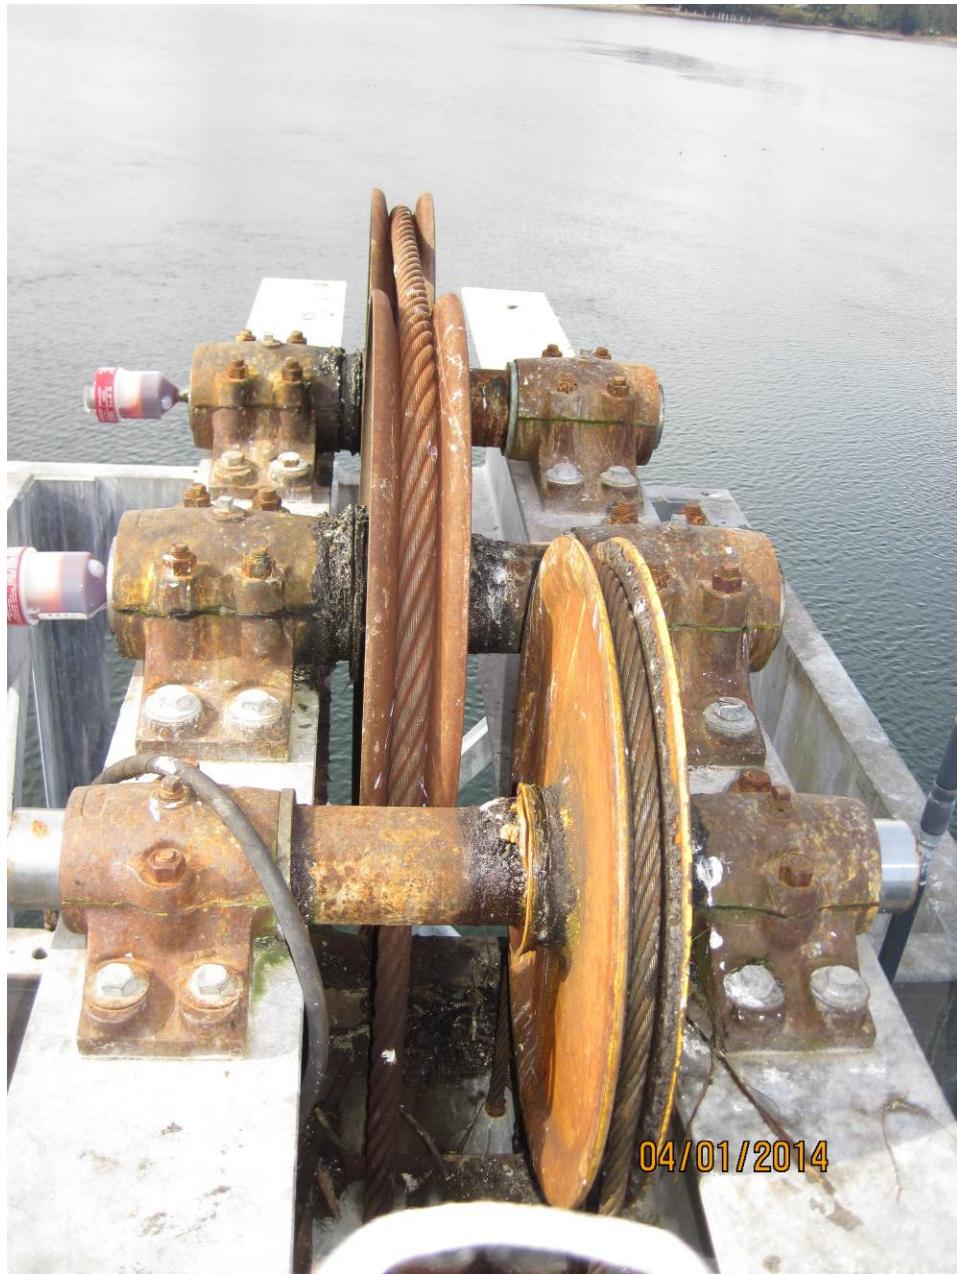
Image 35: Typical of well-greased counterweight sheave. Note dry cables.

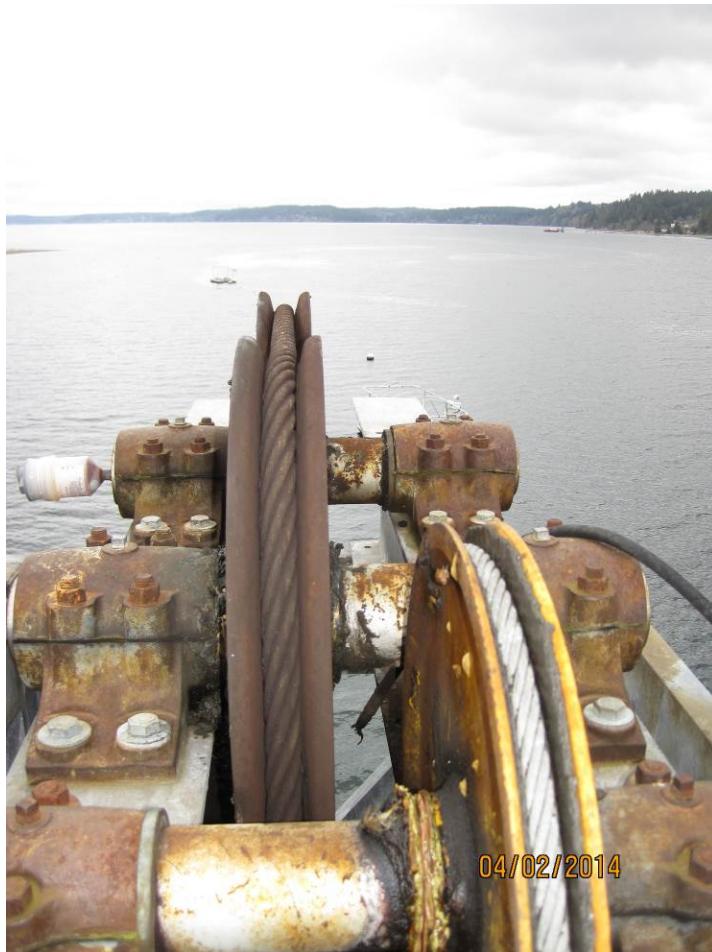
- The lifting cables are in good condition. The left cable is ungreased near the upper sheave, the remaining lengths of cable are well coated. Both cables appear to be winding correctly
- The counterweight cable grease is breaking down but is providing satisfactory protection. There is some minor wear in the strands along the bottom side of the length of cable that passes over the two larger 24 inch diameter sheaves at the top of the lifting tower.

Image 38: Note condition of counter weight grease and lack of lifting cable grease.

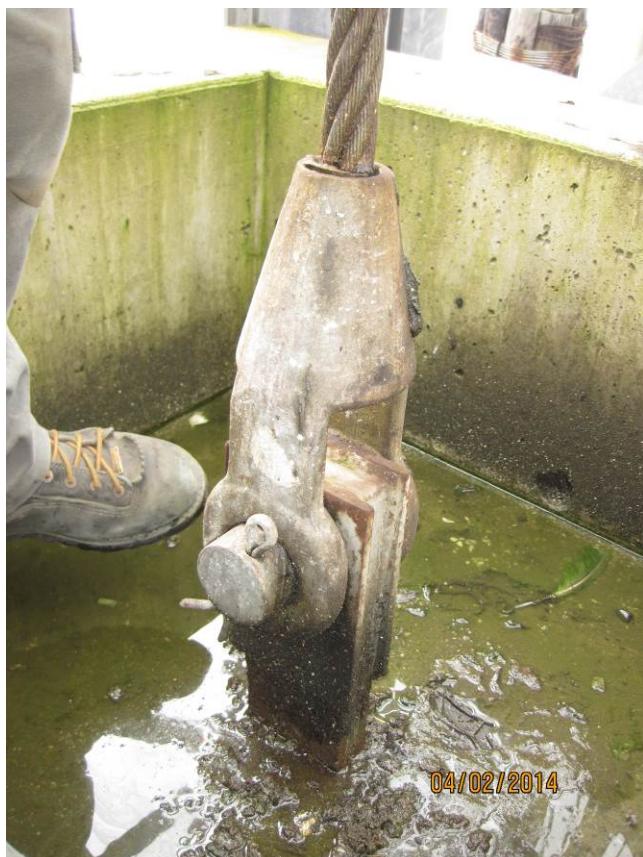
- The counterweight cable anchors are in good condition. Grease is present but breaking down at the top of the spelter socket. The cable anchor plate paint is wearing thin and the plates have some surface corrosion
- The lifting cable anchors are in good condition.

Image 39: Counter weight cable spelter socket connection, at the counter weight.

3. Blast clean and paint the bottom one foot of the mainland and island terminal tower legs.
4. Blast clean and paint the counter weight cable anchor plates. Located in weight cavity

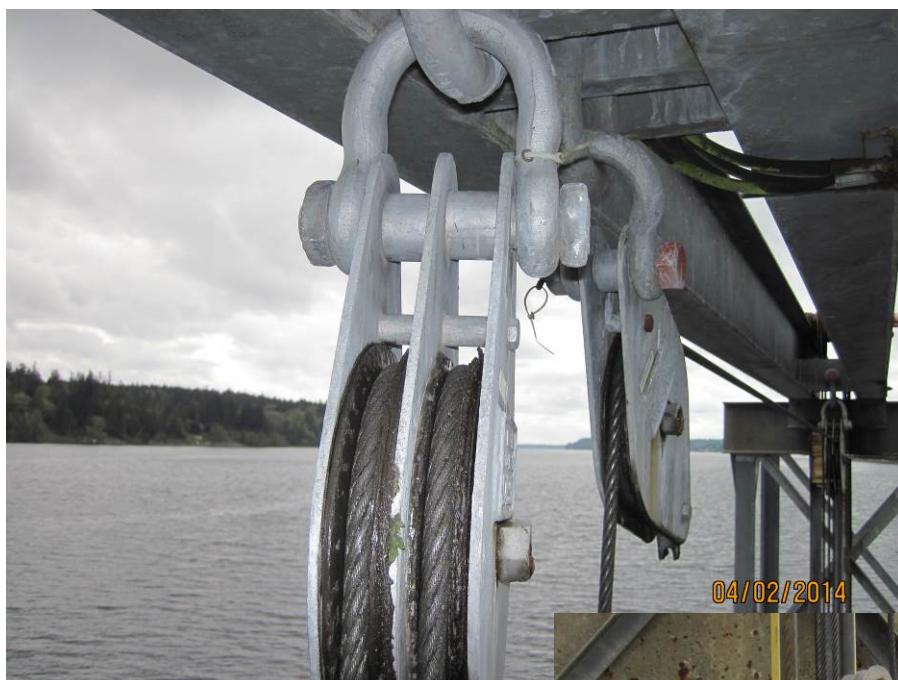
Image 41: Upper lifting pulley block and clevis connection.

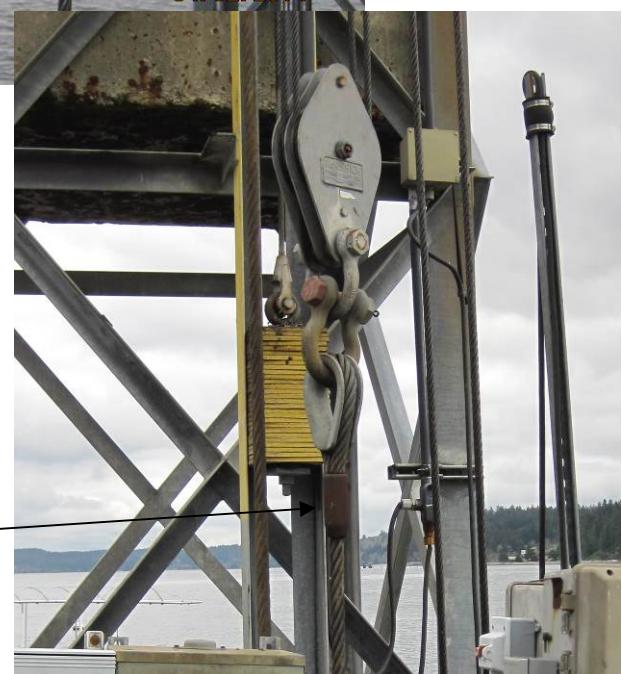
- The pulleys and block pulleys within the lifting cable system are in good condition. The swage that ties off the thimbled loop for the wire rope connecting the winch platform to the lower lifting pulley block has surface corrosion. There is no visible indication of a loss of strength. Swage will be replaced during the upcoming scheduled cable replacement.
- The clevis connections in the counterweight and lifting system are in good condition. There are several clevis connections without cotter pins. There is no indication that any of the bolts in the clevises are loose or that the lack of a cotter pin is a problem.

Image 42: Lower pulley block. Note surface corrosion on swage.

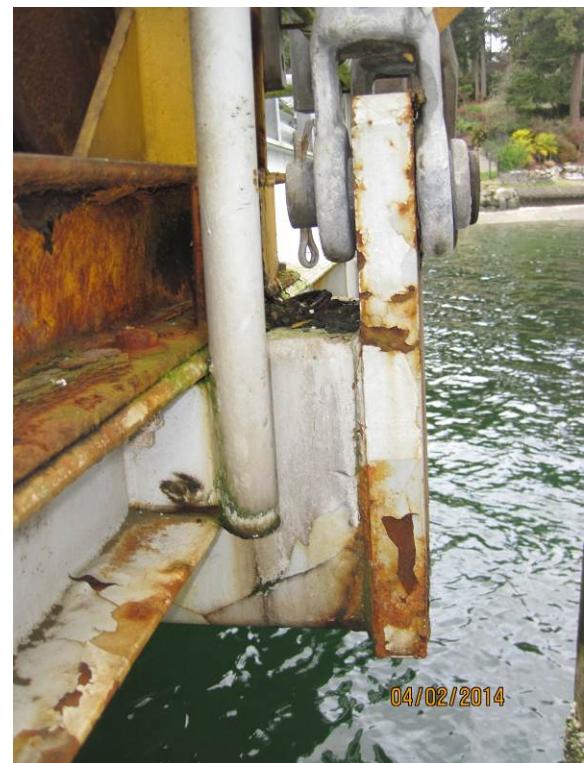
- The winch chain appears in good condition.
- The paint system for the winch platform is failed and corroding.

Image 45: Note failing yellow paint of winch base.

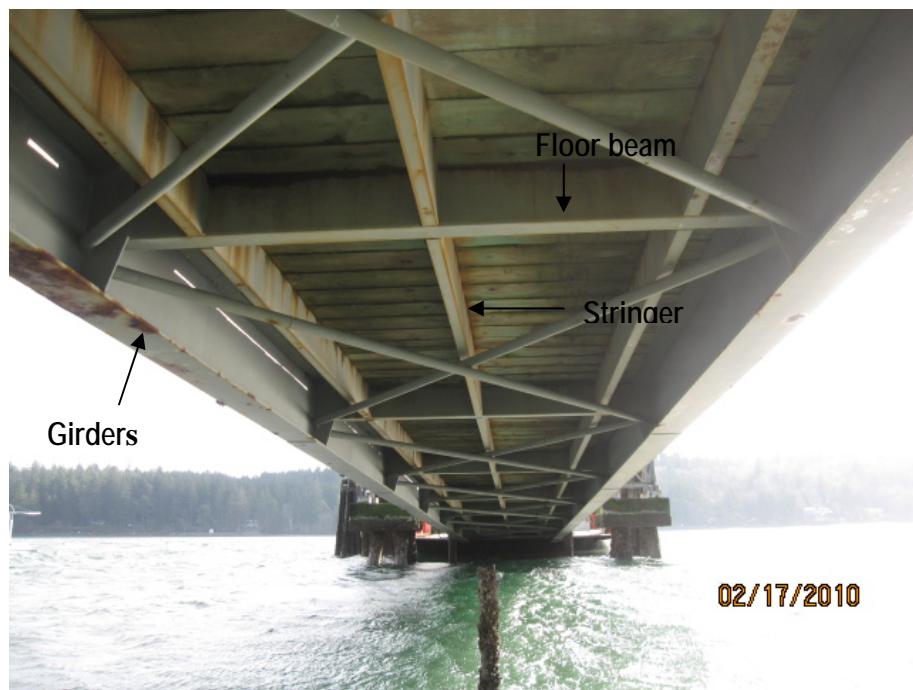
Image 47: Typical of lift span construction.
