Herron Island Ferry Terminals

ROUTINE STRUCTURE INSPECTION – 2010

Inspection Date: February 17, 2010

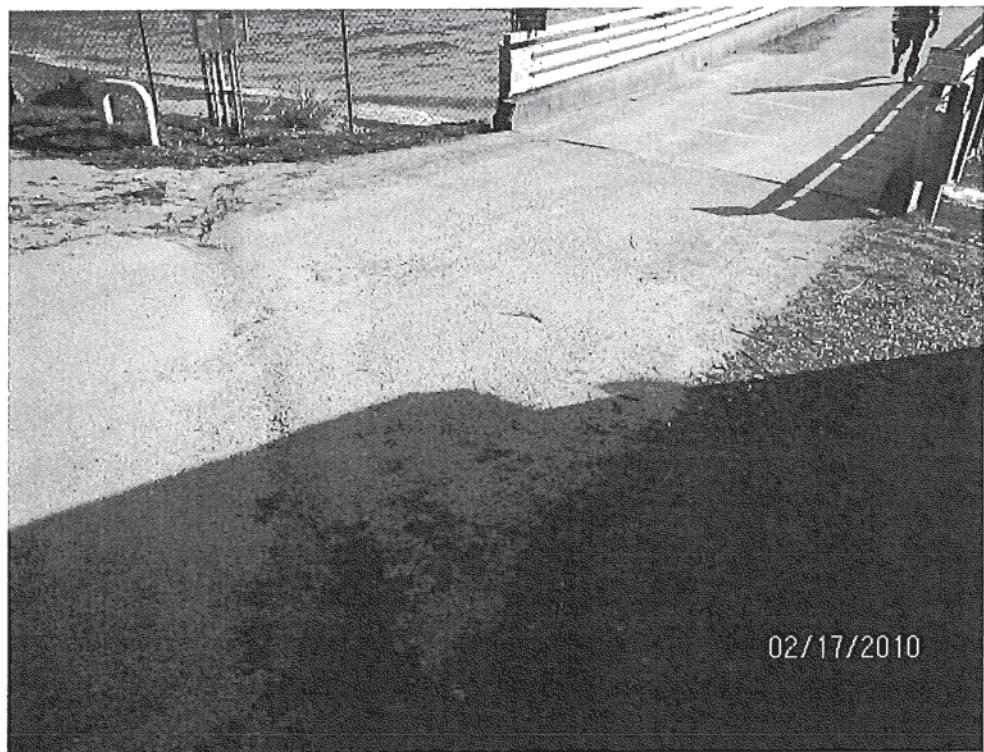
- Some uneven settlement in the asphalt approaches at the bridge end. Settlement causes very little impact to the bridge because of low speed restrictions.

Picture No. 4 - Settlement in asphalt approach at bridge ends of island terminal abutment.

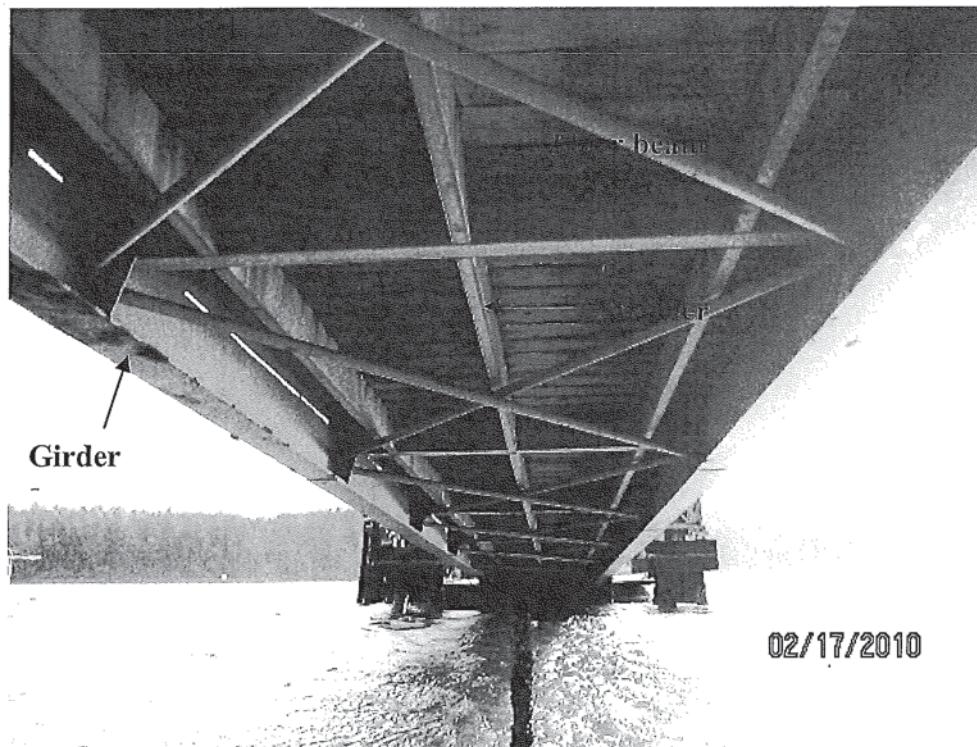
Picture No. 8 - Typical of lift span construction.

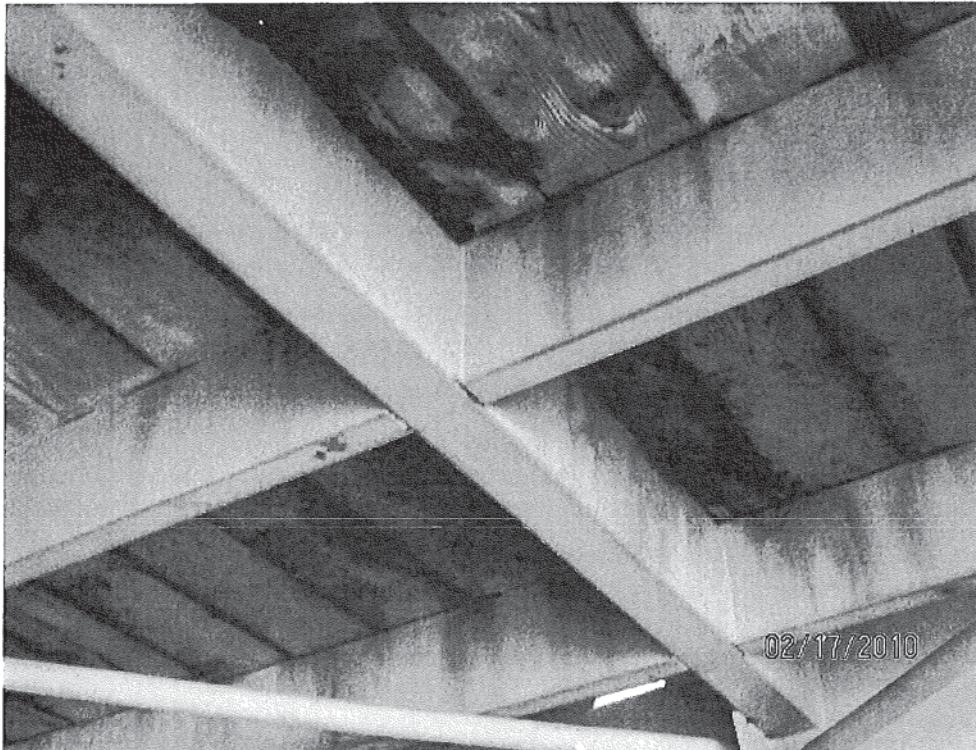
- The painted steel stringers have rust stains washing down from the seam between stringers and the deck. Vehicle traffic is most likely causing the deck planks to wear the paint from the tops of the stringers. Several stringers have dark rust stains along their welded connections to the floor beams. No significant corrosion was observed in these joints or on the stringers. There are many local paint failures throughout the stringers, allowing surface corrosion.

Picture No. 9 - Typical of rust staining washing down stringers and floor beams.

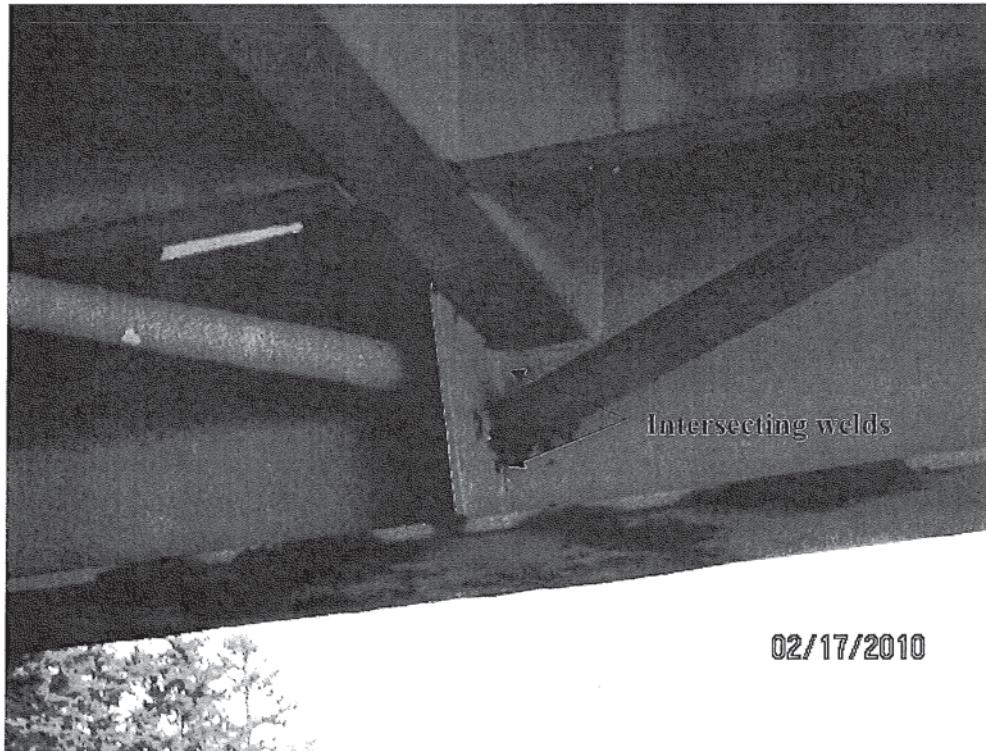
- The painted steel floor beams are in a similar condition as the stringers. The floor beam connection to the main girder is welded. The welds are such that they intersect the welds of adjacent lateral bracing gusset plates. When welds like these intersect, they cause a stress concentration. This area can be susceptible to cracking. No cracking was observed in these welds at the time of this inspection. However, this is a location that should be closely looked at during each inspection.

- There are two main girders in this span. These girders are considered fracture critical because they are steel and there is no load path redundancy. I.E., if one girder were to fail the entire span would fail. The steel girders appear to receive more salt spray than the stringers and girders, as a result there are several areas of blistering paint and surface corrosion. Most blistering is along the bottom flange of the girders. Several strengthening details have intersecting welds similar to those of the floor beams. No cracking in the girders or welds were observed at the time of this inspection. No deficiencies were noted in the lifting outriggers located near the end of the lift span.

Picture No. 10 - Typical of paint blistering and corrosion on girders. Note corrosion on the lateral bracing weld joint. Note intersecting welds.

1. Blast clean and spot paint the steel girders in both terminal lift spans.
2. Monitor lift spans paint systems, schedule complete paint system as necessary.
3. Monitor intersecting welds on floor beams and main girders during subsequent inspections.
4. Monitor and replace lift span deck planks as necessary.
5. Periodically clean out cavity on the top side of the reinforced concrete counter weights.
6. Continue cable and grease maintenance schedule.
7. Continue cable replacement schedule.

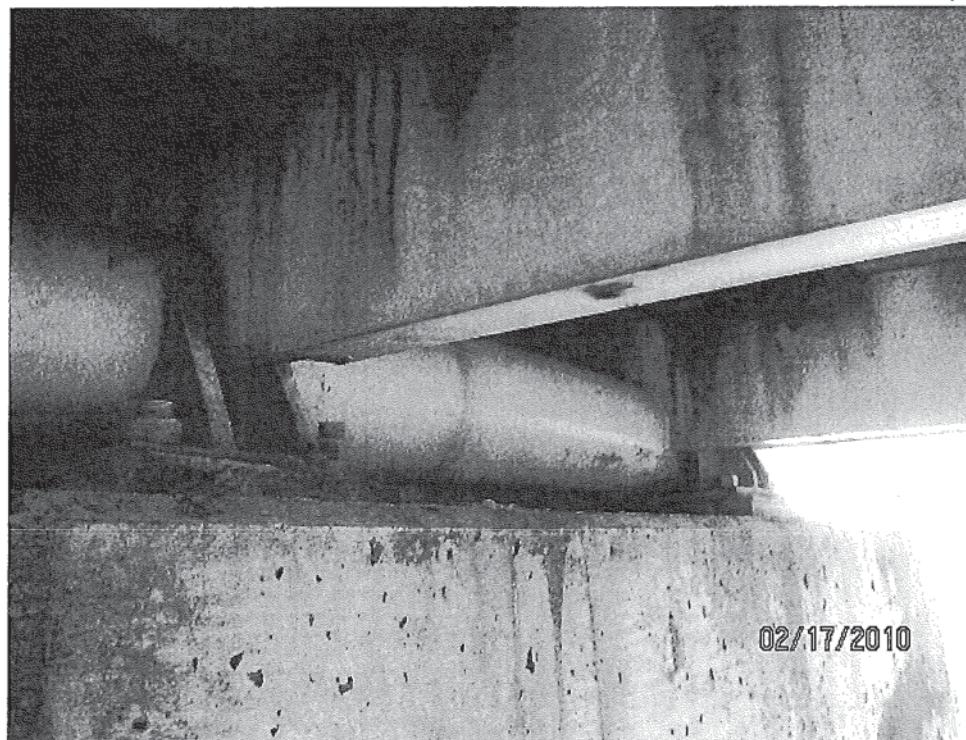
- The movable painted steel bearing at bent 9 appears to be free and in good service condition. There is some paint deterioration and corrosion along the edges of the bearing.

- The movable painted steel bearing at bent 6 appears to be free and in good service condition. There is some paint deterioration and corrosion along the edges of the bearing.

Picture No. 11 - Typical condition of the bearings at bent 6 of the island terminal and bent 9 of the mainland terminal.

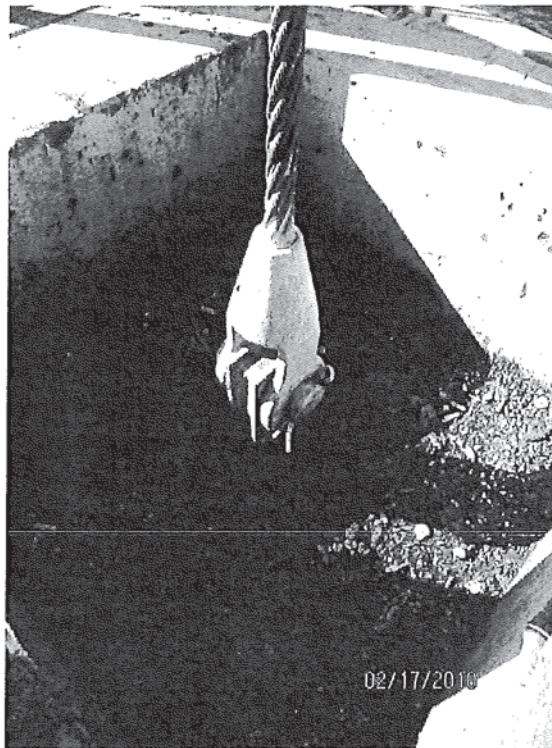
- No deficiencies noted in the galvanized steel tower.
- Debris and muck is accumulating on top of the reinforced concrete counterweight at the cable attachment. The cable and connection were observed to be in satisfactory condition. No significant corrosion was observed. Cable pulley bearings are greased. Grease on the cables is weathered. No significant deficiencies were noted in the cables or pulley system within the tower.

Picture No. 13 - Typical of debris and build up around counter weight/cable attachment point at top of the counter-weights.

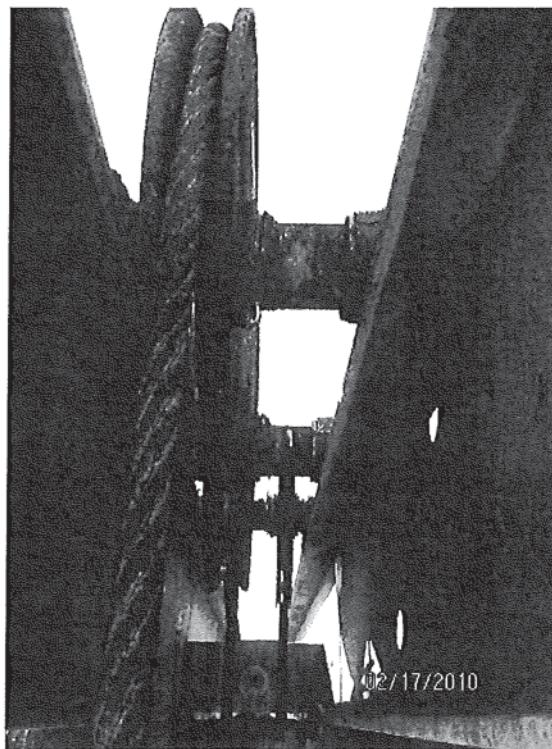
Picture No. 13 - Typical of well lubed pulleys, Typical of condition of cable grease.
