MARINE STRUCTURES CONDITION ASSESSMENT AND REPAIR RECOMMENDATIONS REPORT, HERRON ISLAND, WA

Prepared for HMC Management

KPFF Project No. 109086
September 24, 2010

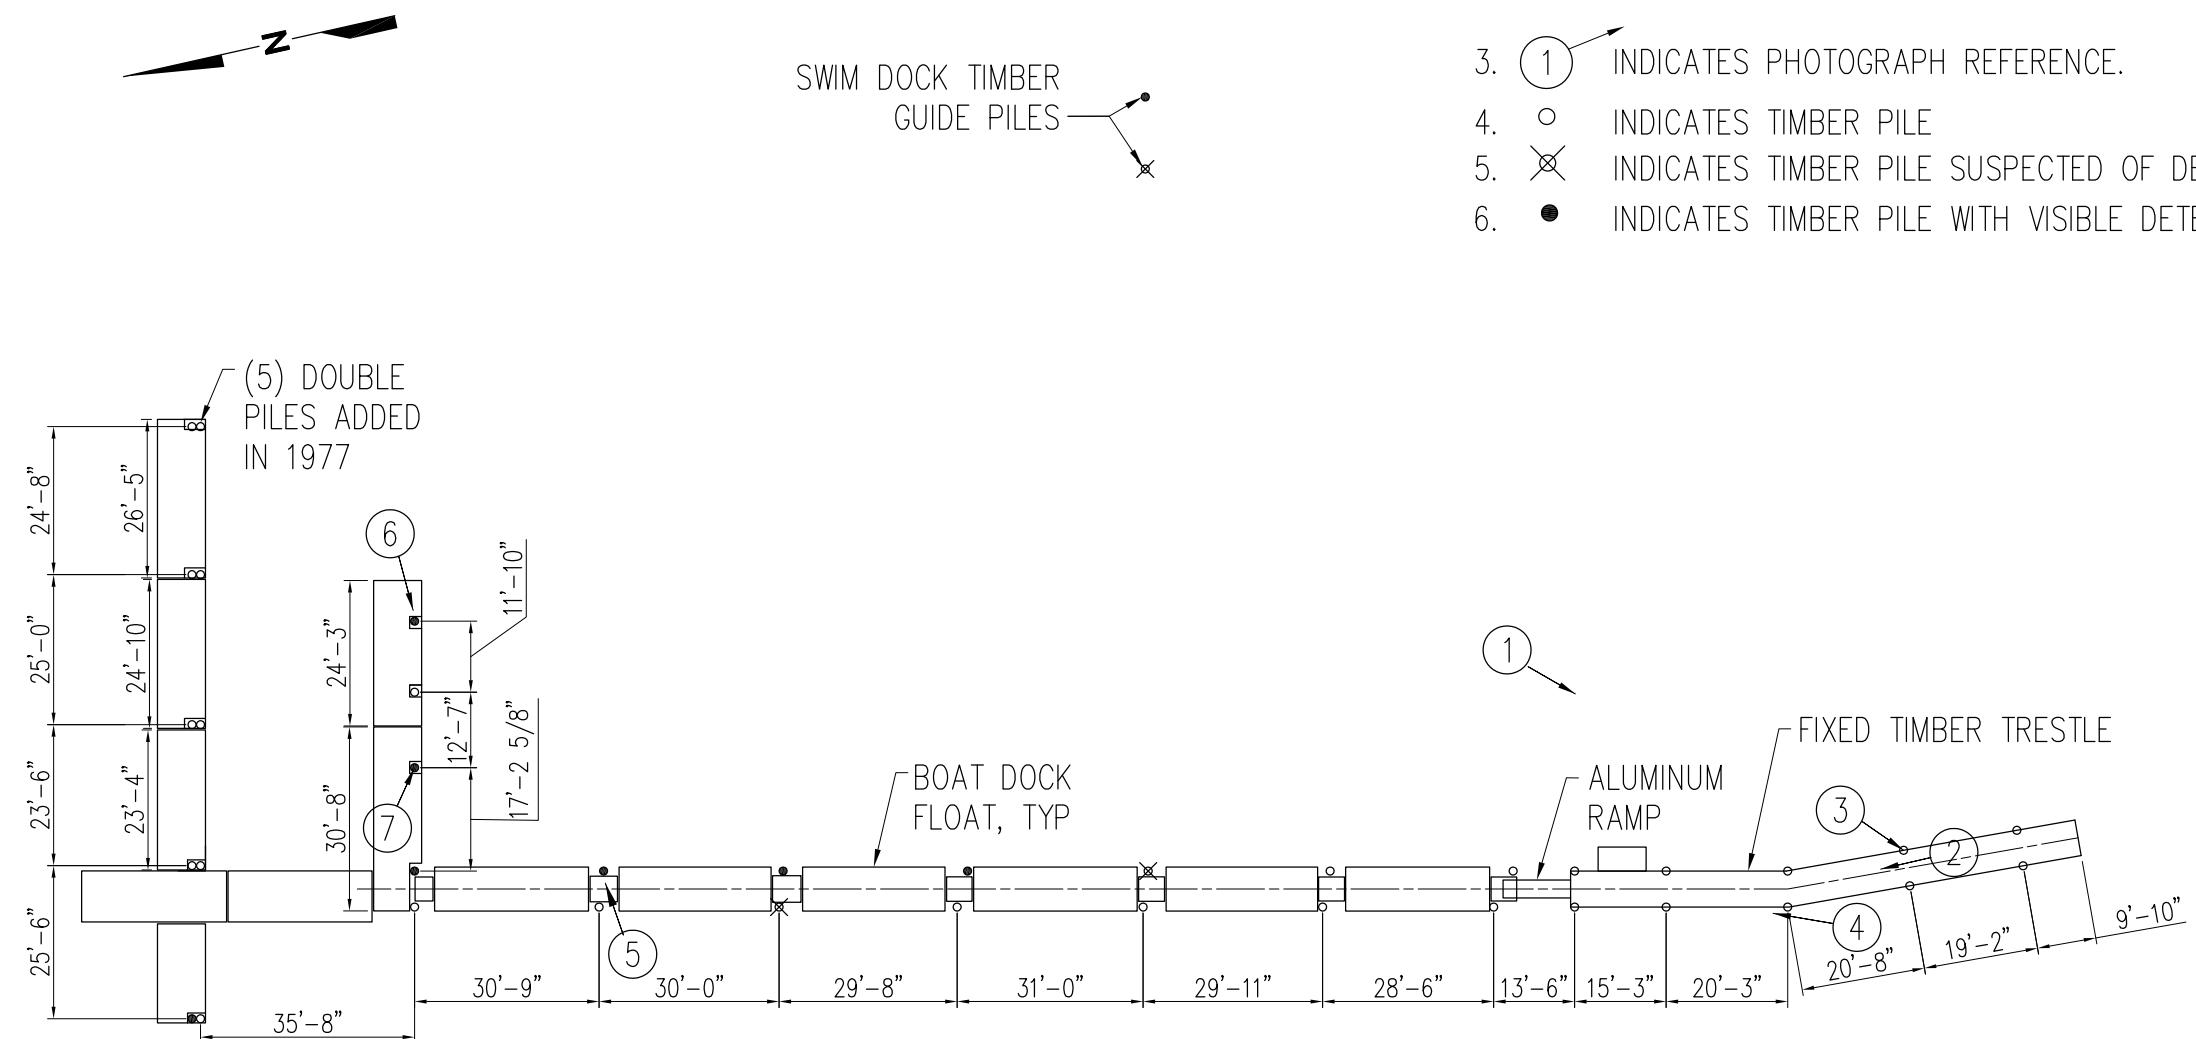
FIG. A

Observed Conditions: A summary of observed conditions is provided below by location. Observed areas of distress are also noted on **Figure A**.

NORTH BEACH MARINA OBSERVED CONDITIONS

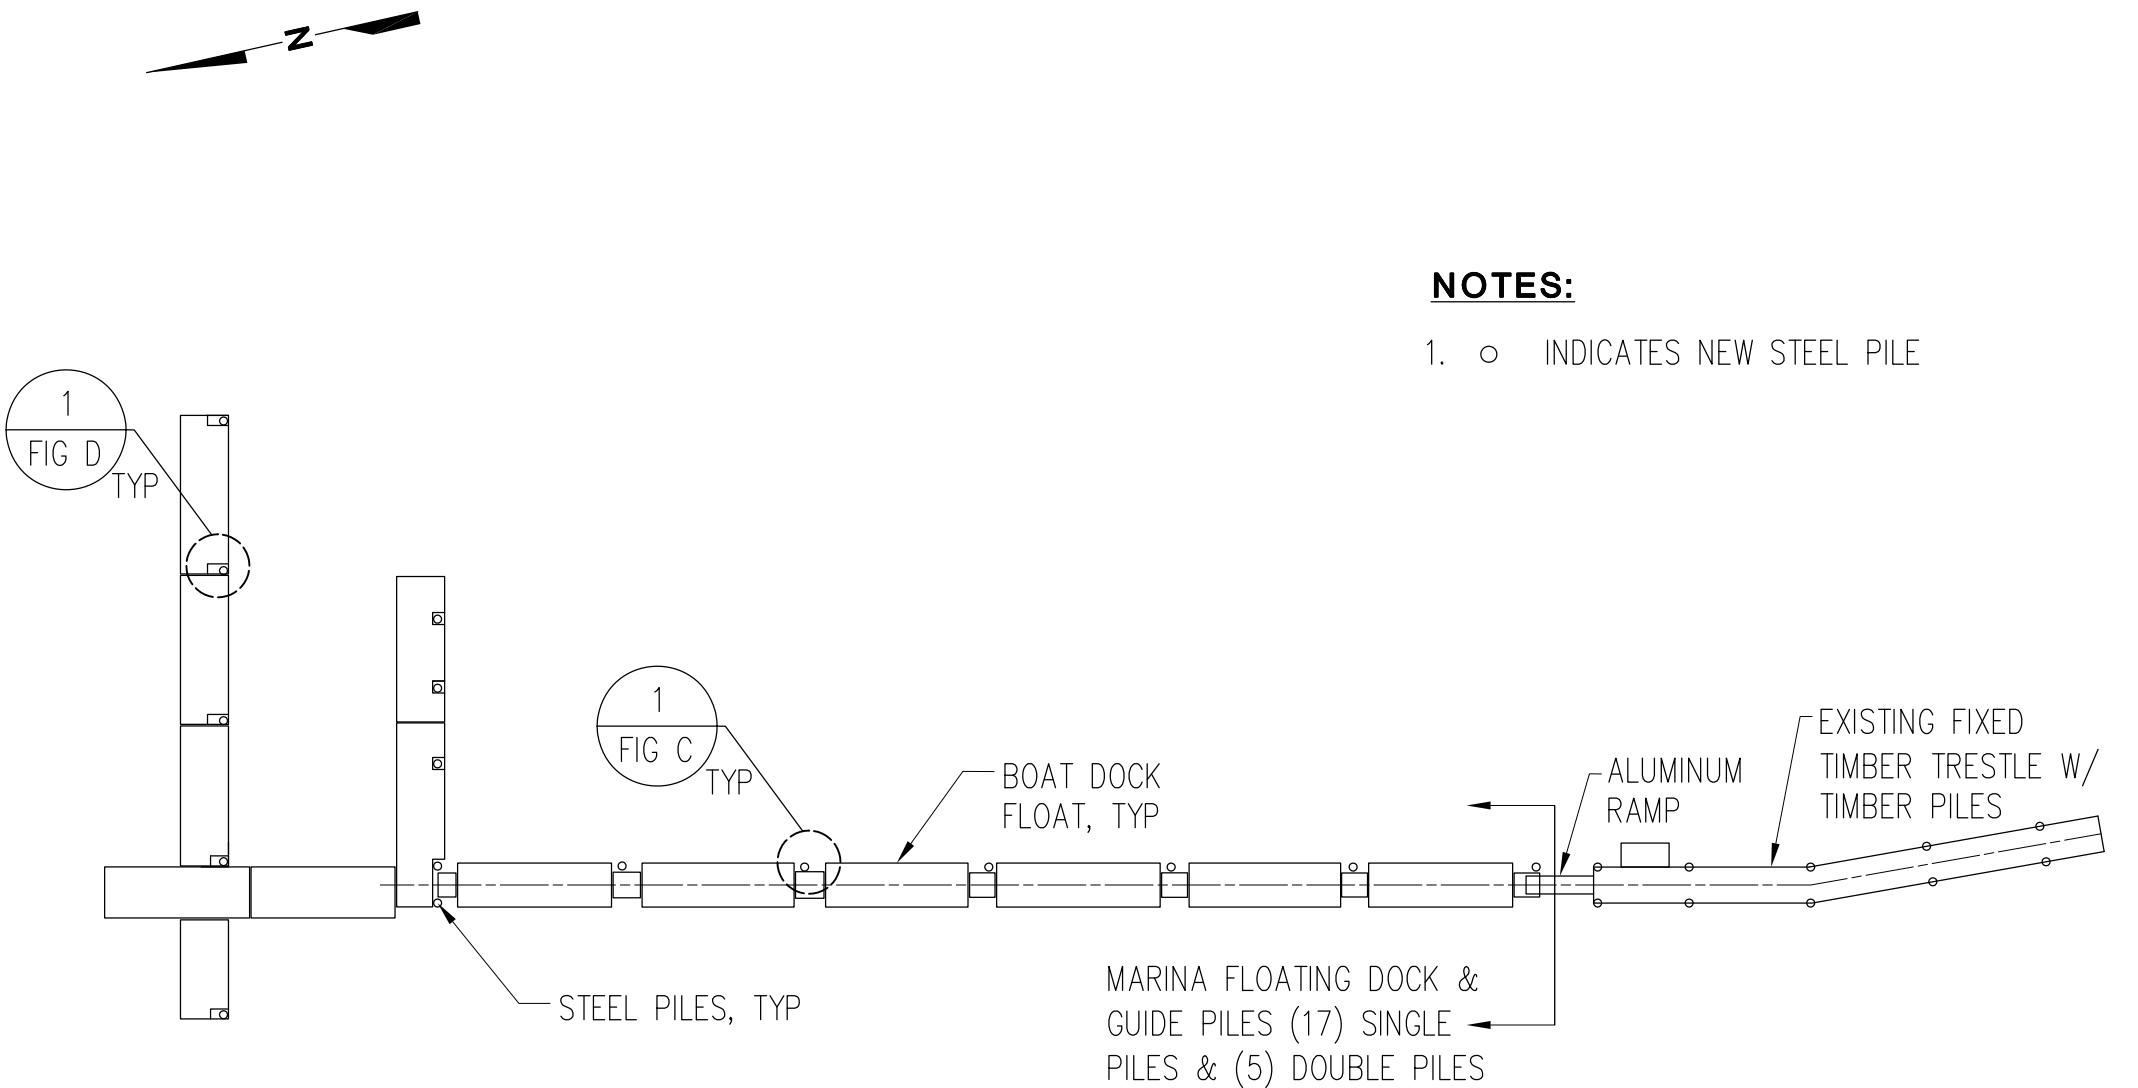
FIG D

NORTH BEACH MARINA RECOMMENDED REPAIR PLAN

INSTALL NEW STEEL REPLACEMENT
PILE WITH PILE COLLAR

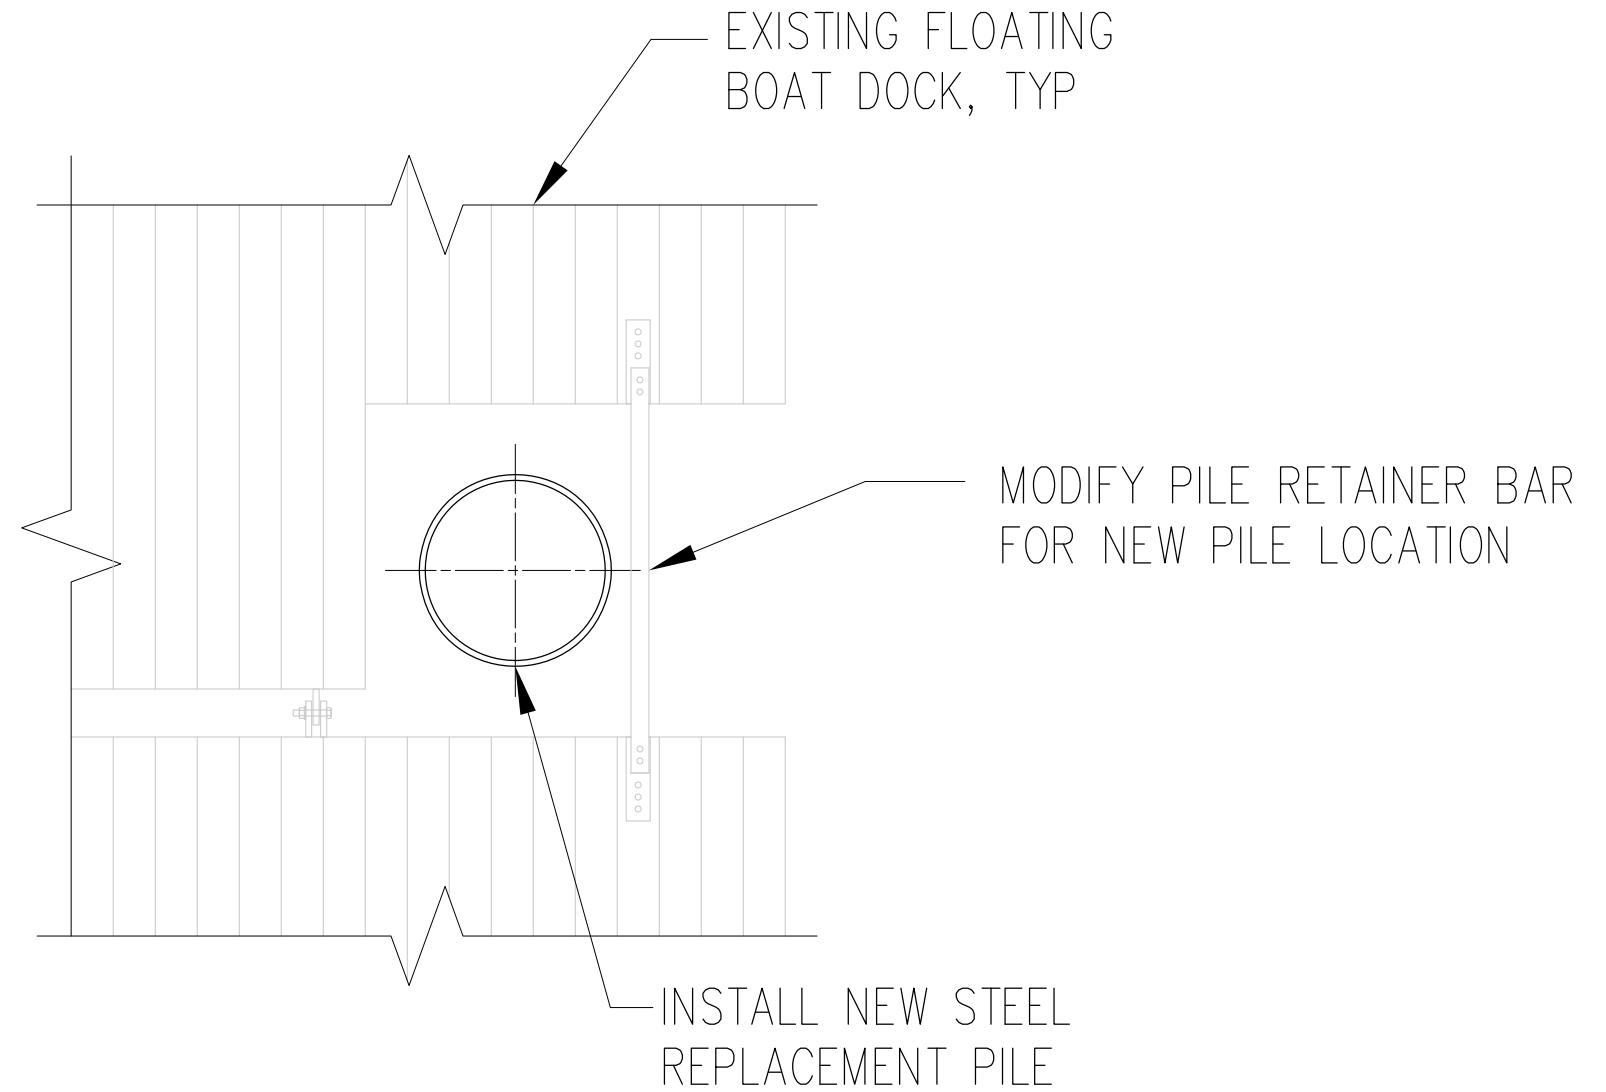
ENLARGED PLAN - NORTH BEACH MARINA

- **North Beach Marina Timber Trestle:** The timber framing of the fixed trestle is generally in good condition. See **Photo #1 and #2**. Wood members were observed to be sound from probing and hammer sounding. All of the timber piles supporting the trestle were also observed to be sound. Two of the four concrete pipes that the trestle piles are cast in are deteriorated and breaking apart. See **Photo #3**. The other two concrete pipes are covered with marine growth. See **Photo #4**.

- **North Beach Marina Timber piles:** Of the 29 piles, six piles were visually observed to have significant deterioration. See **Photos #5, #6, and #7** for examples of such conditions. An additional five piles were observed by hammer sounding to have some interior deterioration. At these five piles core samples were taken to observe the interior condition of the timber. In some of the core samples, the timber was observed to show signs of decay. In some instances, clear water flowed freely from the hole created from taking the core sample indicating that a void exists at the interior. Similar conditions were observed at the two piles to the East of the boat dock. Due to tide conditions at the time of the field work, KPFF

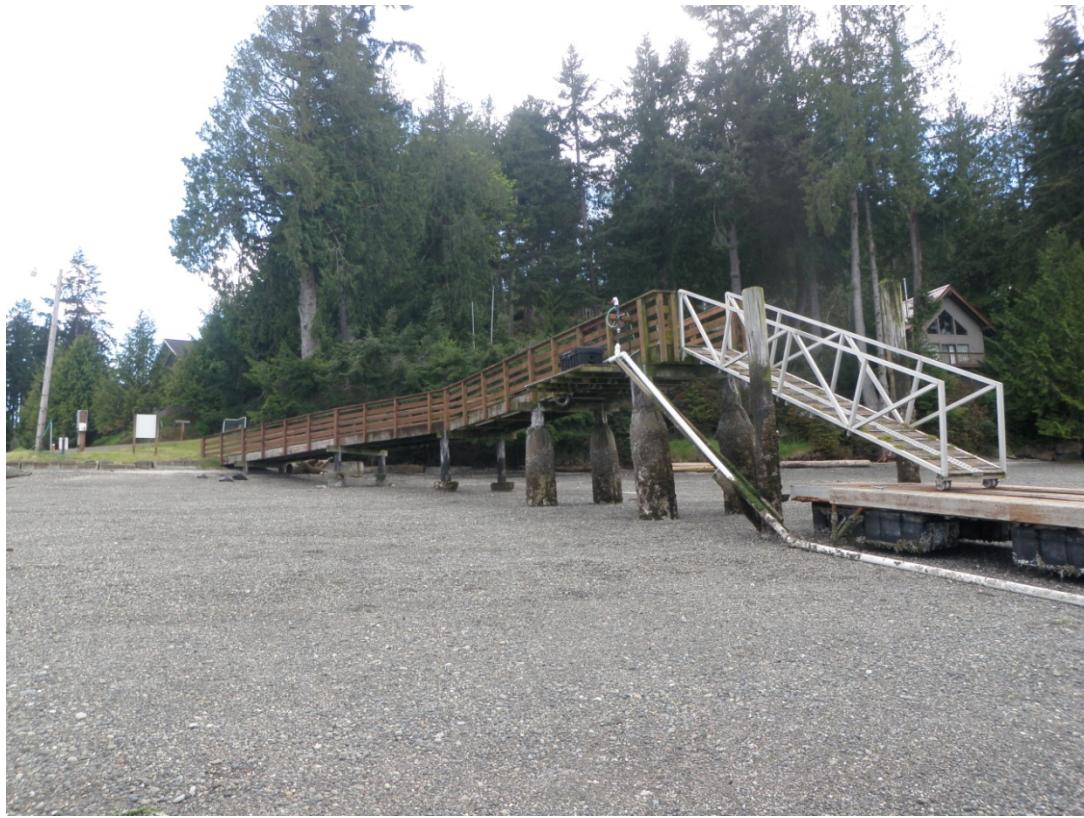
Photo 1 Timber Trestle at North Beach Marina at low tide

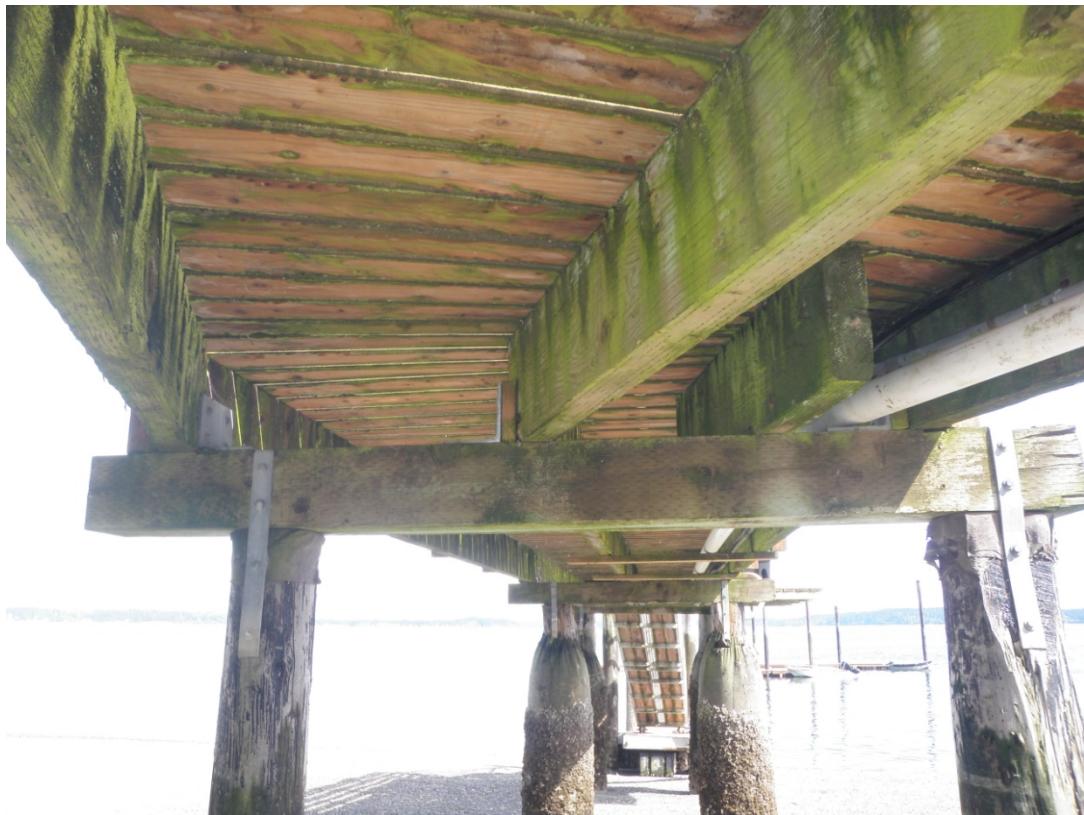
Photo 2 Underside view of Timber Trestle

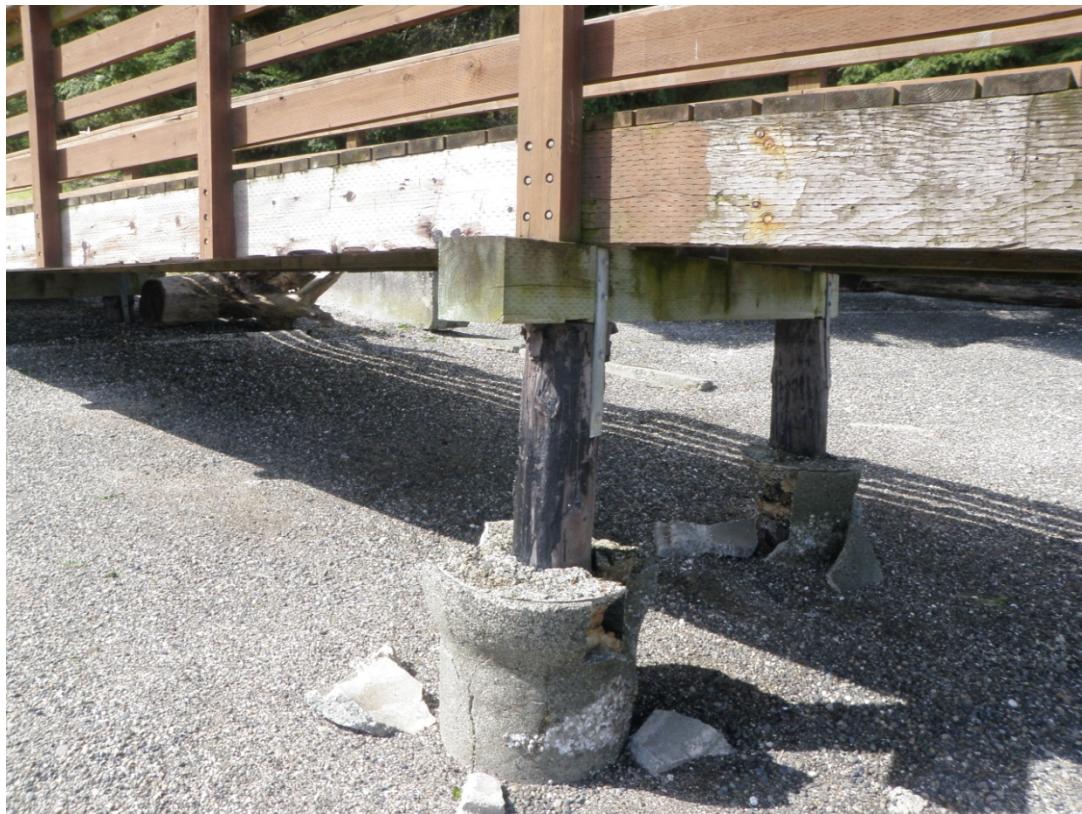
Photo 3 Broken concrete trestle piles set in broken concrete pipe

Recommendation:	Repair the damaged pile concrete encasements at the timber trestle (NB-3). Plan for repair of deteriorated dock guide piles (NB-1B) as soon as possible and attach floating dock to the best piles available in the mean time. Continue to remove the dock floats from the water during the storm season. See "FIG A"

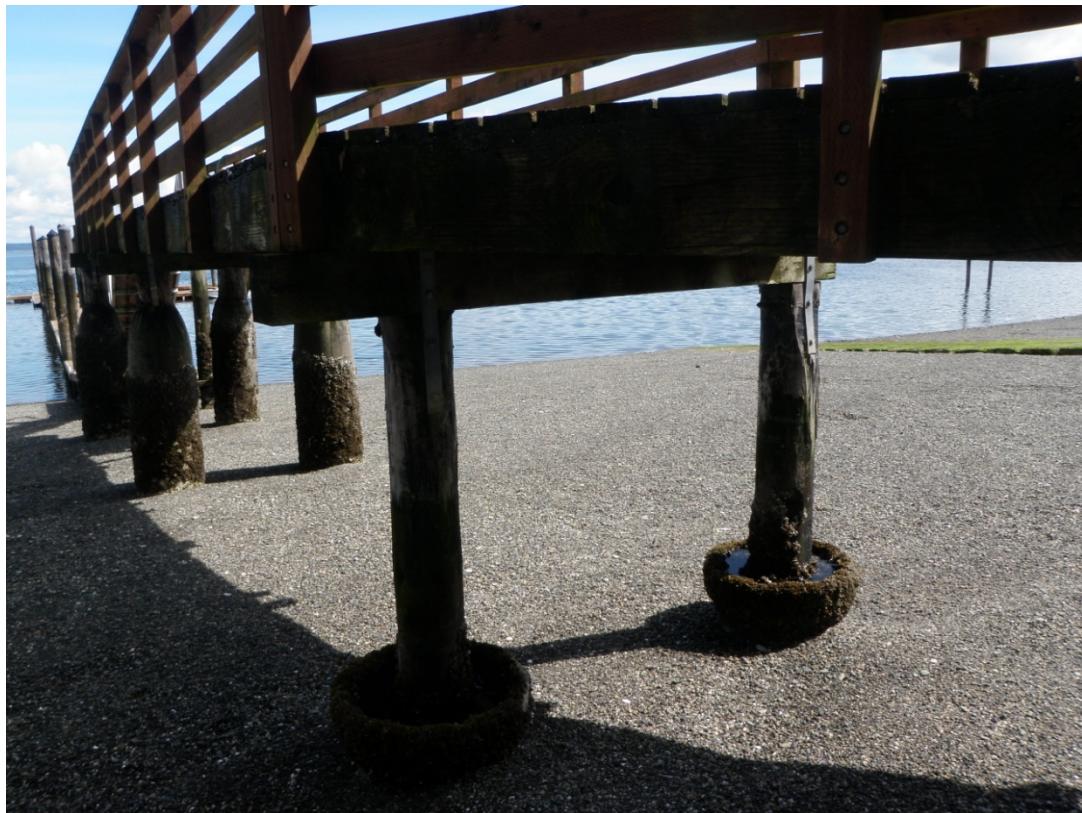
Photo 4 Timber Trestle

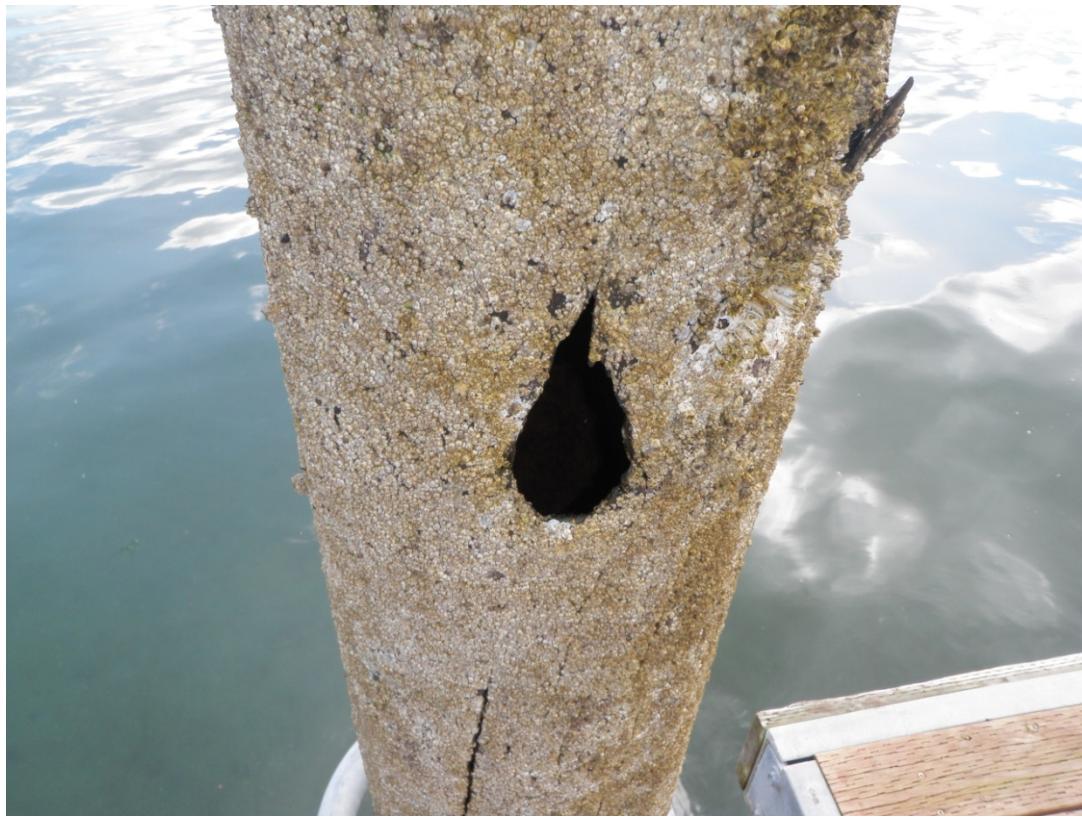
Photo 5 North Beach Marina Boat Dock example of deteriorated Pile

Repair Recommendations: Using the benefits and disadvantages listed above together with our understanding of the financial constraints of HMC Management, we recommend that HMC Management begin planning for option NB-2B. We are recommending the use of steel piles as the lower cost option with a proven system. When properly detailed and installed, this option should provide a service life of around 50 years, with a minimal amount of maintenance.

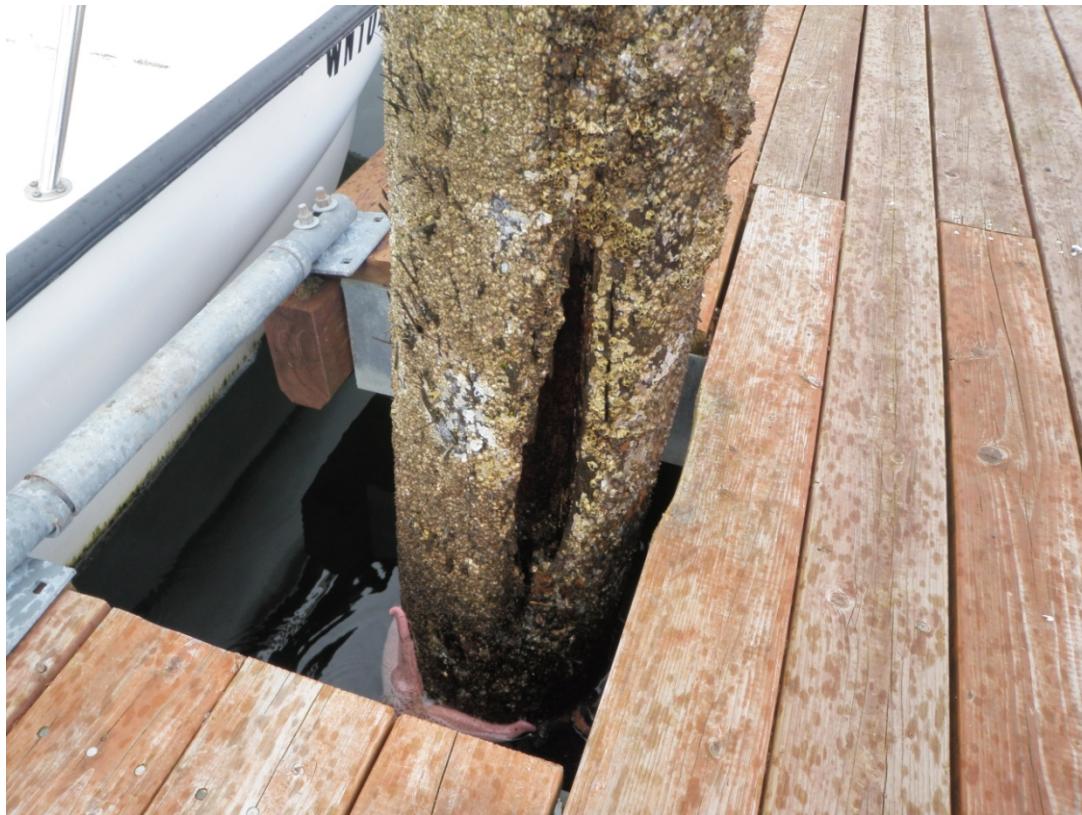
Photo 6 North Beach Marina Boat Dock example of deteriorated Pile

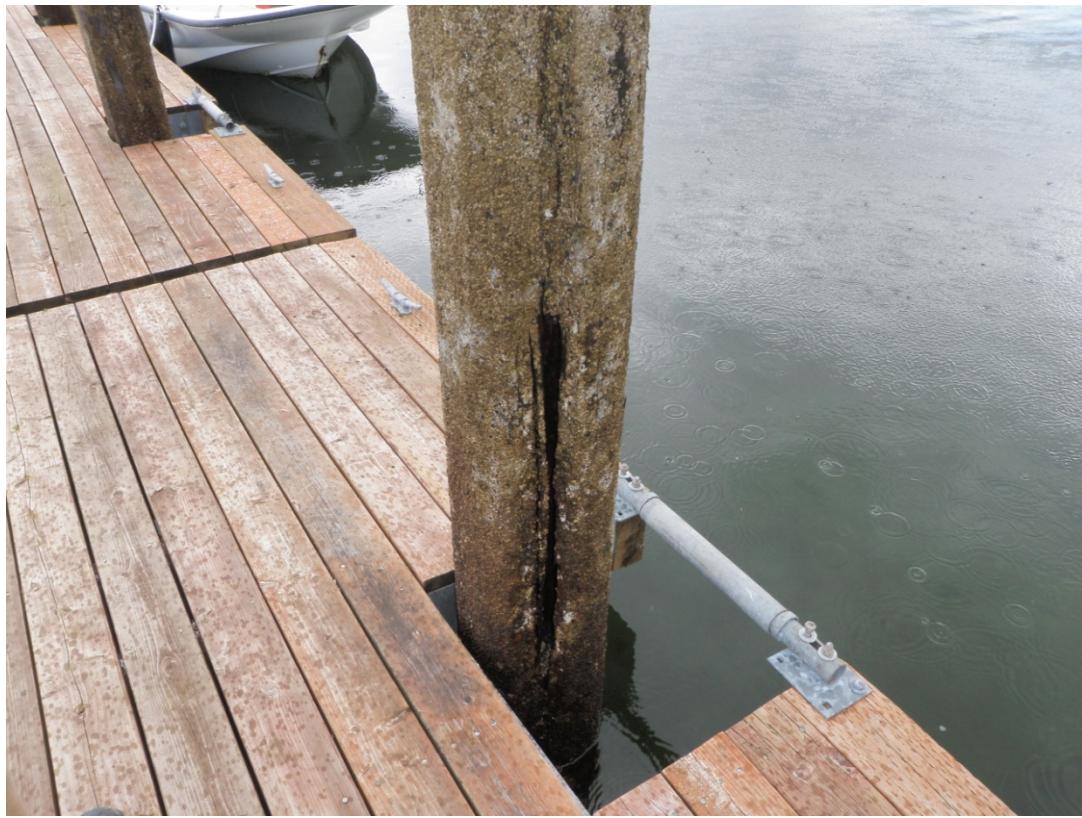
Photo 7 North Beach Marina Boat Dock example of deteriorated Pile

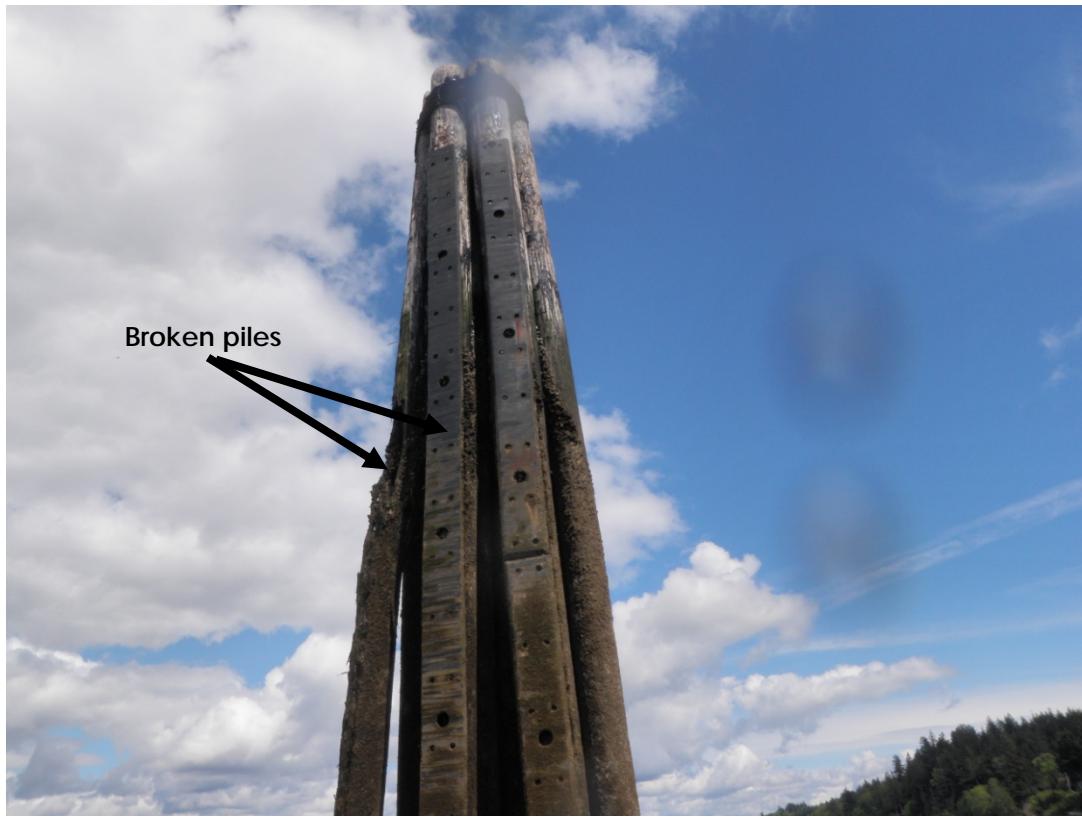
- **Mainland Ferry Terminal Dolphins:** Observations indicate that the outermost piles that were added in 1999 are mostly in good condition, with exception of two of the piles in the Northwest dolphin. It is our understanding that the Northwest dolphin receives the most impact from the ferry and from observation the two piles in question are the first to come in contact with the incoming ferry. These two piles were observed to deflect due to impact from the incoming ferry to such

an extent that they are considered to have little remaining strength. See **Photo #8**. However, the dolphin as a whole was observed to be solid.

Photo 8 North-West timber dolphin at the Mainland Ferry Terminal

Using the benefits and disadvantage listed above together with our understanding of the financial constraints of the HMC Management, we recommend that the HMC Management plan to replace the existing timber cluster pile dolphins with steel mono pile dolphins within the next 10 years. FT-2 is recommended as the option with the lowest cost and shortest construction time with a proven system.

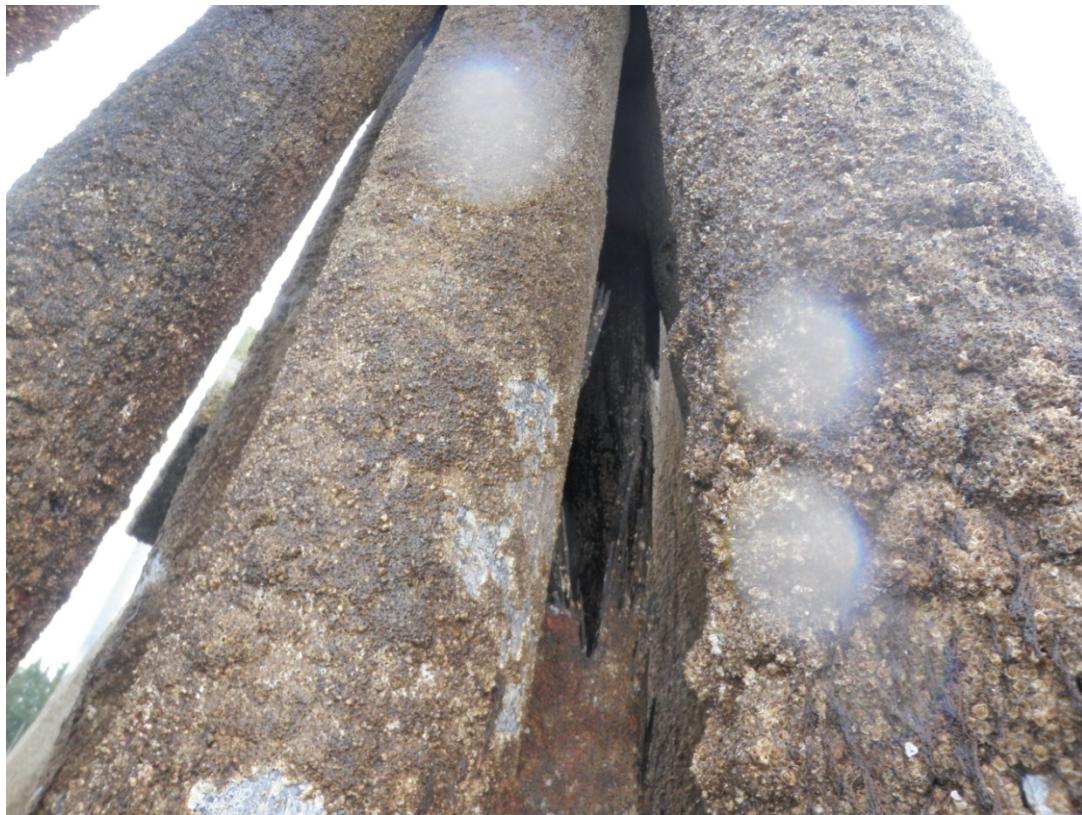
In all of the dolphins, deteriorated piles were observed. In most instances the deteriorated piles were at the interior of the cluster. See **Photos #9 and #10**. With the exception stated previously, the perimeter piles were observed to be in good condition by means of hammer sounding and probing.

Photo 9 Typical example of timber dolphins with deteriorated interior pile

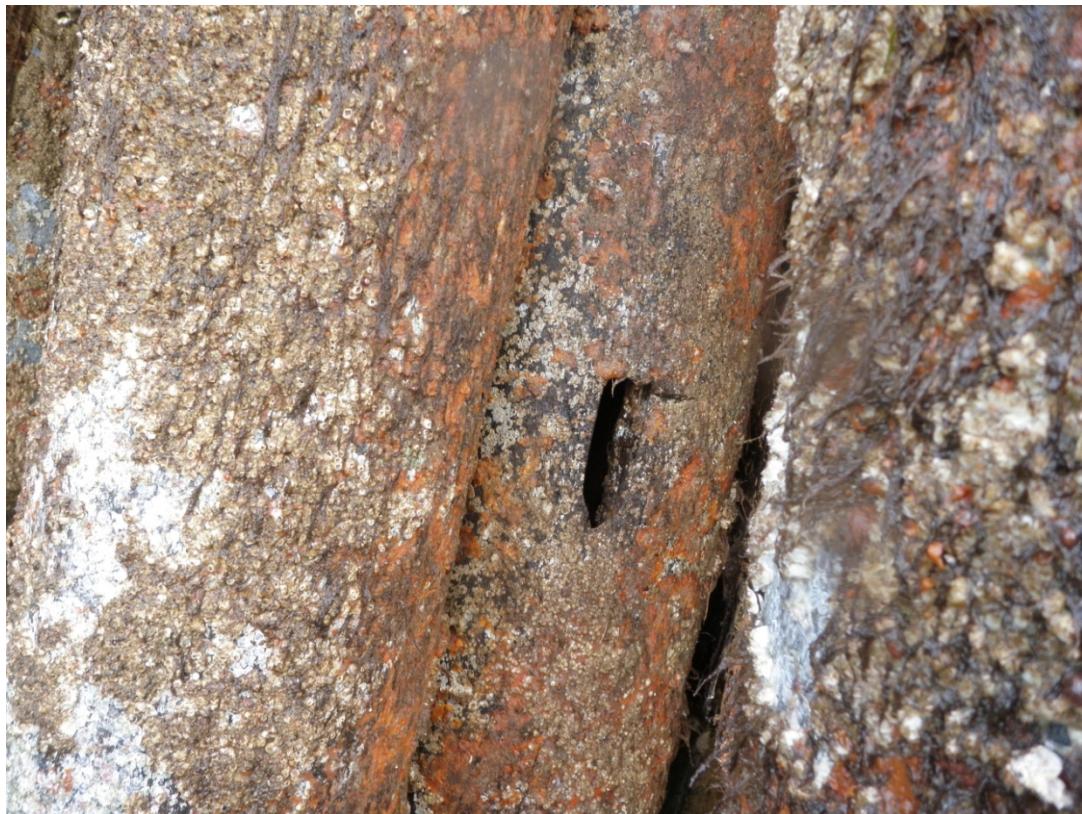
Photo 10 Typical example of timber dolphins with deteriorated interior pile

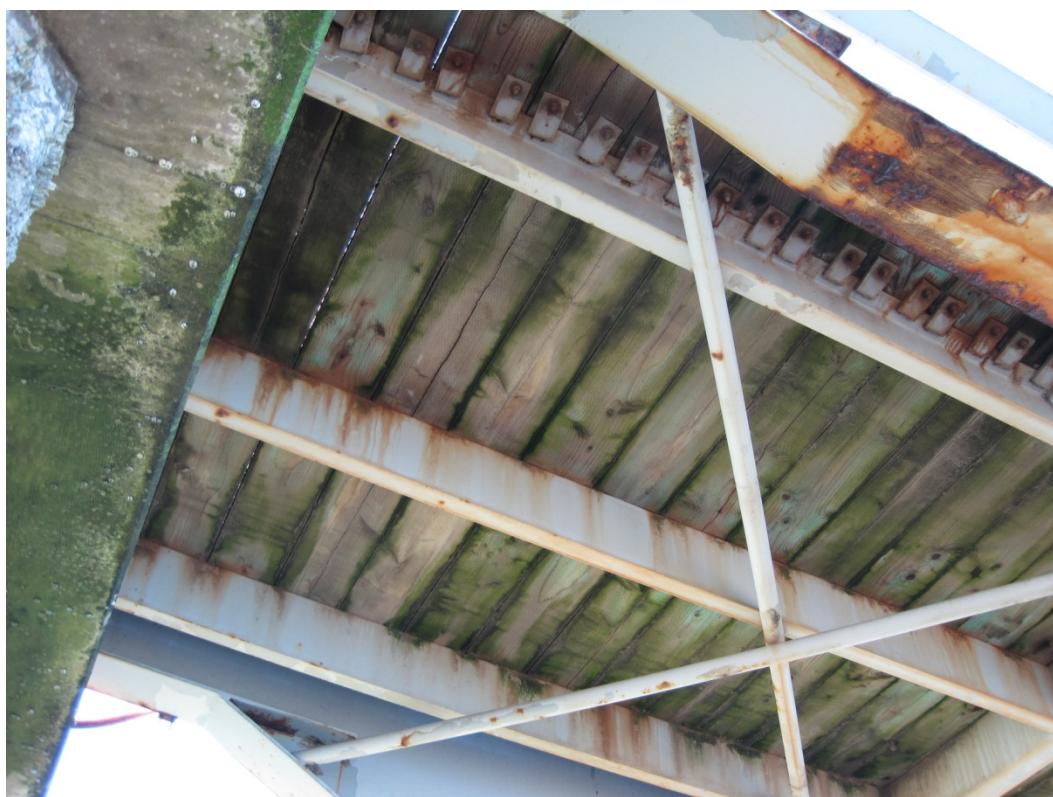
"The painted steel stringer has rust stains washing down from the seam between stringers and the deck. Vehicle traffic is most likely causing the deck planks to wear the paint from the tops of the stringers. Several stringers have dark rust stains along their weld connections to the floor beams. No significant corrosion was observed in these joints or on the stringers. There are many local paint failures throughout the stringers, allowing surface corrosion. There are two main girders in this span. These girders are considered fracture critical because they are steel and there is no load path redundancy. I.E., if one girder were to fail, the entire span would fail. The girders appear to receive more salt spray than the stringers and girders, as a result there are several areas of blistering paint and surface corrosion. Most blistering is along the bottom flange of the girders." (pg. 3), (See Photo #11)

Comparing the condition description from the KPFF report to the Sargent report, it may be extrapolated that the paint has been deteriorating for more than 5 years. See the report by KPFF For a complete review of all conditions observed by KPFF in 2005.

Photo 11 Underside view of steel draw span

- FT-4:** The scope of option FT-4 includes spot cleaning the deteriorated areas of paint on the steel draw span and repainting the entire draw span (does not include stripping of paint if good condition). This would require the removal of the timber decking and the galvanized guardrail. In order to minimize the impact to island residence, the work for this option would be scheduled to coincide with the ferry maintenance schedule. Therefore, the contractor would be required to deliver all materials to the island before the ferry is taken out of service. The contractor would then have to access the island by use of a small boat. This access restriction will increase the cost. Therefore, the cost estimate for this work is separated by the Mainland terminal and the Island terminal. The estimated cost for this option at the Mainland side terminal is \$91,000. The estimated cost for this option at the island side terminal is \$121,000. The cost estimates include overtime costs to limit the work period to two weeks.

Repair Recommendations: We recommend that the HMC Management begin planning for option FT-4. As discussed in the Sargent Engineers report, the paint system is intended to protect the steel material from deterioration. There are sections of the paint system that have failed, leaving the steel at risk of corrosion and section loss. We believe that this is a critical repair that should be scheduled as soon as is practical.
