# *Herron Island Mainland and Island Ferry Terminal*

## *ROUTINE STRUCTURE INSPECTIONS – 2014*

Inspection Date: April 1<sup>st</sup> and 2<sup>nd</sup>, 2014

**RE: Ferry Terminal Observation  
Project No.: A14111.00**

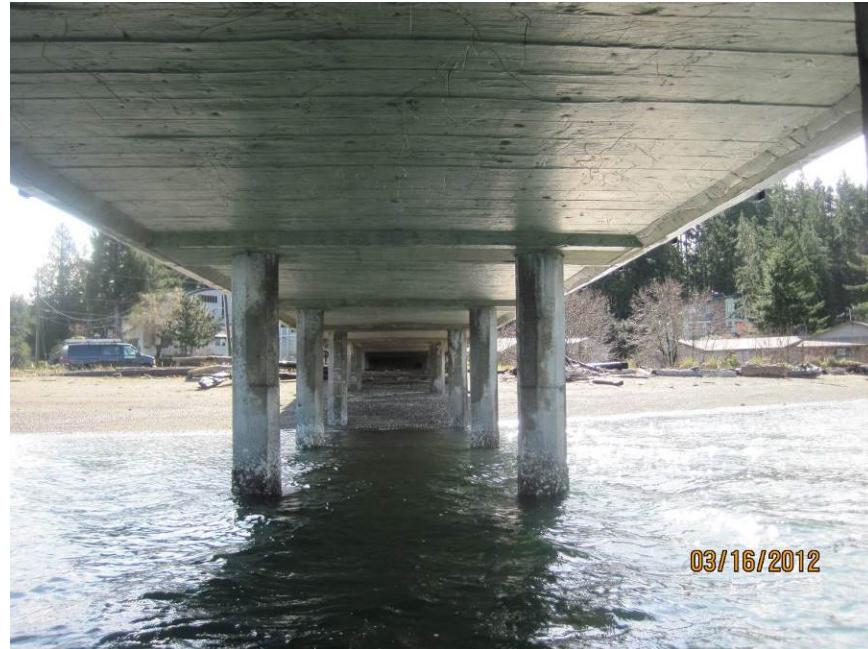
- Good condition, small concrete patches in several columns, patches are in good condition.

Image 1: Reinforced concrete approach spans.

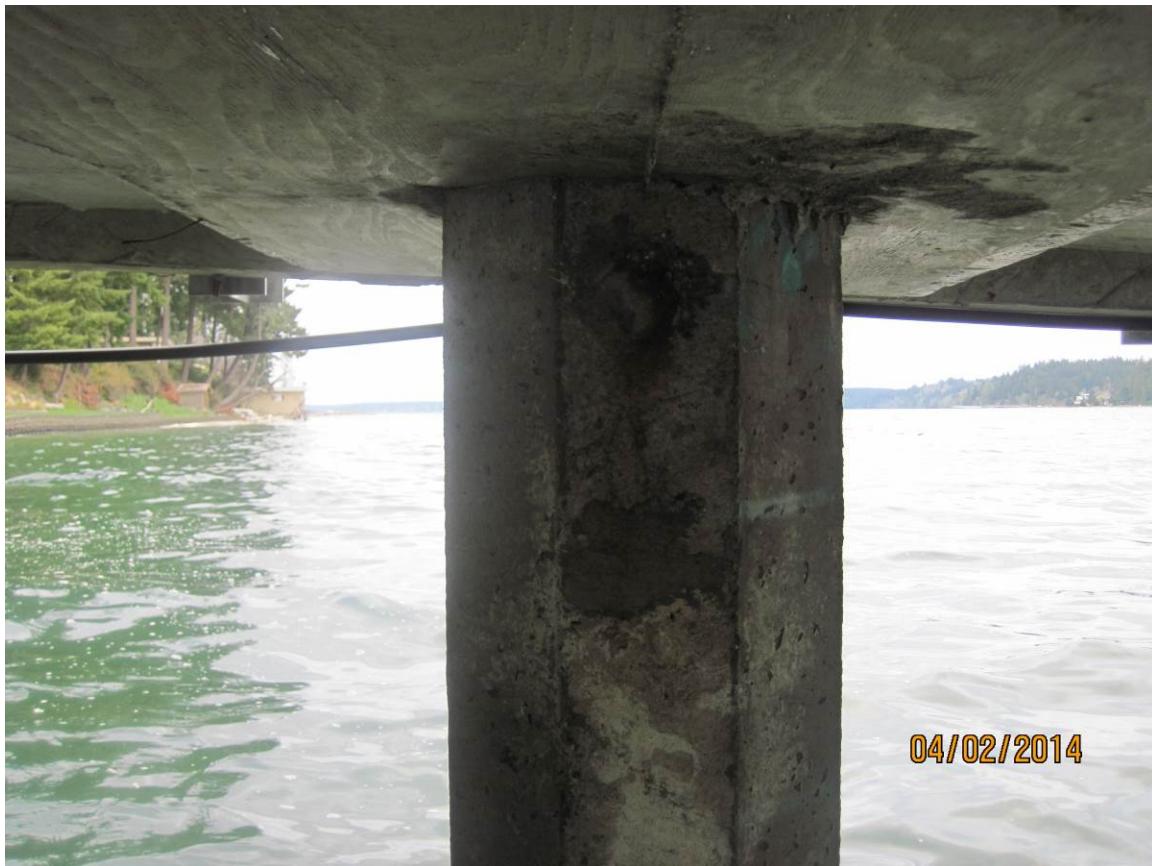
- Minor hairline cracking near tops of several piles. (1) Minor spall with a short length exposed rusting rebar. Small concrete patches in several columns, patches are in good condition.

Image 3: Typical of patches. Short length of exposed rebar visible near the top.

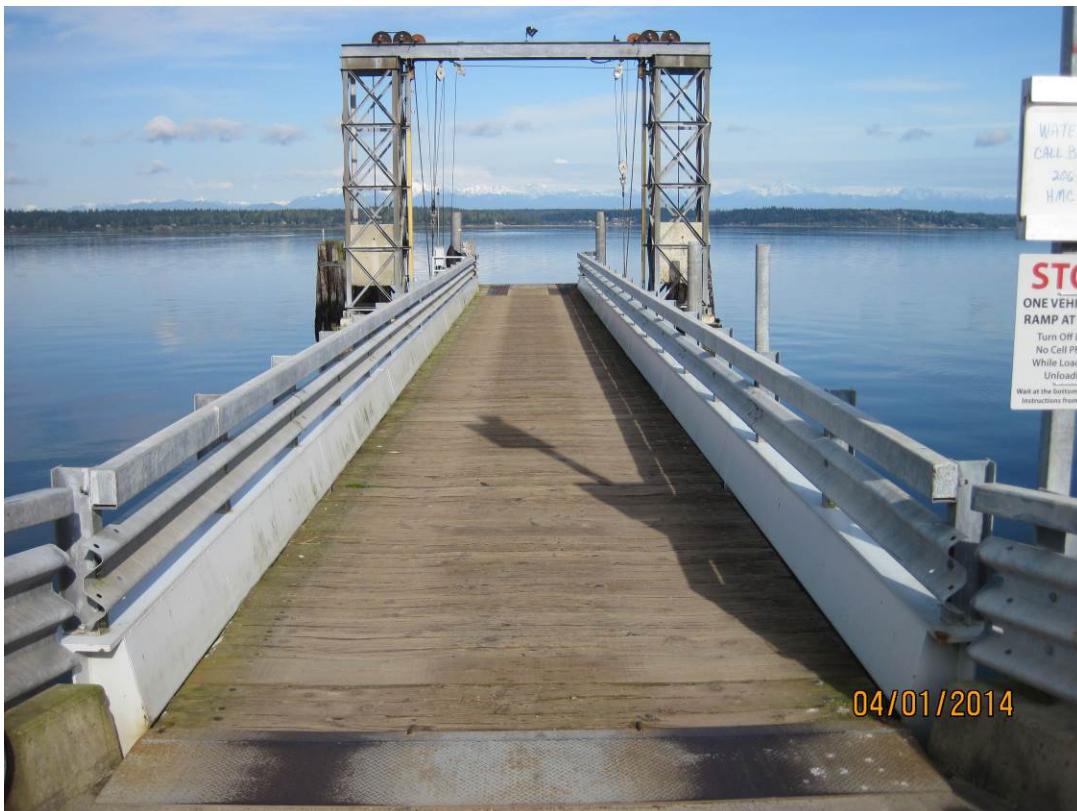
- The surface of the planks is wearing and rutting in the traffic wheel lines and there are checks and splits in the top side of many of the planks. The bottom surface of the planks is in better condition with little or no checking or splitting. Very little rot or decay was observed in the planks. It appears most all deterioration is from vehicle traffic and exposure. Though the deck planks are becoming worn and are in the later stages of their service life, it is likely have several years of service life remaining. Counting from the mainland end, planks 1, 2, 17, 21, and 29 were found to have advanced splitting and wear and should be replaced. The remaining planks should be monitored and replaced when significant splitting is noticed. The clips attaching the timber decking to the stringer tops are appear secure and in good condition.

Image 4: Mainland transfer span timber decking.

5. Monitor intersecting welds on the floor beams and main girders during subsequent inspections.
6. Replace the deck planks noted for replacement in the report, monitor and replace remaining planks as necessary.

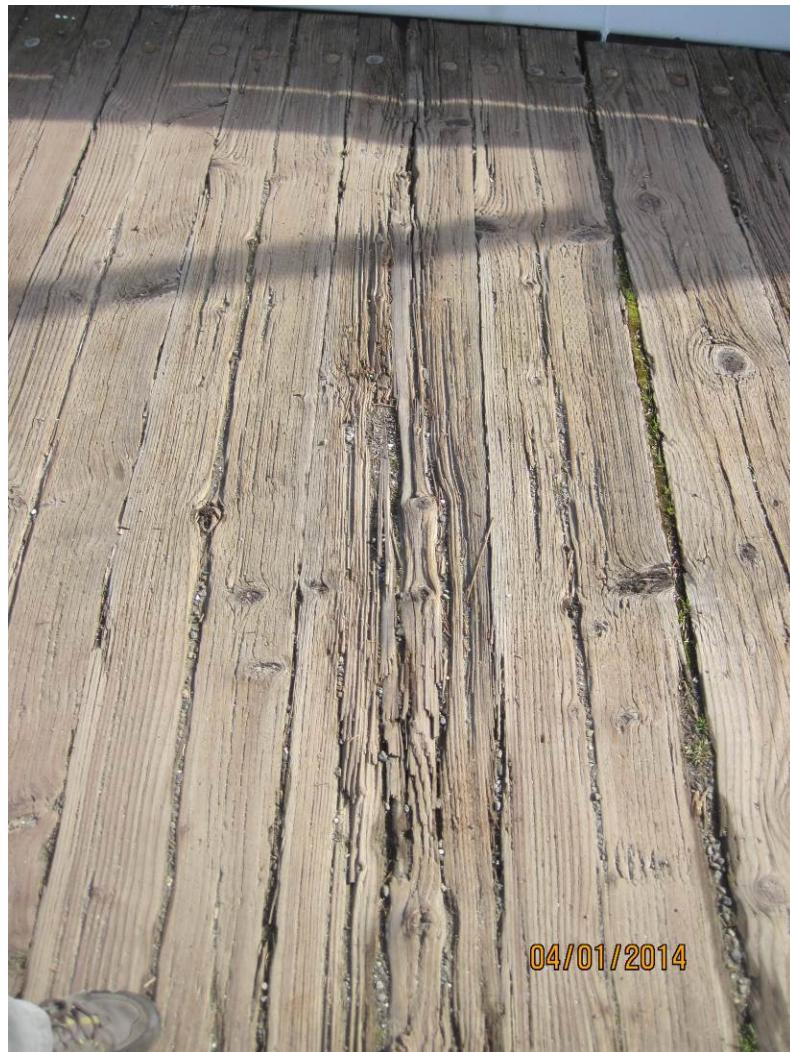
**Image 5:** General condition of mainland transfer span timber decking.

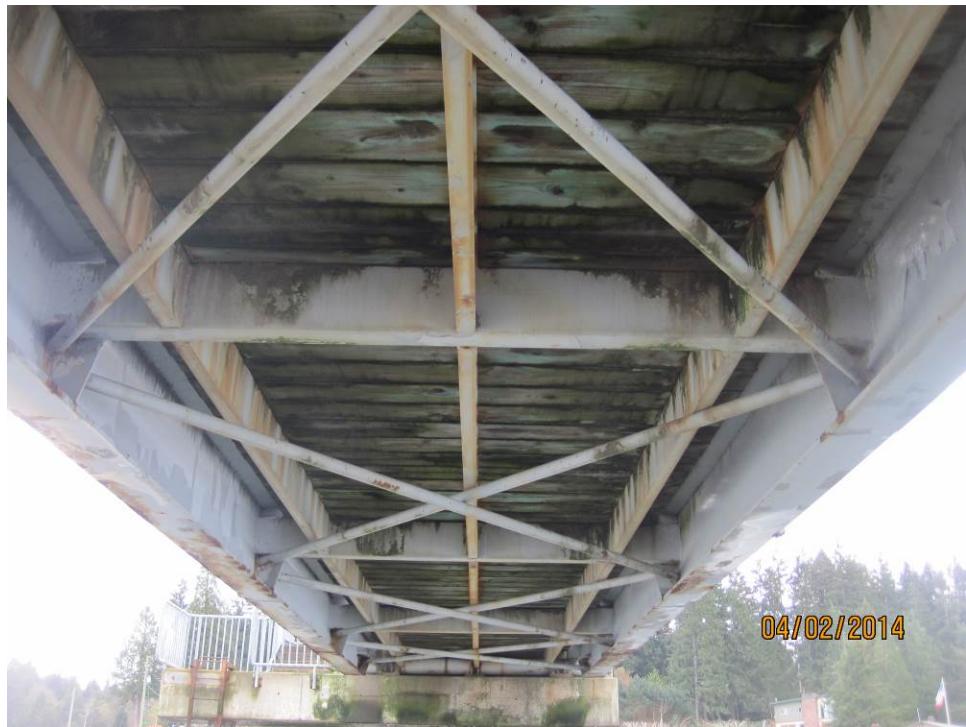
- Generally, the paint on the steel members on the land side of the counterweight towers is in better condition than the paint on the steel members beyond the towers. The transfer span area beyond the towers must get more exposure and have more contact with salts. The primary areas with deficiencies are along the stringer top flanges and the stringer to floor beam connections. Along the stringer top flanges, there are rust stains washing down from the interface between the stringers and the deck. Vehicle traffic is most likely causing the deck planks to wear against the tops of the stringers, causing the paint to wear. At the stringer connection to the floor beam, paint is deteriorated along the welded connection and along the bottom edge of the stringer. This is a typical location for accelerated paint breakdown and corrosion. No significant loss of section from corrosion was observed. No cracking in the members was observed.

Image 6: General paint condition of steel members inland of counter weight towers.

1. Blast clean and spot paint or fully re-paint the steel members of the mainland terminal within the next two years
2. Blast clean and spot paint or fully re-paint the steel members of the island terminal within the next two to three years.

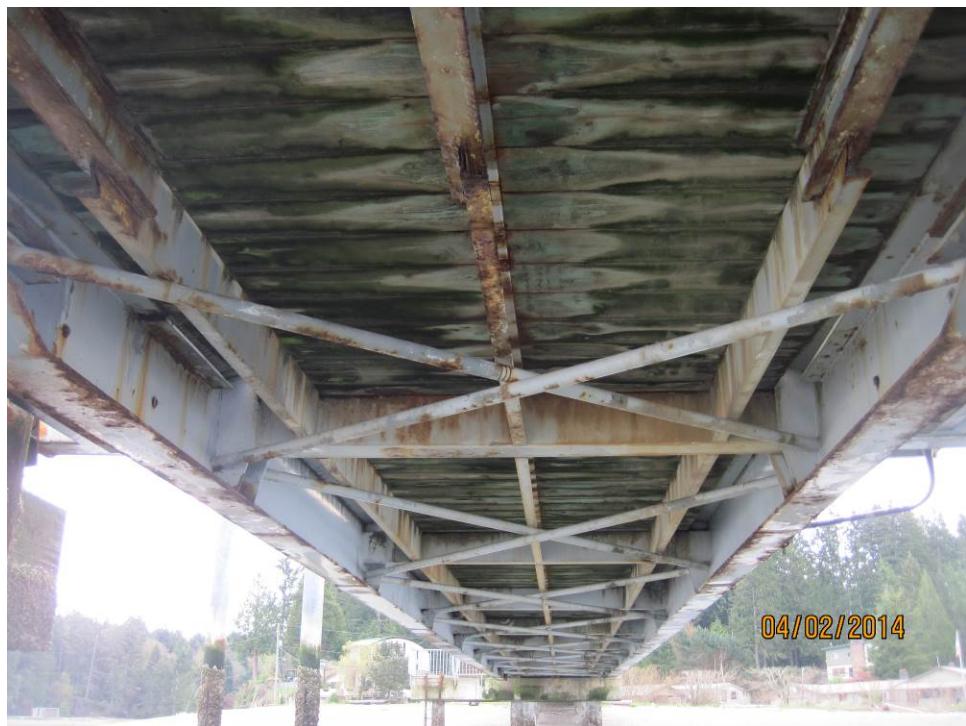
Image 7: General paint condition of steel members located beyond counter weight towers.

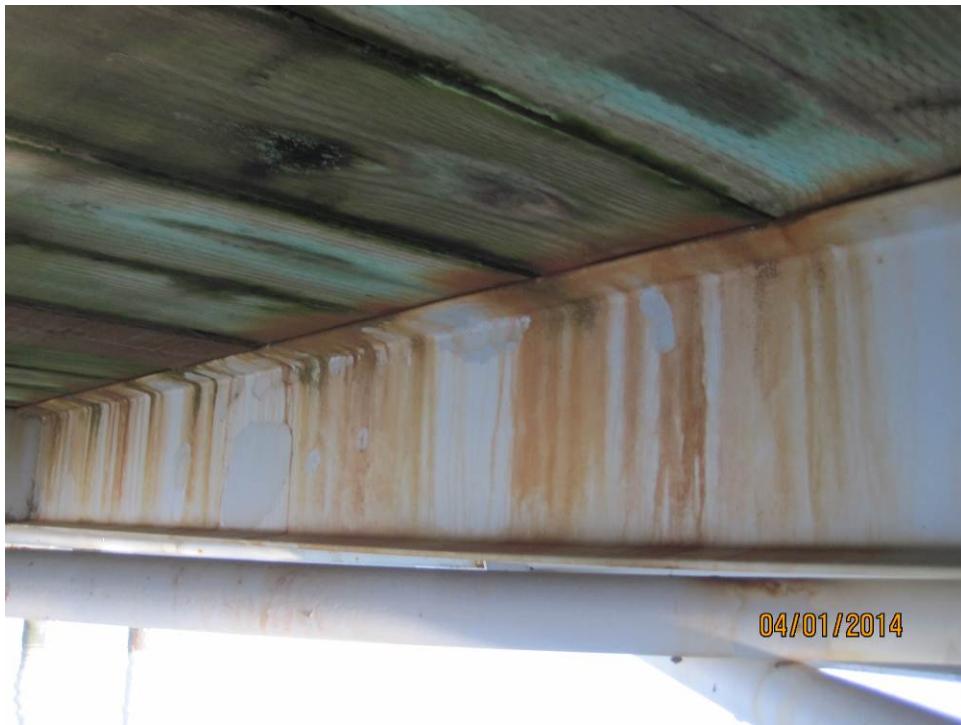
**Image 8:** Typical of rust stains along the stringer top flange, from wear at the interface with the timber plank decking.

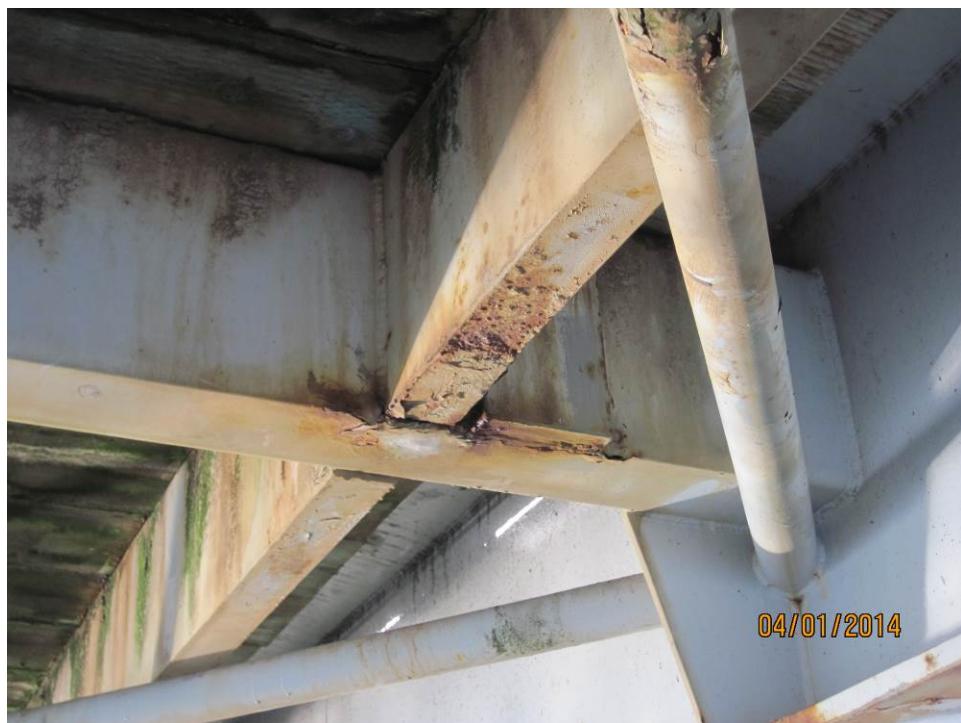
**Image 9:** Stringer to floor beam connection area.

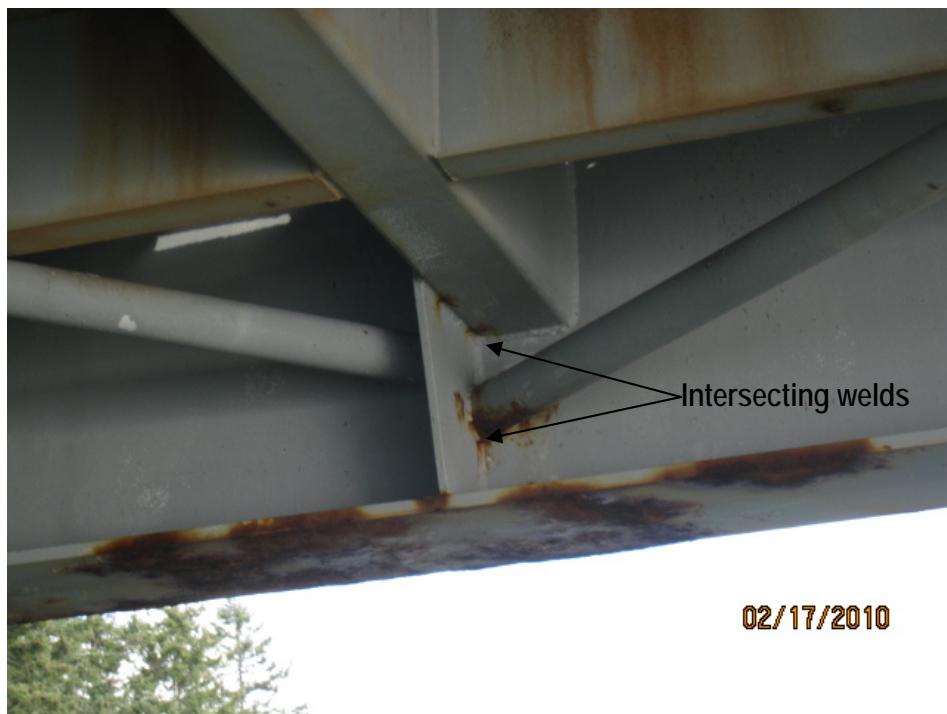
- The paint condition of the floor beams varies with location similar to the stringers, with the poorest conditions being beyond the towers. The floor beam connections to the main girders are welded. The welds of the girder gusset plates and the floor beams intersect. When welds like these intersect, they cause a stress concentration. This area can be susceptible to cracking from fatigue. No cracking was observed at the time of this inspection. The area surrounding this connection is convoluted with intersecting members, creating pockets that hold moisture and salts. This typical condition accelerates the breakdown of paint and corrosion of exposed steel. The paint in these areas continues to deteriorate, and the amount of area with exposed steel and corrosion is increasing. No significant loss of section from corrosion was observed. No cracking in the members was observed.

Image 10: Location of intersecting welds.

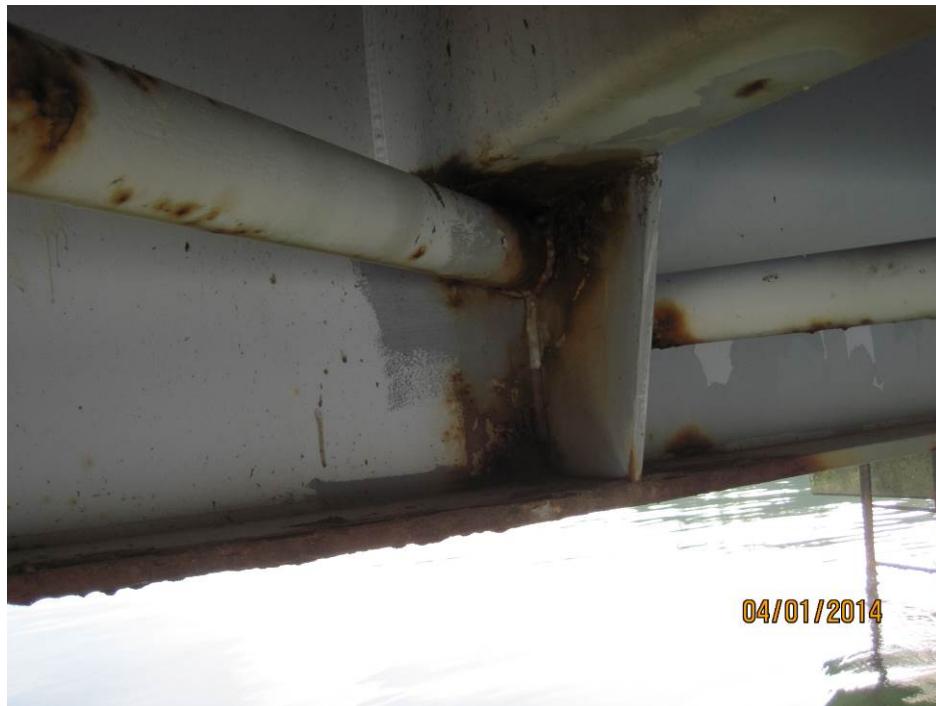
**Image 11:** Corrosion in areas of intersecting members at the floor beam to girder connection.

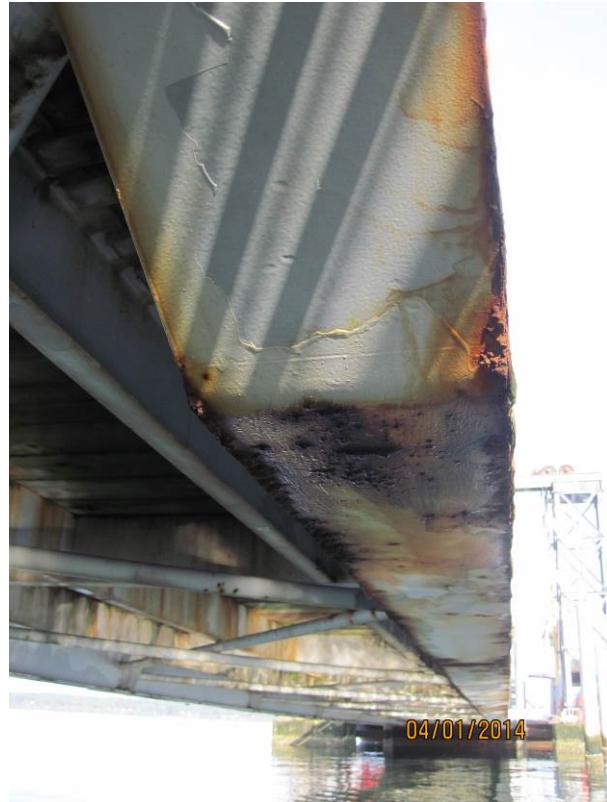
- Two girders support the floor beams and stringers along the transfer span. These girders are considered fracture critical because they have no load path redundancy. I.E., if one girder were to fail the entire span would fail. Like the floor beams, there are several girder strengthening details with intersecting welds. Like the stringers and floor beams, the girder lengths beyond the towers have more paint deterioration than those on the land side of the towers. The majority of that paint deterioration is along the bottom edge of the girders and at connections with intersecting members. The amount of corrosion has increased slightly since the last inspection. No areas with a drastic increase in corrosion were observed. No cracking in the girders or welds were observed.

Image 12: Typical of corrosion along the bottom girder edge.

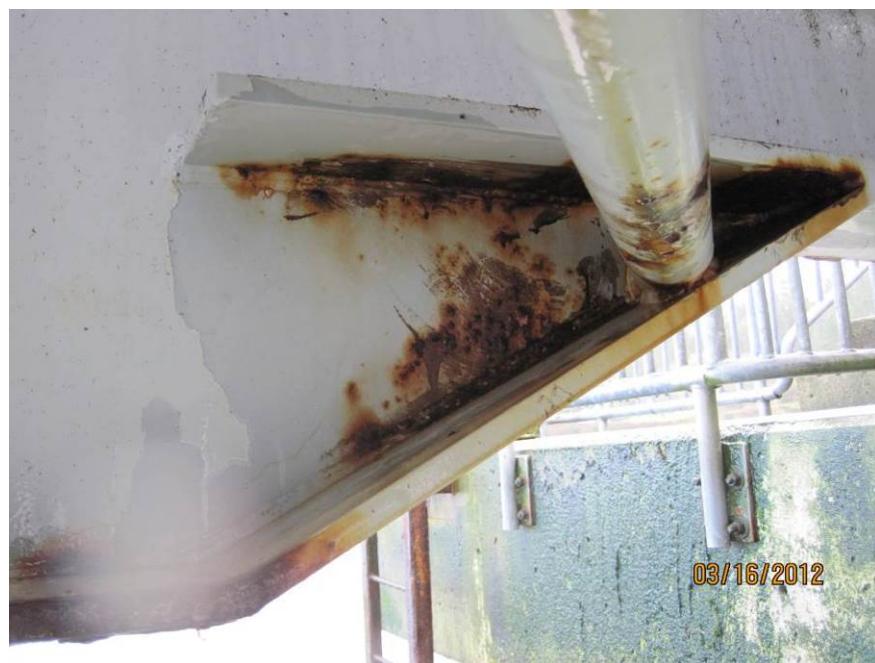
Image 13: 2012 - Interior face of a steel girder: Typical of the corrosion around the connections areas.

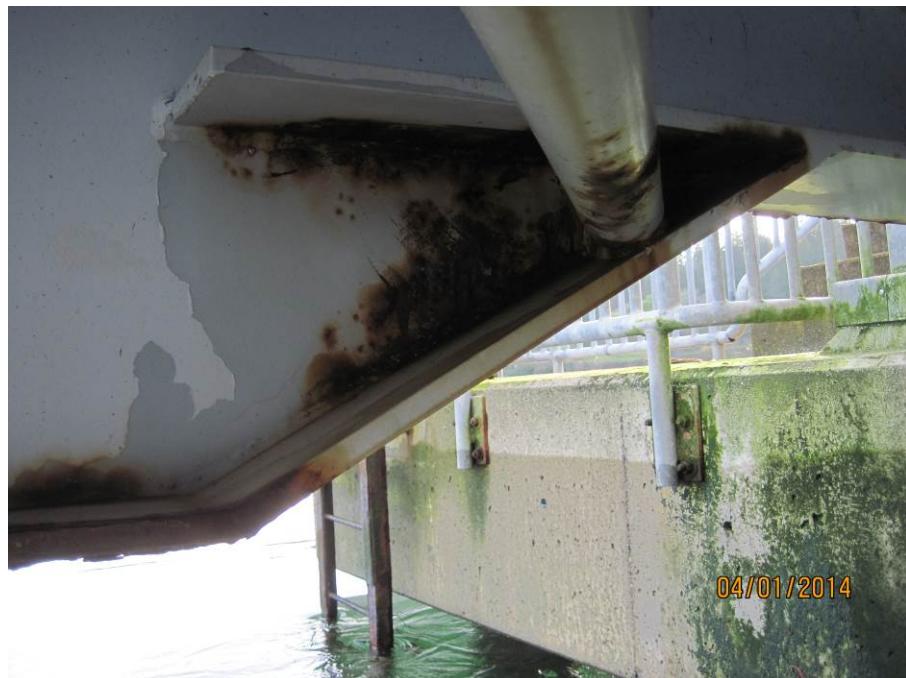
**Image 14:** 2014 – Photograph of same location as above, some increase in the amount of surface area with corrosion since 2012.

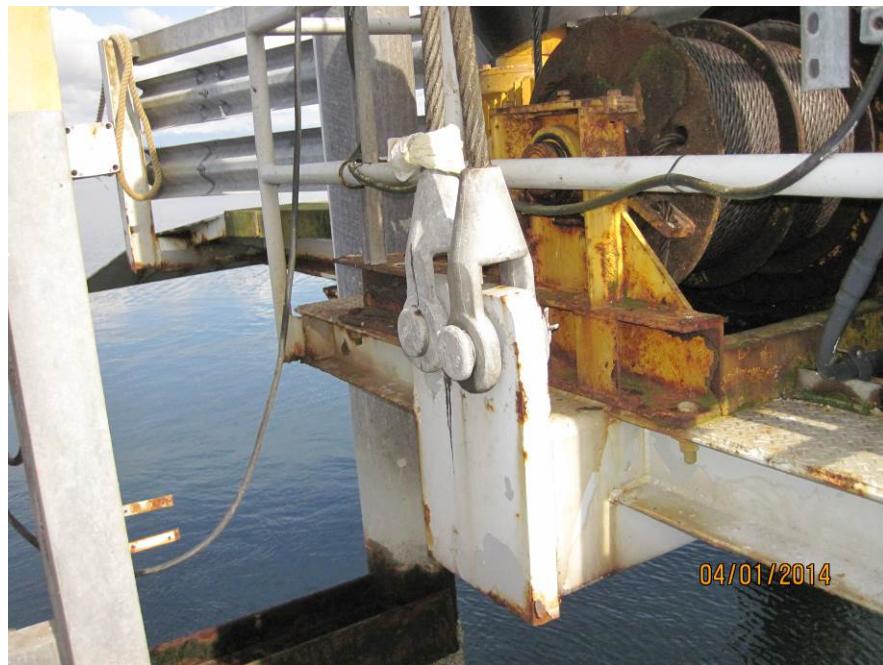
- The paint condition of the steel outriggers, which connect the girders to the lifting cables, is generally in fair condition. There is failed paint along the edges and along the underside. No cracking in the outriggers or welds were observed.

**Image 15:** 2014 – Painted steel outrigger.

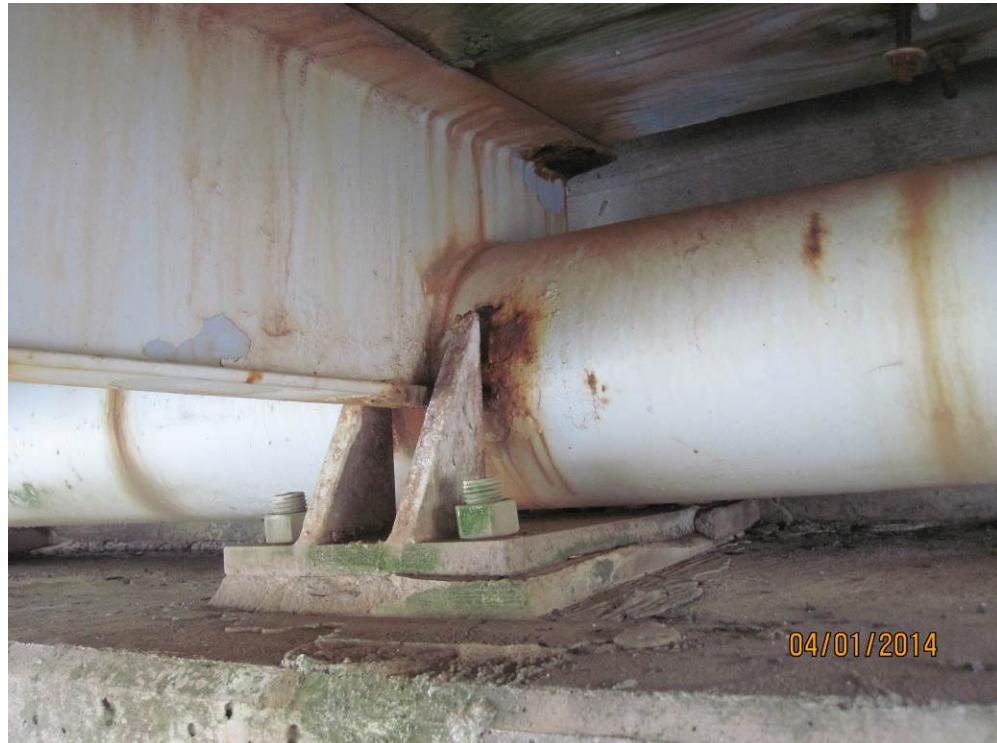
- The bearings are in fair condition. The movable painted steel bearing at bent 9 appears to be free and in good service condition. There is some paint deterioration and corrosion along the edges of the bearing.

Image 16: Typical of the corrosion around the girder bearing.

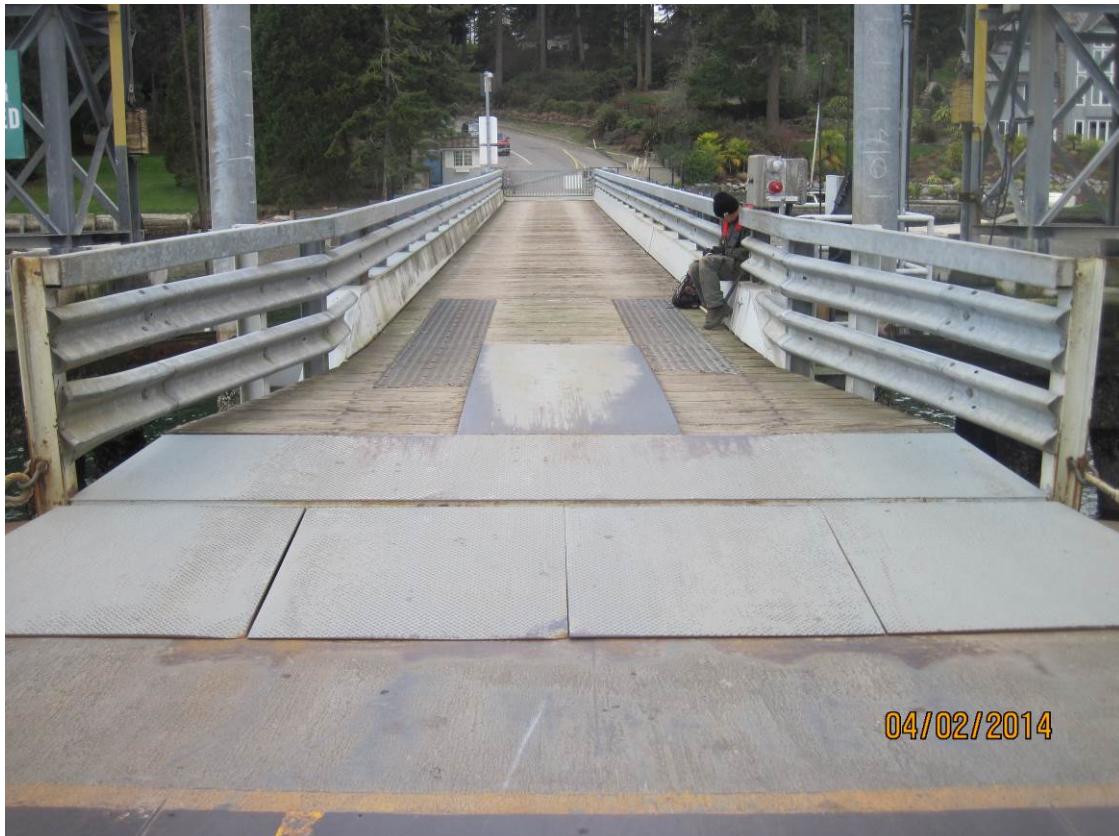
- Generally, the island deck planks are in the same condition as the mainland planks and have the same remaining service life expectancy. The planks should be monitored and replaced when significant splitting is noticed. The clips attaching the timber decking to the stringer tops are appear secure and in good condition.

Image 17: Island transfer span timber decking.

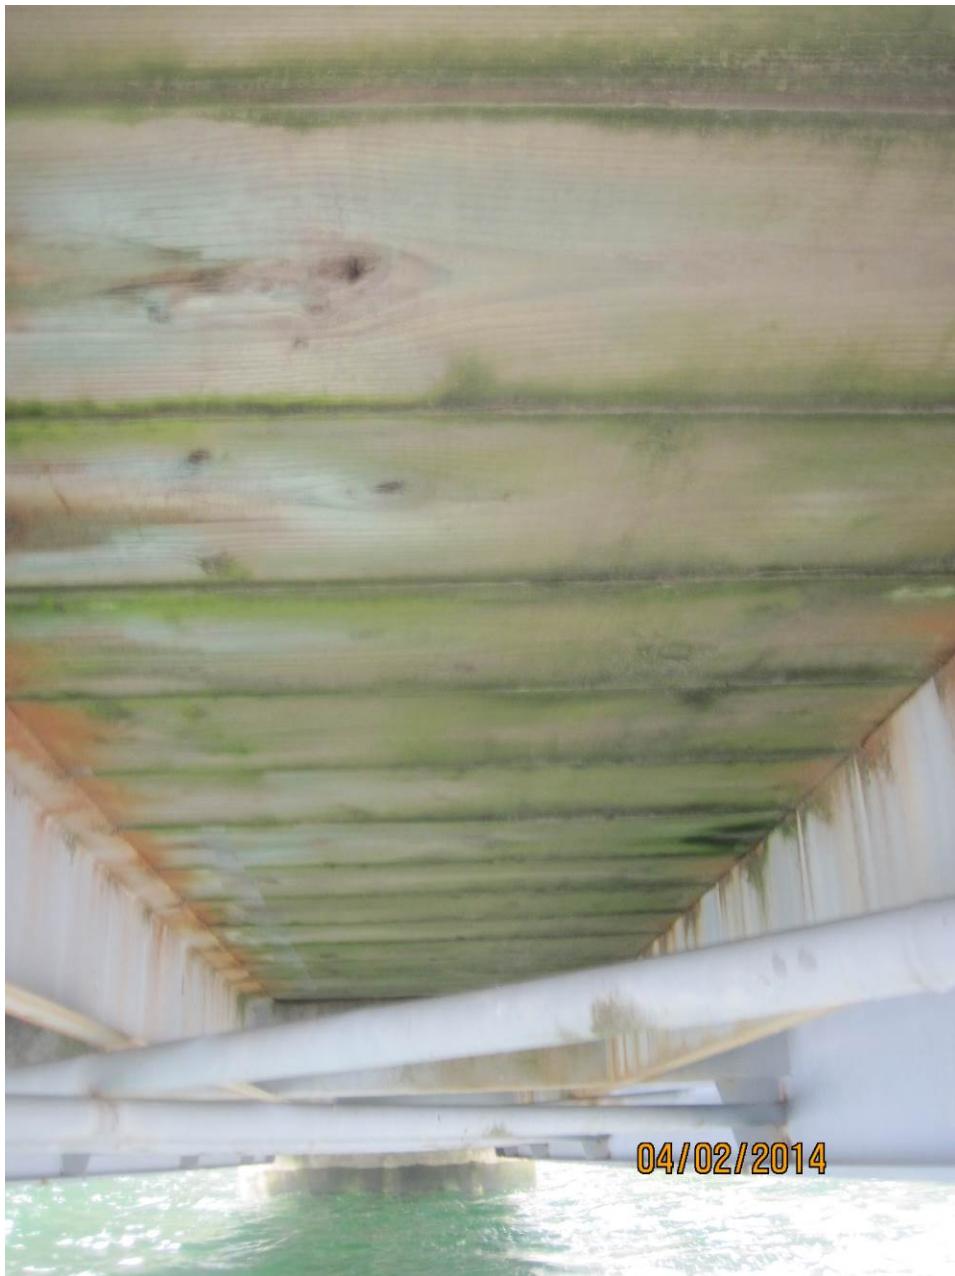
**Image 18:** Underside of plank decking is in fair condition.

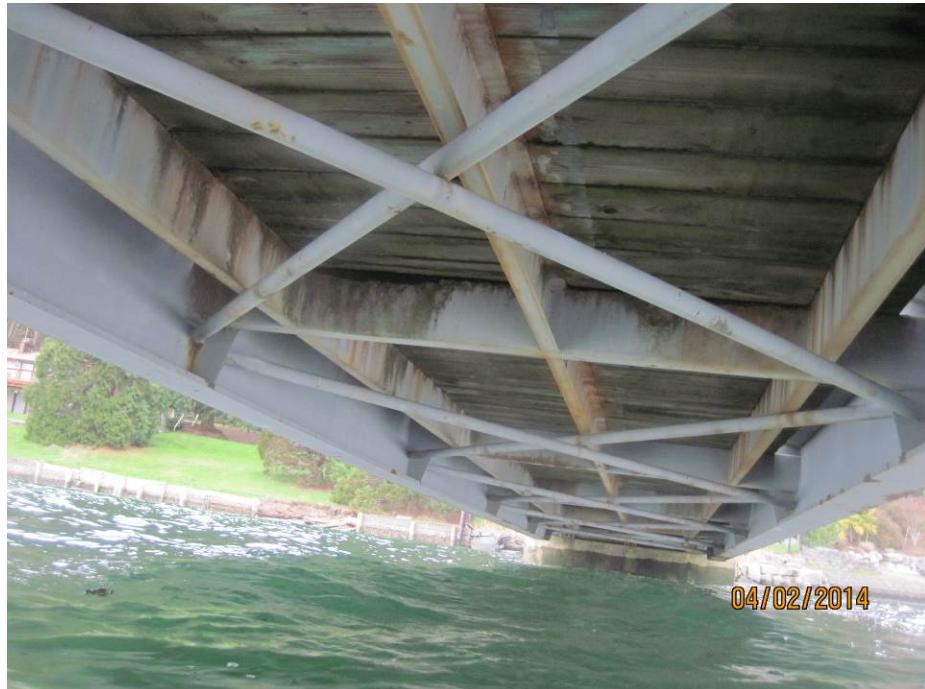
- Like the mainland stringers, the paint on the steel members on the land side of the counterweight towers is in better condition than the paint on the steel members beyond the towers. The locations of paint deterioration are the same as the mainland, though overall the degree of corrosion is less. This is attributed to the fact that the island terminal is somewhat sheltered by the island from the southwest winds, where the mainland terminal

**Image 19:** General paint condition of steel members located inland of counter weight towers.

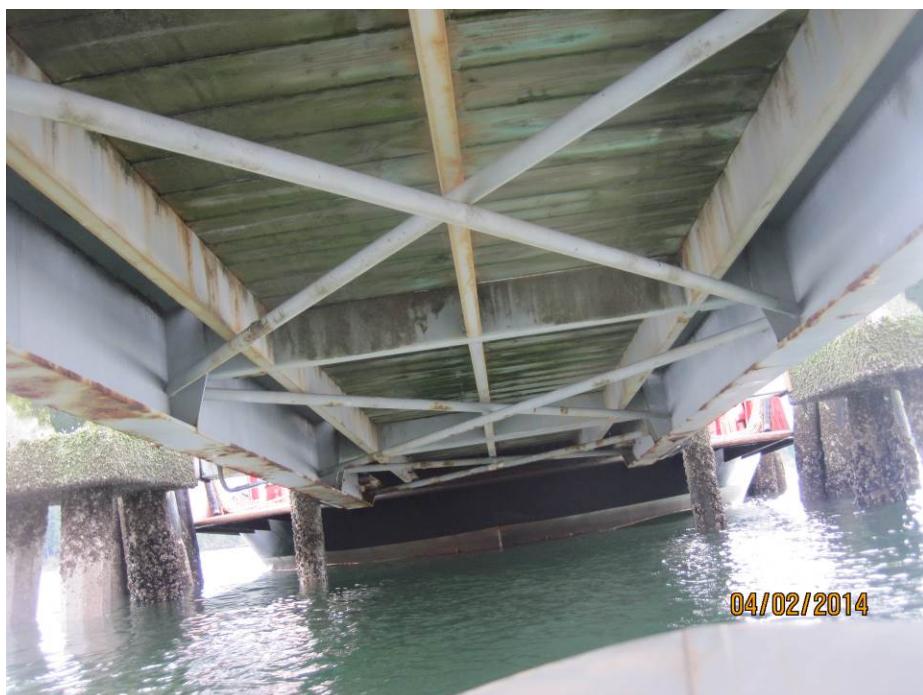
**Image 20:** General paint condition of steel members located beyond counter weight towers.

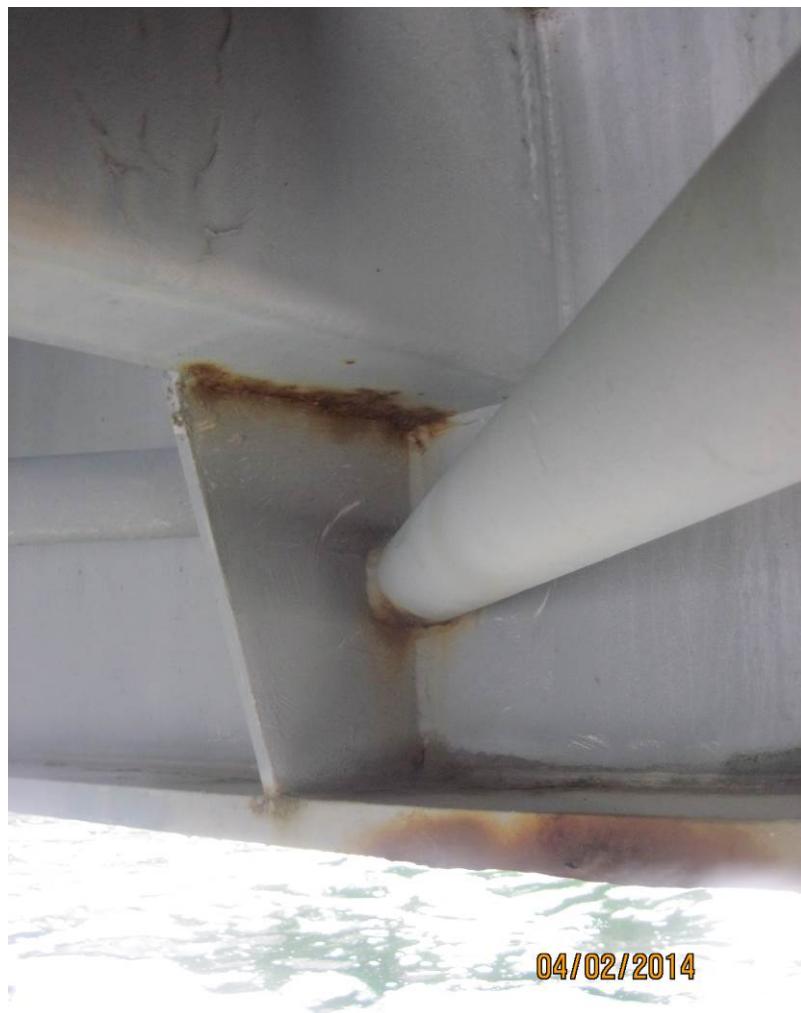
- Like the mainland floor beams, the paint on the steel members on the land side of the counterweight towers is in better condition than the paint on the steel members beyond the towers. The locations of paint deterioration are the same as the mainland, though overall the degree of corrosion is less, and again is attributed to shelter from the winds. No significant loss of section from corrosion was observed. No cracking in the members was observed.

Image 21: Corrosion in areas of intersecting members at the floor beam to girder connection.

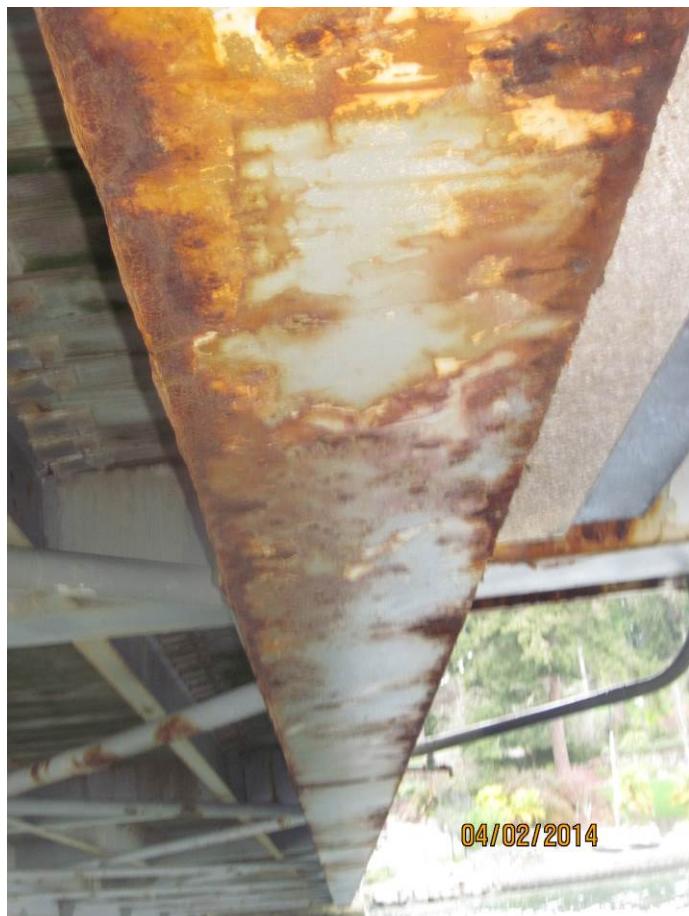
- The girders are fracture critical. Like the stringers and floor beams, the girder lengths beyond the towers have more paint deterioration than those on the land side of the towers. The majority of that paint deterioration is along the bottom edge of the girders and at connections with intersecting members. The amount of corrosion has increased slightly since the last inspection. No areas with a drastic increase in corrosion were observed. No cracking in the girders or welds were observed.
- The paint condition of the steel outriggers is generally in fair condition. There is some failed paint along their edges and along the underside. No cracking in the outriggers or welds were observed.

Image 22: Typical of corrosion along the bottom edge.

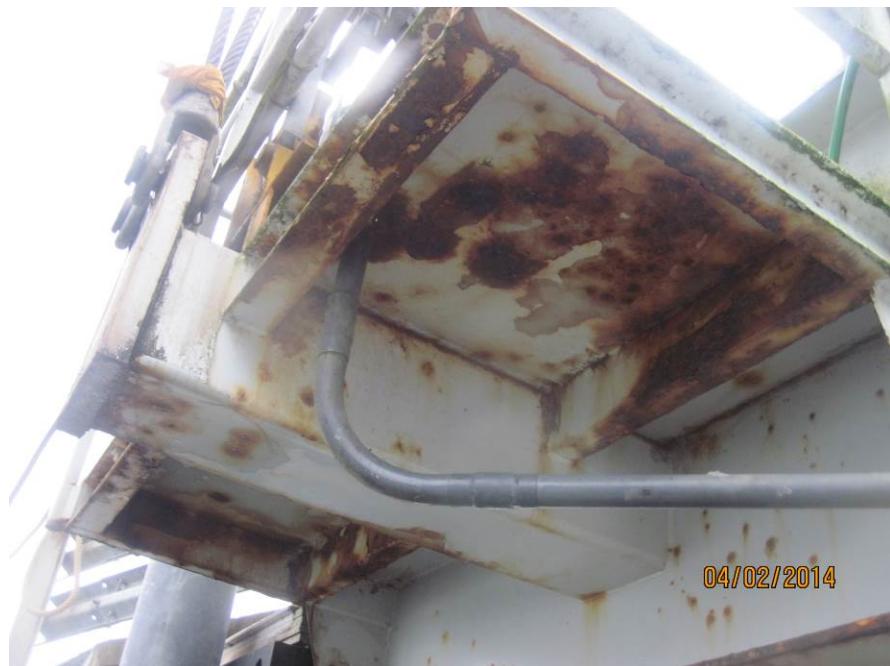
**Image 23:** 2014 – Painted steel outrigger. Also note the paint deterioration in the winch cable platform.

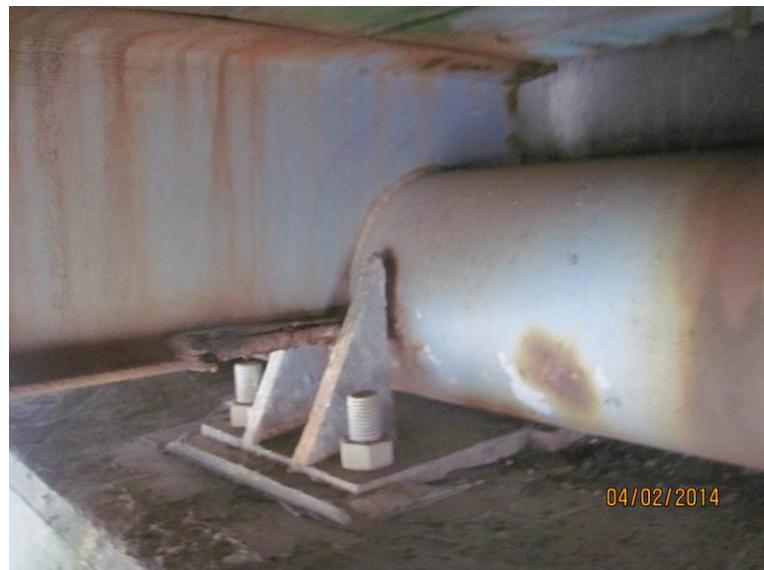
- The bearings are in fair condition. The movable painted steel bearings appear to be free and in good service condition. There is minor paint deterioration and corrosion along the edges of the bearings.

**Image 24:** Typical of the corrosion around the girder bearing.

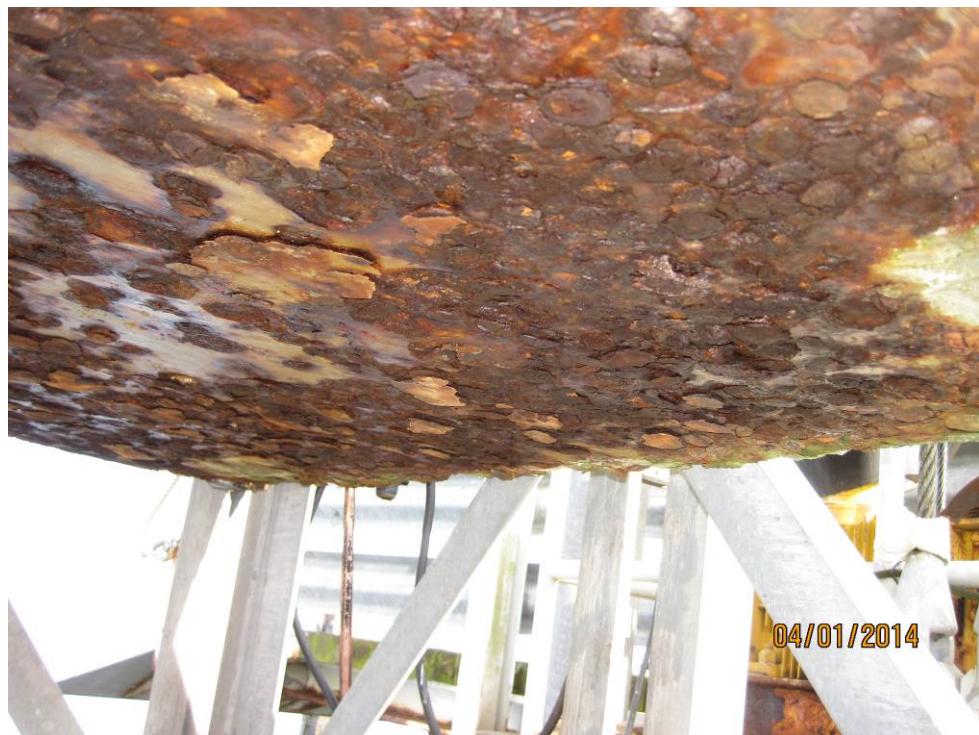
- Generally in very good condition. The galvanizing protection system is also in good condition. The steel tower base plates are corroding. No cracking or section loss from corrosion was observed.
- Steel lug weights that are embedded in the concrete counterweight are corroding. Most significantly at the bottom face of the counterweight. Eventually the corrosion could cause spalling and delamination in the counterweight.

Image 26: Typical corrosion of steel lugs on the bottom face of the tower concrete counter weights.

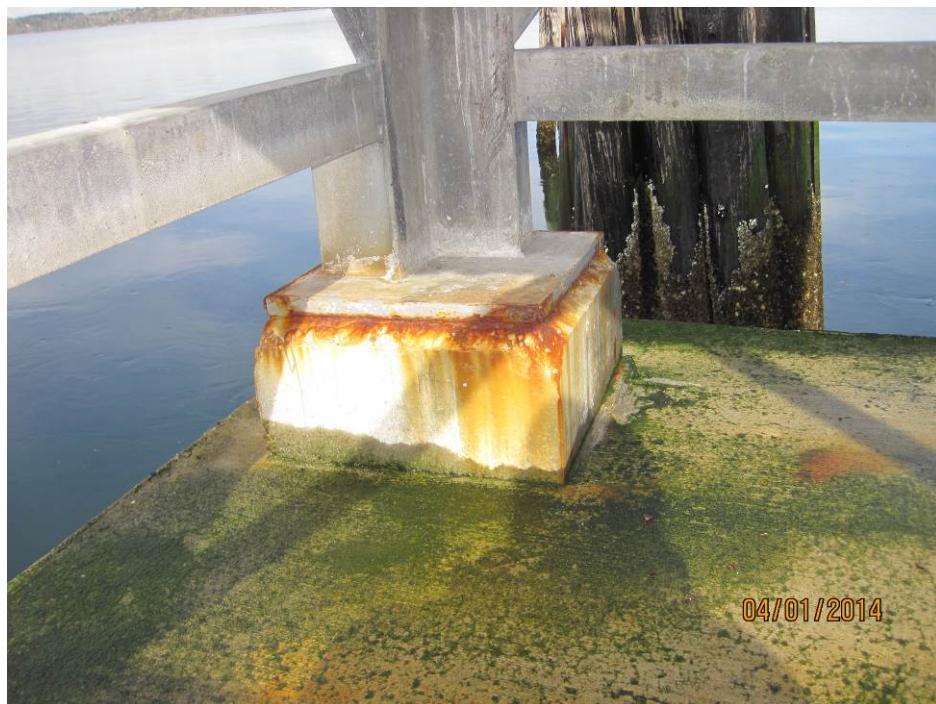
Image 27: Typical of corrosion at the tower leg base plates

3. Blast clean and paint the bottom one foot of the mainland and island terminal tower legs.
4. Blast clean and paint the counter weight cable anchor plates. Located in weight cavity

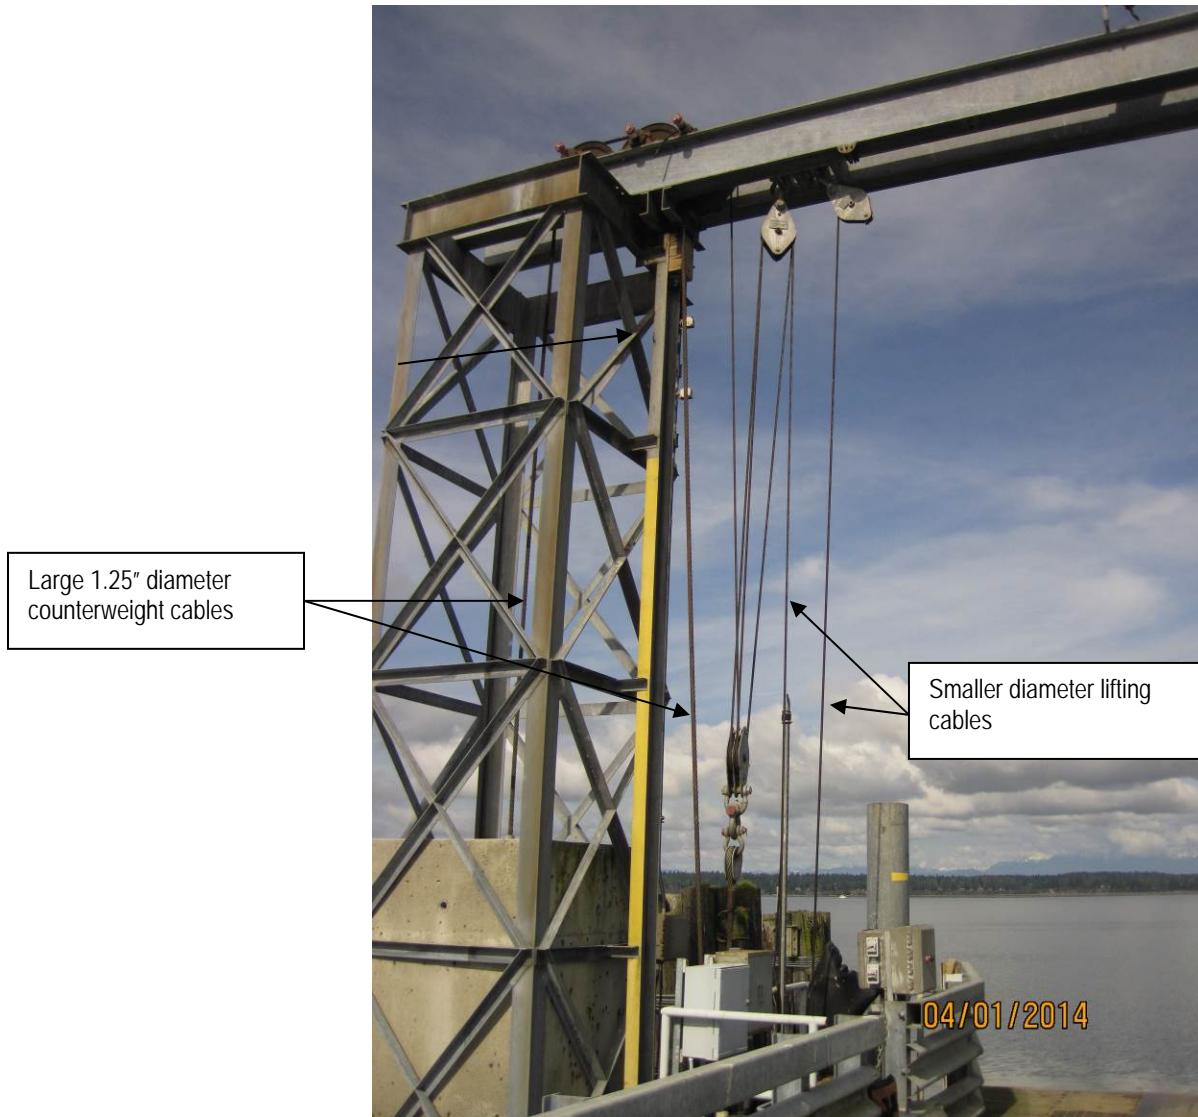
- The mainland terminal has more exposure to the winds, salts, and birds than the island terminal. The added exposure causes the mainland greases to wear and dissipate faster. The lifting cables are in fair condition. At the time of this inspection, both cables were dry along the lengths that do not reach the winch spool. The left hand cable is not galvanized and has some surface rusting. Both cables appear to be spooling correctly.
- The concrete counterweight cables are in fair condition. At the time of this inspection they were dry.

Image 28: Mechanical cable lifting system.

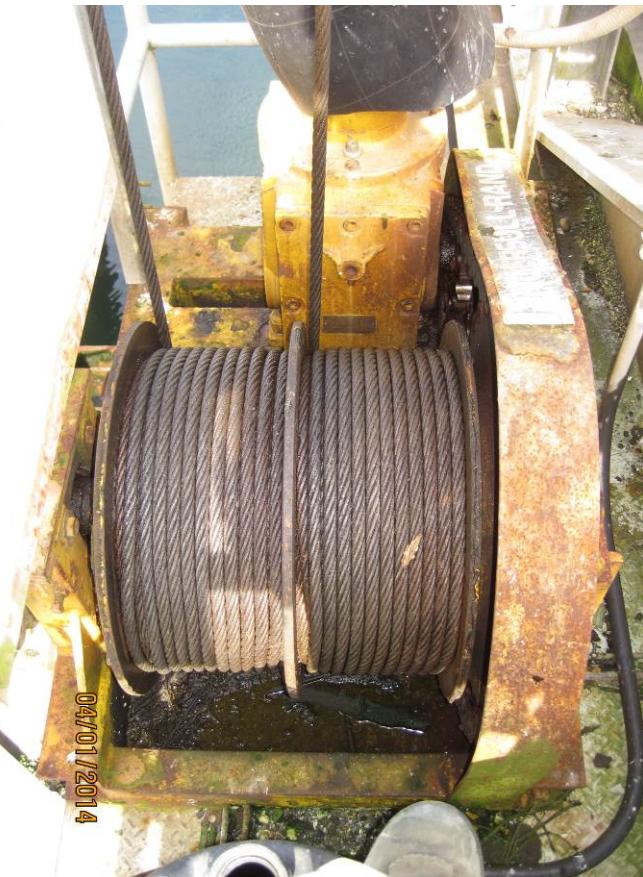
**Image 29:** Correctly spooled lifting cables.  
Well-greased at the spool.
