# *Herron Island Mainland and Island Ferry Terminal*

## *ROUTINE STRUCTURE INSPECTIONS – 2014*

Inspection Date: April 1<sup>st</sup> and 2<sup>nd</sup>, 2014

**RE: Ferry Terminal Observation  
Project No.: A14111.00**

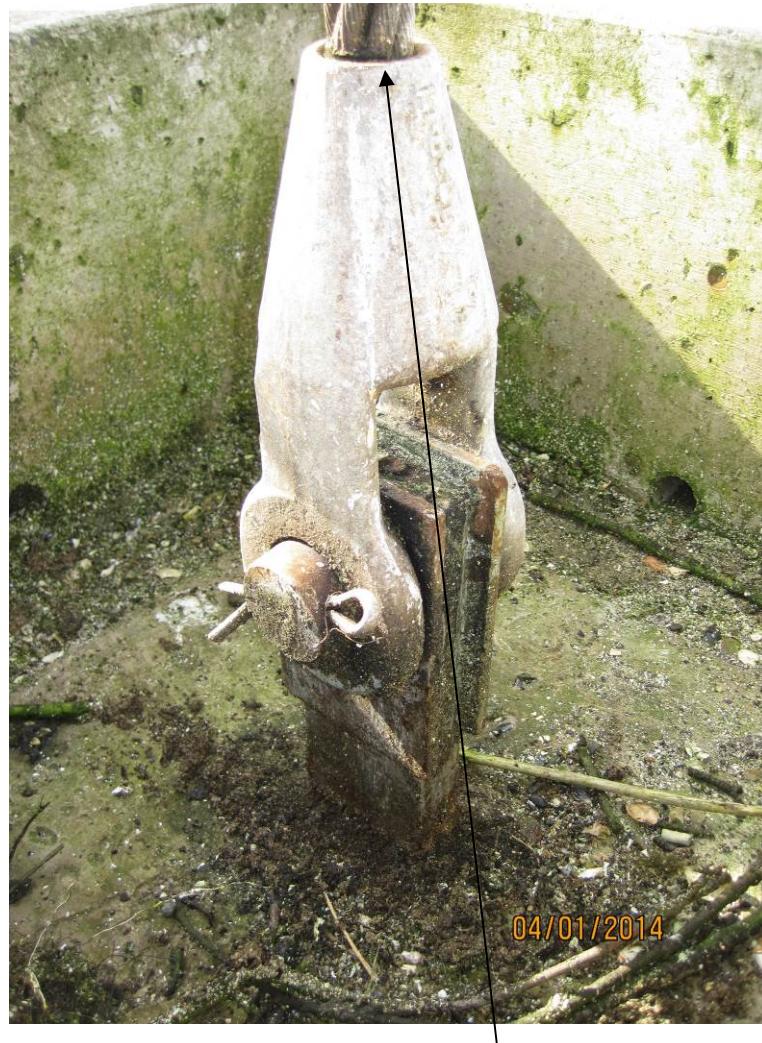
- The counter weight cable anchors are in satisfactory condition. There is some minor surface rusting. The grease at the point where the cable enters the spelter socket is breaking down at the connections to the counterweight and at the winch platform. Grease here prevents water for penetrating inside of the connection. The no section loss or cracking was observed.
- The lifting cable anchors are in satisfactory condition. There is some minor surface rusting. The grease at the point where the cable enters the spelter socket is breaking down. The no section loss or cracking was observed.

Image 31: Typical counter weight cable anchor. Note grease at the spelter socket breaking down..

7. Continue to periodically clean out the cavity on the top side of the reinforced concrete counter weights.
8. Continue cable and grease maintenance schedule. Increase frequency of greasing on the mainland terminal. Include greasing top of spelter sockets.

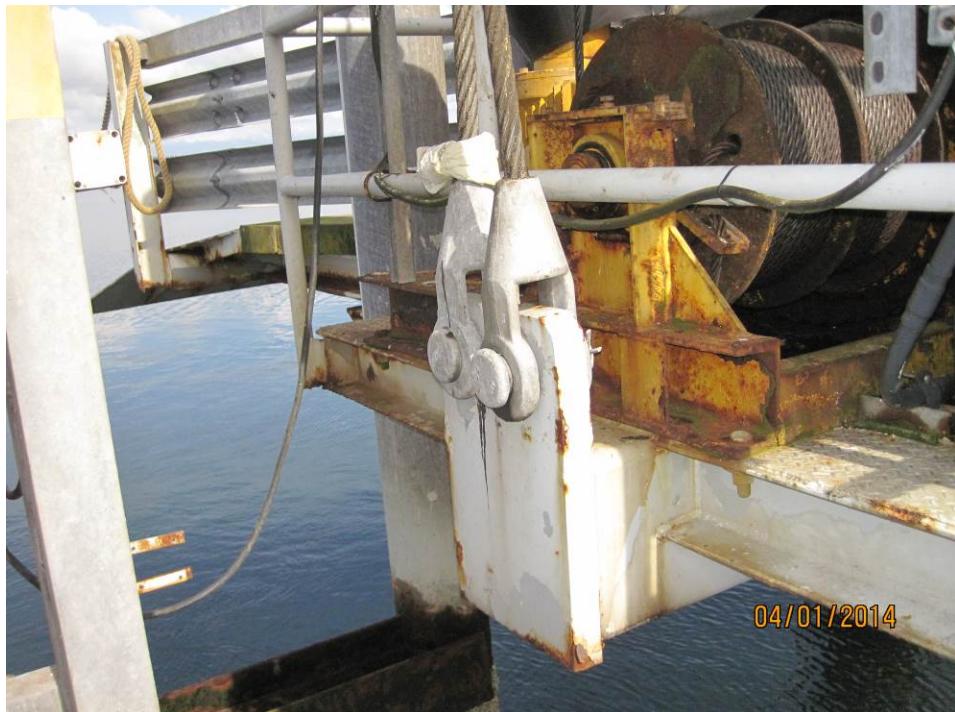
**Image 32:** Typical lifting cable anchor. Note grease at the spelter socket breaking down.

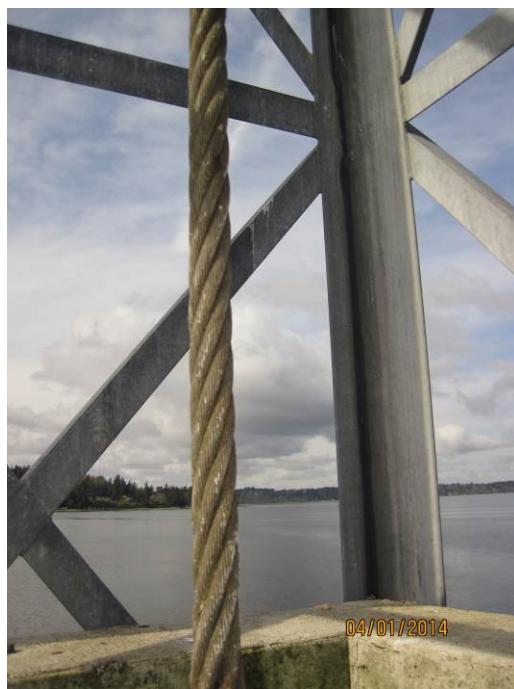
**Image 33:** Typical dry counter weight cable.

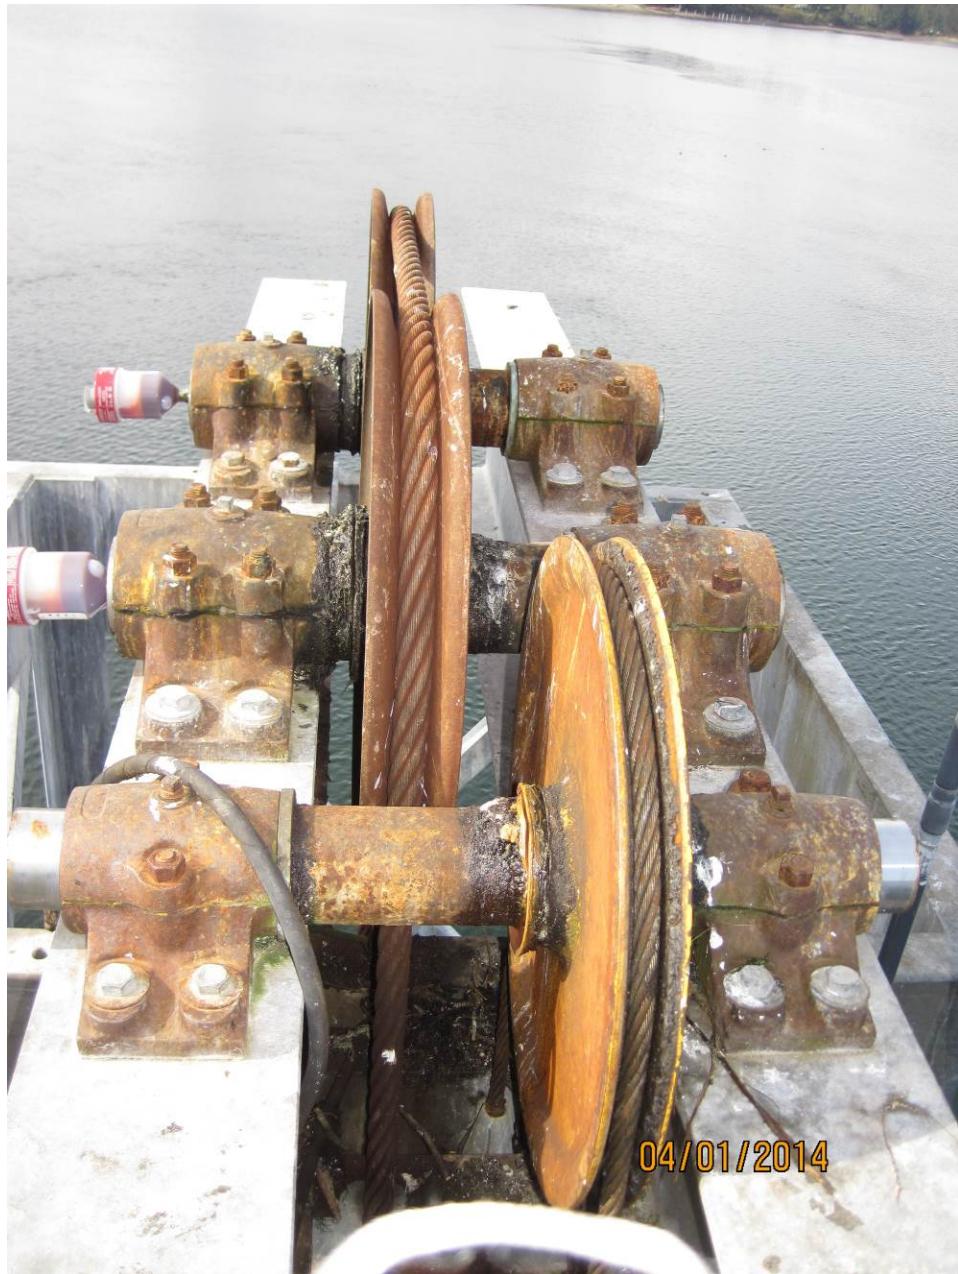
- The 20 inch diameter sheaves in the lifting cable system and the 24 inch diameter sheaves in the counterweight system are in good condition. All of the sheaves are well greased and appear to be running smoothly. The bearing oilers were at least half full.

Image 35: Typical of well-greased counterweight sheave. Note dry cables.

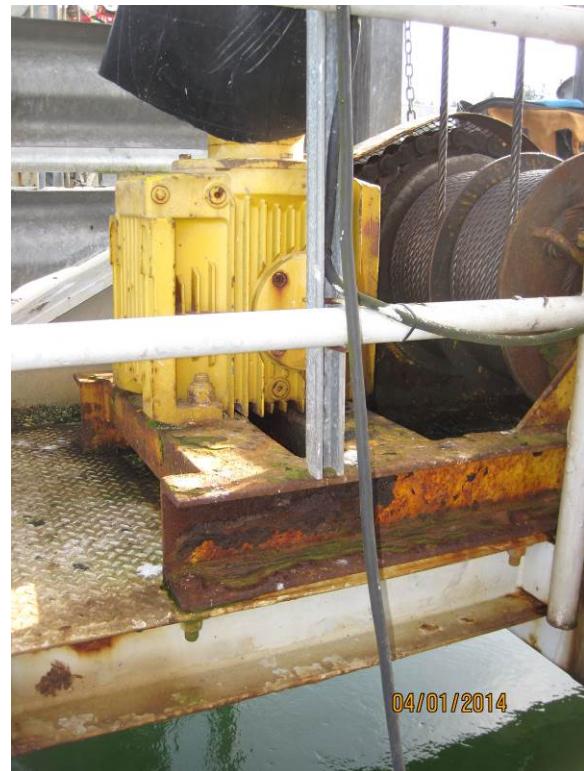
Image 37: Failed paint and corrosion of winch platform.

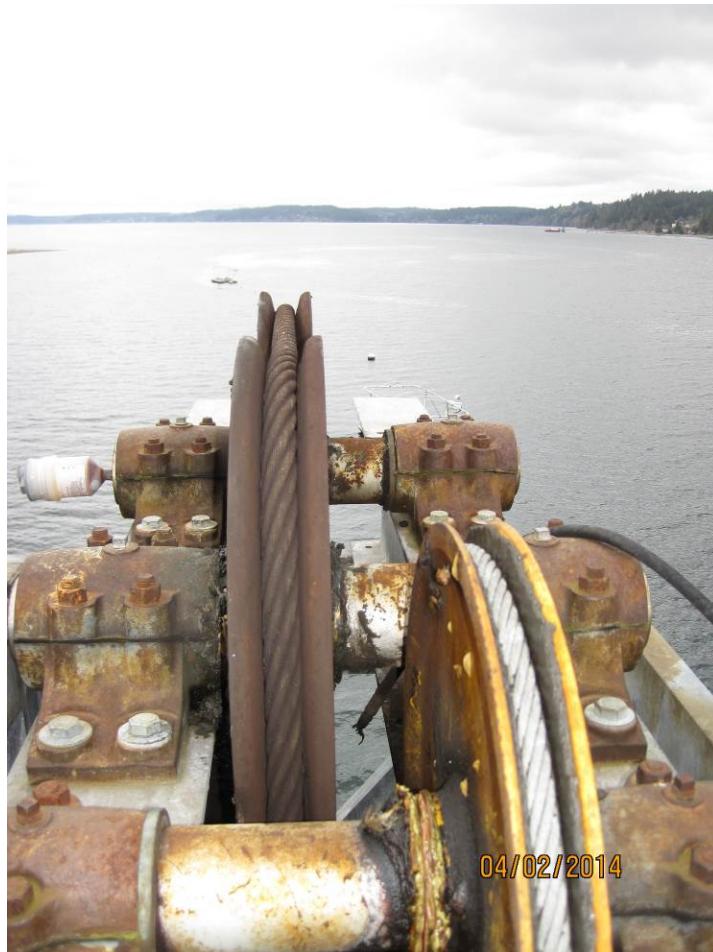
- The lifting cables are in good condition. The left cable is ungreased near the upper sheave, the remaining lengths of cable are well coated. Both cables appear to be winding correctly
- The counterweight cable grease is breaking down but is providing satisfactory protection. There is some minor wear in the strands along the bottom side of the length of cable that passes over the two larger 24 inch diameter sheaves at the top of the lifting tower.

Image 38: Note condition of counter weight grease and lack of lifting cable grease.

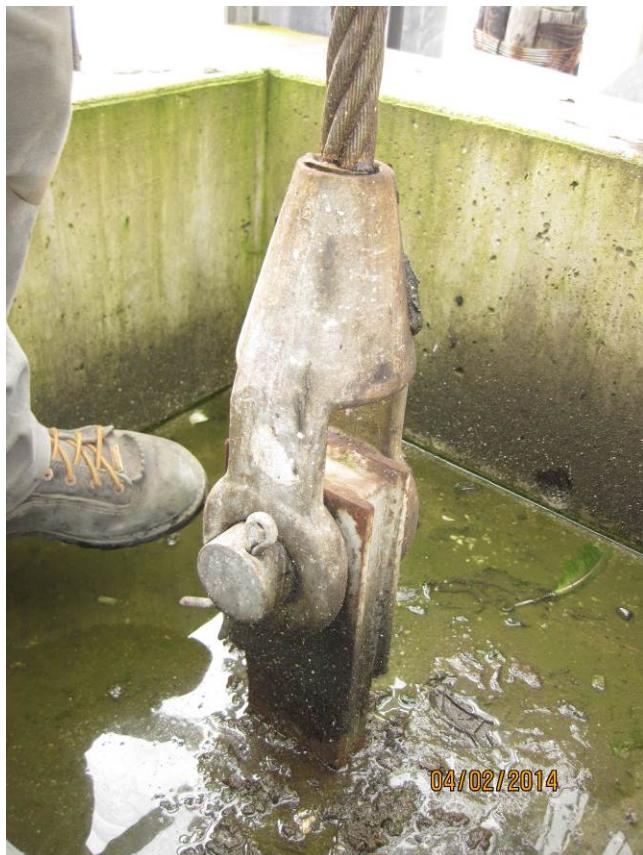
- The counterweight cable anchors are in good condition. Grease is present but breaking down at the top of the spelter socket. The cable anchor plate paint is wearing thin and the plates have some surface corrosion
- The lifting cable anchors are in good condition.

**Image 39:** Counter weight cable spelter socket connection, at the counter weight.

3. Blast clean and paint the bottom one foot of the mainland and island terminal tower legs.
4. Blast clean and paint the counter weight cable anchor plates. Located in weight cavity

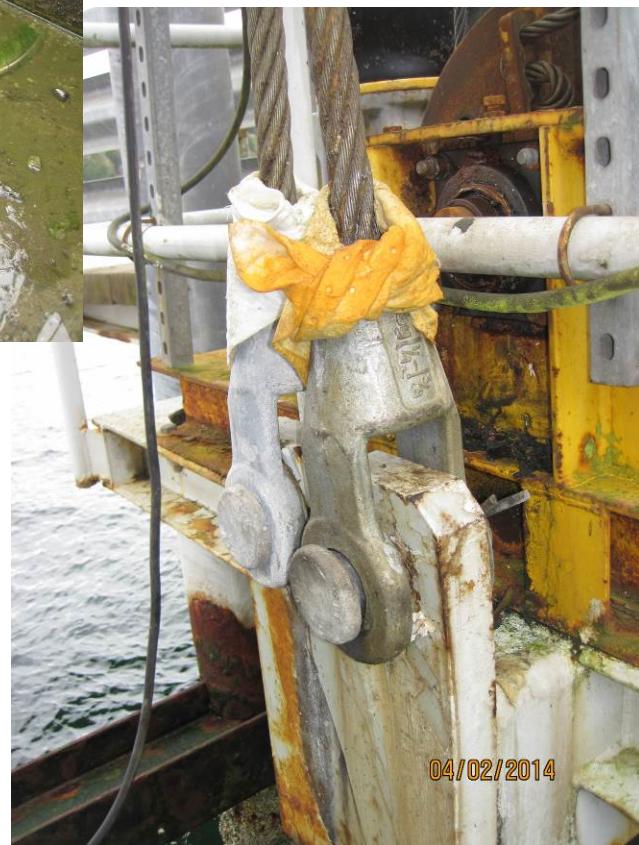
**Image 40:** Counter weight spelter socket connection at the lifting platform.

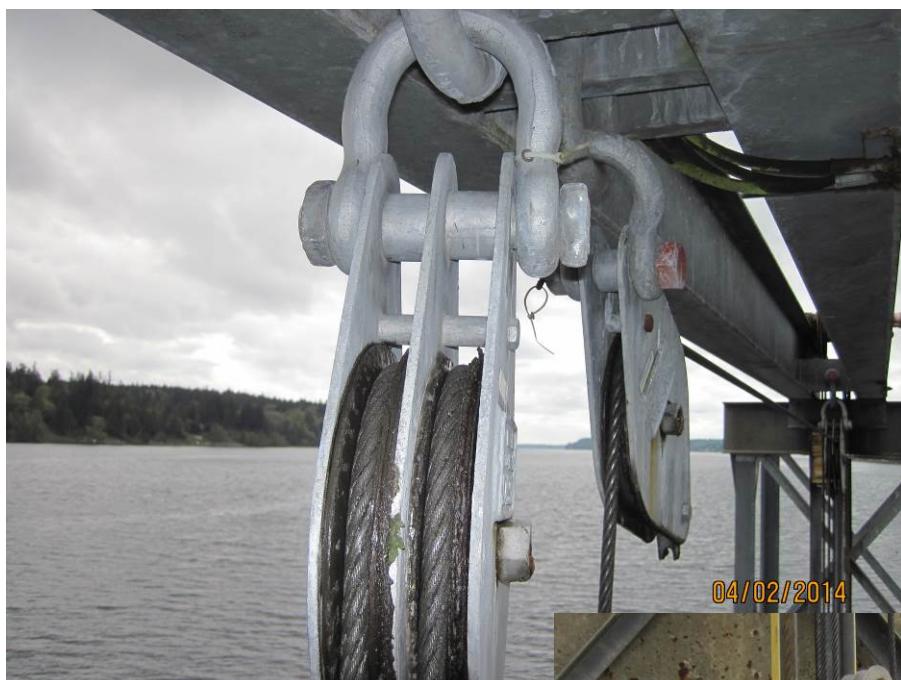
- The pulleys and block pulleys within the lifting cable system are in good condition. The swage that ties off the thimbled loop for the wire rope connecting the winch platform to the lower lifting pulley block has surface corrosion. There is no visible indication of a loss of strength. Swage will be replaced during the upcoming scheduled cable replacement.
- The clevis connections in the counterweight and lifting system are in good condition. There are several clevis connections without cotter pins. There is no indication that any of the bolts in the clevises are loose or that the lack of a cotter pin is a problem.

Image 41: Upper lifting pulley block and clevis connection.

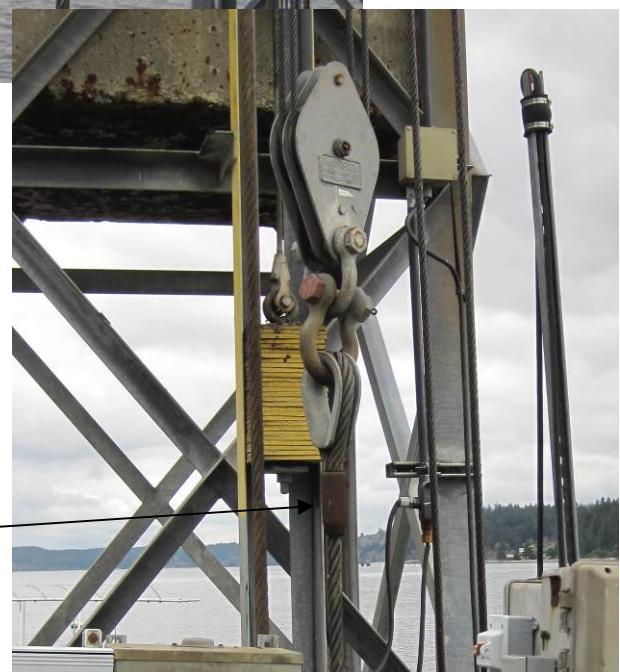
Image 42: Lower pulley block. Note surface corrosion on swage.

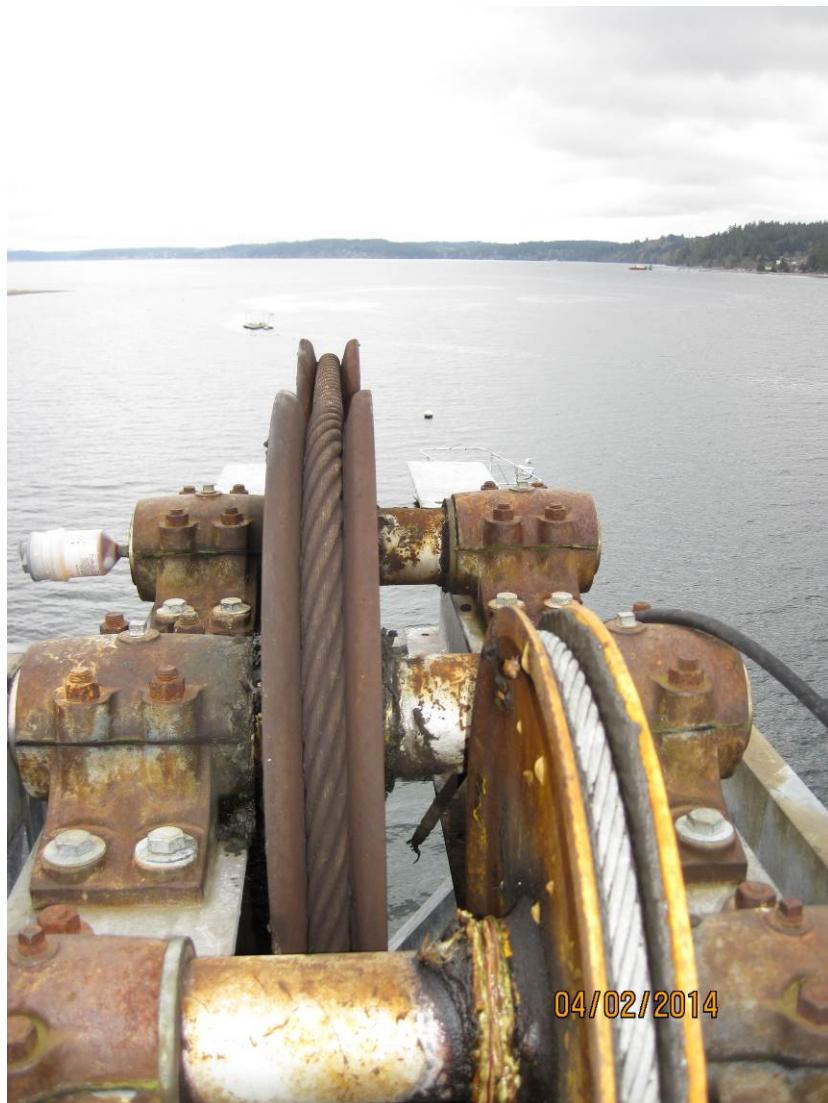
- The 20 inch diameter sheaves in the lifting cable system and the 24 inch diameter sheaves in the counterweight system are in good condition. All of the sheaves are well greased and appear to be running smoothly. At the time of this inspection one bearing auto oiler was empty.

Image 43: Lifting cable and counter weight sheaves.

9. Refill upper sheave bearing oilers.
10. Continue current cable replacement schedule, consider replacing the newly replaced un-galvanized cable at the mainland terminal.

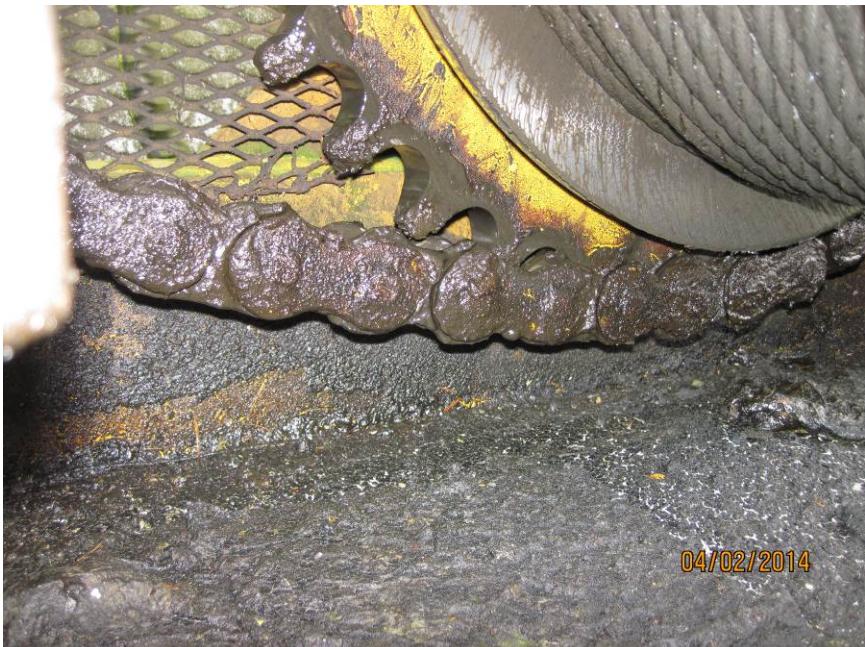
- The winch chain appears in good condition.
- The paint system for the winch platform is failed and corroding.

Image 44: Winch drive chain.

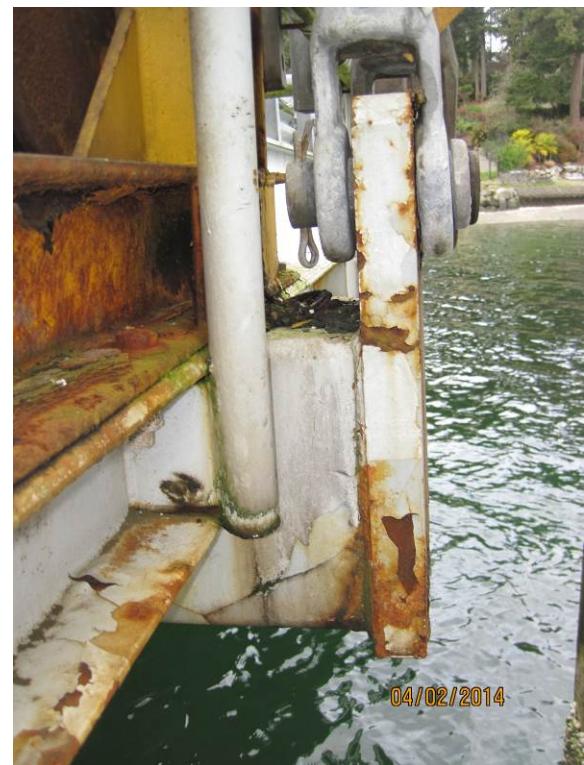
Image 45: Note failing yellow paint of winch base.

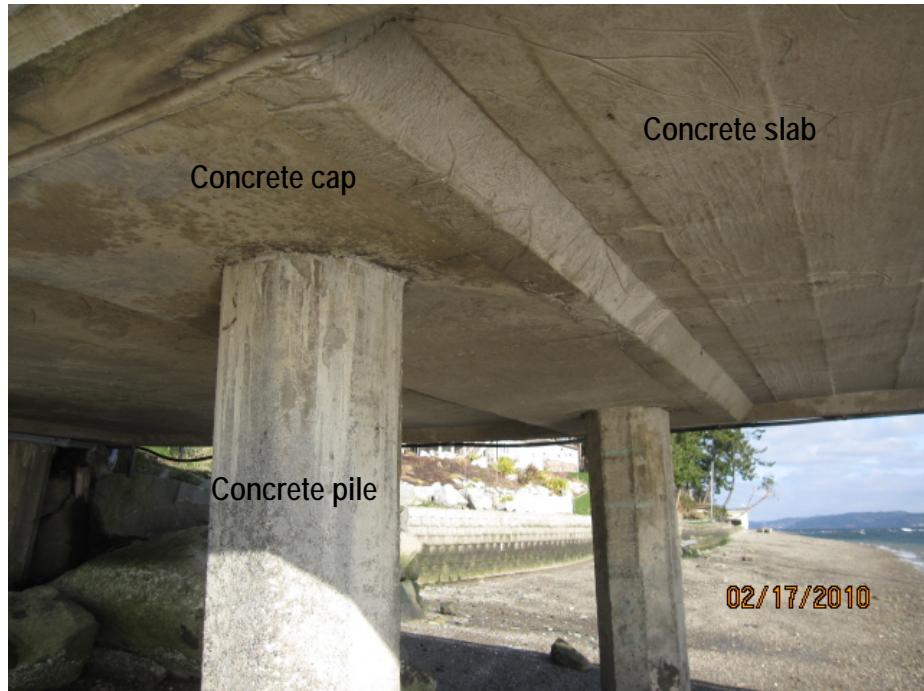
Image 46: Typical of approach span construction.

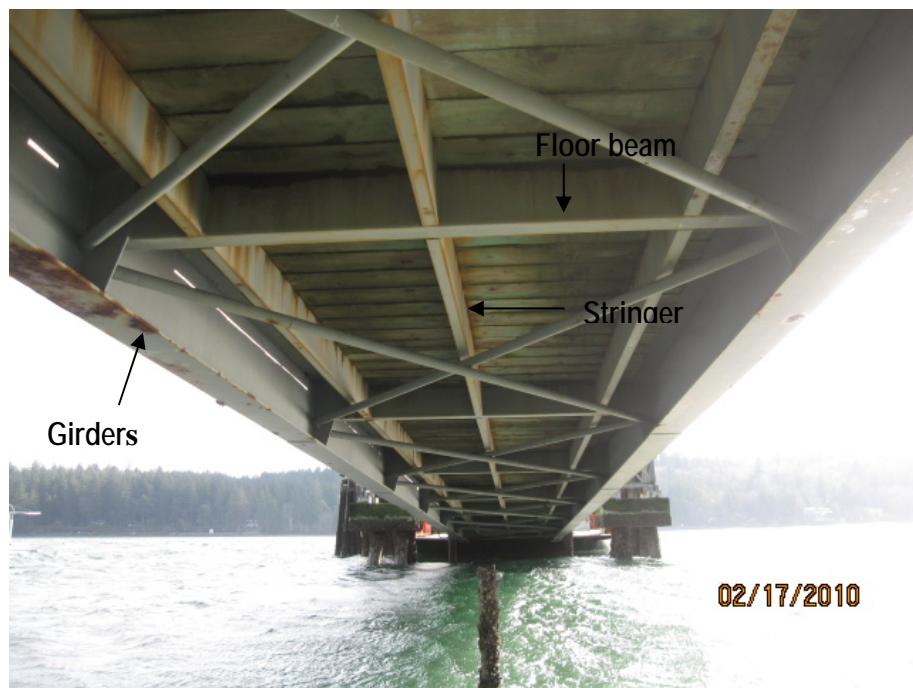
Image 47: Typical of lift span construction.
