REPORT TO NASA COMMITTEE ON  
AIRCRAFT OPERATING PROBLEMS  
RELATIVE TO AVIATION SAFETY ENGINEERING  
AND RESEARCH ACTIVITIES

AvSER Report No. 63-11

Aviation Safety Engineering and Research  
2871 Sky Harbor Blvd., Phoenix, Arizona  
A Division of  
Flight Safety Foundation, Inc.  
1 September 1963

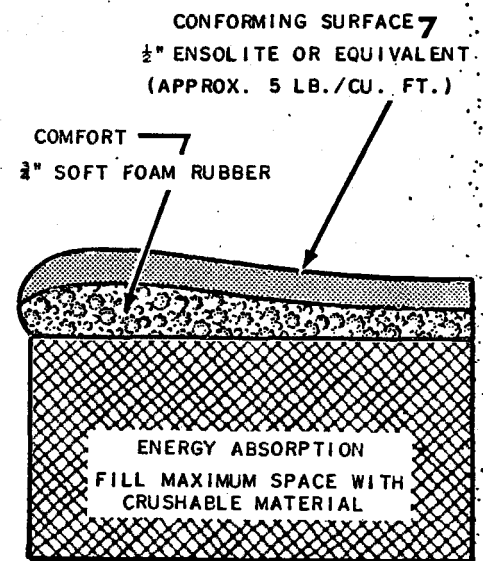
Four occupants of an aircraft received dangerous and critical spinal injuries of the dorsal and lumbar areas when their fully-loaded aircraft failed to remain airborne after takeoff from a private strip. The aircraft stalled and impacted, with wheels retracted, in a flat attitude on the upgrade of a ravine, sliding to a stop in 30 feet.

The designer can exercise some control over the crash force transmitted to the occupants through the use of energy-absorbing material in the seat cushion. Several crushable materials appear to have promise, such as treated paper honeycomb, urethane and polystyrene foams; however, in order to utilize the ultimate benefits of these materials, their crushing strength must be closely controlled between 9 and 11 psi. If the strength is lower than 9 psi, the cushion does not offer maximum energy absorption; if the strength is greater than 11 psi, the occupant is likely to be exposed to high vertical forces and subsequent injury to the spinal column. The thickness of the energy-absorption material to be used will depend on the practical limit of the seat pan and cockpit geometry.
