**COMPARISON OF NONDESTRUCTIVE TESTING
TECHNOLOGIES USED FOR INSPECTION OF WELDED
JOINTS**

A Thesis Presented to the Faculty of Graduate School at the
University of Missouri-Columbia

HABIBURAHMAN HOTAKI

JUNE 2014

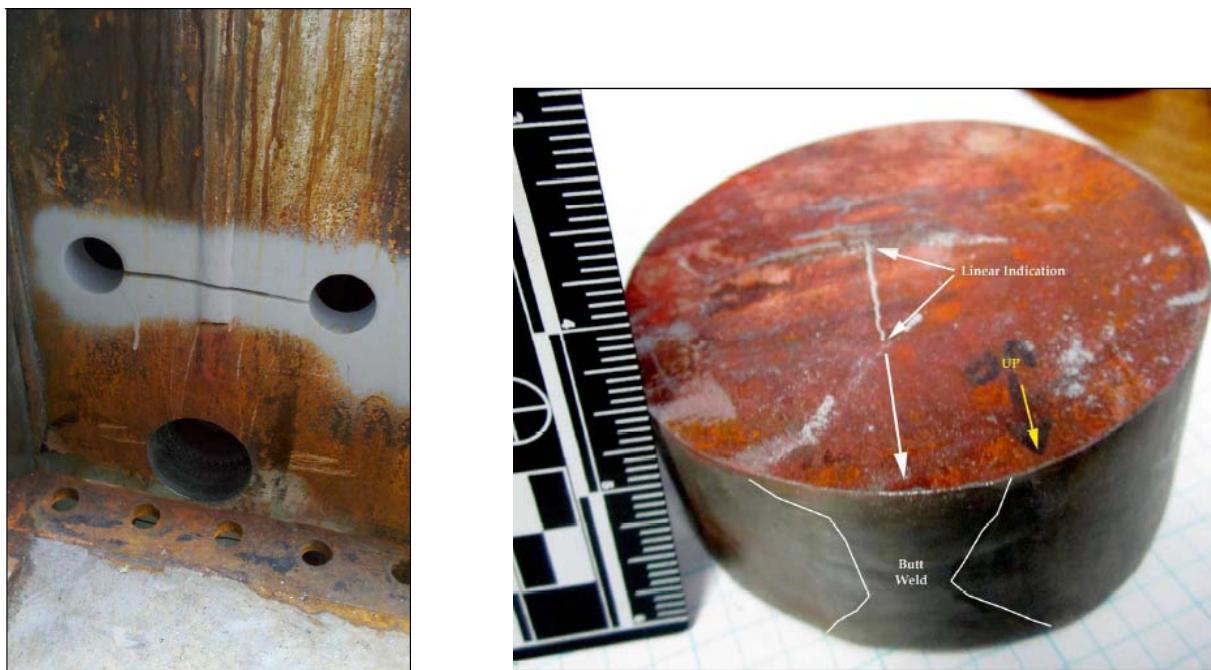
core. Since this core was also located near the shelf plate, it is possible that UT may not have had access to detect this indication (Figure 4-3). The RT report showed a 0.5 in long incomplete fusion at the core location (26 in from top of the web plate). Figure 4-3 shows a surface longitudinal crack at the center of the core along the weld. Based on the core picture, approximately half of the crack was above the origin and half was below the origin (origin at 26 in from top). RT reported a 0.5 in incomplete fusion from 26 in to 26.5 in measured from top of the web. Therefore, it was assumed that RT had an overlap of 0.5 in with the half of the crack located below the origin.

Figure 4-3. Left: Core #4 location. Right: Core #4 after removal (Supplied by Baker Inc.)

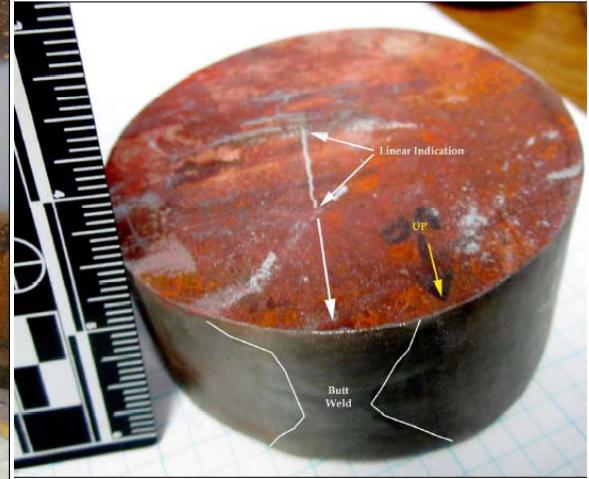
Figure F11. (A) Location of Core #4 on the interior surface prior to removal. (B) Location of Core #4 on the exterior surface after removal. (C) Longitudinal crack on the vertical butt weld on the exterior surface.

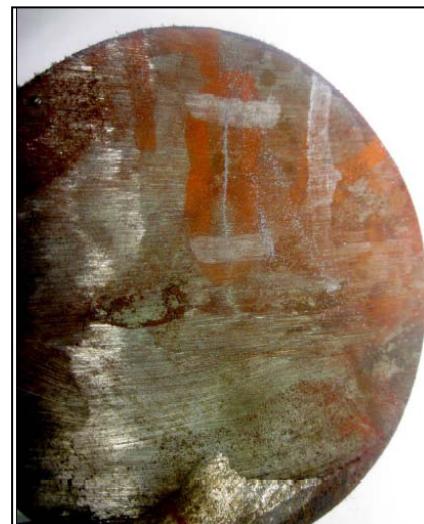
Figure F36. (A) Location of Core #9 on interior web surface. (B) Location of Core #9 on the exterior web surface. (C) Indication of a vertical flaw by ATS MT lab inspection

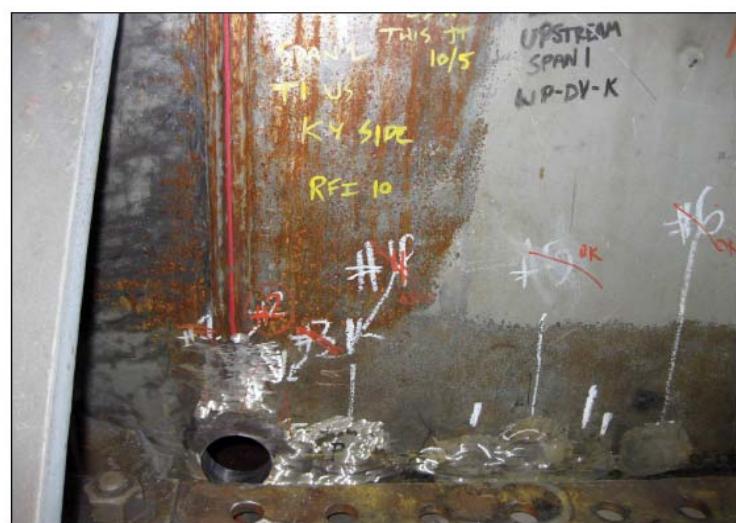
Figure F46. (A) Vertical falw indication at Core #11 on exterior surface. (B) Core #11 location on the exterior surface of the web. (C) Core #11 location on the interior web surface.

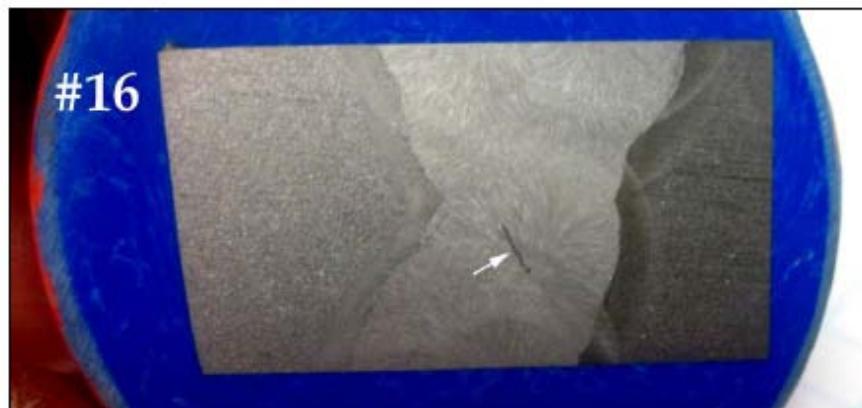
Figure F71. (A) Core #16 location on the exterior surface of the web. (B) Transverse metallographic section through indication at Core #16.

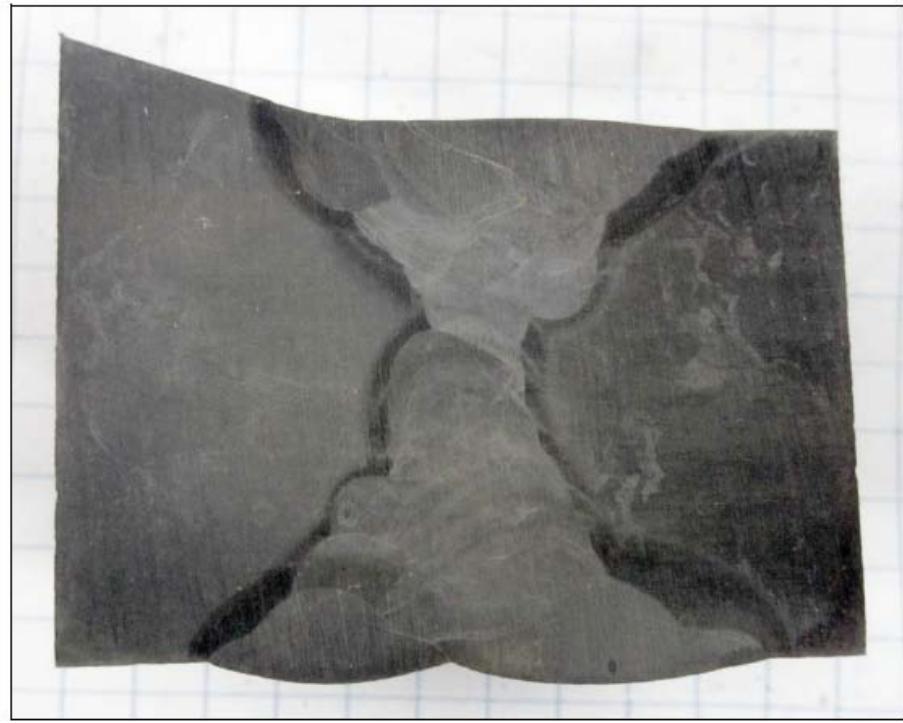
Core #17 Location	Inspection Method	Flaw Location from Top – Y (in)	Flaw Length (in)	Flaw Disposition	Flaw Overlap %	Comments
DS-2, T3, DV-K 2.16" Dia. Core from Top (18")	MT – PSI	-	-	-	-	Accept
	RT – ATS	14.0	0.55	Incomplete Fusion	0	Reject
		18.0	0.20	Porosity	0	Reject
	UT – PSI	25.0-26.0	0.50	Inc. F., Porosity, Slag	0	Reject
		6.0-7.1	1.1	C, 0.72" from surf.	0	Accept
		12.7-16.8	4.1	A, 0.70" from surf.	0	Reject
	Visual	15.0-16.7	1.7	C, 0.72" from surf.	0	Accept
		-	-	-	-	-
Core-ATS		No Flaw	-	No flaw found	NA	0 flaws

Figure F76. (A) Location of Core #17 on exterior surface of the web. (B) Macro-etched section of Core #17 (No cracks found).

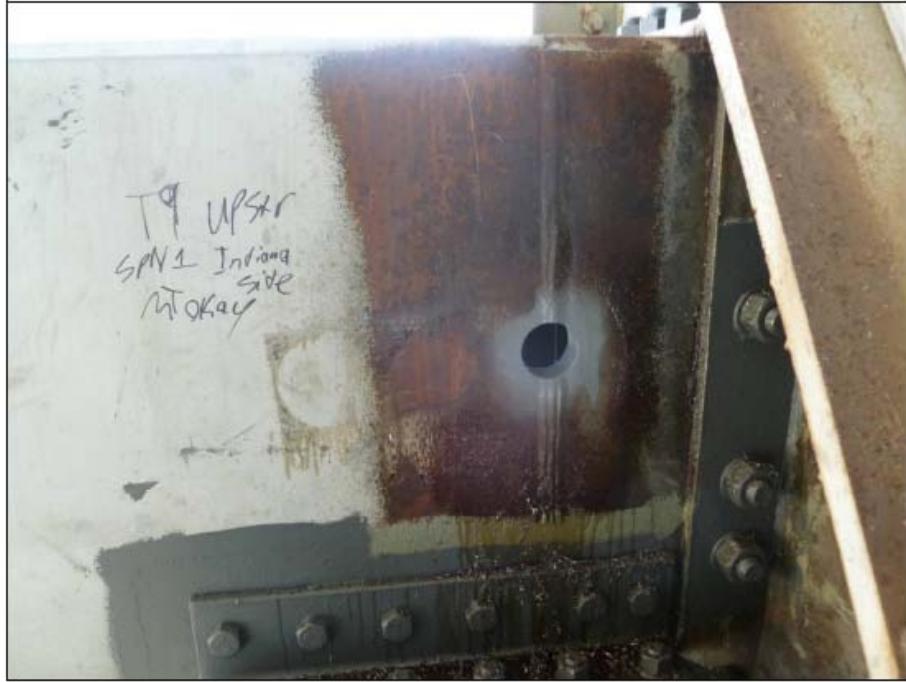
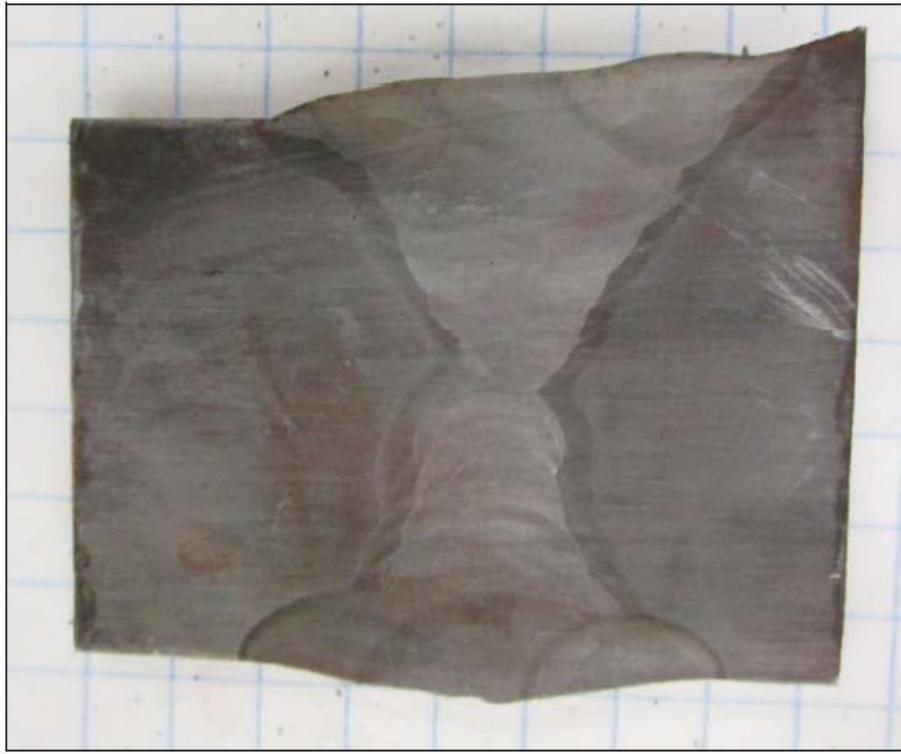
Core #18 Location	Inspection Method	Flaw Location from Top – Y (in)	Flaw Length (in)	Flaw Disposition	Flaw Overlap %	Comments
US-1, T9, DV-I 2.17" Dia. Core from Top (12")	MT – PSI	-	-	-	-	Accept
	RT – ATS	12.0-13.0	0.8	Slag	0	Reject
	UT – PSI	-	-	-	-	Accept
	Visual	-	-	-	-	-
	Core-ATS	No Flaw	-	No flaw found	NA	0 flaws

Figure F81. (A) Core #18 location on the exterior surface of the web. (B) Macro-etched cross section of the Core #18.
