**COMPARISON OF NONDESTRUCTIVE TESTING  
TECHNOLOGIES USED FOR INSPECTION OF WELDED  
JOINTS**

A Thesis Presented to the Faculty of Graduate School at the  
University of Missouri-Columbia

HABIBURAHMAN HOTAKI

JUNE 2014

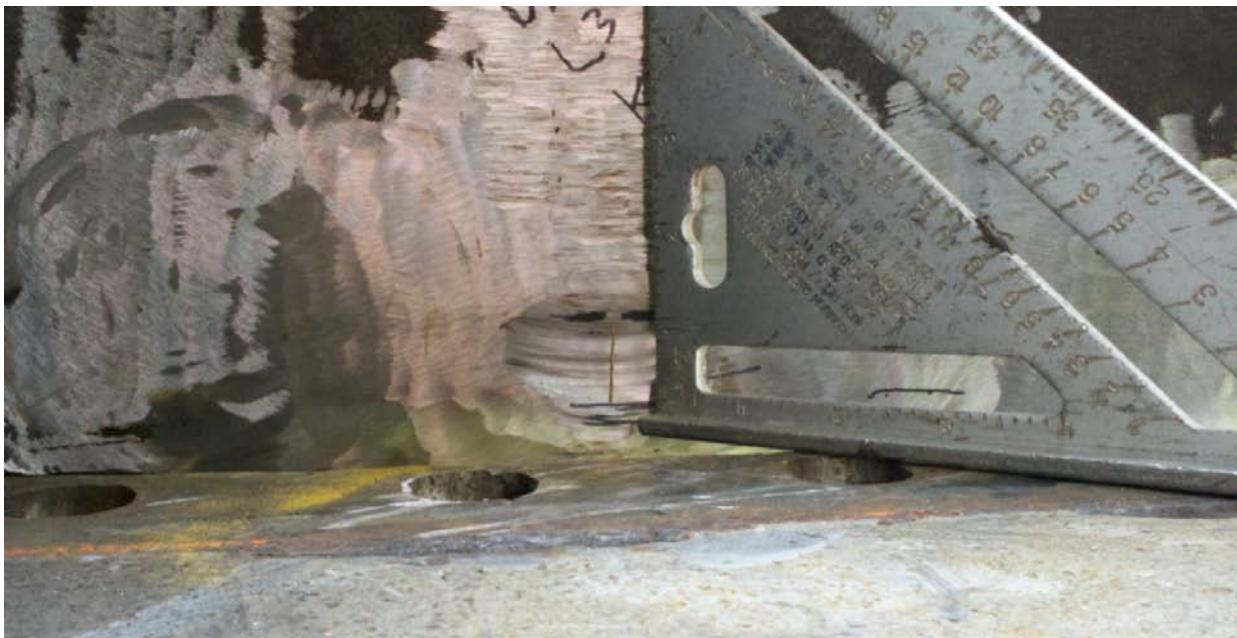
**Figure 2-2. (a) MT showing the crack after removal of the connection plate (b) Top view of lateral bracing-to-arch tie connection (c) Bolted detail of the connection ([18](#)).**

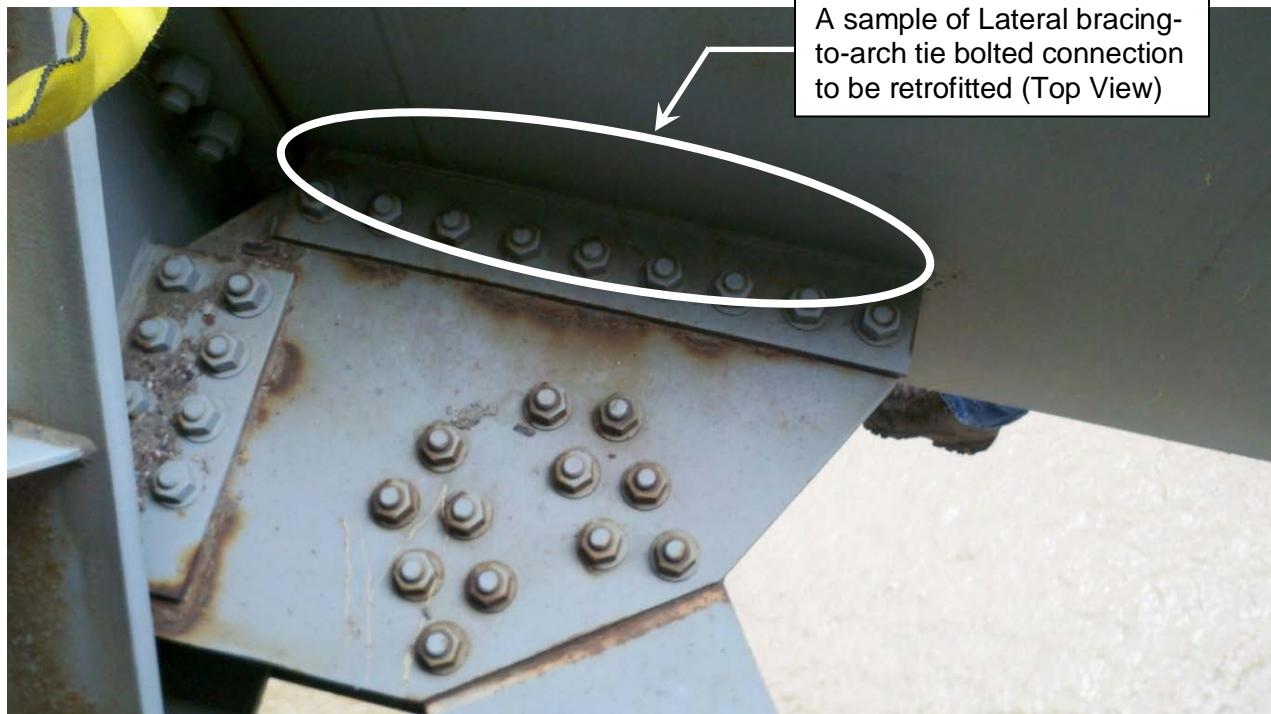
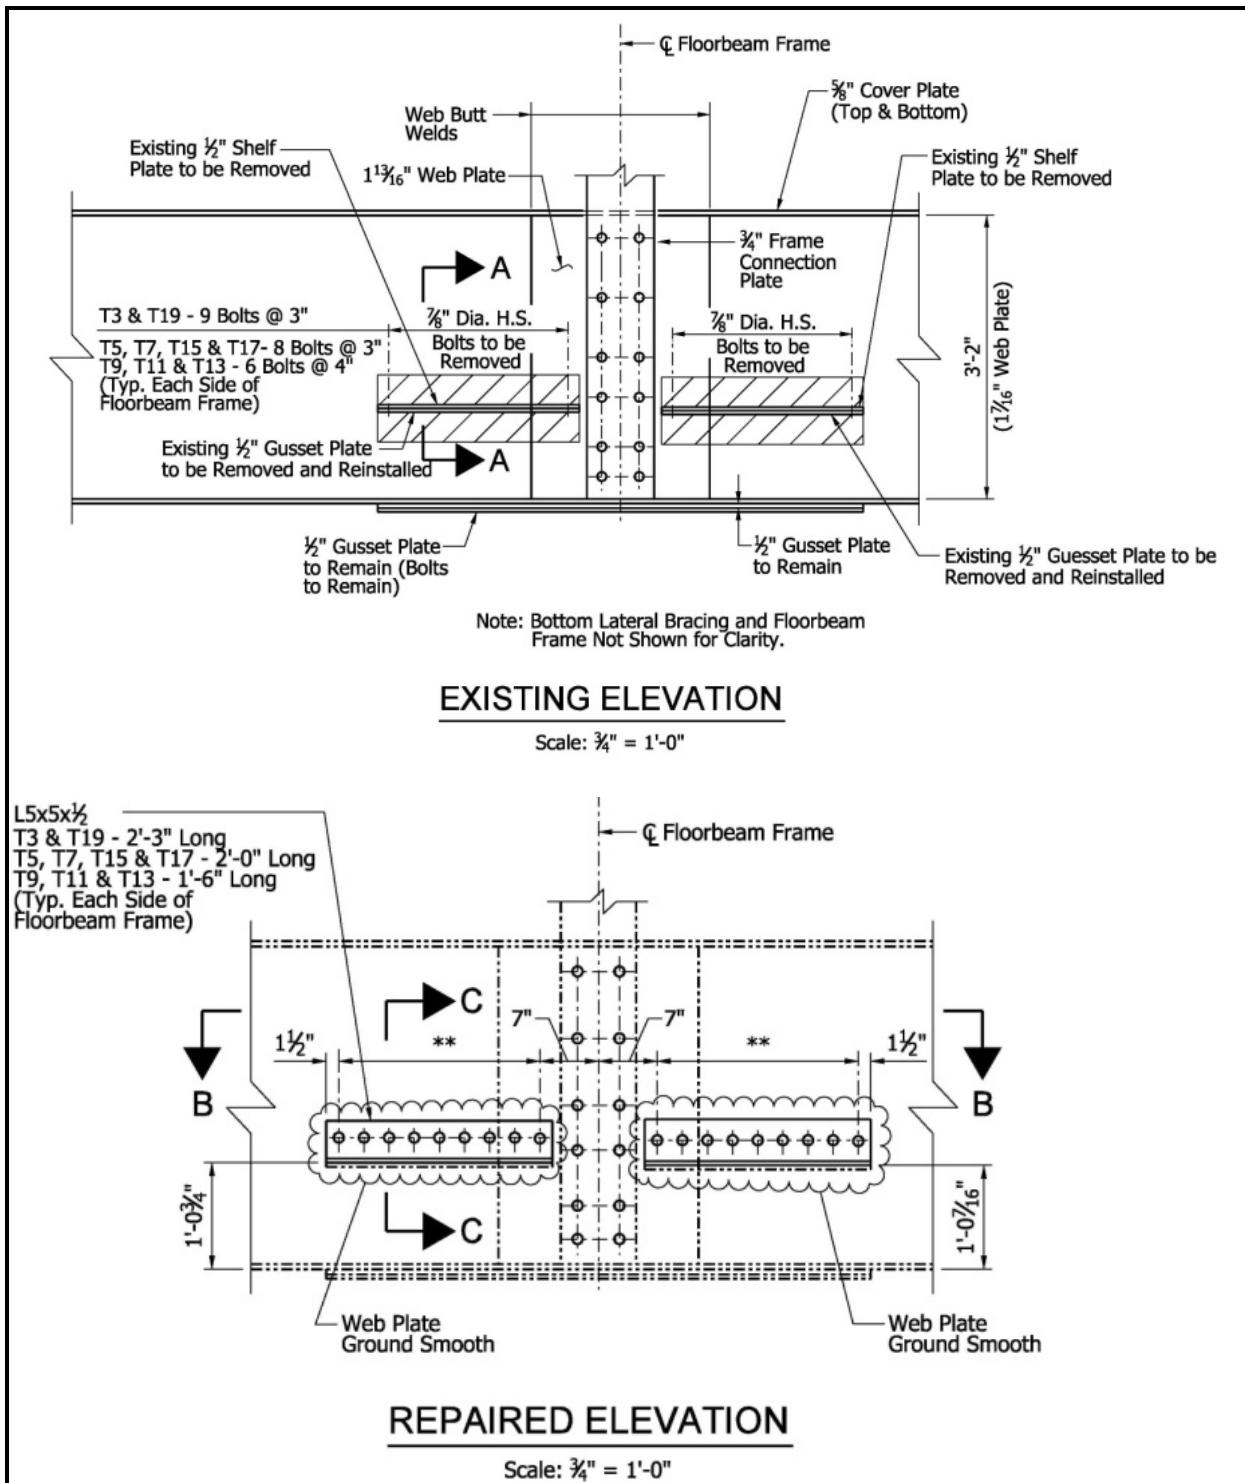
To facilitate the inspection process, the inspector firm hired by INDOT named and categorized each butt weld on the FCM tie girder (352 butt welds). The nomenclature and acronyms used for the SMB will be discussed in the later chapters. The particular crack of concern and primary reason for closing the bridge was located on (US tie/T3KY/DS face of DS vertical plate) which means the upstream tie girder, the third panel point on Kentucky side, and downstream face of the downstream vertical plate. However, according to Gorrill, in addition to this particular butt weld crack, there were many other factors that led the bridge to the full closure ([18](#)). The finding of this crack was the concrete evidence proving that the bridge was potentially unsafe. This crack was found during the process of retrofitting the shelf plate (lateral bracing-to-arch tie connections) (Figure 2-2b). The process of retrofitting required that the 88 lateral bracing-to-arch tie connection plates to be removed and the welded connections to the tie to be replaced with a bolted detail (Figure 2-2c).

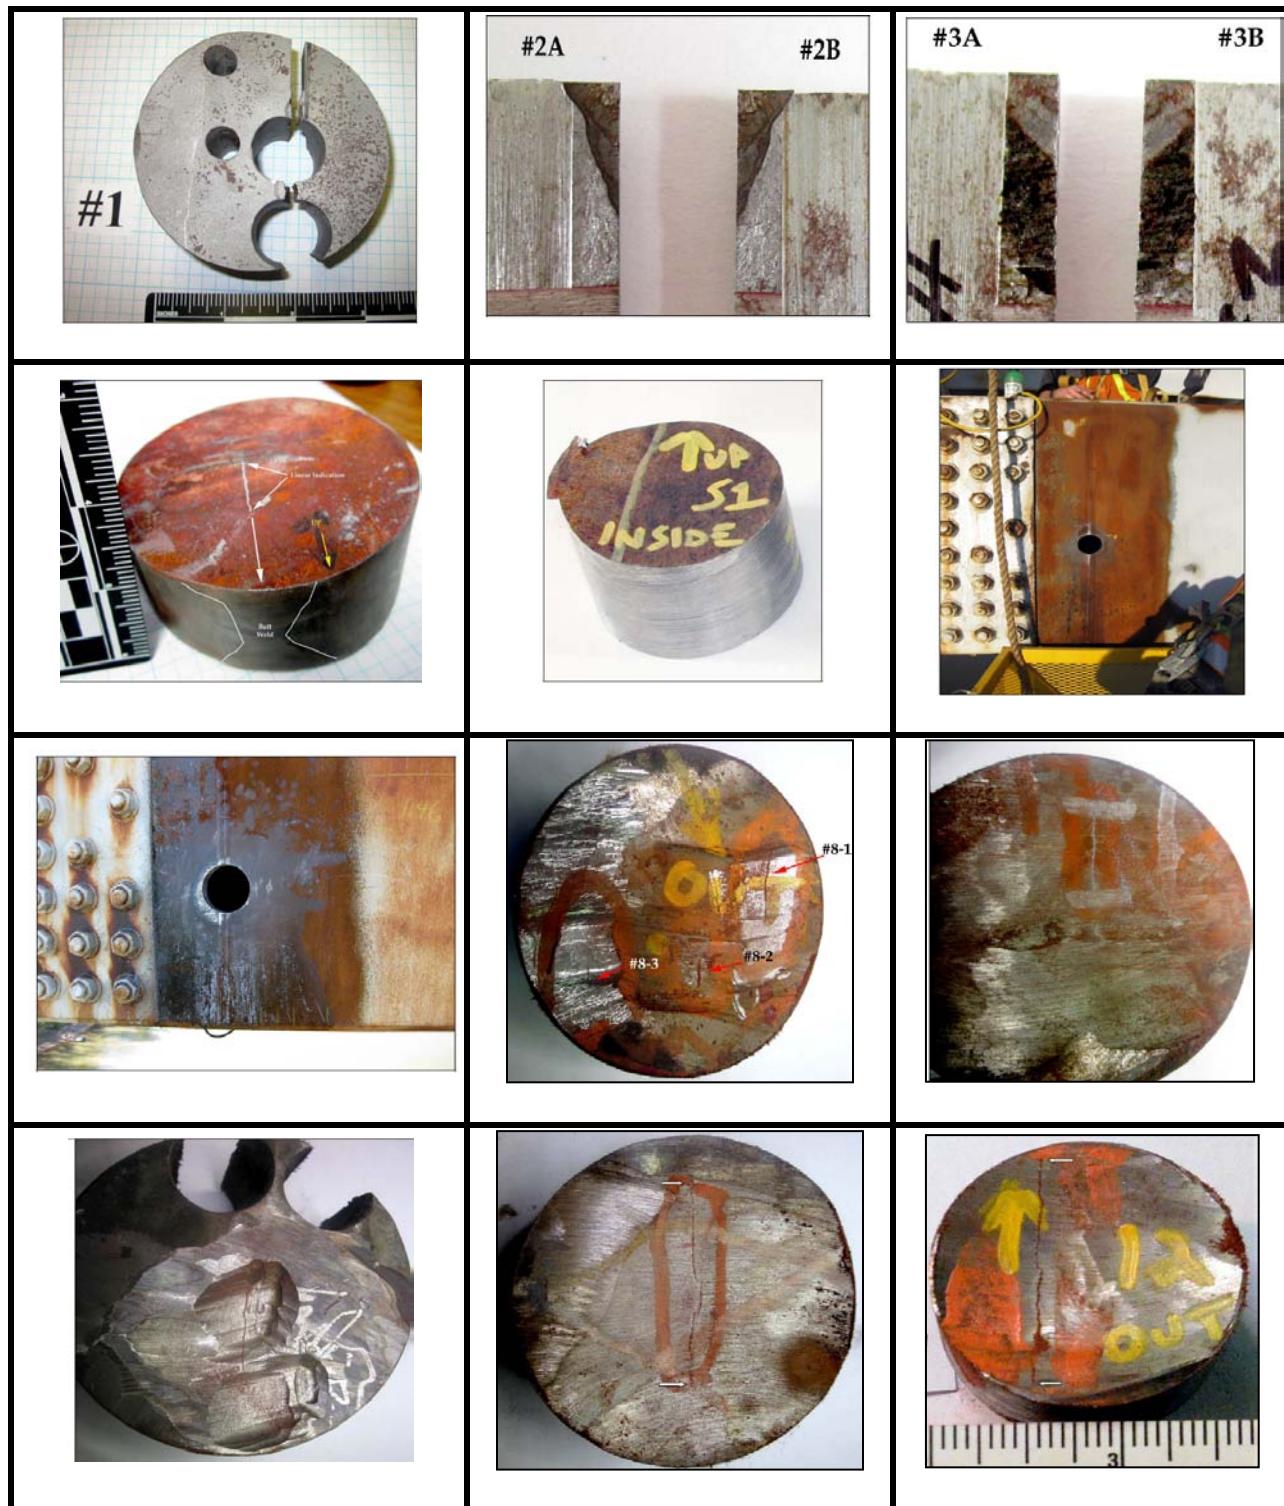
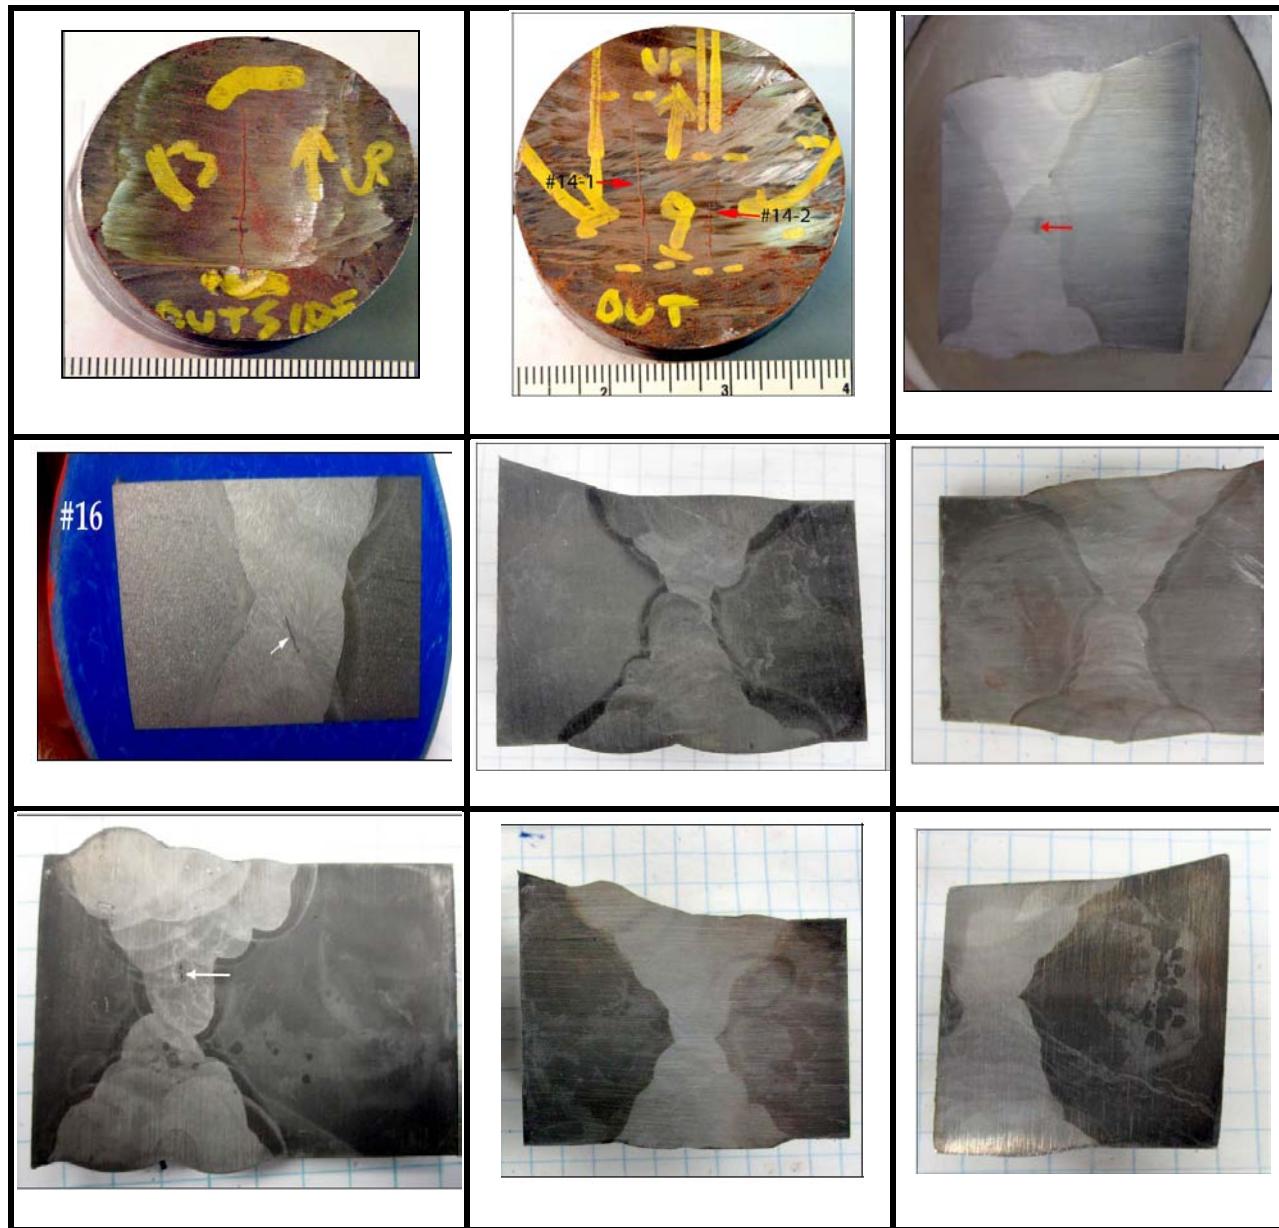
**Table 3-3. Pictures of 21 cores organized in rows left to right based on core number.**

Core photographs were provided by Michael Baker Jr. Inc. at the time of core removal in the field; however, some of these pictures are from the ATS lab taken after grinding, macro-etch, and/or micro-etch. The locations of these cores on the tie girders of the bridge are illustrated on a photo of the bridge spans, taken from the top, as shown in the next section.

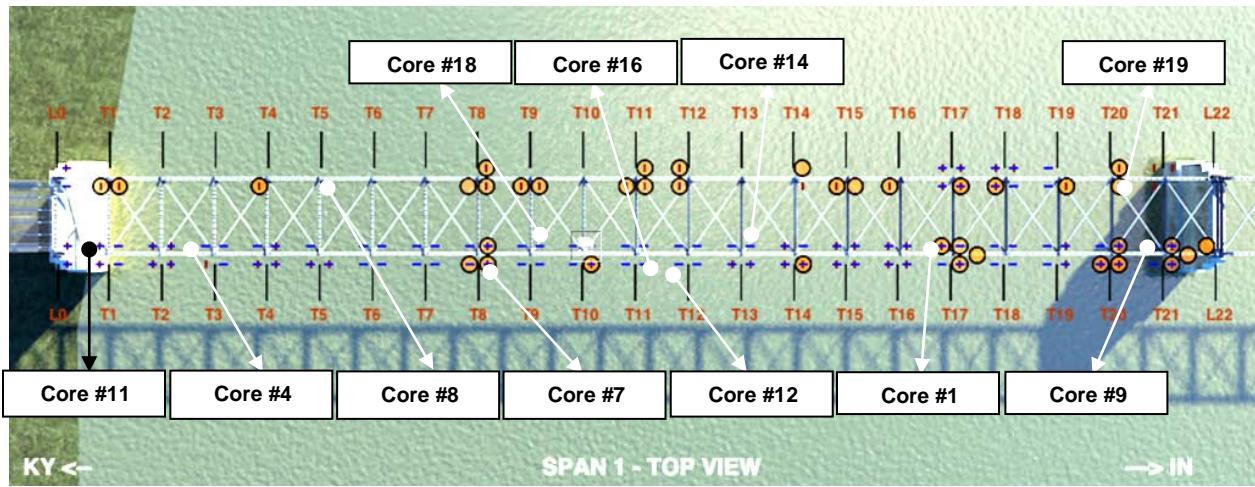
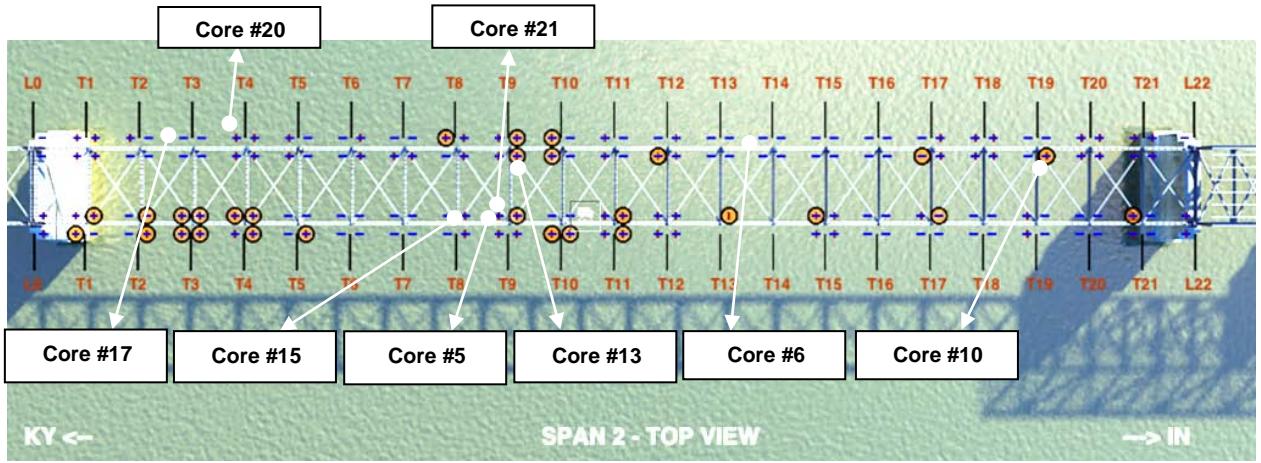
**Figure 3-2. Spans 1 and 2 field inspection results by Thornton Tomasetti**

A Forensic Information Model (FIM) was created by Thornton Tomasetti from field inspection reports, including the previous inspection periods, to visualize the locations of the indications in butt welds along the tie girders of the bridge (17). Therefore, the locations of 21 cores were identified on FIM in Figure 3-2. This identification of core locations on the top view of the bridge spans also simplifies the understanding of location nomenclature and abbreviations used in Table 3-2. According to Davey, the purpose of producing an FIM was to identify any locations on which inspection had not been conducted. In addition, FIM was used to assure any possible trends at certain butt welds that had been identified as having many indications in previous inspection periods.

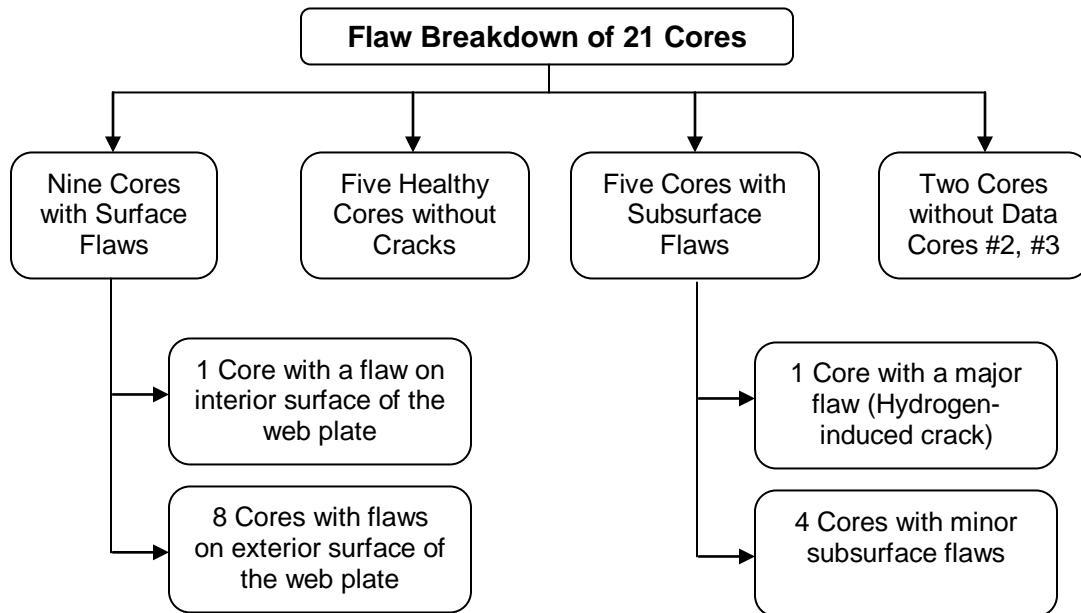
**Figure 4-1. Summary of laboratory results for the 21 core samples**

Table 4-1 summarizes the results of the laboratory study. Two cores (#2 and #3) did not have known locations or field inspection data. Healthy cores (without cracks) were reported for five out of 21 cores, showed in the Table 4-2. Surface-breaking flaws, or planar indications which initiated from the surface of tie girder web plates were found in nine cores out of 21 cores. Of these nine cores, only Core #1 was identified with a flaw initiated from the interior surface of the web plate. The remaining 8 cores had flaws initiated from the exterior surface of the web plate. Subsurface flaws were found in 5 cores out of 21 cores (Figure 4-1). Among these cores, Core #5 had one major

subsurface hydrogen-induced flaw (at/after fabrication time). The other 4 cores had minor volumetric flaws such as slag and porosity.

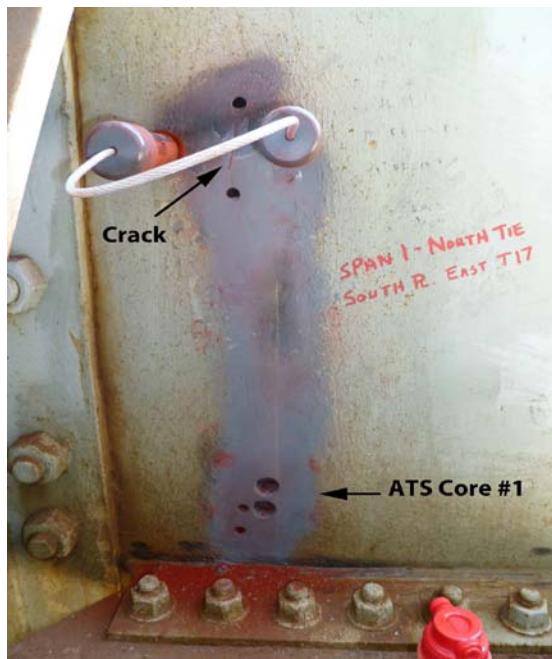
Core #1 contained a 1.61 in crack as determined by the ATS lab analysis. The UT report showed an 11.2 in indication across a length that included the location of the core. As such, the overlap was determined to be the length of the crack, 1.61 in. Figure 4-2 shows the location of this core near to the shelf plate. RT inspected this core location after its removal (Table 4-1). For RT, an indication measuring 1.2 inches was located nearby the core, but not within the core because the core was removed. Consequently, an overlap of 0 was determined. Small diameter holes inside the Core #1 indicate previous core removals.

**Figure 4-2. Location of Core #1 on the exterior face of the web (Supplied by Baker Inc.)**

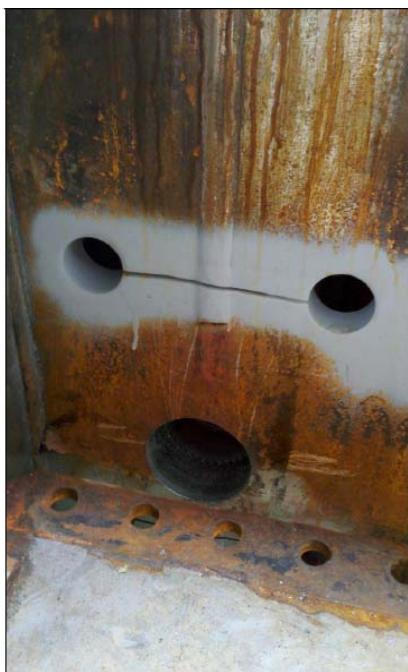
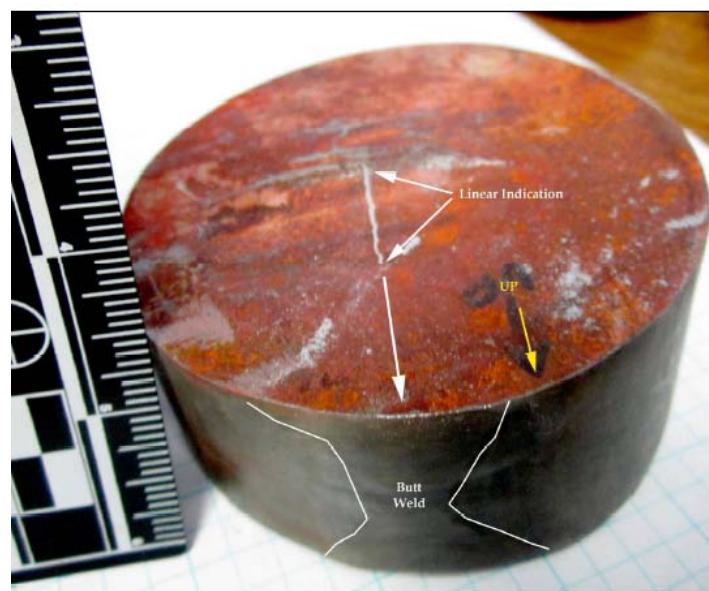
core. Since this core was also located near the shelf plate, it is possible that UT may not have had access to detect this indication (Figure 4-3). The RT report showed a 0.5 in long incomplete fusion at the core location (26 in from top of the web plate). Figure 4-3 shows a surface longitudinal crack at the center of the core along the weld. Based on the core picture, approximately half of the crack was above the origin and half was below the origin (origin at 26 in from top). RT reported a 0.5 in incomplete fusion from 26 in to 26.5 in measured from top of the web. Therefore, it was assumed that RT had an overlap of 0.5 in with the half of the crack located below the origin.

**Figure 4-3. Left: Core #4 location. Right: Core #4 after removal (Supplied by Baker Inc.)**

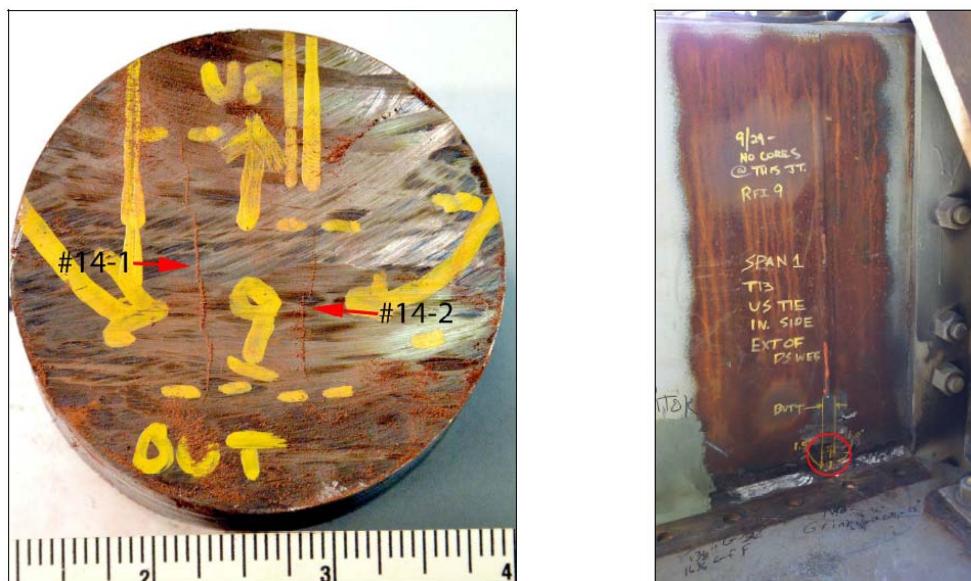
Core #14 contained two indications (1.5 in and 1 in long). Lab reported these indications as brittle fractures. UT reported an 8.5 in long indication from 19 in to 27.5 in from top of the web plate. The core origin/center was located approximately 27 in from top. Therefore, an approximate 0.8 in overlap of UT indication with 1.5 in actual lab measurement was noted (Figure 4-4). RT reported four cracks (1.17 in, 0.22 in, 0.23 in, and 0.30 in) at 28 in distance from top of the web. An approximate overlap of 1.17 in was considered between RT and lab measurements.

**Figure 4-4. Left: Core #14 at the lab. Right: Core #14 location (Supplied by Baker Inc.)**

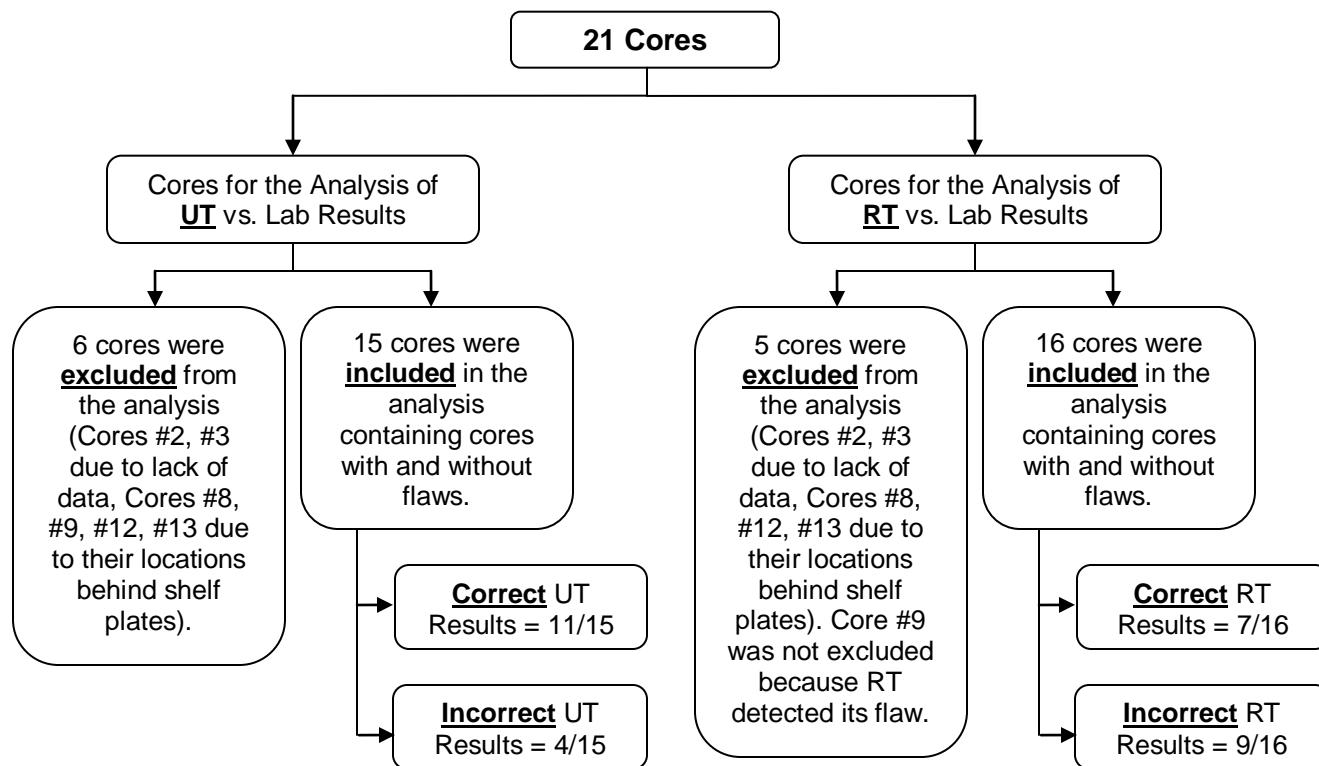
**Figure 4-5. Summary of the comparative analysis of UT and RT vs. lab results based on**

According to the data in Table 4-2, UT was more successful than RT. UT had 11 correct inspection results among 15 cores (4 cores behind shelf plates and 2 cores without data are excluded), while RT had 7 correct results among 16 cores (Figure 4-5).

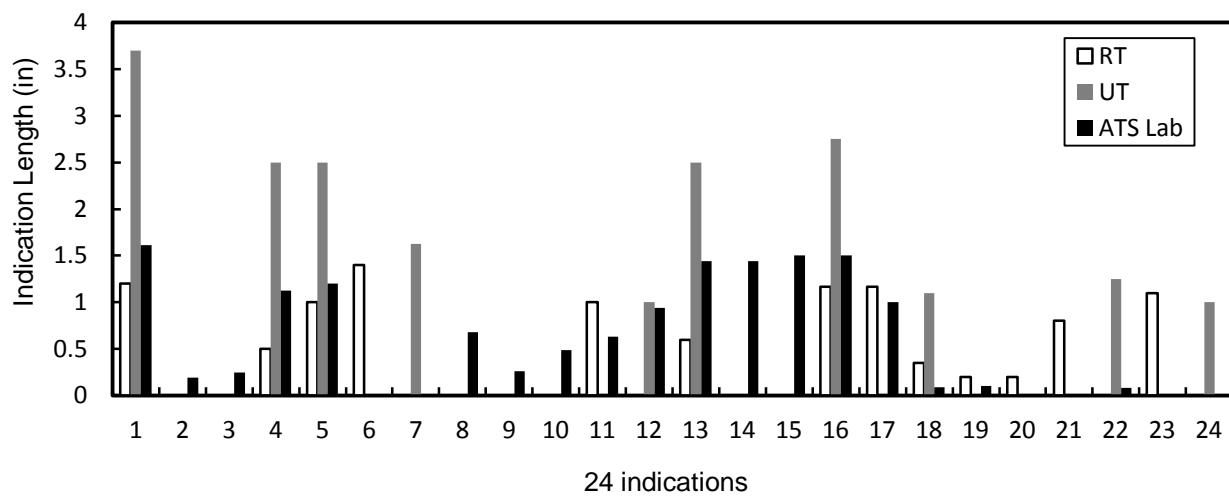
Figure 4-6. Comparison of RT, UT, and lab for 24 indications in 21 cores

Figure 4-6 compares UT, RT, and lab by illustrating missed flaws, detected flaws, false calls, over-measured flaws, and under-measured flaws. ATS lab results were considered as the reference data compared with UT and RT.

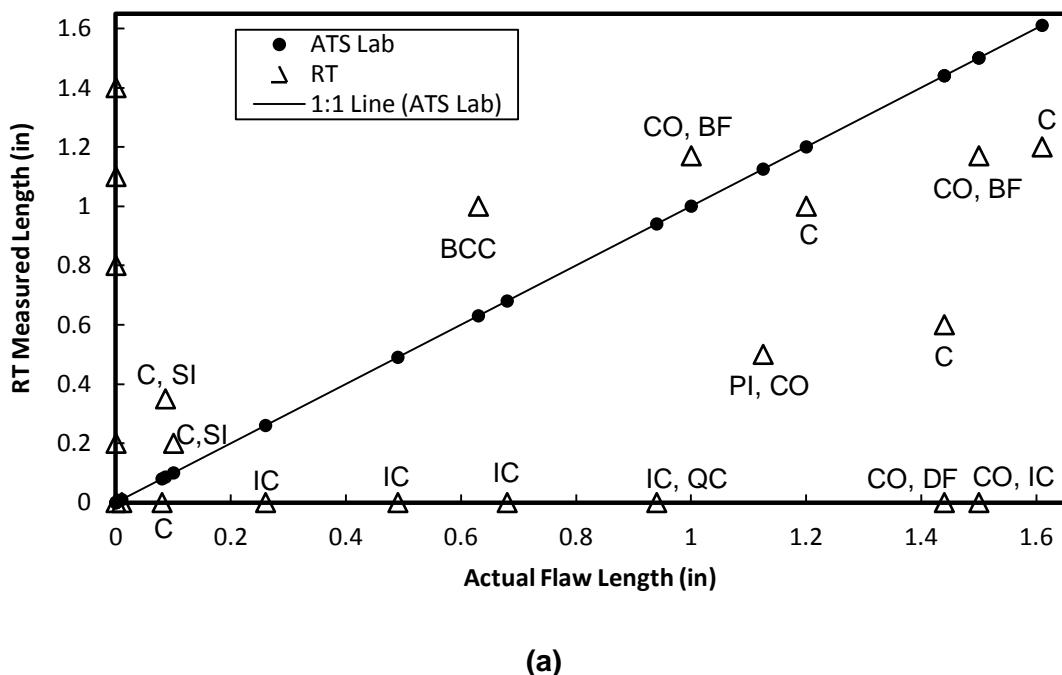
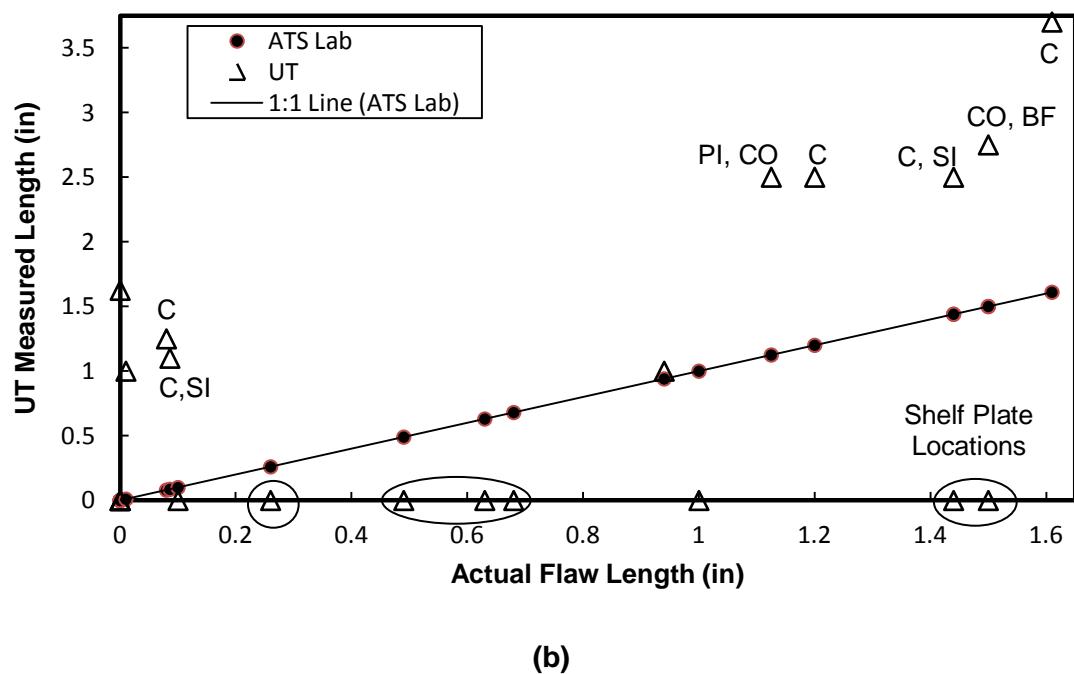
**Figure 4-7. RT & UT length measurements vs. actual flaw length**

In Figure 4-7, only 22 data points (flaw quantity except cores #2, #3) were considered. Quantitative comparison of length measurements indicated that UT had slightly more scattered results than RT. Also, Table 4-4 shows UT having a greater standard deviation than the RT when compared to the lab results; this means wider range of normal distribution curve. These results are reasonable because length measurement of UT is different from RT. Using RT technique, the length of a flaw is directly measured from an RT image. However, in UT method, the edges of an indication are identified where the measured amplitude changes -6 dB or drops 50% below the appropriate amplitude level for the given indication class ([34](#); [48](#)). In addition to the greater standard deviation of UT, data points on the horizontal axis in Figure 4-6b show missed flaws by UT. However, as circled on the figure, these missed flaws were included in the cores behind the shelf plates and UT did not have access to detect in the field. On the other hand, RT had many false calls in addition to missed flaws. All data

points located on the vertical axis of Figure 4-7a suggest that RT had false calls; this supports the data presented in Table 4-3 and the discussion in section 4.2. Comparison of RT and lab sectioning showed that RT missed a 0.01" long crack related to core #21. This particular crack, hard to see in Figure 4-7a, was both very small and parallel to the radiation beam path and it was difficult for RT to detect. Based on Figure 4-7a, RT missed many planar flaws such as inter-granular cracks. RT also missed a ductile fracture, a quasi-cleavage, and some corrosion indications. The nomenclature and abbreviations indicated on Figure 4-7 was defined in Table 4-3.

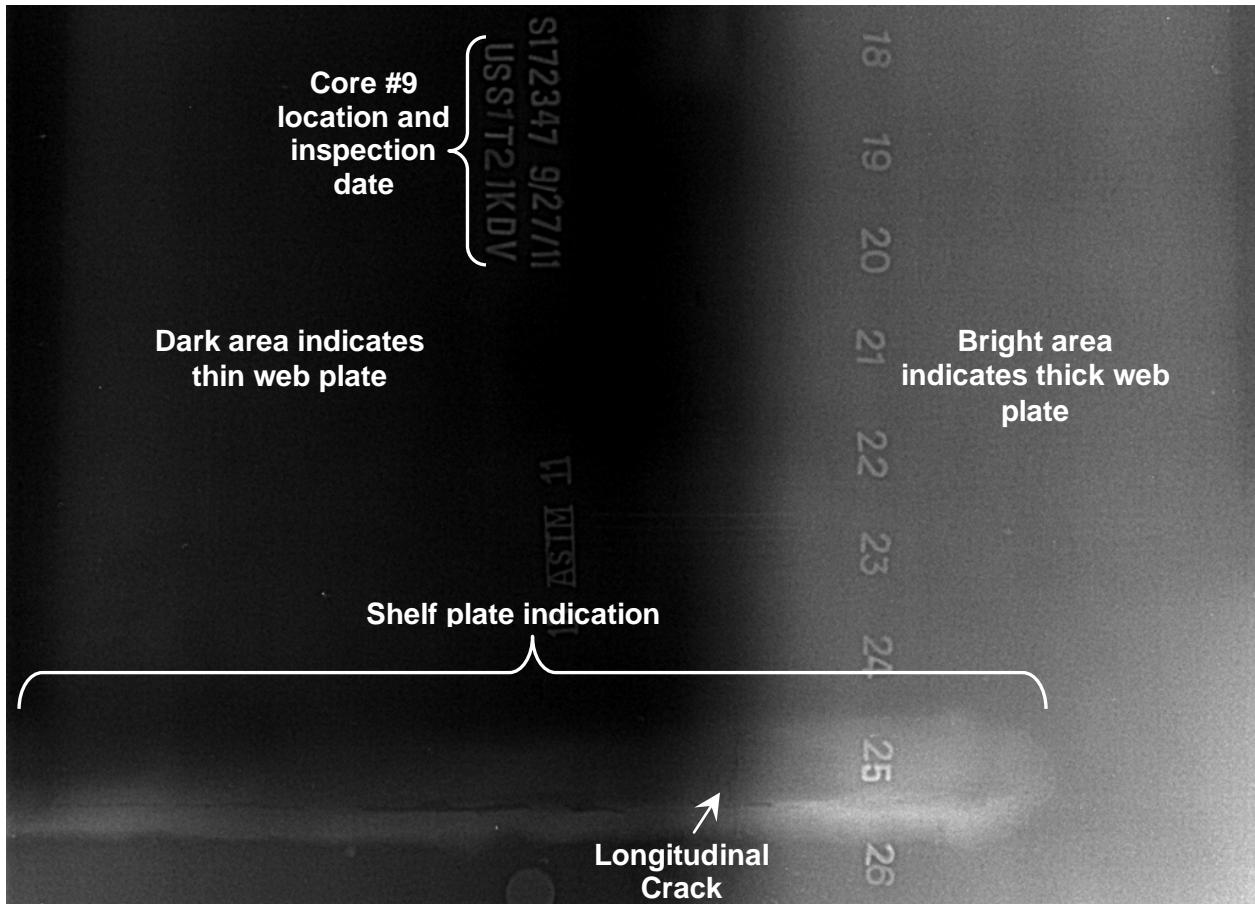
**Figure 5-3. RT image for core #9 showing the shelf plate and a longitudinal crack along the weld from 25" to 26"**

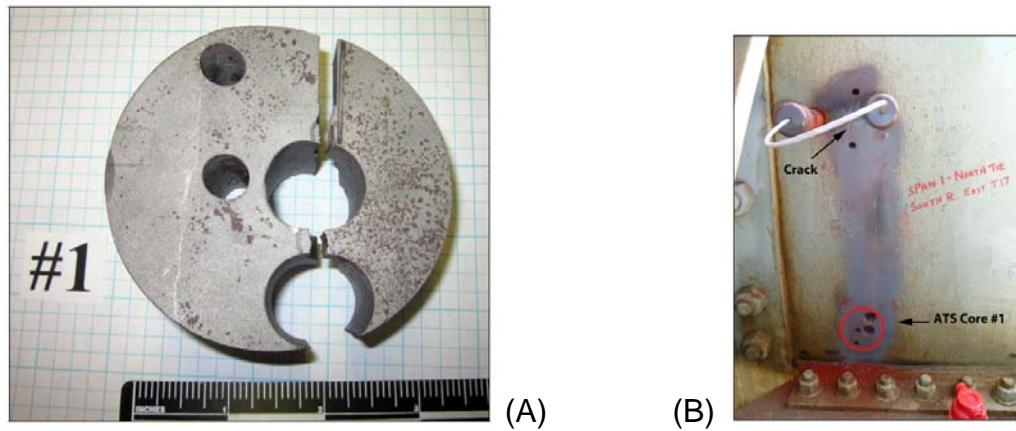
**Figure F5. (A) Plan view of the interior surface of the Core #1. (B) Location of Core #1 on the exterior surface of the web**

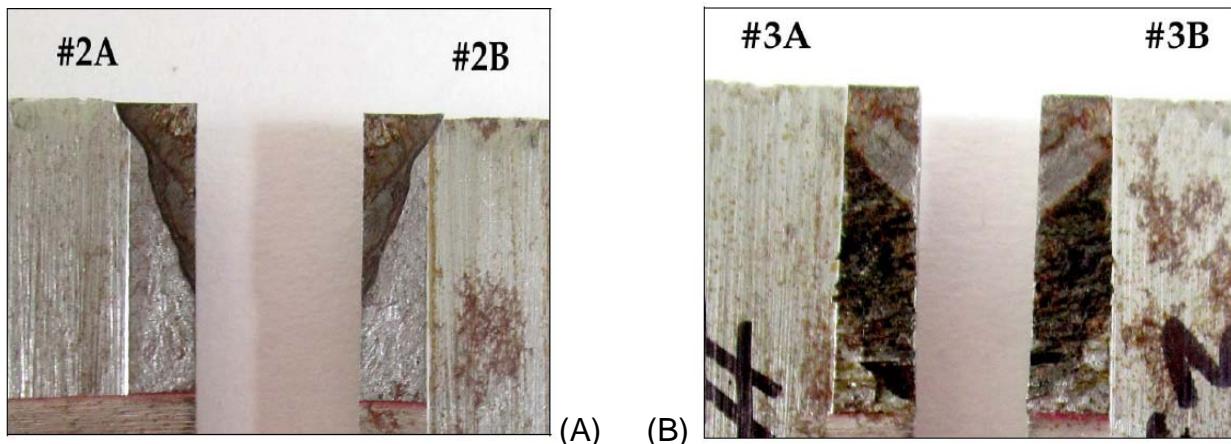
**Figure F7. (A) View of fracture surfaces on Core#2. (B) View of fracture surface on Core#3**

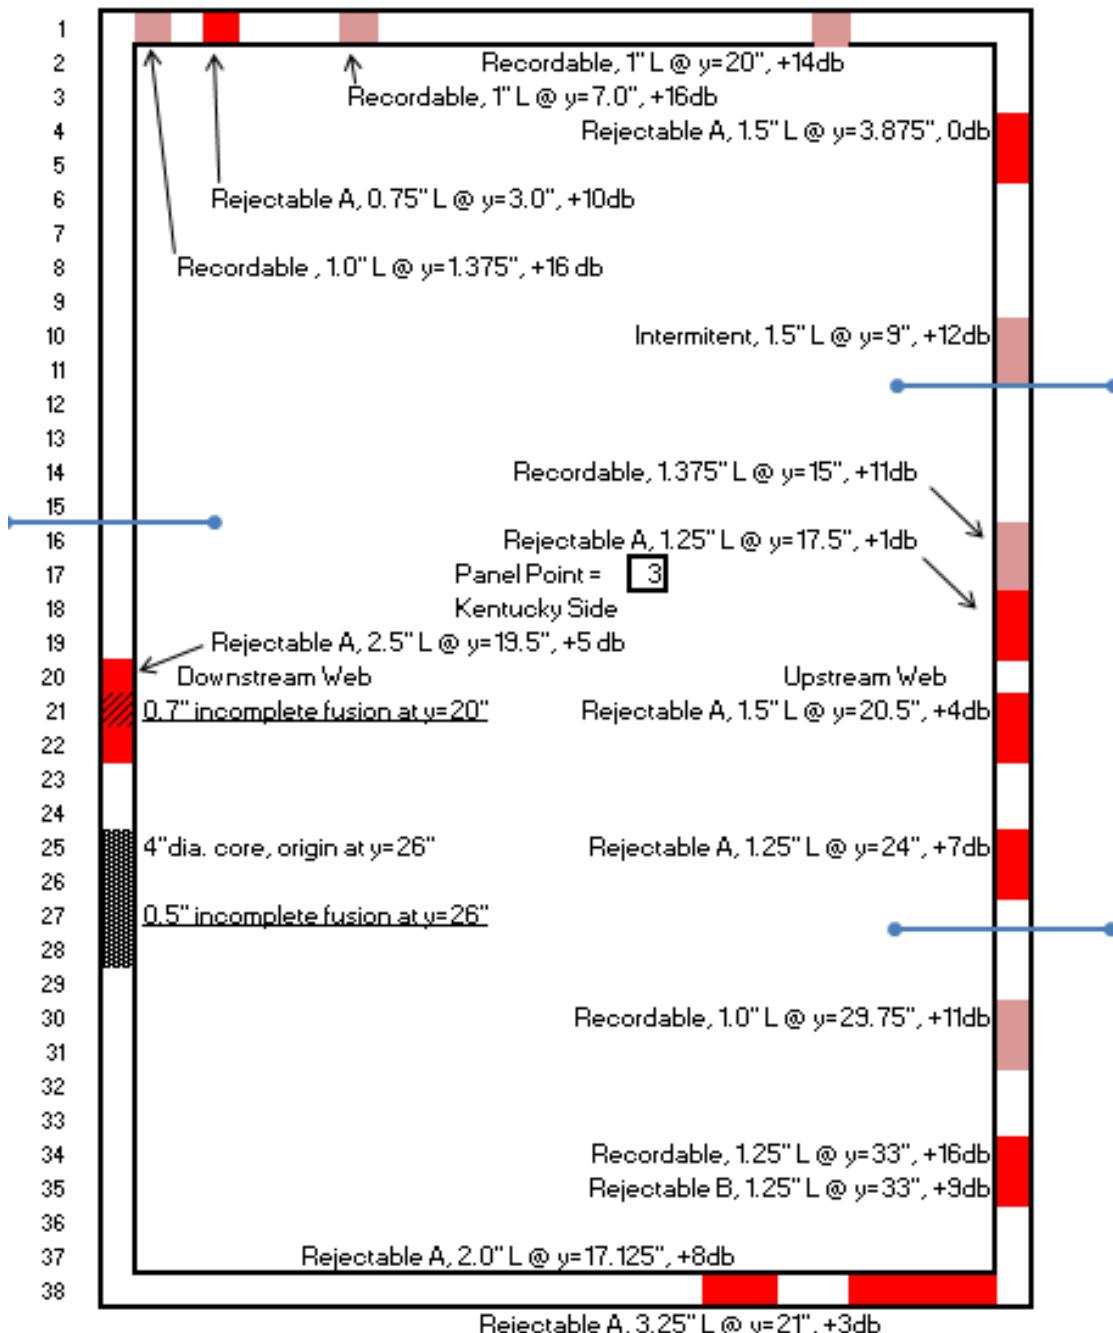
WEB REJECTED BY RT - DEFECTS NOTED

Figure F12. Cross section of the panel point T-3 and Core #4 location on the downstream web.

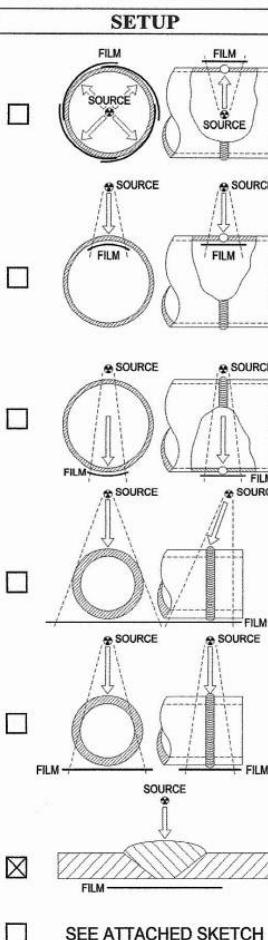
**Figure F15. ATS RT report showing one crack at the Core #5 location**

1-16	X	X										1" @ 4"-5" IN HAZ	
12-26	/												
30-36	/												
32-37	X	X											
DV													
1-16	/												
12-27	X	X										3.2" @ 13"-18", 1.7" @ 20"-22" *	
23-37	/											0.4" @ 24"	
												<input type="checkbox"/>

* Recommend Grind Flush & Re-X-Ray	
												Note: Intersecting corner @ top and Bottom of weld has rejectable weld flaws per AWS D1.5	
												<input checked="" type="checkbox"/> SEE ATTACHED SKETCH

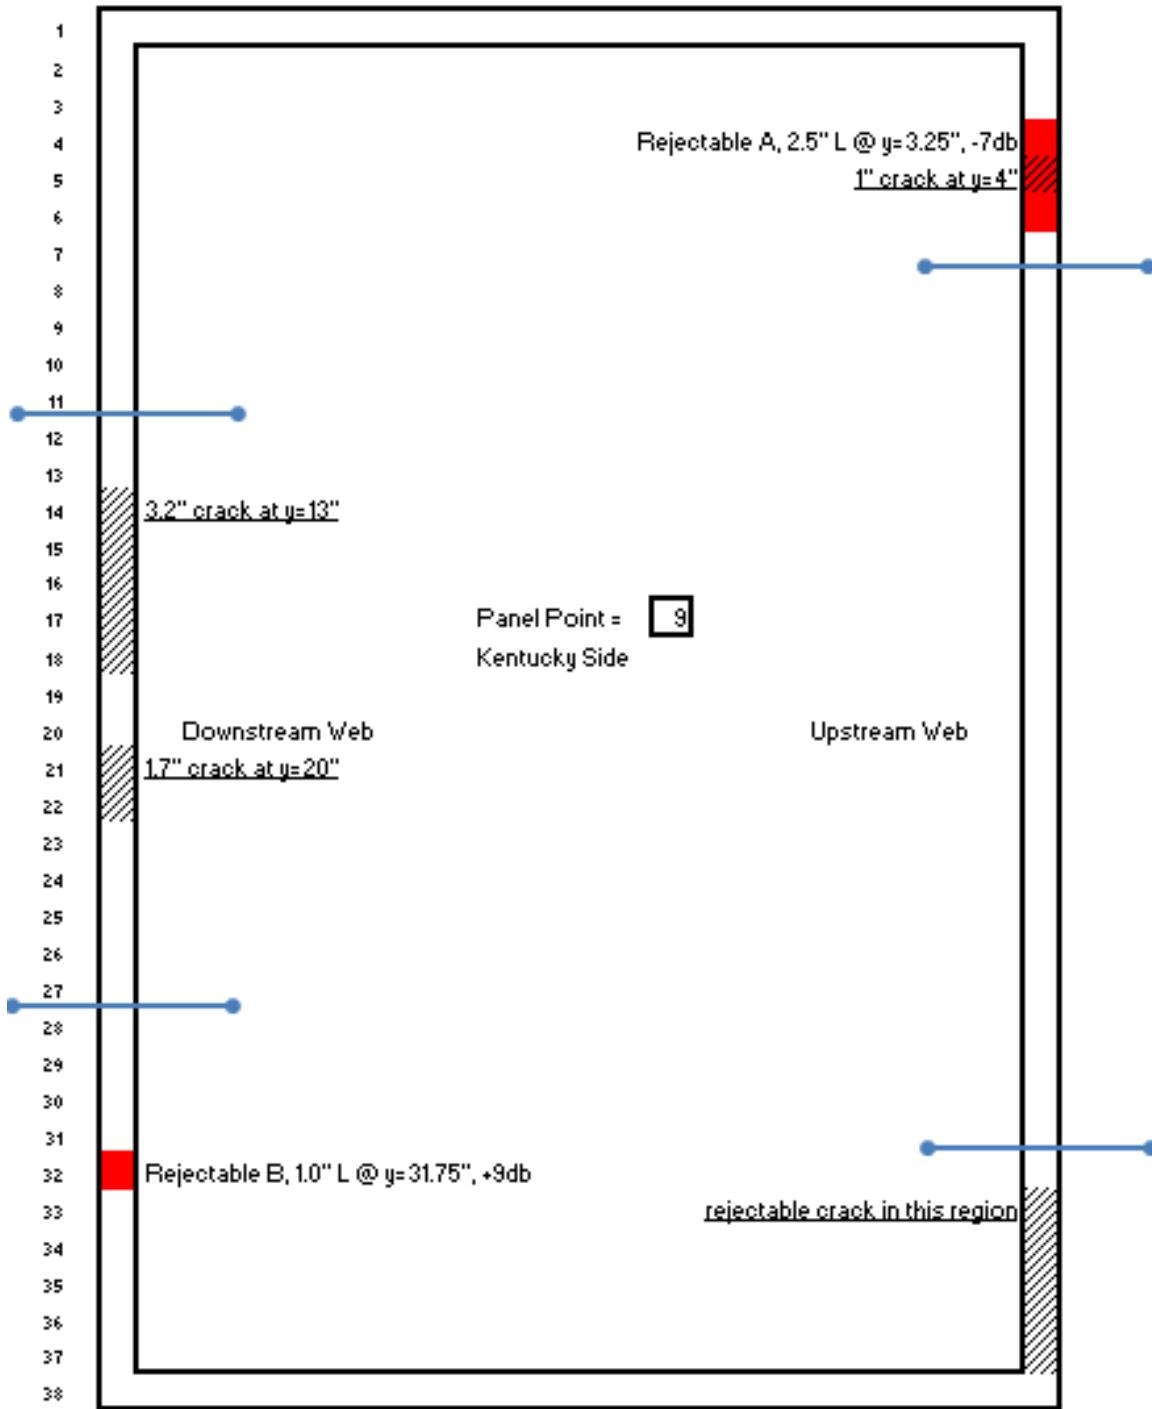
WEB REJECTED BY RT - DEFECTS NOTED

Figure F17. Cross section of the panel point T9 and Core #5 location

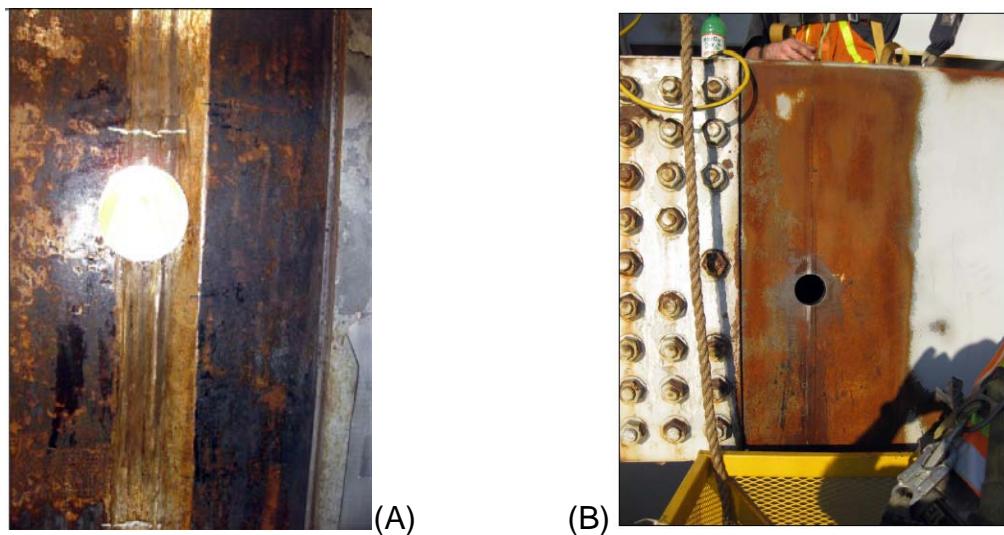
**Figure F21. (A) Core #6 on the interior surface of the web. (B) Core #6 on the exterior surface of the web.**

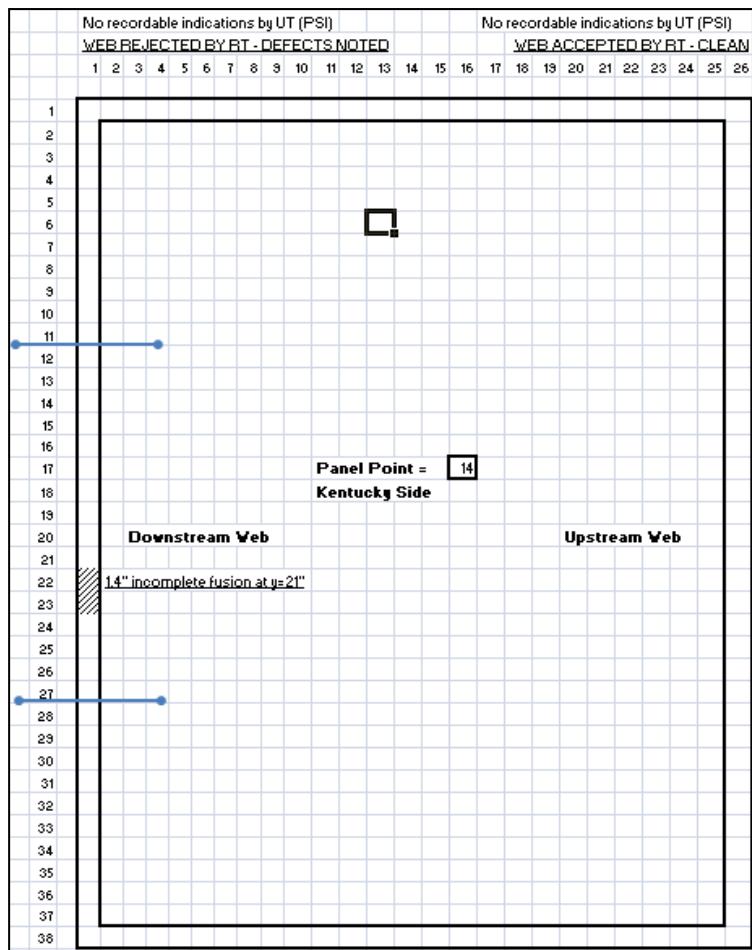
**Figure F22. Cross section of the panel point T-14 and the Core #6 location**
