**COMPARISON OF NONDESTRUCTIVE TESTING  
TECHNOLOGIES USED FOR INSPECTION OF WELDED  
JOINTS**

A Thesis Presented to the Faculty of Graduate School at the  
University of Missouri-Columbia

HABIBURAHMAN HOTAKI

JUNE 2014

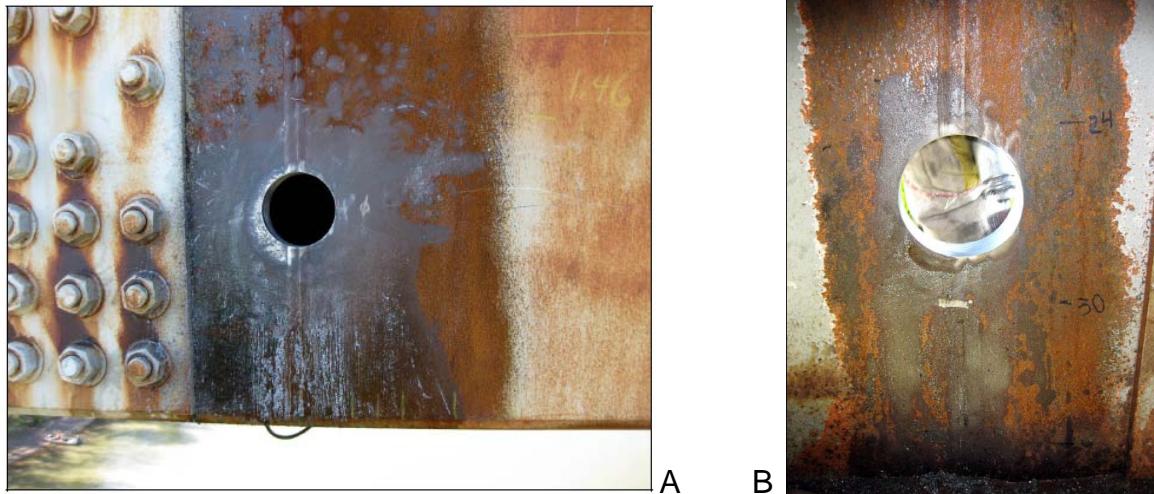
**Figure F26. (A) Core #7 location on exterior face. (B) Core #7 location on interior face.**

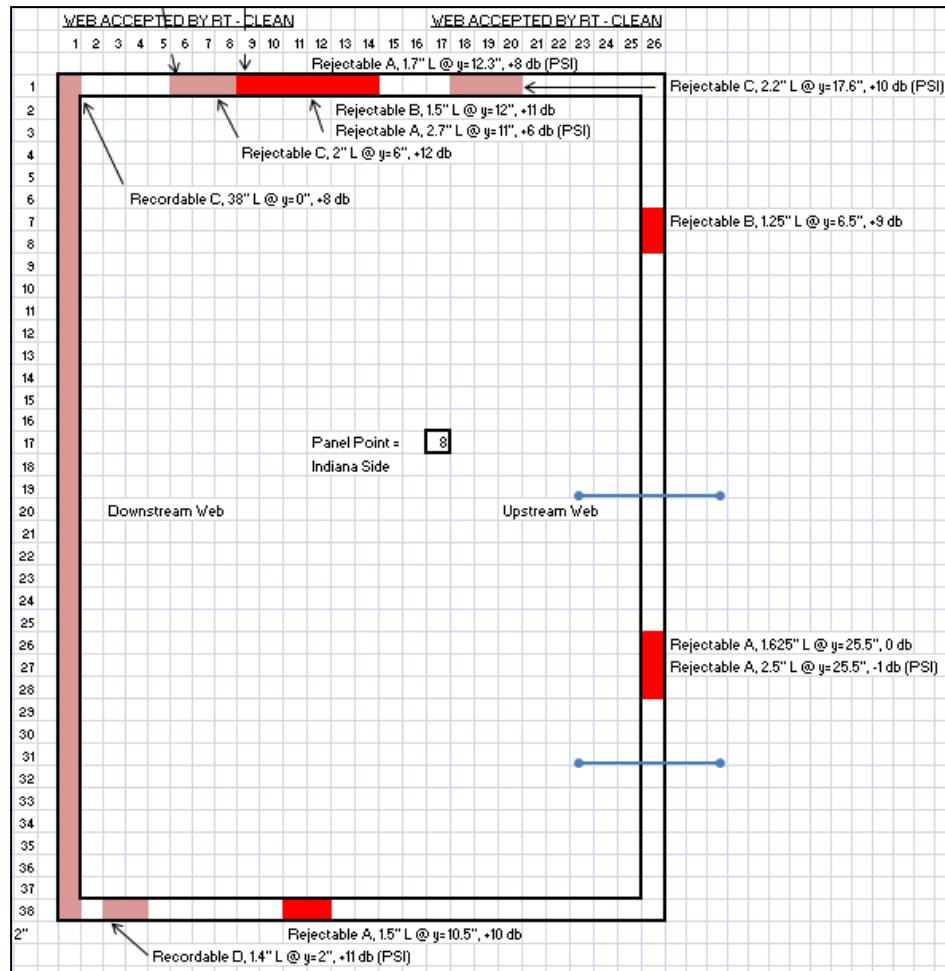
**Figure F27. Cross section of panel point T8 and the Core #7 location**

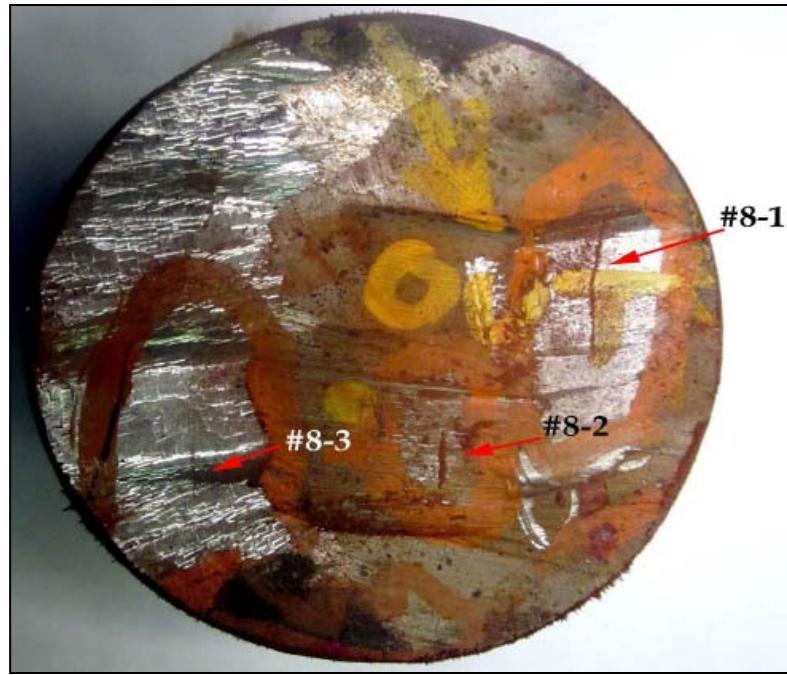
Figure F30. Three vertical cracks found by ATS lab MT method at the Core #8

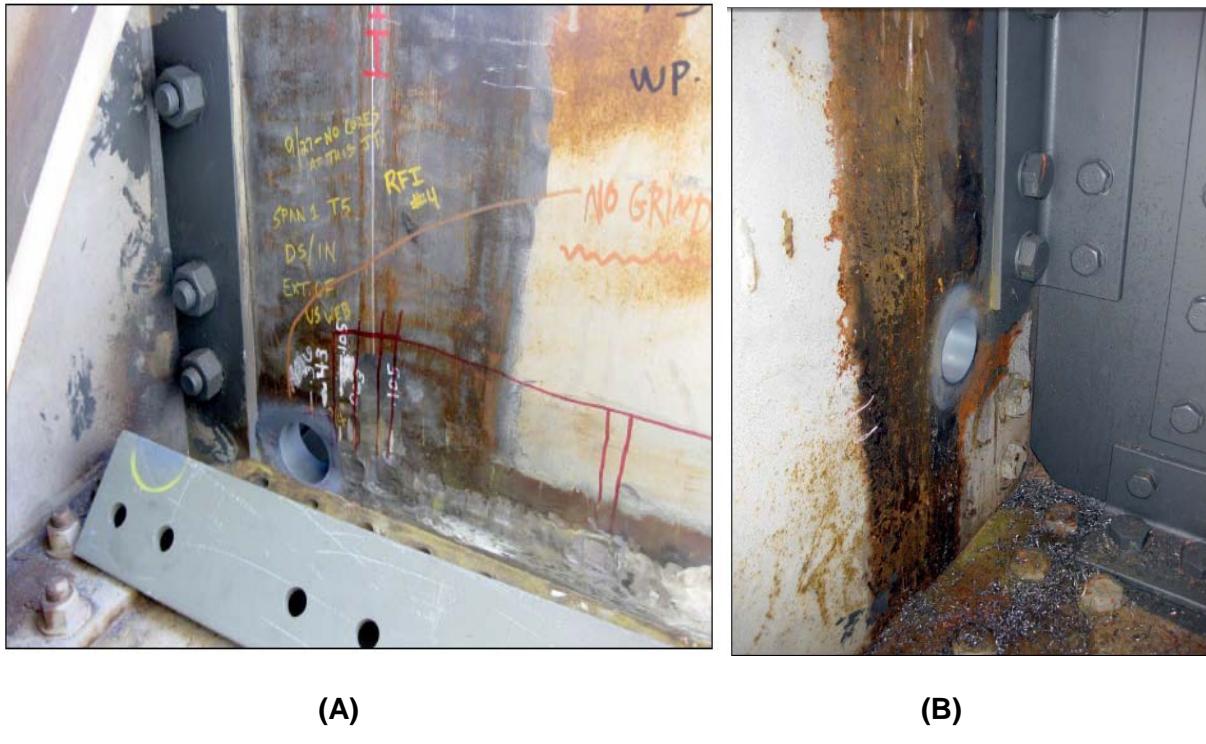
Figure F31. (A) Core #8 location on the exterior face. (B) Core #8 location on the interior face of web plate.

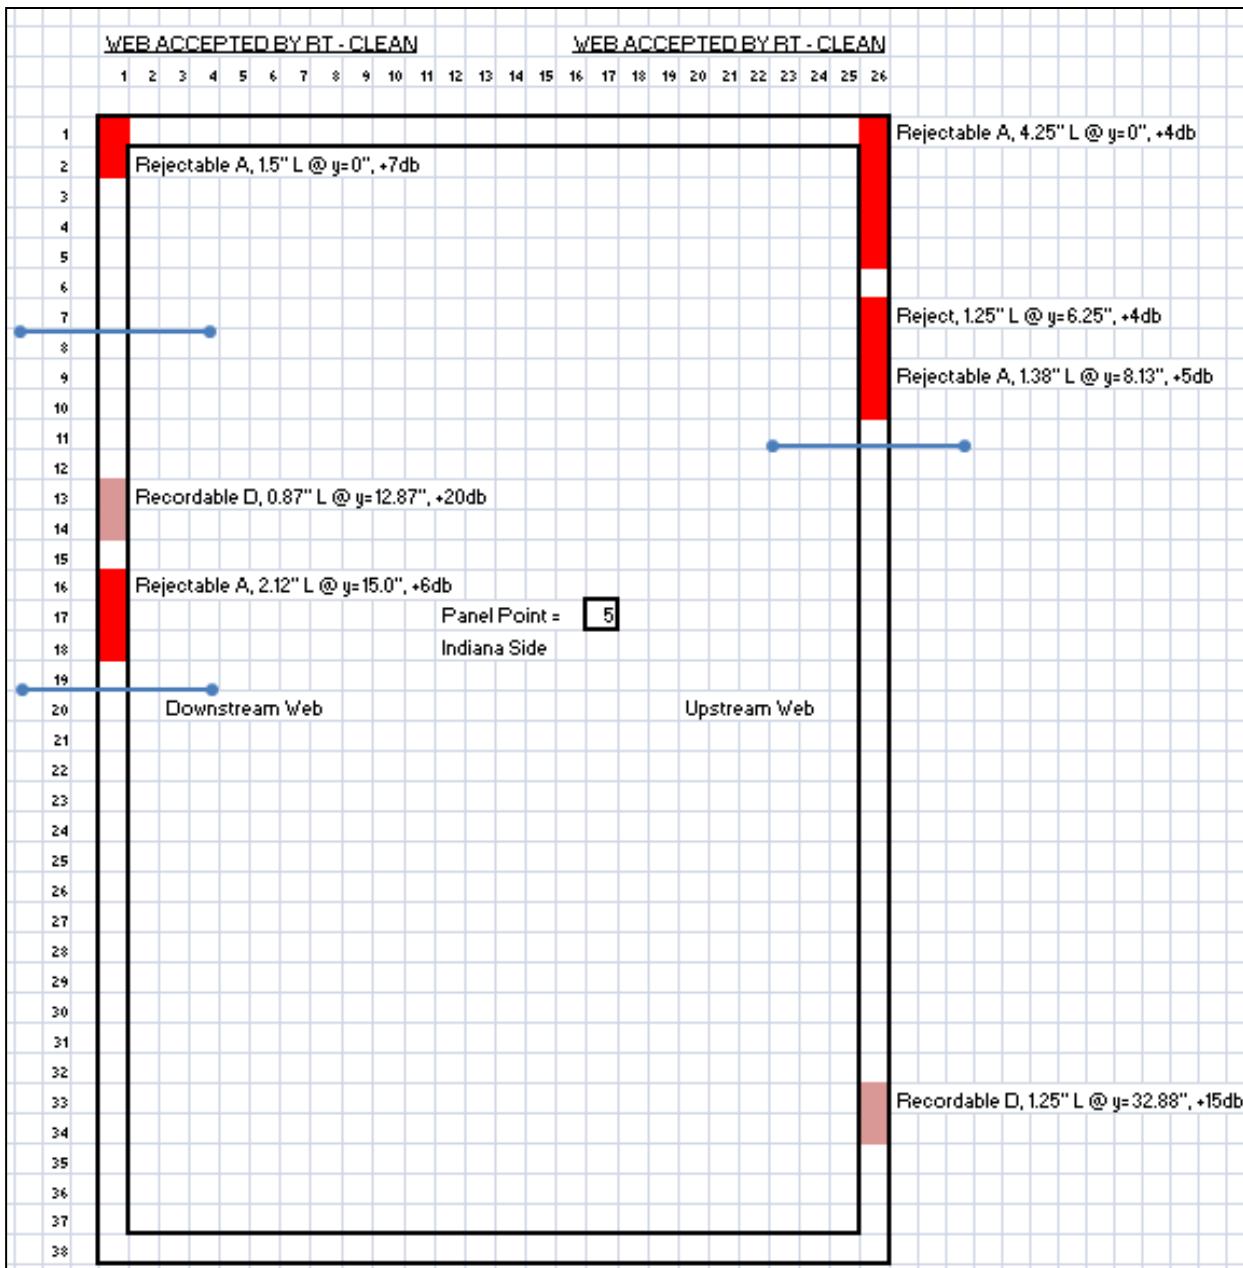
**Figure F32. Cross section for the panel point T5 and the Core #8 location**

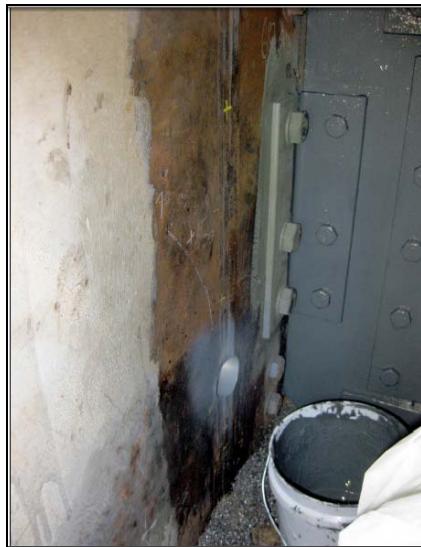
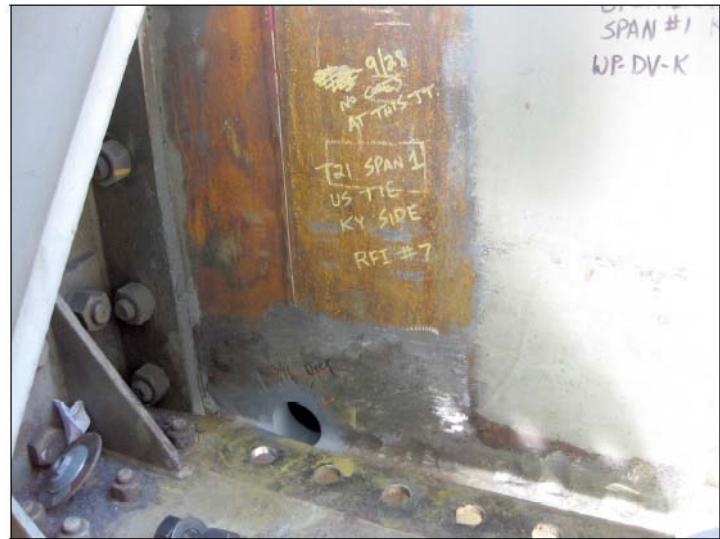
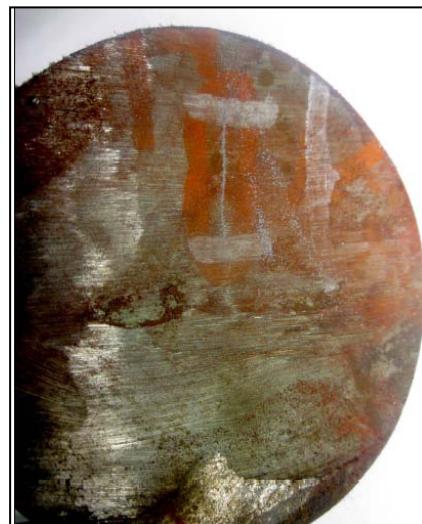
**Figure F36. (A) Location of Core #9 on interior web surface. (B) Location of Core #9 on the exterior web surface. (C) Indication of a vertical flaw by ATS MT lab inspection**

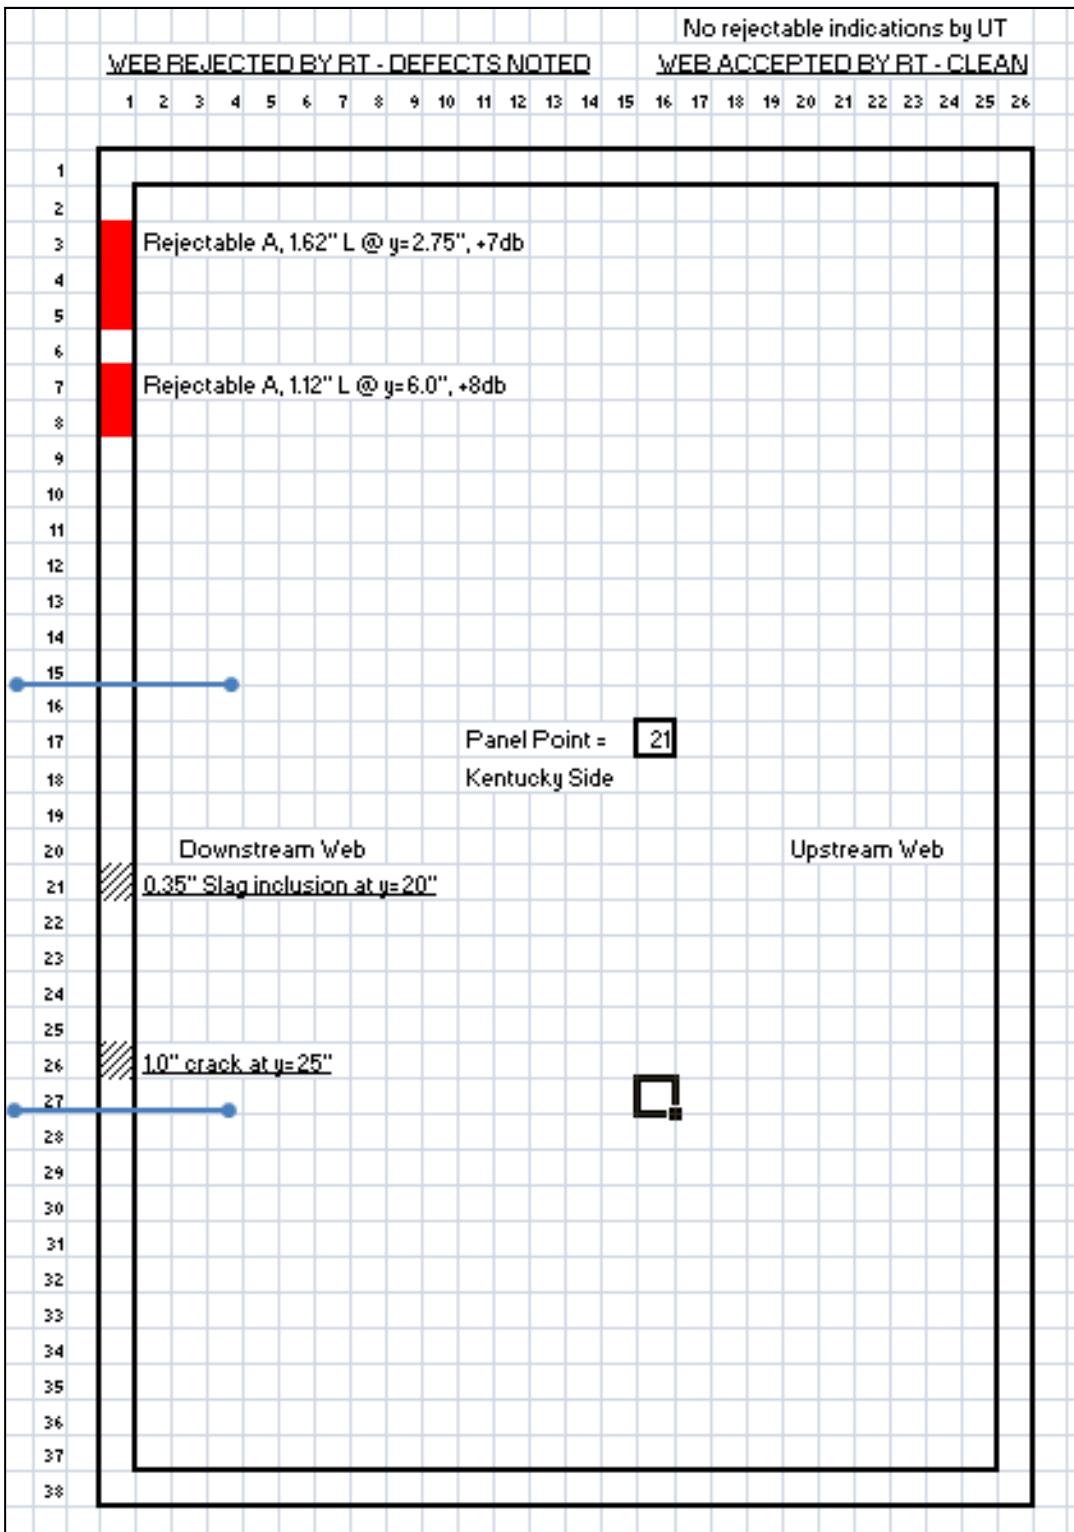
Figure F37. Cross section of panel point T21 and showing of one crack detected by RT at

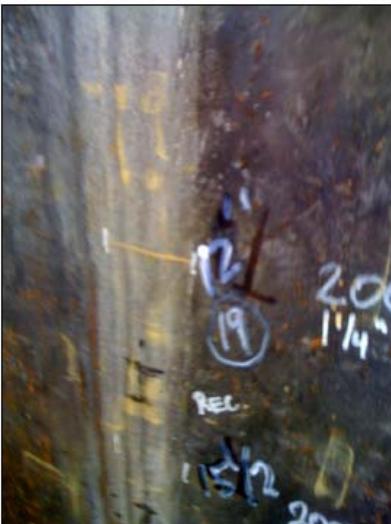
Figure F38. (A) FISH MT report showing no relevant indication at Core #10 location. (B) PSI MT report showing no flaws at Core #10 location. (C) Showing crack below the lateral connector.

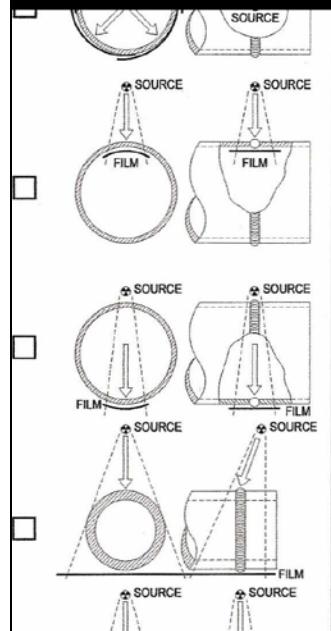
Figure F40. ATS RT report showing cracks between drilled holes in the region of Core #10 location.

PART I.D./ FILM VIEW	Accept	Reject	Crack	Slag Inclusion	Tungsten Inclusion	Porosity	Undercut	Incomplete Fusion	Incomplete Penetration	Root Concavity	Root Convexity	REMARKS	
DS-S2-T19-IN	/	/	/	/	/								
UV													
1-15	/	/											0.4" @ 4" Crack b/w drill holes
9-24	/	/											Crack b/w drill holes
28-36	/	/											Crack b/w drill holes
30-38	/												0.4" @ 37"-38"
DV													
1-15	/												
12-26	/												
23-37	/												2 Ind, 0.1" @ 27"-29"

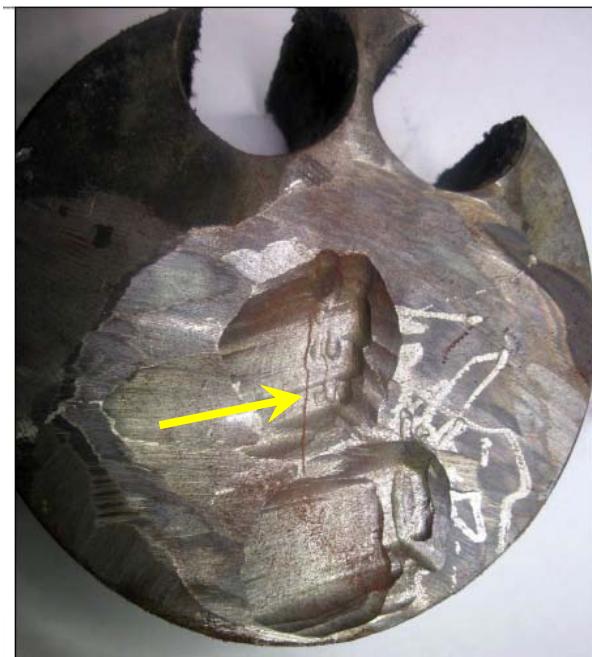
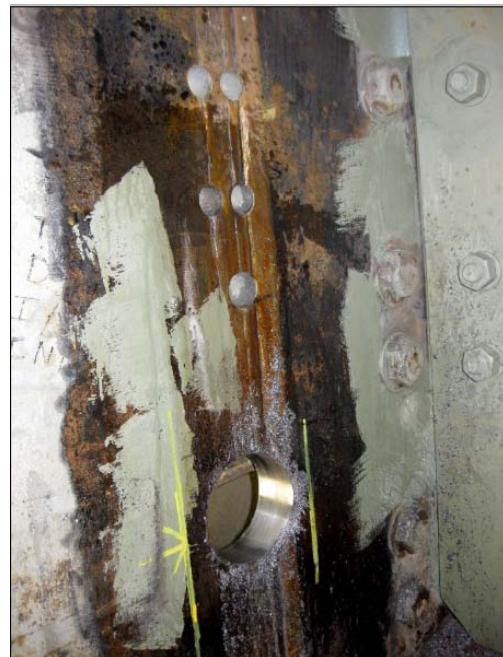
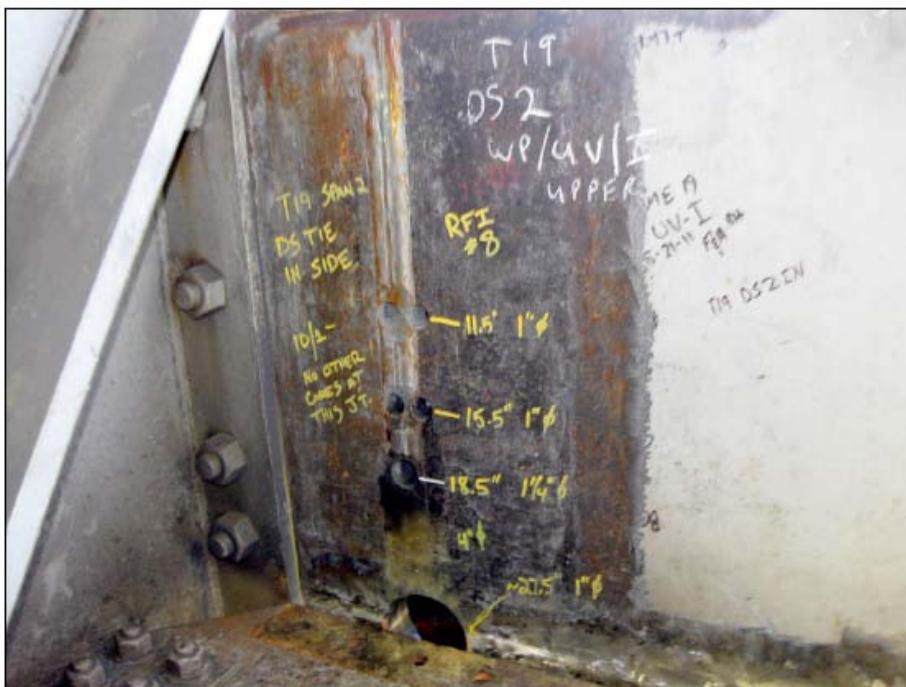
**Figure F41. (A) A vertical flaw was identified by MT method on the exterior surface of the web at Core #10 location. (B) Core #10 location on the interior web surface. (C) Core #10 location on the exterior web surface conflicting with the shelf plate.**

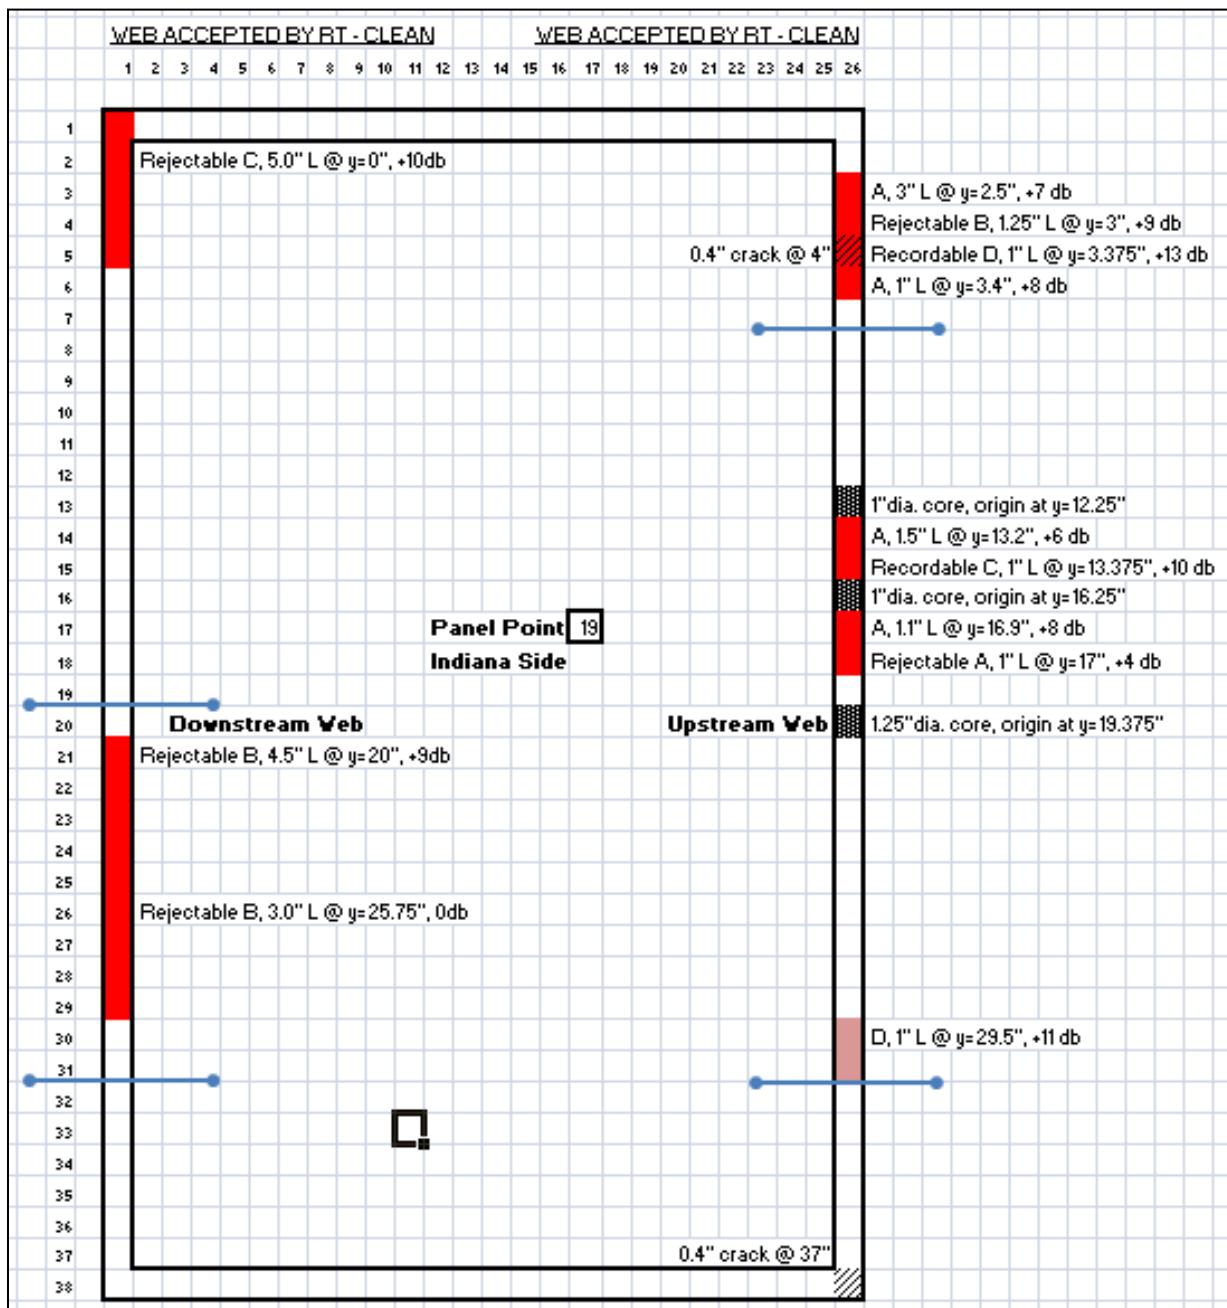
**Figure F42. Cross section of panel point T-19 and the upstream web along Core #10 location.**

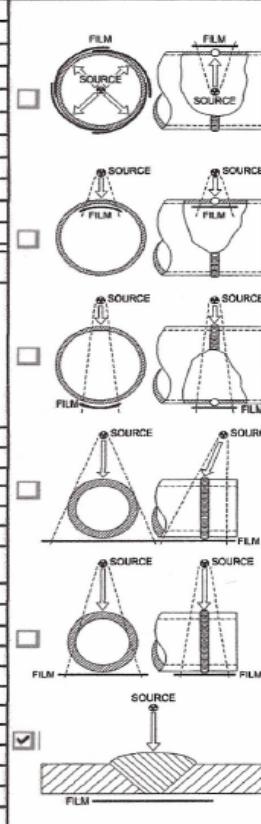
Figure F45. ATS RT report showing flaws at the Core #11 location.

DV_1													
1-15	X	X	/								C: 0.4" @ edge b/w 0"-1", S: 0.2" @ 4"-5", C: 1.6" @ 9"-11"		
5-20	X	X				X					6.3" @ 10"-18"		
25-32	X		X								0.6" @ 30"-31"		
29-37	X	X	/								C: 0.2" @ 37", S: 0.3" @ 34"-35"		
											*Same Indication		
											Note: Linear Indications are longitudinal with weld except as noted		
											Note: Intersecting corner @ top and Bottom of weld has rejectable weld flaws per AWS D1.5		
Art.=artifact which is a non-relevant indication													
<input checked="" type="checkbox"/> SEE ATTACHED SKETCH

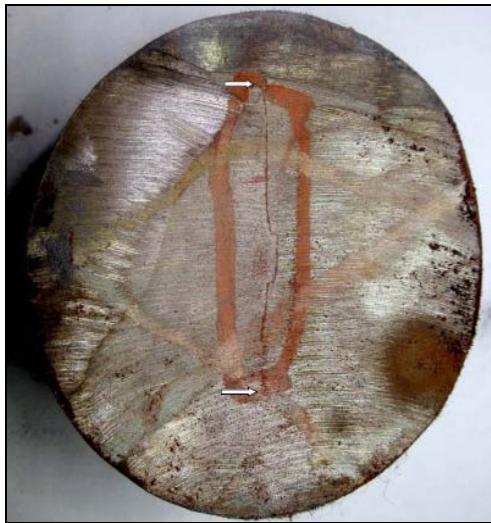
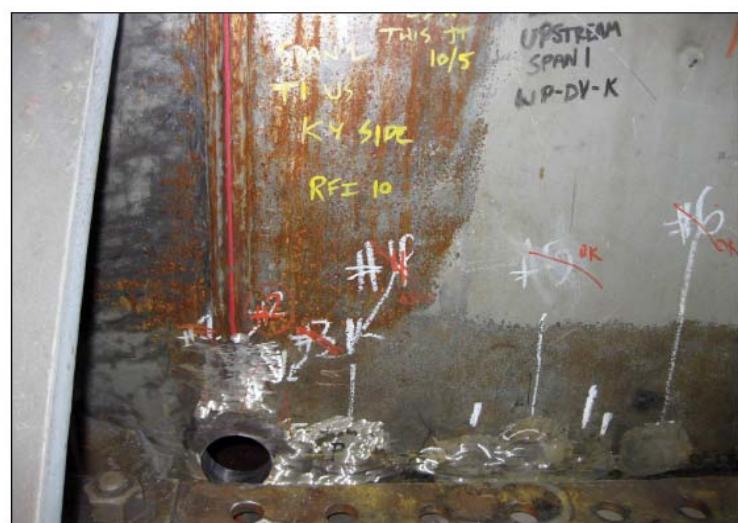
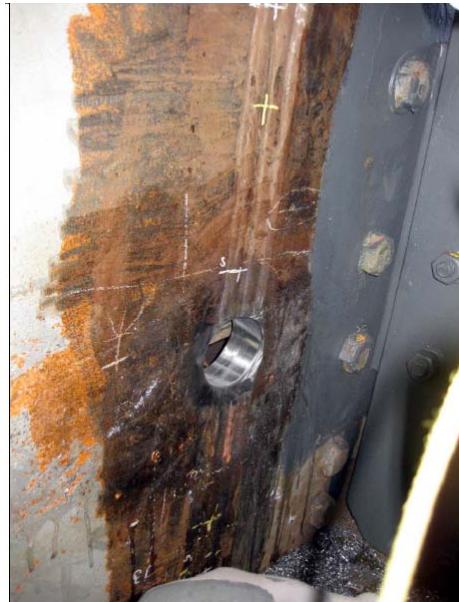
**Figure F46. (A) Vertical falw indication at Core #11 on exterior surface. (B) Core #11 location on the exterior surface of the web. (C) Core #11 location on the interior web surface.**

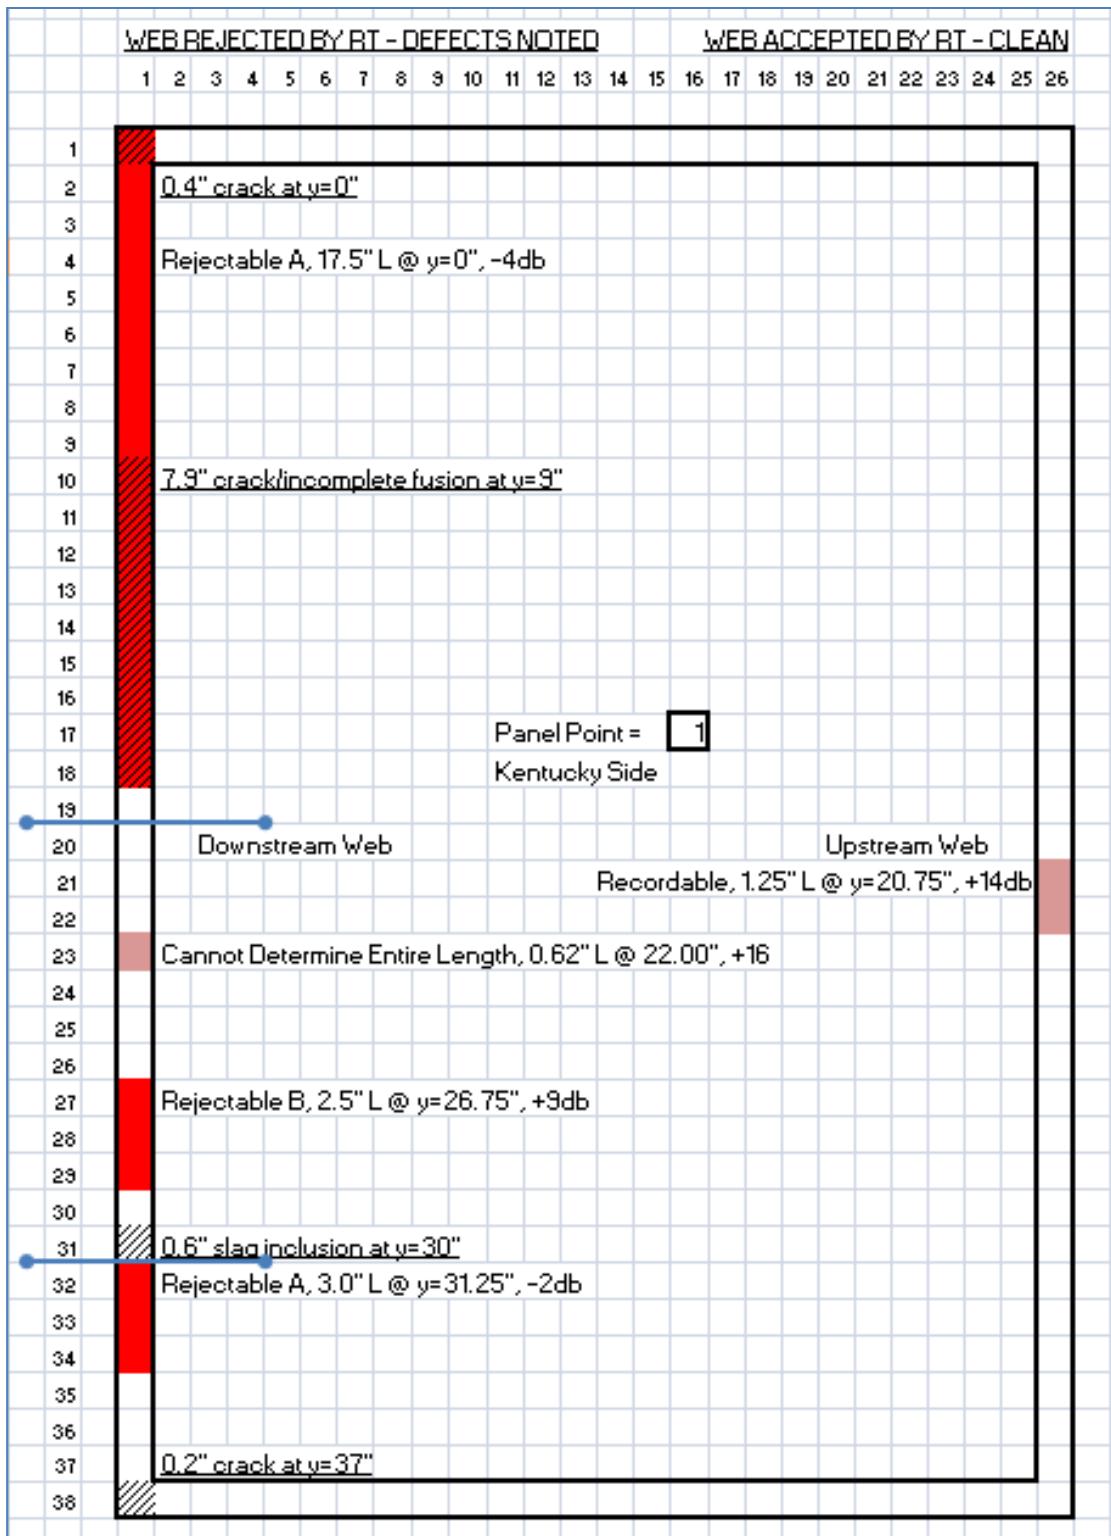
Figure F47. Cross section of the panel T-1 (Kentucky side) showing flaws along the Core #11 location.

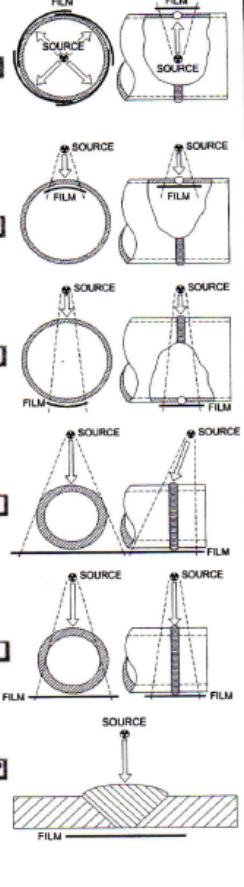
Isotope Ir192	Digital System Fuji Dynamix Series V													
Curies 96.0	Software Version VFC1 4.0													
KV N/A	IP Type Fuji ST-VI													
MA N/A	Sensitivity 0.032													
Time 12 min	Penetrometer ASTM 1B													
SFD 27"	Shim(s) N/A													
SOD 25"	Screen(s) Type Pb Front .010 Back N/A													
OFD 2"	Focal Size 0.166													
Source Size (Physical) .126" x .128"	Weld Reinforcement Ground Flush													
Geometric Unsharpness 0.013"	Weld Process N/A													
INTERPRETATION														
PART ID/ FILM VIEW	Accept	Reject	Crack	Slag Inclusion	Tungsten Inclusion	Porosity	Undercut	Incomplete Fusion	Incomplete Penetration	Root Convexity	Root Convexity	REMARKS		
US-S1-T12-KY														
UV														
1-15	X							X				0.8" @ 8"-9", Art. @ 14"-15"

12-26	/													
24-37	/													
DV														
1-15	/													
11-26	/													
24-37	/													
													Note: Linear Indications are longitudinal with weld except as noted Note: Intersecting corner @ top and Bottom of weld has rejectable weld flaws per AWS D1.5. Edge blocks not used	
													<input checked="" type="checkbox"/> SEE ATTACHED SKETCH

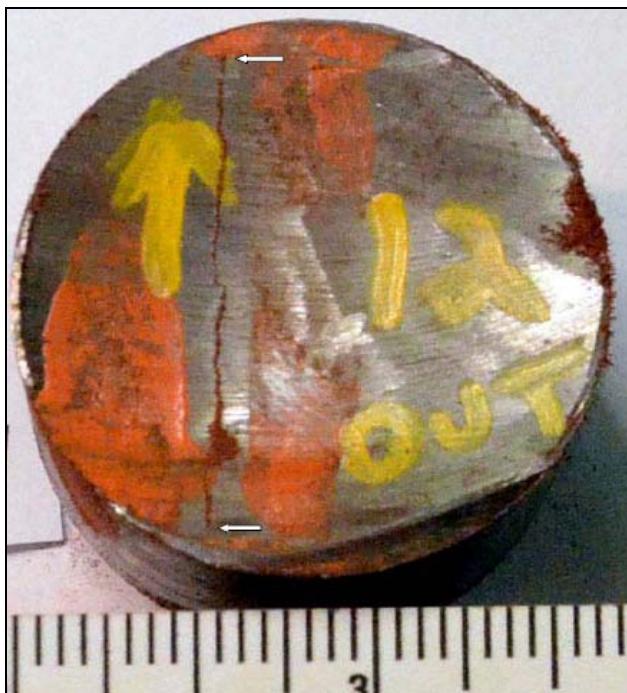
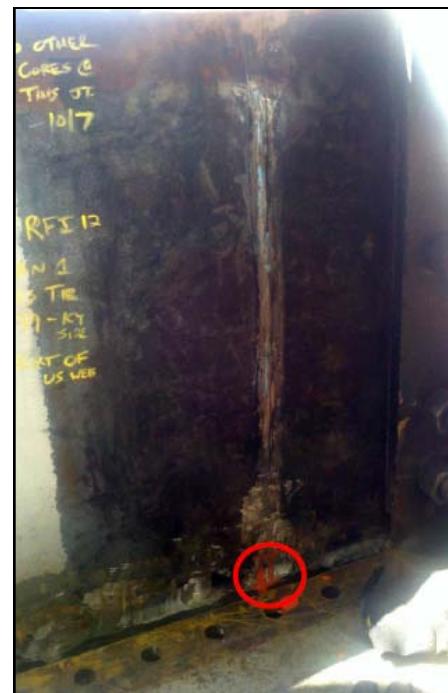
**Figure F51. (A) Indicated vertical flaw was determined by MT method at the ATS lab on the exterior surface of the web (Core #12). (B) Core #12 location on the exterior surface of the web.**

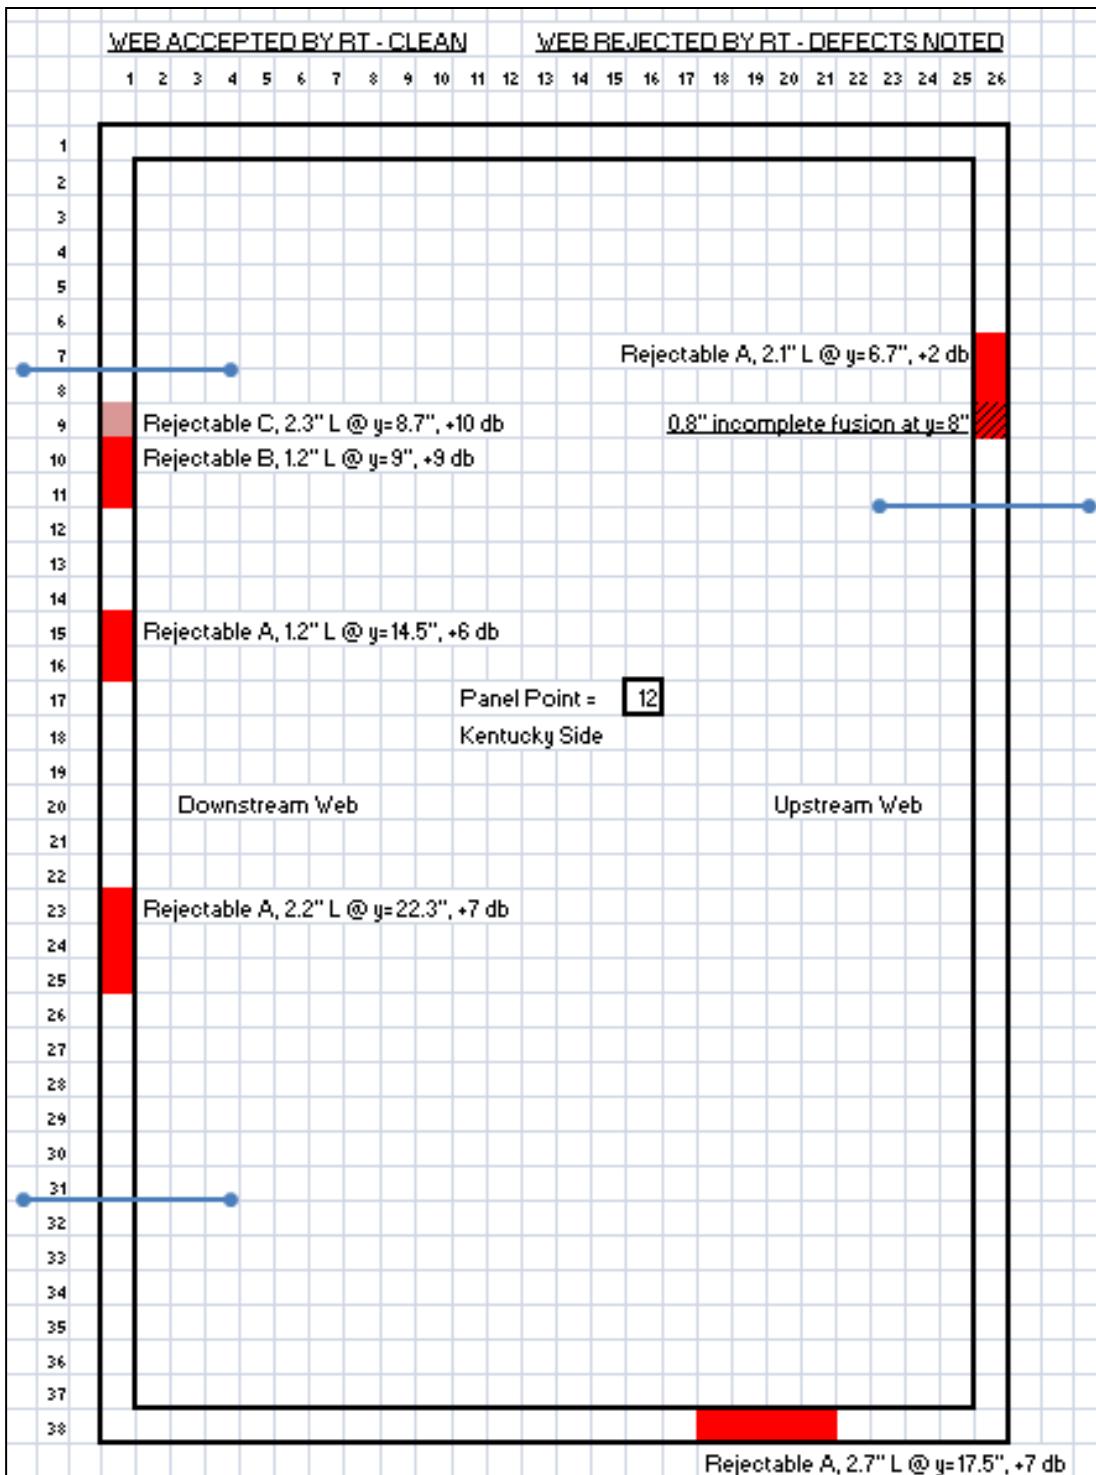
Figure F52. Cross section of the panel point T-12 and flaw indications along the web that Core #12 was located.

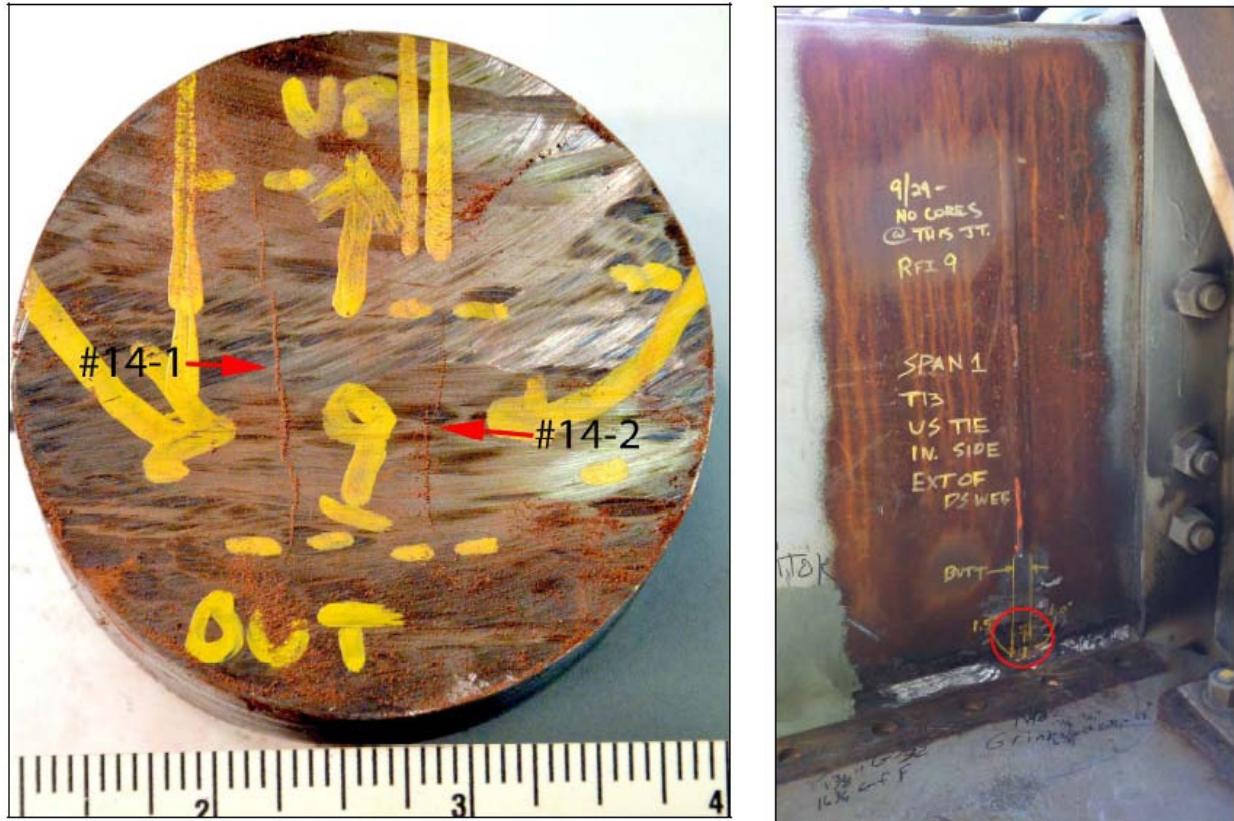
**Figure F61. (A)** Vertical flaws on the exterior surface of the Core #14 detected by MT. **(B)** Core #14 location on the exterior surface of the web.

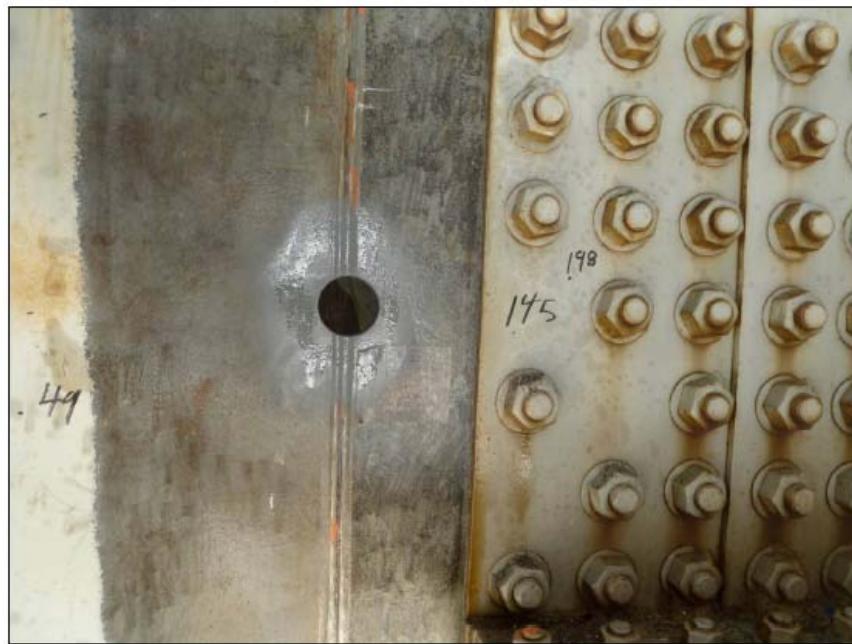
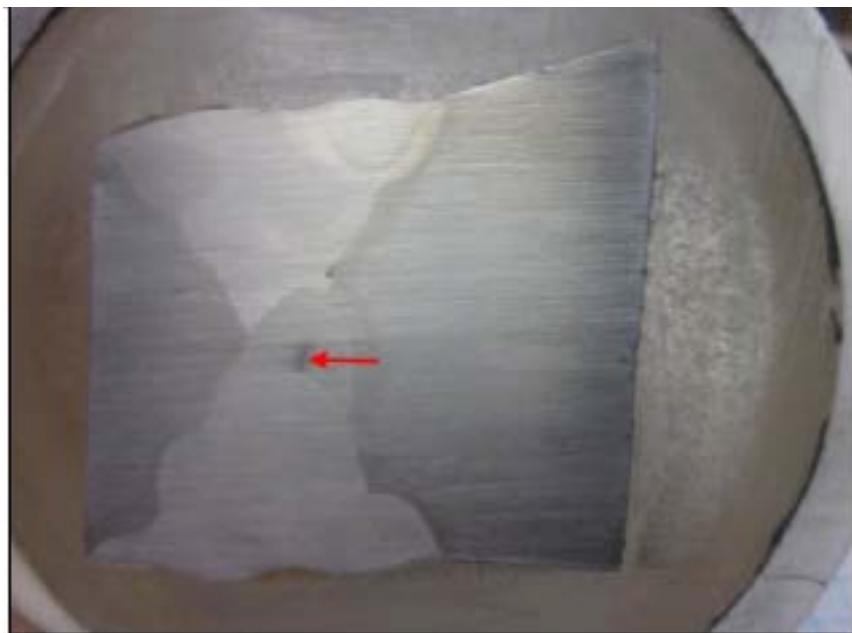
**Figure F66. (A) Core #15 location on the exterior surface of the web. (B) Transverse metallographic section through the indication at Core #15.**

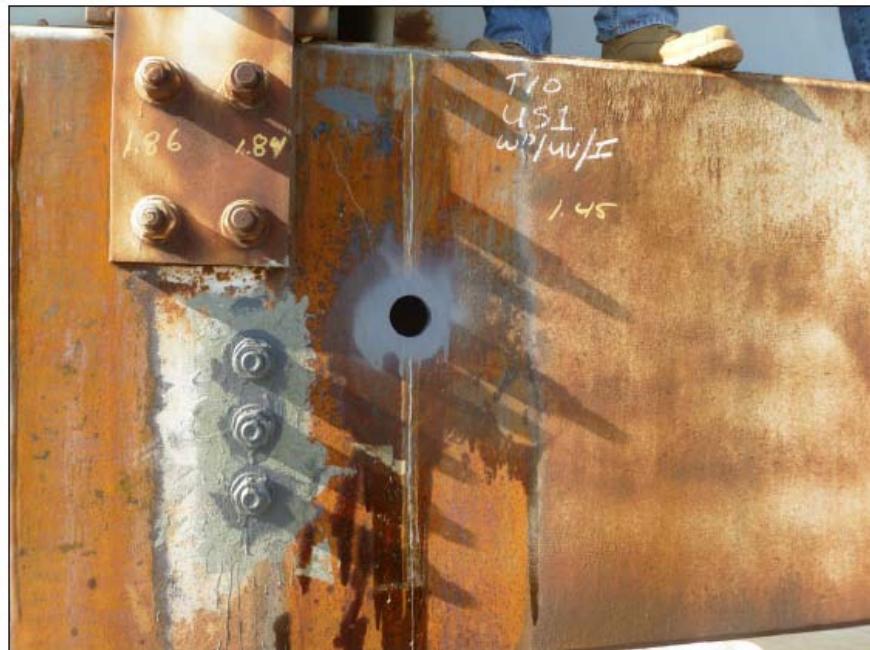
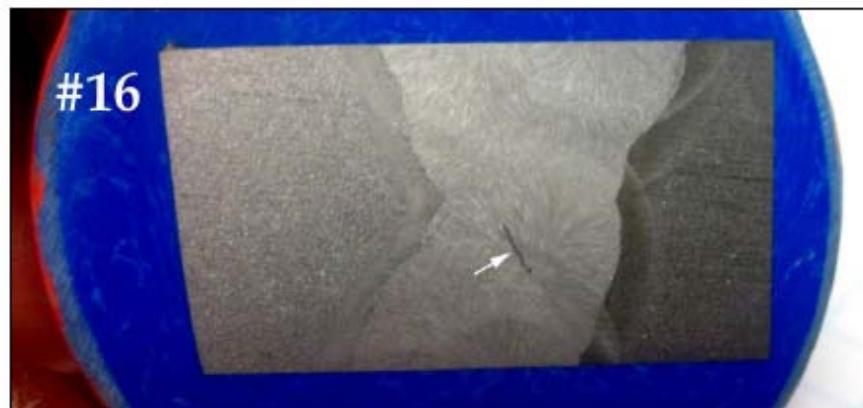
**Figure F71. (A) Core #16 location on the exterior surface of the web. (B) Transverse metallographic section through indication at Core #16.**

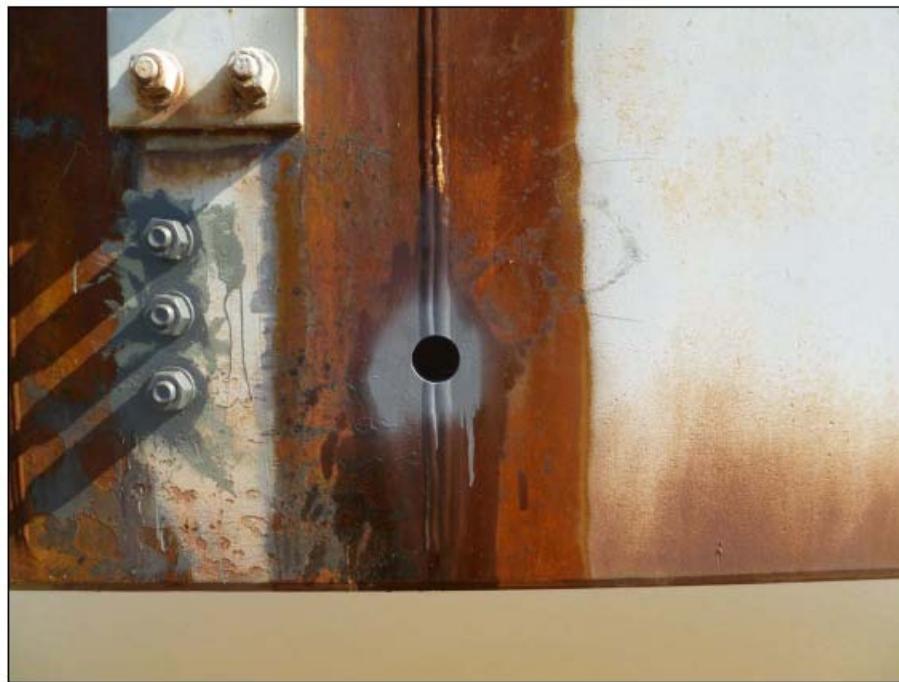
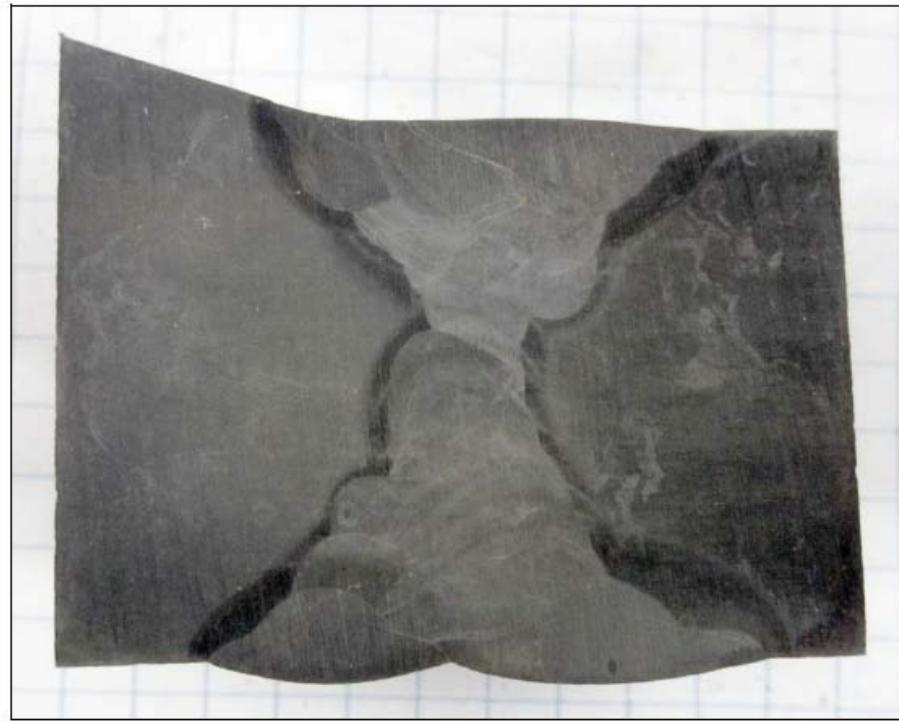
Core #17 Location	Inspection Method	Flaw Location from Top – Y (in)	Flaw Length (in)	Flaw Disposition	Flaw Overlap %	Comments
DS-2, T3, DV-K  2.16" Dia. Core from Top (18")	MT – PSI	-	-	-	-	Accept
	RT – ATS	14.0	0.55	Incomplete Fusion	0	Reject
		<b>18.0</b>	<b>0.20</b>	<b>Porosity</b>	<b>0</b>	<b>Reject</b>
	UT – PSI	25.0-26.0	0.50	Inc. F., Porosity, Slag	0	Reject
		6.0-7.1	1.1	C, 0.72" from surf.	0	Accept
		12.7-16.8	4.1	A, 0.70" from surf.	0	Reject
	Visual	15.0-16.7	1.7	C, 0.72" from surf.	0	Accept
		-	-	-	-	-
<b>Core-ATS</b>		<b>No Flaw</b>	-	<b>No flaw found</b>	<b>NA</b>	<b>0 flaws</b>

**Figure F76. (A) Location of Core #17 on exterior surface of the web. (B) Macro-etched section of Core #17 (No cracks found).**

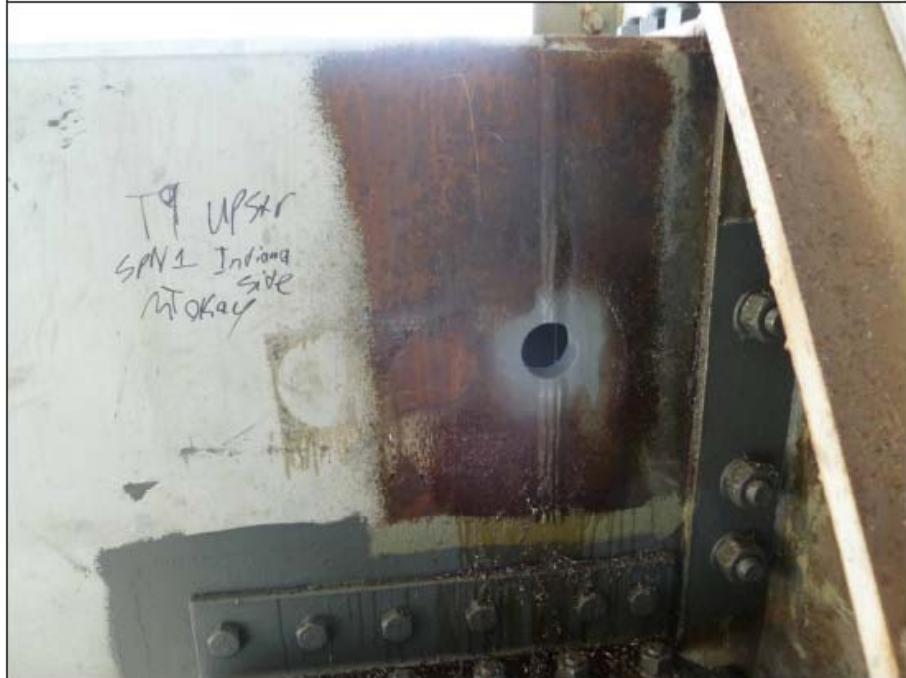
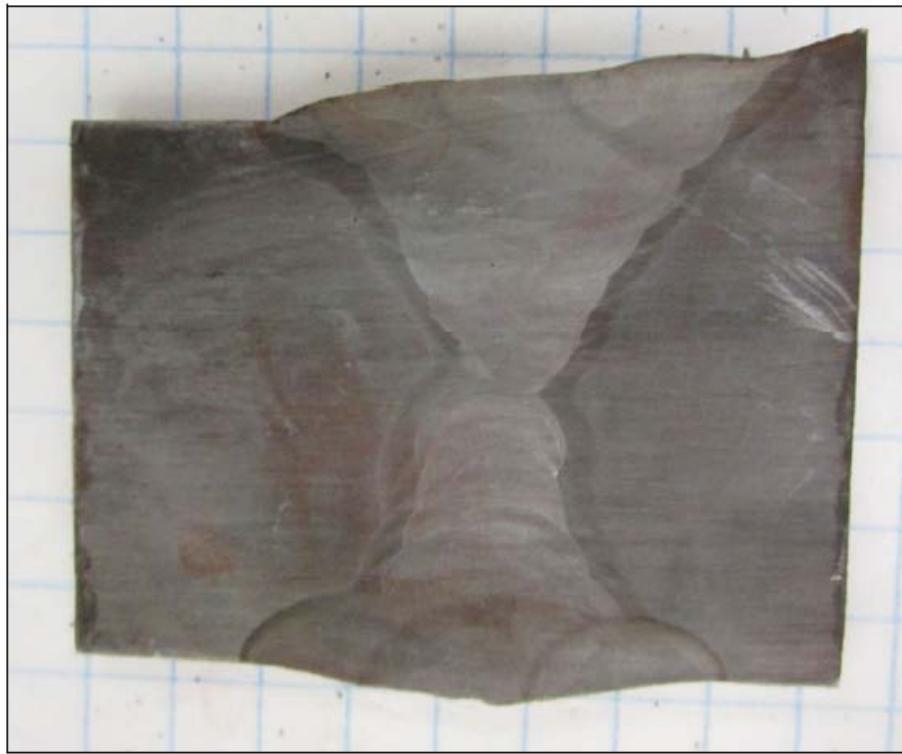
Core #18 Location	Inspection Method	Flaw Location from Top – Y (in)	Flaw Length (in)	Flaw Disposition	Flaw Overlap %	Comments
US-1, T9, DV-I  2.17" Dia. Core from Top (12")	MT – PSI	-	-	-	-	Accept
	RT – ATS	12.0-13.0	0.8	Slag	0	Reject
	UT – PSI	-	-	-	-	Accept
	Visual	-	-	-	-	-
	Core-ATS	No Flaw	-	No flaw found	NA	0 flaws

**Figure F81. (A) Core #18 location on the exterior surface of the web. (B) Macro-etched cross section of the Core #18.**
