**COMPARISON OF NONDESTRUCTIVE TESTING  
TECHNOLOGIES USED FOR INSPECTION OF WELDED  
JOINTS**

A Thesis Presented to the Faculty of Graduate School at the  
University of Missouri-Columbia

HABIBURAHMAN HOTAKI

JUNE 2014

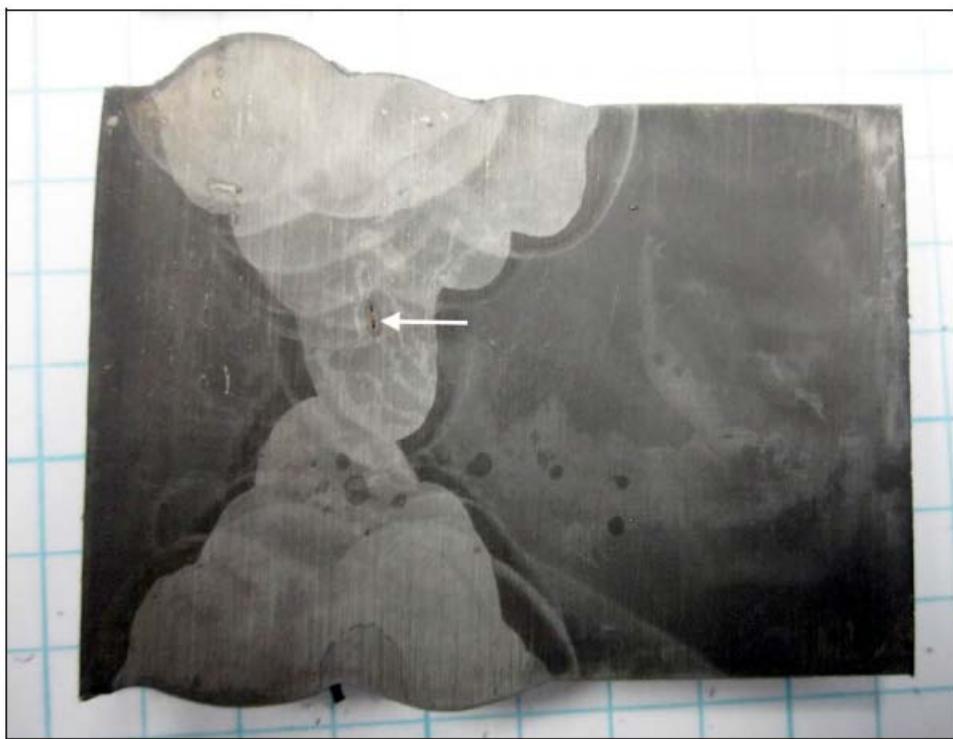
Figure F87. Macro-Etched cross section of the Core #19 indicating a flaw

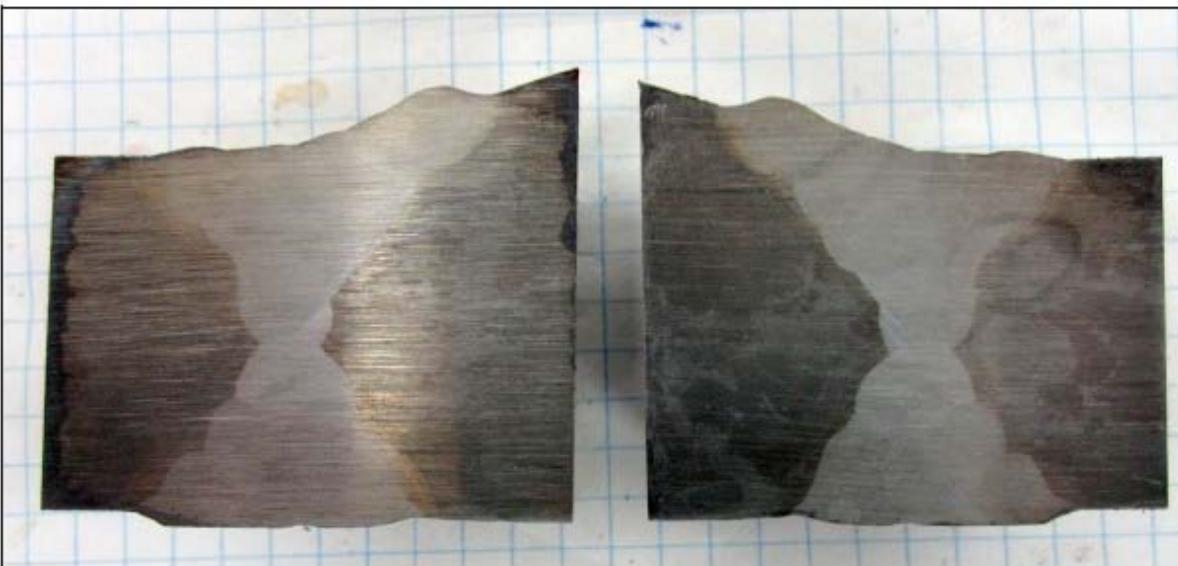
Core #20 Location	Inspection Method	Flaw Location from Top – Y (in)	Flaw Length (in)	Flaw Disposition	Flaw Overlap %	Comments
DS-2, T4, DV-K  2.16" Dia. Core from Top (7")	MT	-	-	-	-	Accept
	RT	7 - 9	1.1	<i>Inc. fusion &amp; porosity</i>	-	Reject
		20 - 22	1.7		-	Reject
	UT	30.75	1.5	A, 0.70" from surf.	0	Reject
		24.0	1.5	A, 0.60" from surf.	0	Reject
		2.78	1.0	C, 0.62" from surf.	0	Record
		11.5	1.5	A, 0.78" from surf.	0	Reject
	Visual	DV-K (Ext)	-	Excessive Convexity	-	Reject
		DV-K (Int)	-	Excessive Convexity & Lack of Fusion	-	Reject
	Core-ATS	No Flaw	-	No flaw found	NA	0 flaws

Figure F93. Core #20 Macro-Etched cross section showing no flaws
