## 11. Case Study

## Post-Tropical Cyclone Gita Mission in Tonga

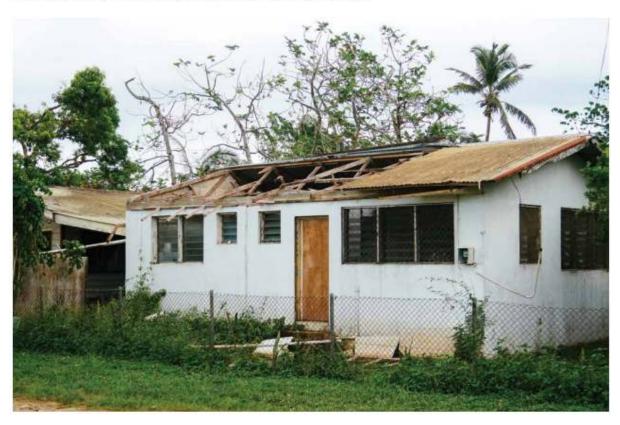
• Crowdsourced building damage assessment by the Humanitarian OpenStreetMap Team (HOT). The pre- and post-event UAV images were used to carry out a crowdsourced damage assessment. A small subset of volunteers from HOT were tasked with doing the visual interpretation of the damage to housing. A simple classification scheme was used: houses that appeared to be more than 50 percent damaged were labeled "destroyed," and those that appeared to be less than 50 percent damaged were labeled "damaged" (Figure 16).

Figure 16 A house destroyed by Tropical Cyclone Gita in Longolongo village, Tongatapu, Tonga.

Photo: Malani Wolfgramm/World Bank. Damaged home in Longolongo, Tongatapu,
